SUBJECT: SHIPROCK DISPOSAL SITE
OBSERVATIONAL SITE VISIT

Report: WM-00058/12-001

Facility: Shiprock Disposal Site

NRC Trip Report

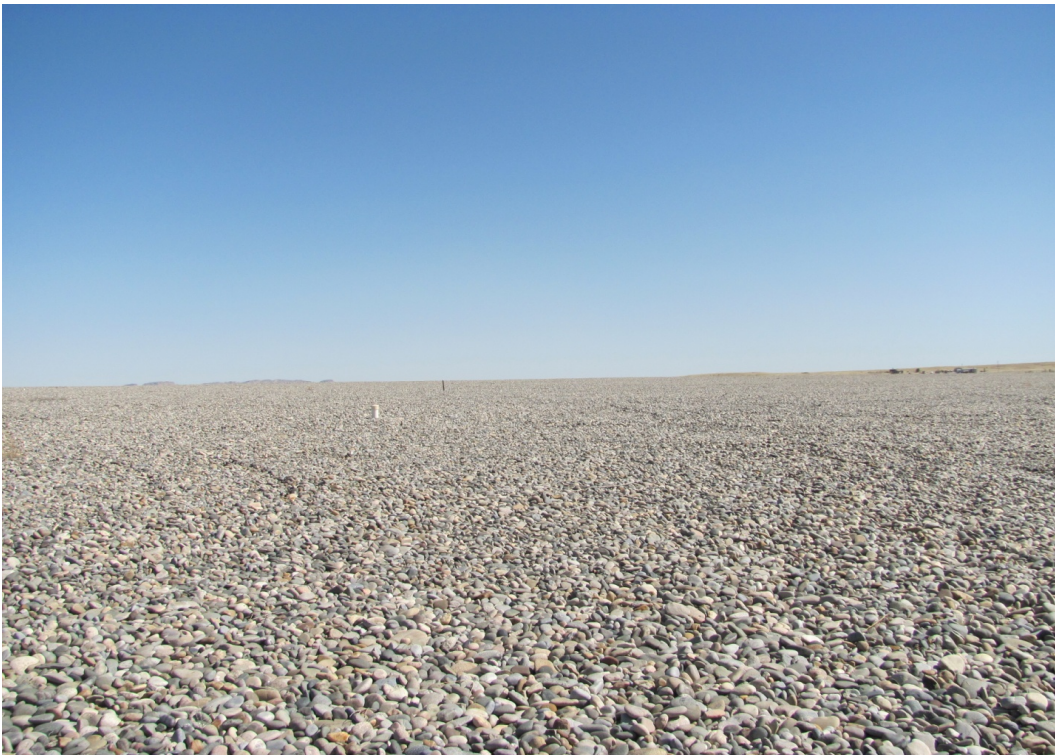
Figure 2: Top of Cell

During the inspection, DOE contractors observed that the site fences were adequately intact, most site and survey markers and monuments were in place, and the entrance gate was intact. Only one of three boundary monuments, BM-1, could be located. An unsuccessful attempt was made by the DOE contractors to locate the two other boundary markers, which are obscured from view by sand, using a metal detector. There was sand, tumbleweed, and trash accumulation along the fence, although the fence was still functional. The disposal cell appeared to be in excellent condition, with small amounts of scattered vegetation on the top and sides. The erosion barrier was in place, and no settlement was observed.

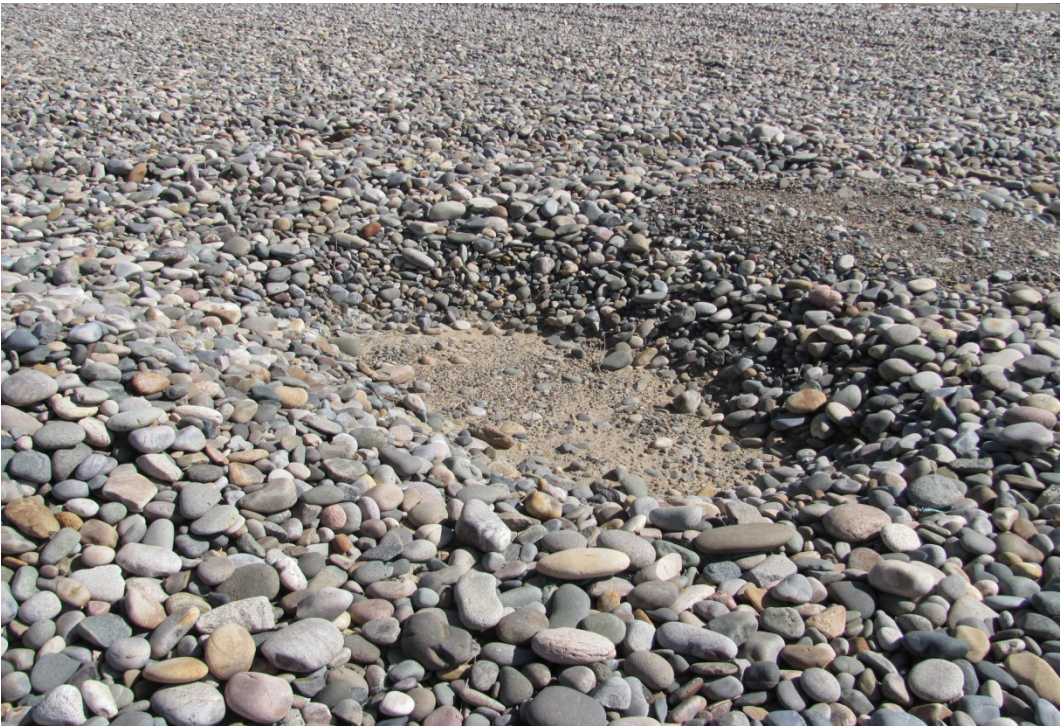
Figure 4: Experimental Pit on Top of Cell

On top of the disposal cell, four open research pits, which have been identified in past DOE inspection reports, were viewed. Each pit had the rock removed down to the bedding layer. The NRC inspector questioned why these pits had not been closed if the research was complete. The DOE Site Manager stated that the pits will be closed over with the rock cover during a future visit.
