Report on Deployment of Miscellaneous Tank and Piping Cleaning Equipment and Methodology

**Tank Focus Area Milestone B.1-1 for
Technical Task Plan (TTP) OH0-0-WT-22**

August 30, 2002

West Valley Nuclear Services, Co.

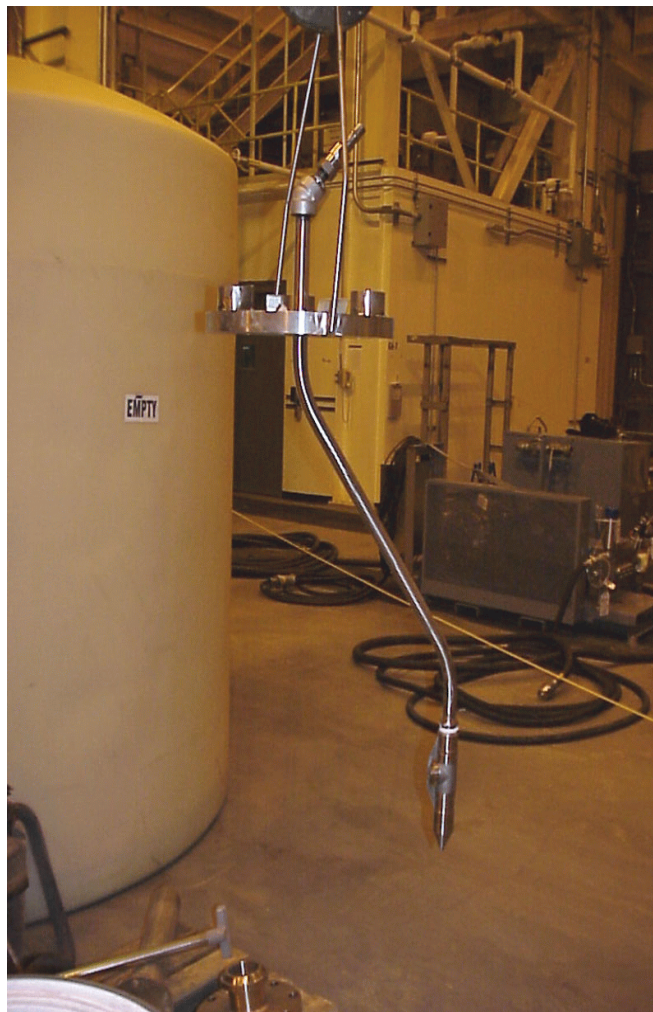
For cleaning of the tank internals a rotary spray nozzle was selected from Gamajet® to provide a spherical coverage of the internal surfaces of the vessel. The pump was operated between 500 and 1200 psi with a flowrate between 25 and 35 g.p.m. The nozzle took approximately 24 minutes to make one complete cycle in a tank. The Gamajet® rotating turbine is driven by the cleaning-fluid so that no additional services are necessary. The cleaner was purchased both as a standard item and specially modified to include lead-ins and tapered edges to accommodate remote entry into a 3-inch opening. To deploy the nozzle remotely, several fixtures were designed for adapting to various nozzles on the vessels.

Tank Cleaning Fixture With
Gamma Jet Nozzle
Photo 3-3

Two cleaning fixtures were designed and fabricated to fit in a CFMT 12-inch nozzle. The first incorporated a mounting flange and could be positioned in two orientations to provide two different spray positions. A second unit was modified, based upon field experience, with a change to the flange orientation to allow easier installation and withdrawal from the tank. These units were also used on the MFHT with an additional flange adaptor. An additional 6-inch flange-mounted cleaner was also built to provide coverage in other areas of the MFHT head. Prior to initial deployment in the cell the cleaning fixtures were tested in a mock-up to verify that the assembly, fixture, connectors and hose would hang straight, and could be remotely installed.

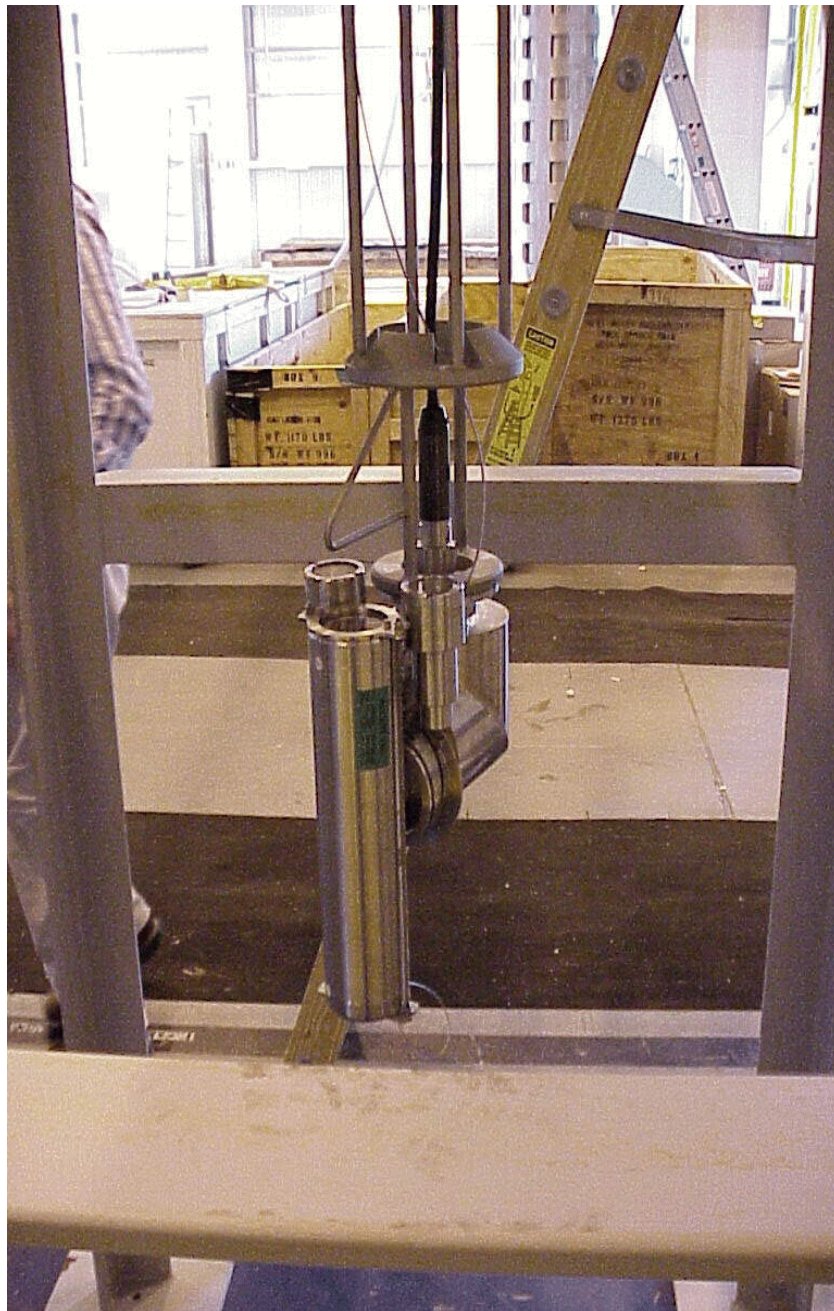
One camera and a spare were purchased for in-tank viewing to monitor flushing progress. A Rees R-981 radiation-resistant, black-and-white camera was purchased. It is equipped with a non-browning 12:72 mm zoom lens, two 75w underwater lights, and pan/tilt capability. A special holding and positioning fixture was designed and fabricated to adapt the camera for deployment by the process crane hook. Before and after viewing of external surfaces was recorded by conventional photographic equipment. Pictures were taken in the Vit aisle ways through the Vit Cell shield windows.

Rees Camera Assembly
Photo 3-5

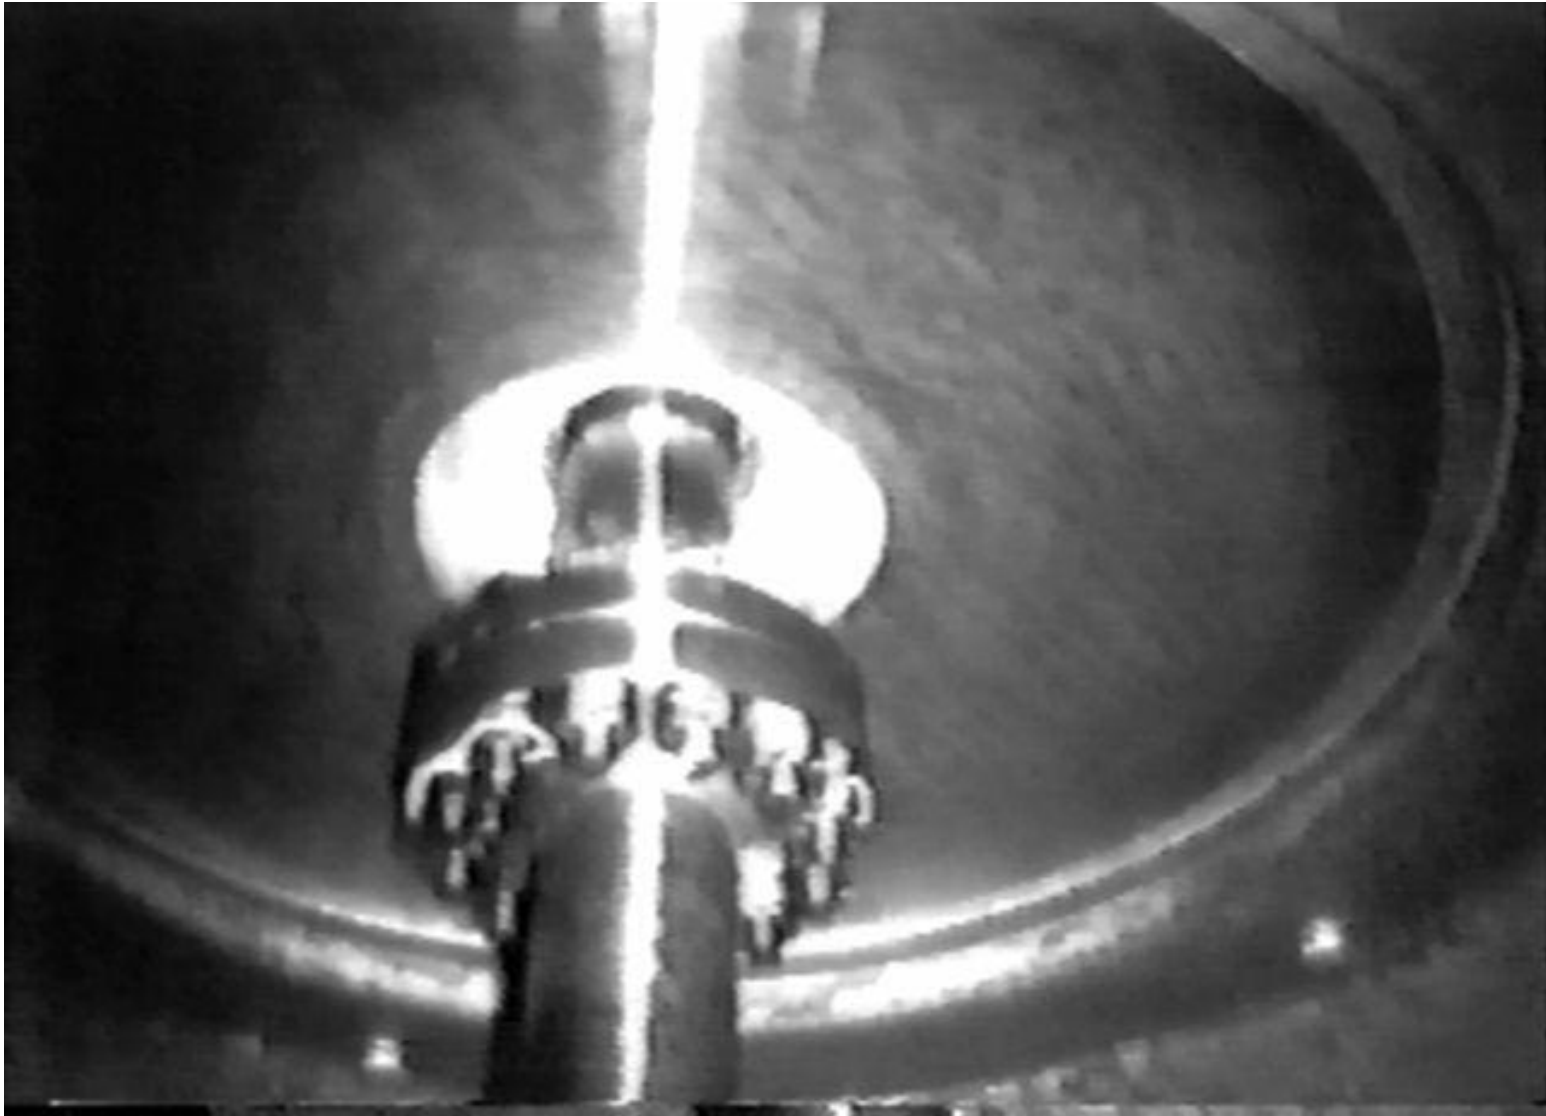
The Rees camera was used to inspect the CFMT internals before and after the flushing. The following still pictures were taken from the VHS recorder attached to the Rees camera. The video tape clearly indicated that the targeted areas of the tank were effectively cleaned during flushing:

CFMT Agitator After Flushing
Photo 4-2

Results of the flushing were evaluated. The video inspections conducted of the CFMT and MFHT internal surfaces showed a dramatic improvement in the degree of cleanliness. The internal surfaces of these tanks were essentially free of any visible deposits and it was noted that even the fabrication weld beads and polishing marks could be identified. The radiation probe data from the CFMT and MFHT was not conclusive as the background contribution to the readings was limiting. The SBS flushing was effective in reducing the solids content within the vessel and reducing the pressure differential across the bed. Waste header flushing was effective based on the reduction of radiation readings taken on the transfer lines. The resultant effect from external high pressure spraying of the accessible vitrification pit components and the pit floor was difficult to assess as the degree of staining of the base metal masked the capability of the CCTV cameras to determine cleanliness. The tank tops were cleaned off and flushed to the cell floor. The liquid on the cell floor was transferred to the CFMT and sampled. The samples obtained during all the flushing evolutions are being analyzed for future use in cell characterization.

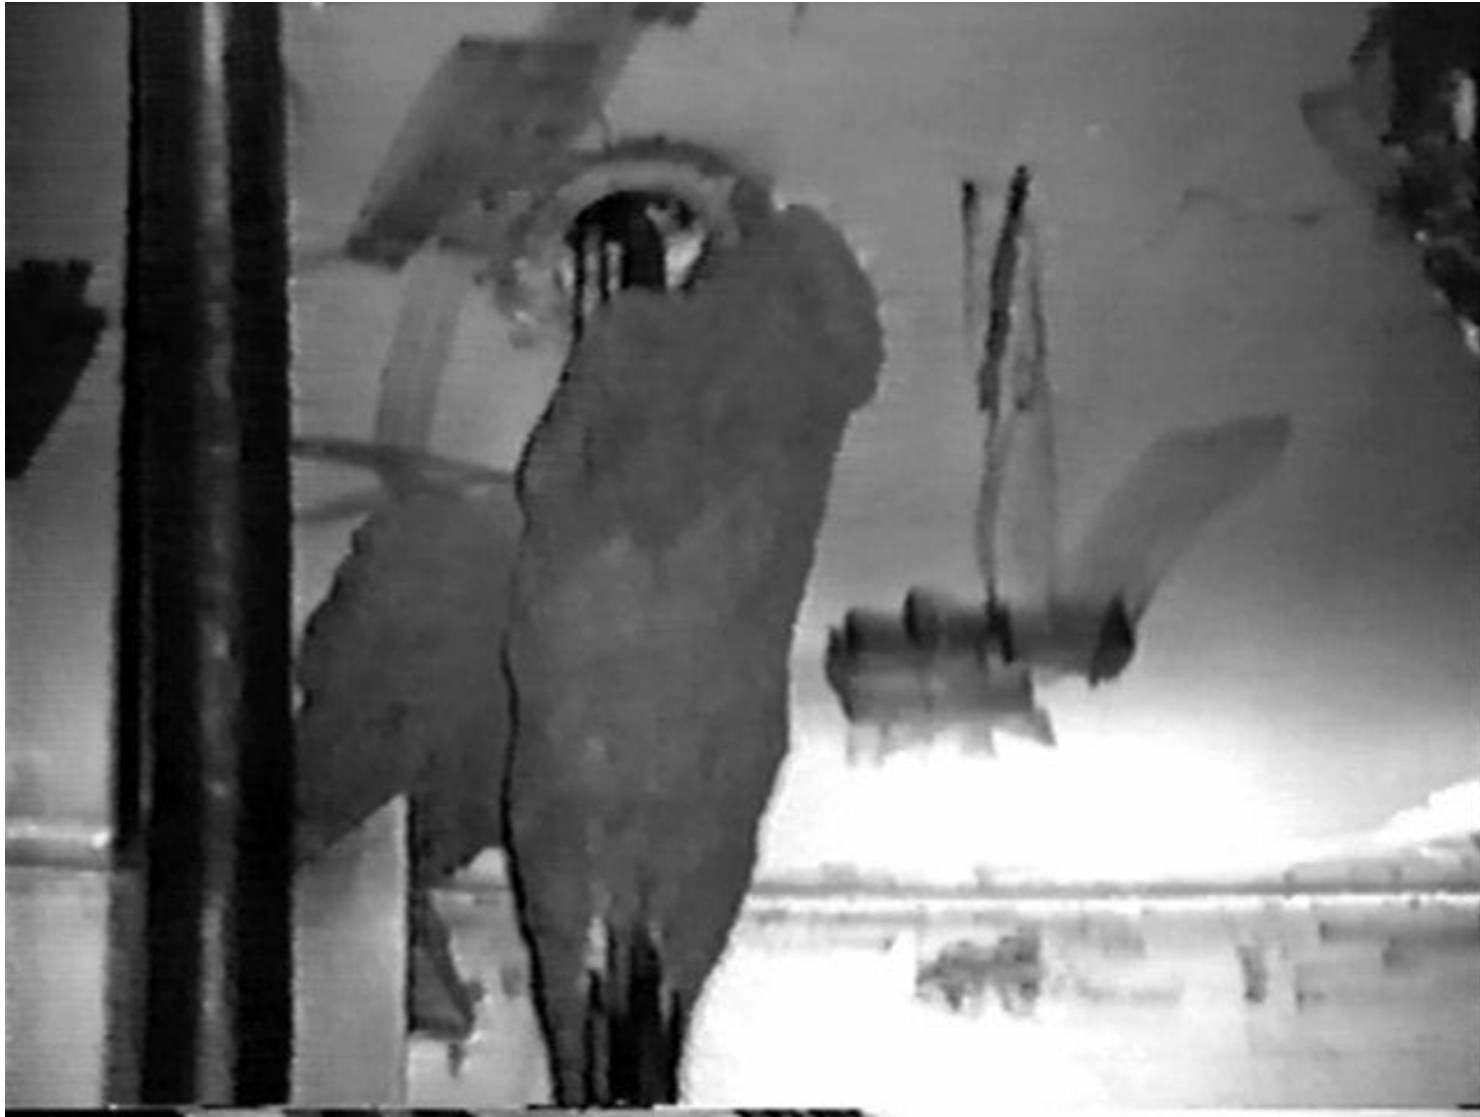
CFMT Internals Before Flushing
Photo 4-3

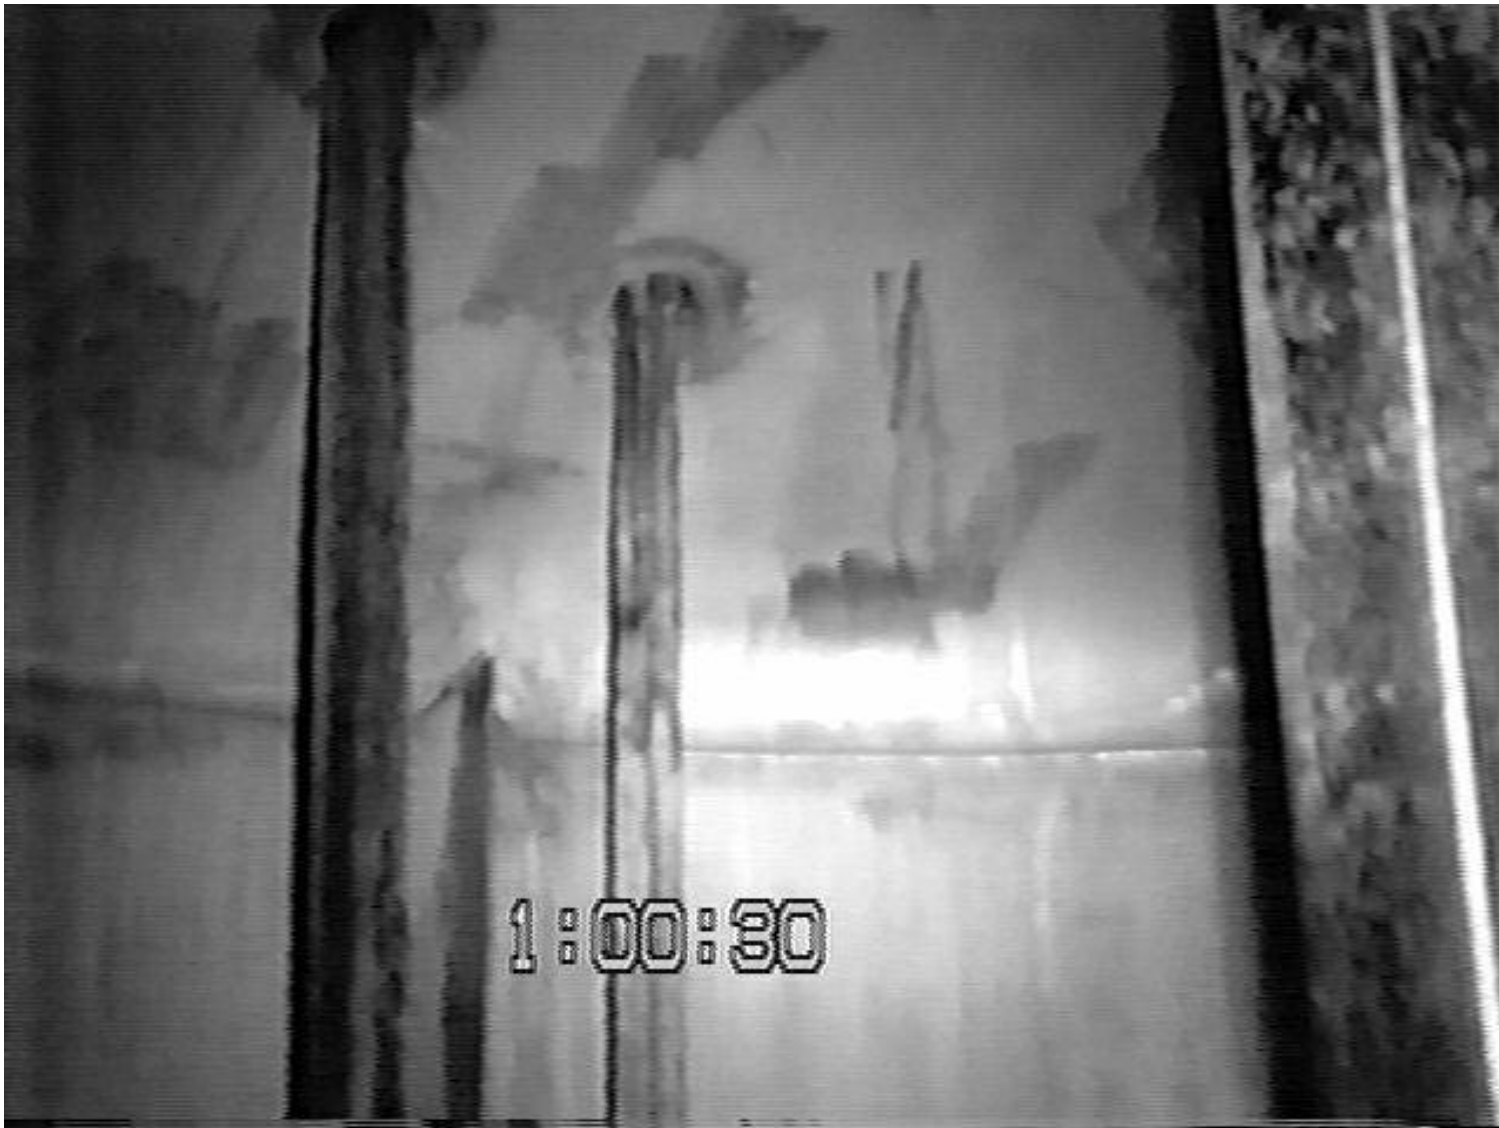
CFMT Internals After Flushing
Photo 4-4

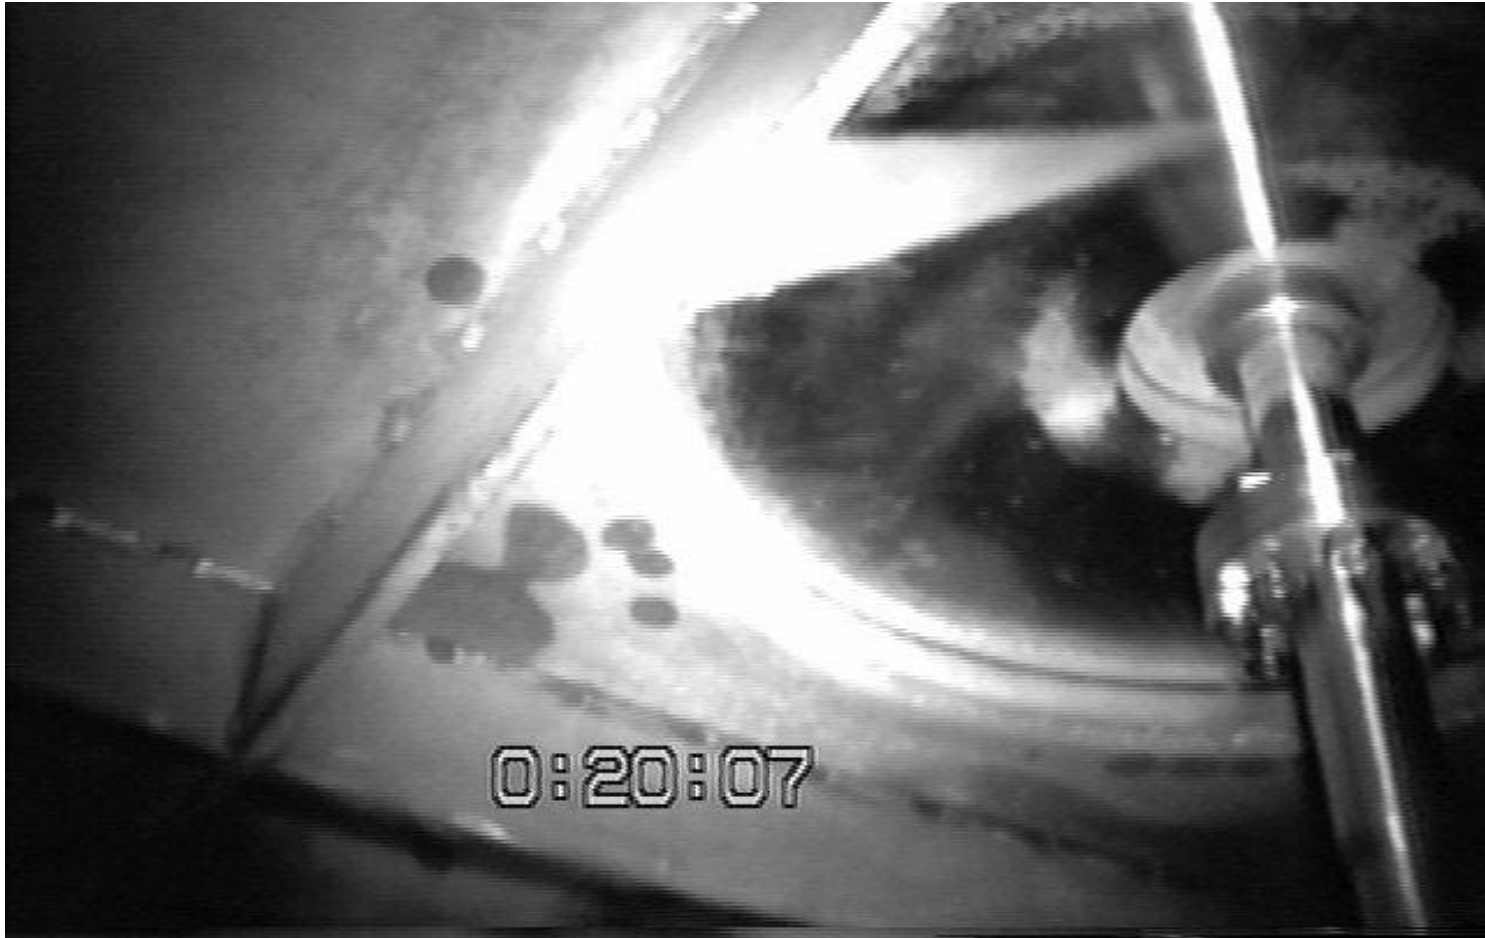
The Rees camera was used to inspect the MFHT internals before and after the flushing. The following still pictures were taken from the VHS recorder attached to the Rees camera. The tape clearly indicated that the targeted areas of the tank were effectively cleaning during the flushing:

MFHT Agitator After Flushing
Photo 4-6

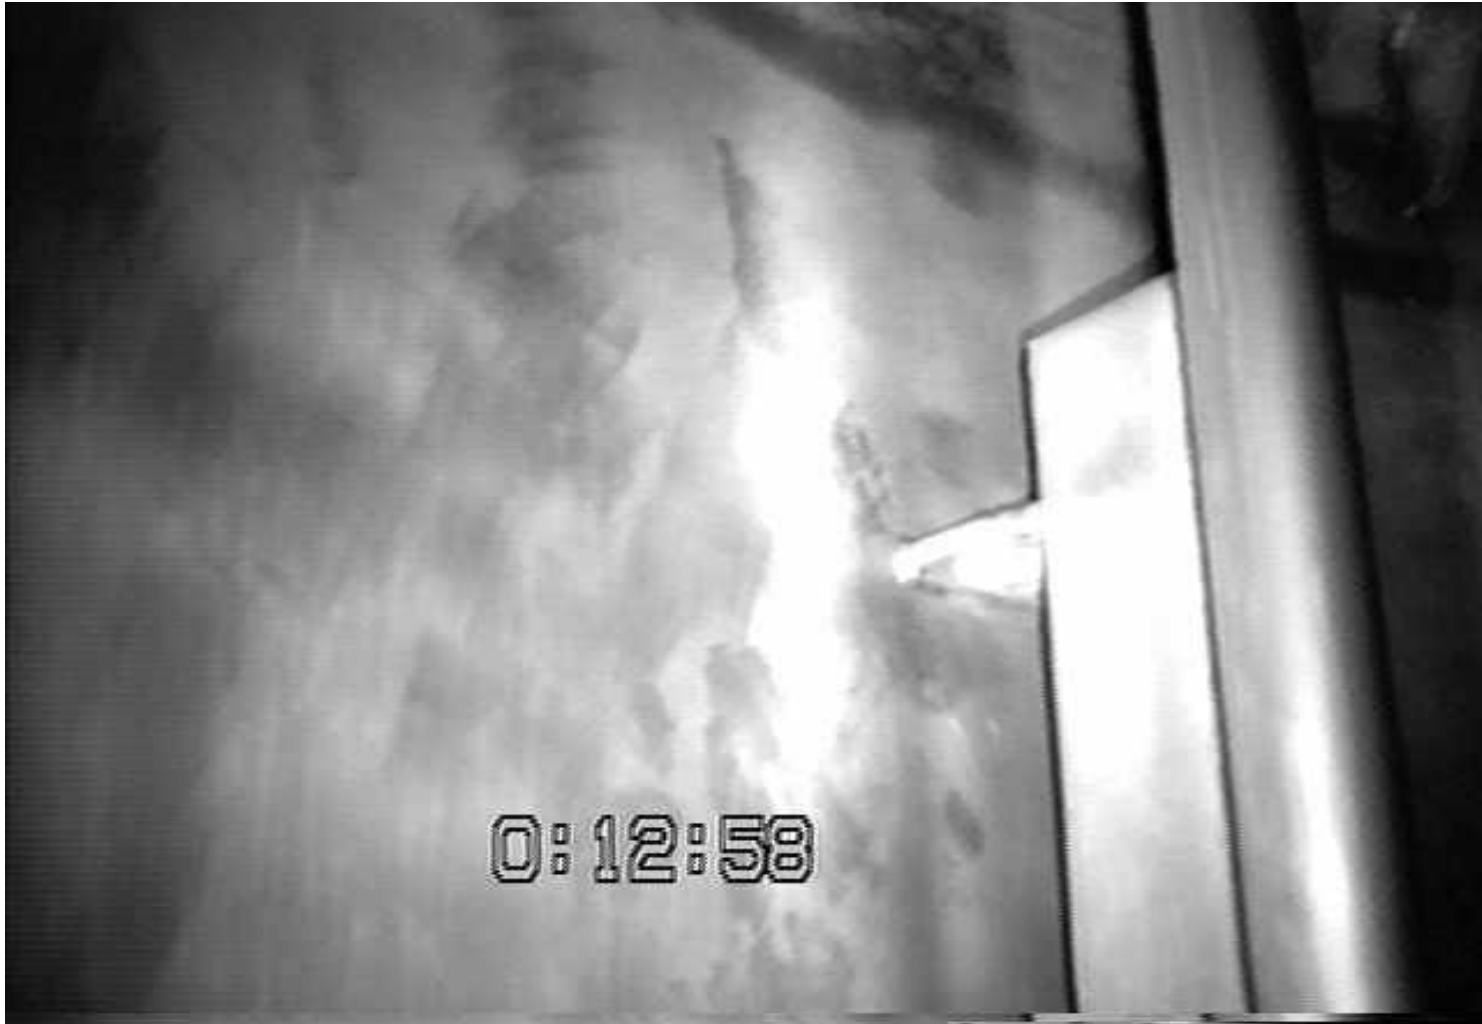
MFHT Internal Baffle After Flushing
Photo 4-8
