PENNSYLVANIA HISTORIC RESOURCE SURVEY FORM – PHOTO/SITE PLAN SHEET

Survey Code / Tax Parcel / Other No.: _____ County: Luzerne 079
Municipality: Salem Township Address: 62 Kiliti Road
Historic Name / Other Name: Kiliti Farm

Date of Survey January 2008

Name of Surveyor Matthew G. Hyland

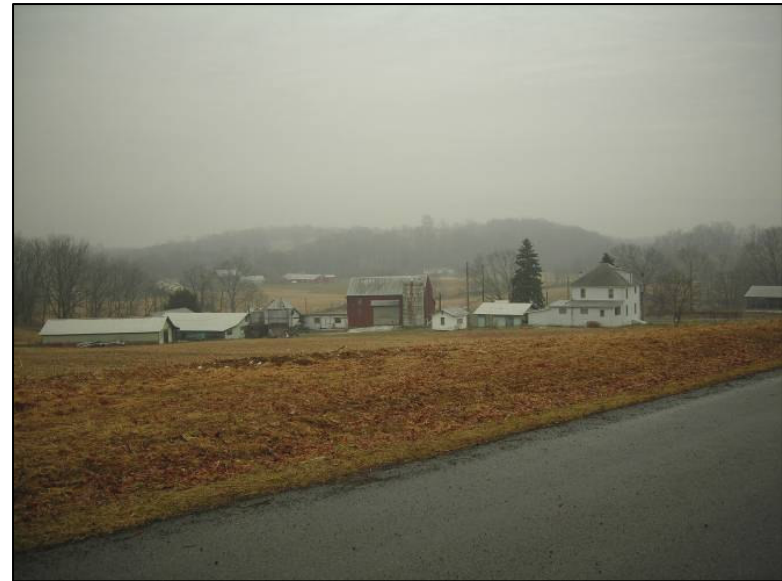
Number	Description of View	Direction of Camera
_____	Overview	<u>S</u>
_____	_____	_____
_____	_____	_____
_____	_____	_____

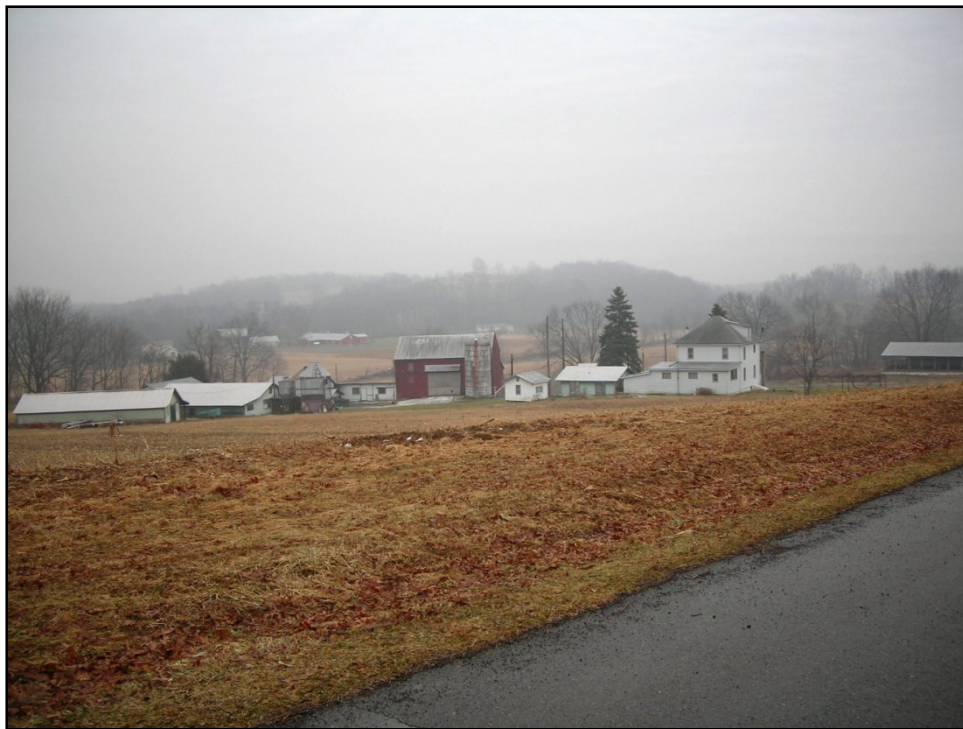
1. Photograph 1
2. Kiliti Farm
3. Salem Township, Luzerne County
4. Farm Overview, Facing Southeast

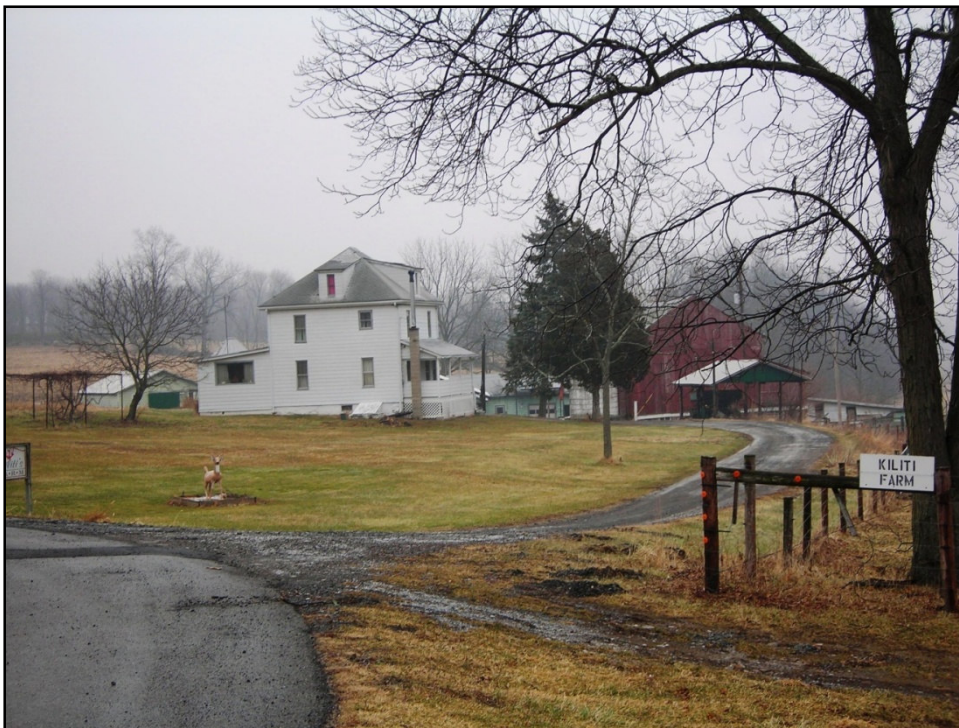
1. Photograph 2
2. Kiliti Farm
3. Salem Township, Luzerne County
4. House, Barn, and Outbuildings, Facing Northeast

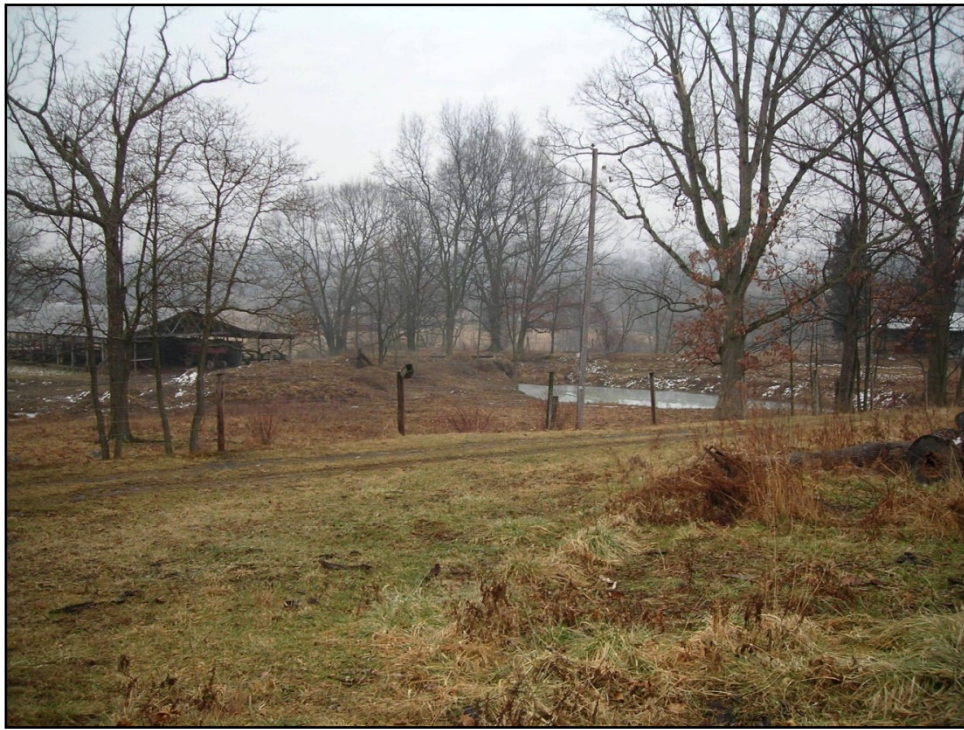
1. Photograph 3
2. Kiliti Farm
3. Salem Township, Luzerne County
4. Vehicle/Equipment Shed and Pond, Facing Southeast

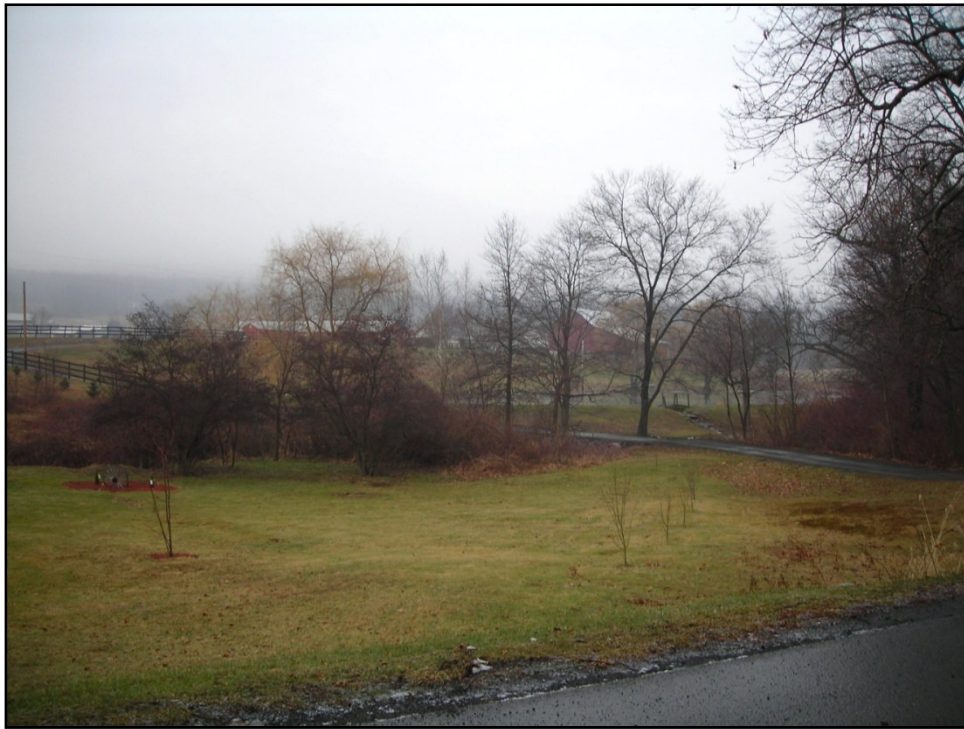
1. Photograph 1
2. Heller Farm
3. Salem Township, Luzerne County
4. Farm Overview, Facing Northwest

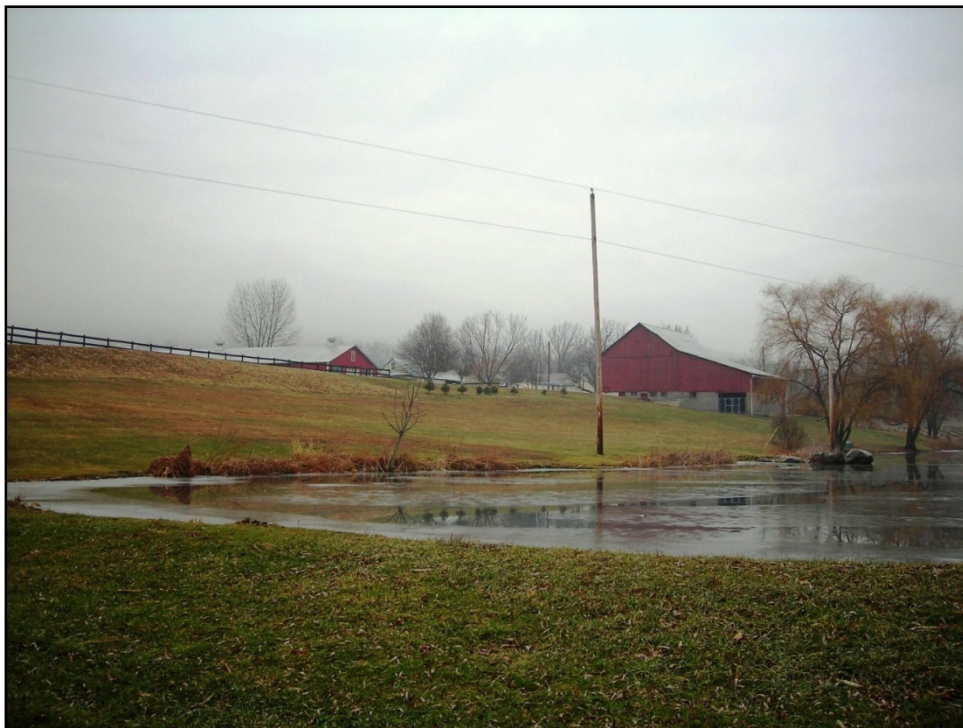
1. Photograph 2
2. Heller Farm
3. Salem Township, Luzerne County
4. Farm Overview, Facing North

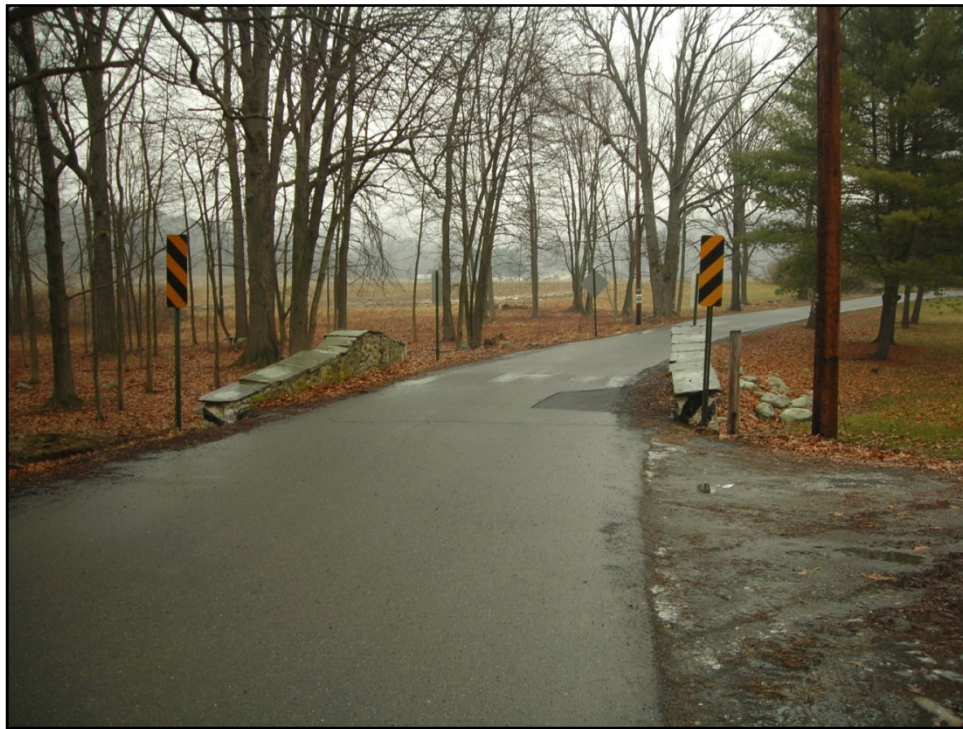
1. Photograph 1
2. North Market Street Bridge
3. Salem Township, Luzerne County
4. Facing North

This bridge is not directly associated with any significant events or trends in local or regional history. As such, it is recommended not eligible for NRHP listing under Criterion A. No documentary evidence linking the bridge to any significant individuals in local or regional history could be identified. Therefore, this bridge is recommended not eligible for NRHP listing under Criterion B. This bridge, however, is a rare and well-preserved example of a 20th-century stone arch bridge in the area. Therefore, it is recommended eligible for NRHP listing under Criterion C.

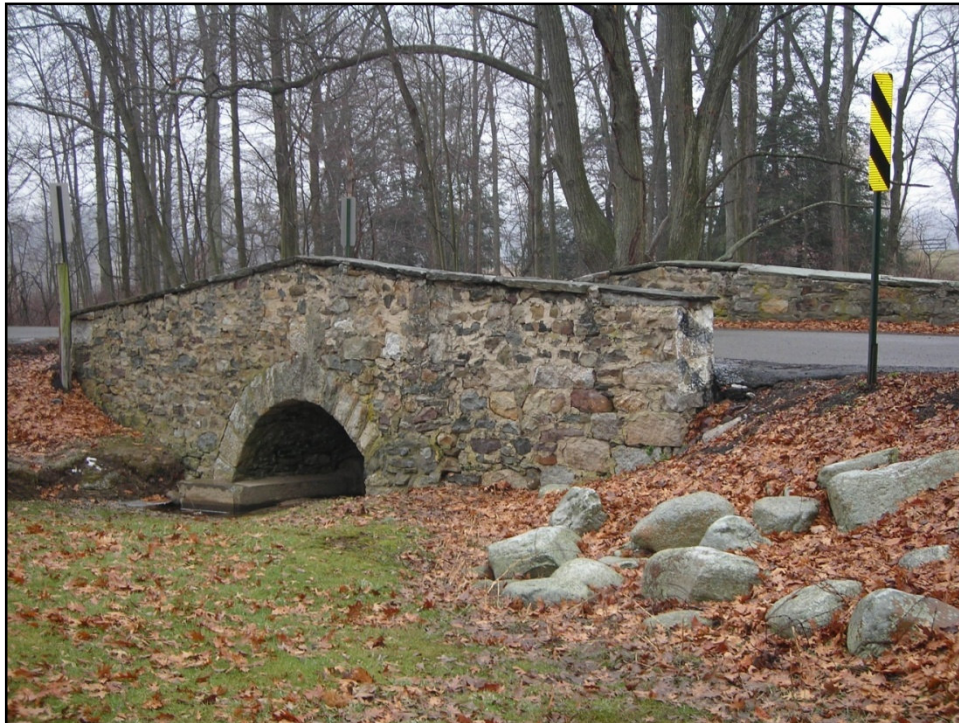
1. Photograph 2
2. North Market Street Bridge
3. Salem Township, Luzerne County
4. Facing West

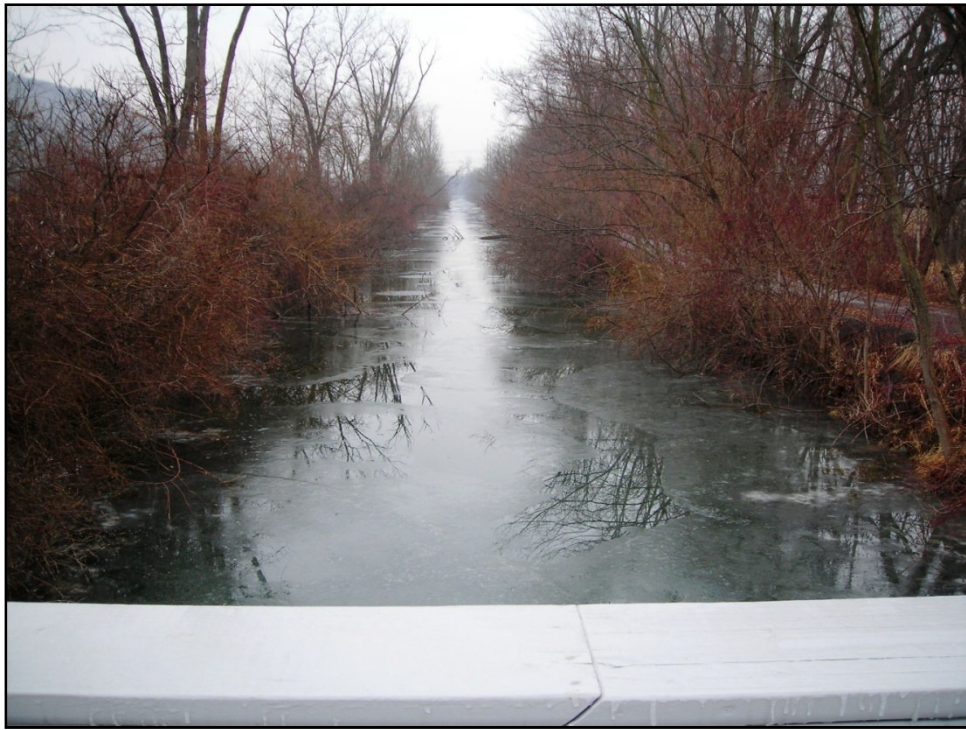
1. Photograph 1
2. North Branch of the Pennsylvania Canal
3. Salem Township, Luzerne County
4. Canal Prism, Facing North

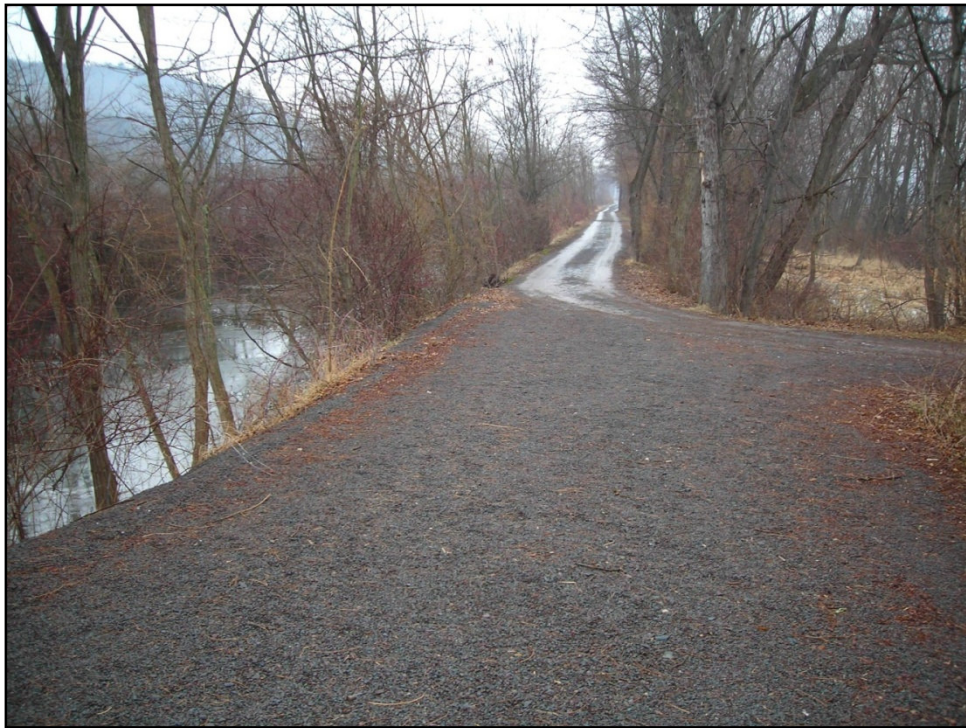
1. Photograph 2
2. North Branch of the Pennsylvania Canal
3. Salem Township, Luzerne County
4. Towpath and Basin, Facing North

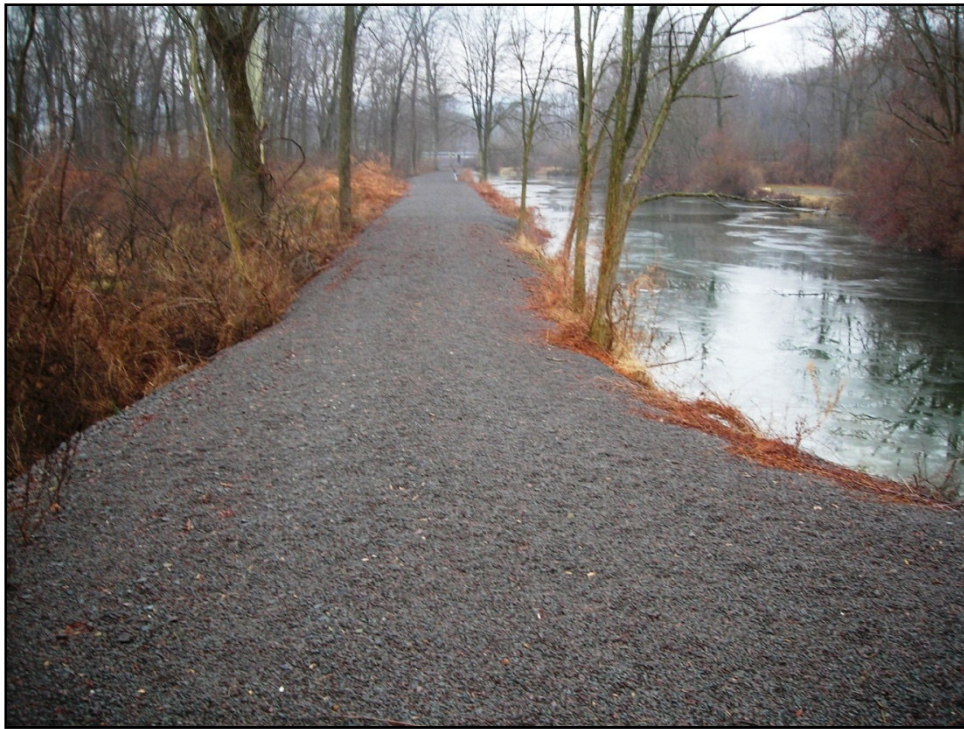
1. Photograph 3
2. North Branch of the Pennsylvania Canal
3. Salem Township, Luzerne County
4. Canal Prism and Towpath, Facing South

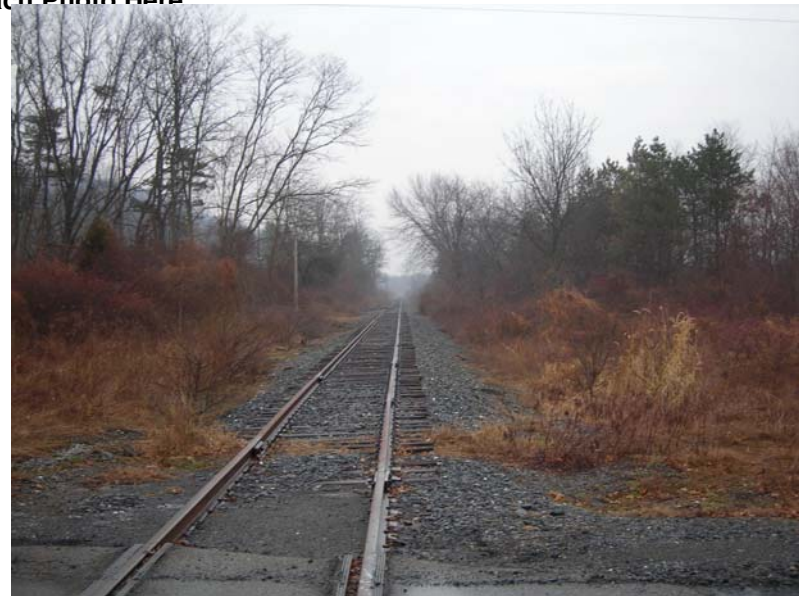
Railroad bed and rails	N
------------------------	---

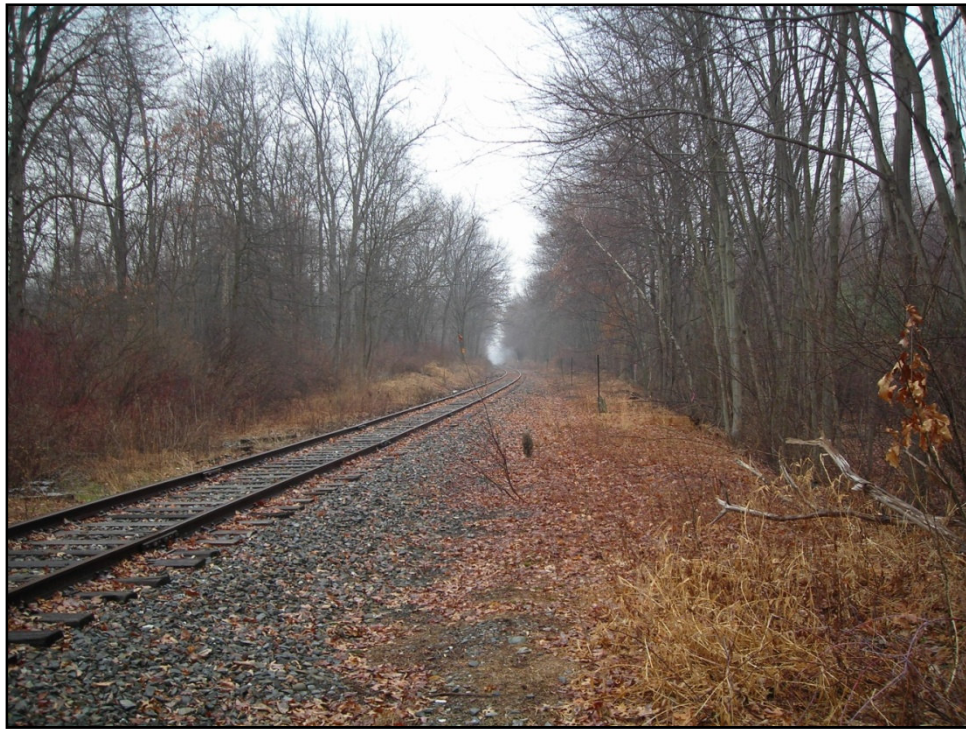
1. Photograph 1
2. Canadian Pacific/Bloomsburg Division of the Delaware, Lackawanna & Western Railway
3. Salem Township, Luzerne County
4. Facing North

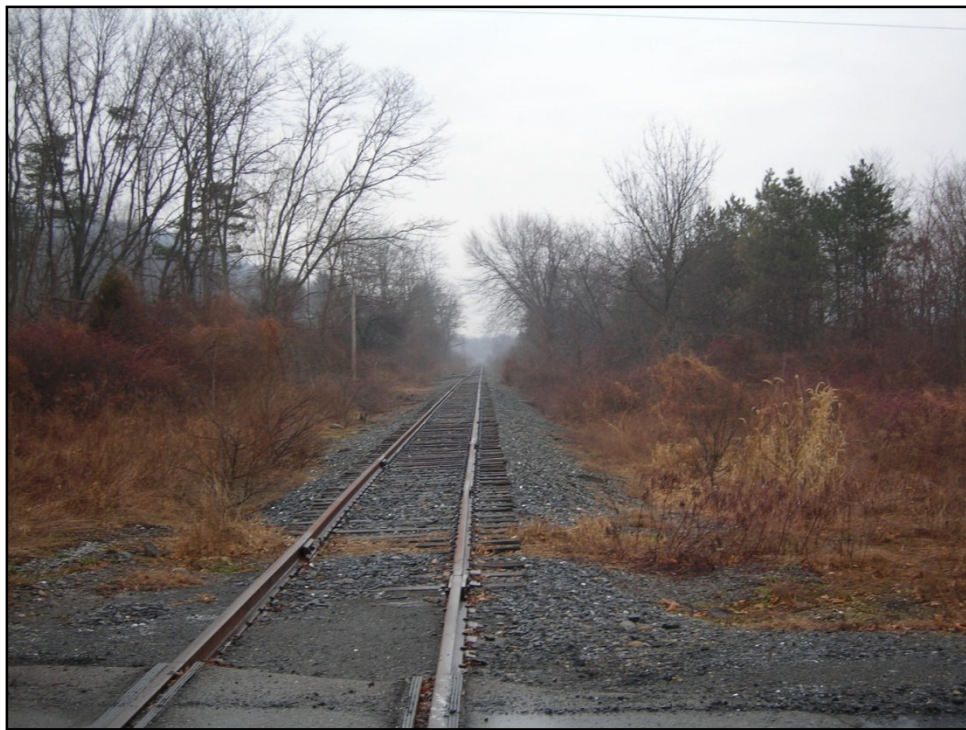
1. Photograph 2
2. Canadian Pacific/Bloomsburg Division of the Delaware, Lackawanna & Western Railway
3. Salem Township, Luzerne County
4. Facing North

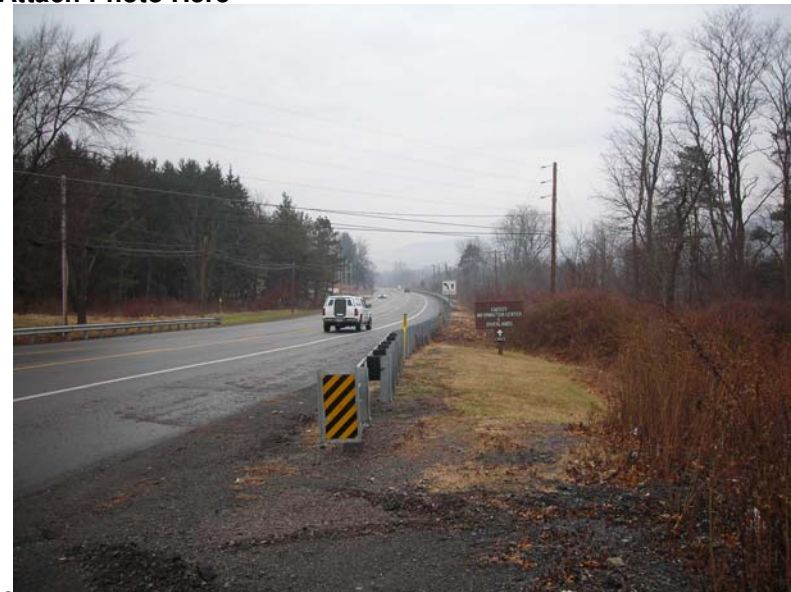
Road bed	N

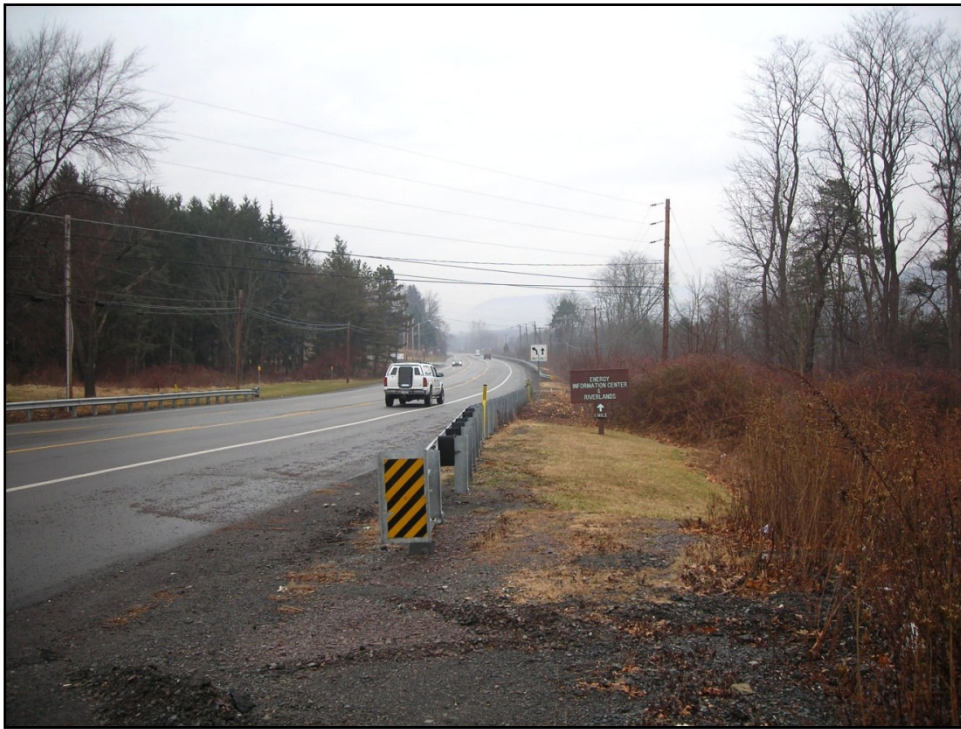
1. Photograph 1
2. Susquehanna and Tioga Turnpike
3. Salem Township, Luzerne County
4. Facing North

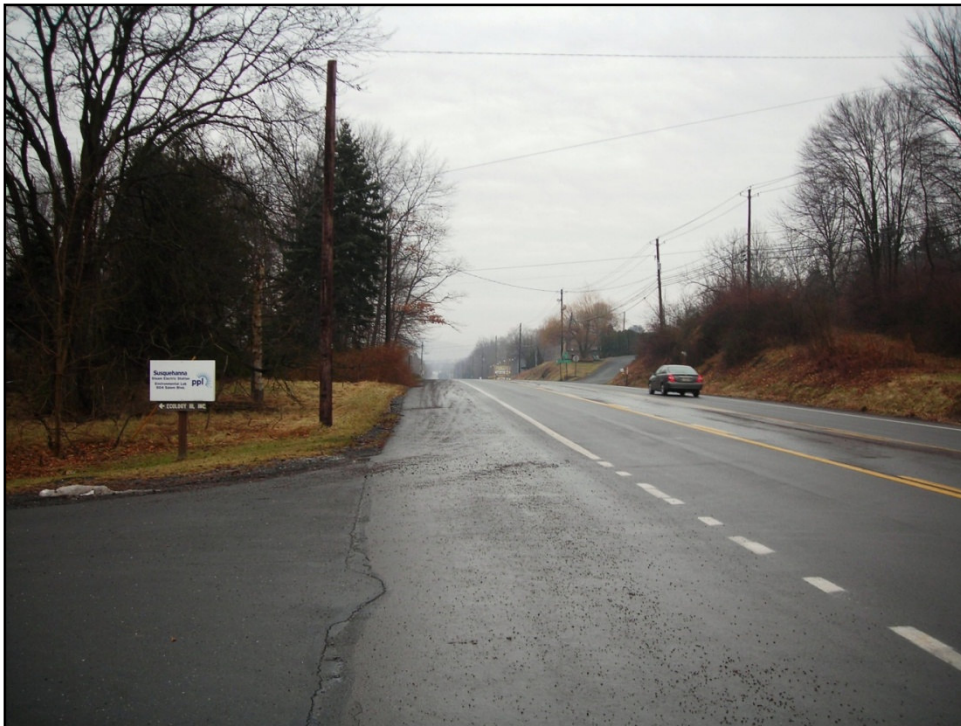
1. Photograph 2
2. Susquehanna and Tioga Turnpike
3. Salem Township, Luzerne County
4. Facing South

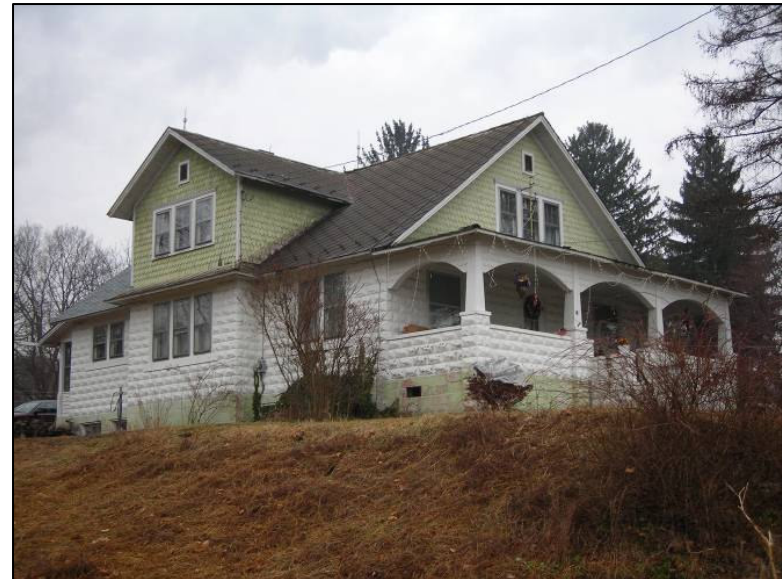
Number	Description of View	Direction of Camera
_____	<u>Facade and SE Elevation</u>	<u>NW</u>
_____	_____	_____
_____	_____	_____
_____	_____	_____
_____	_____	_____

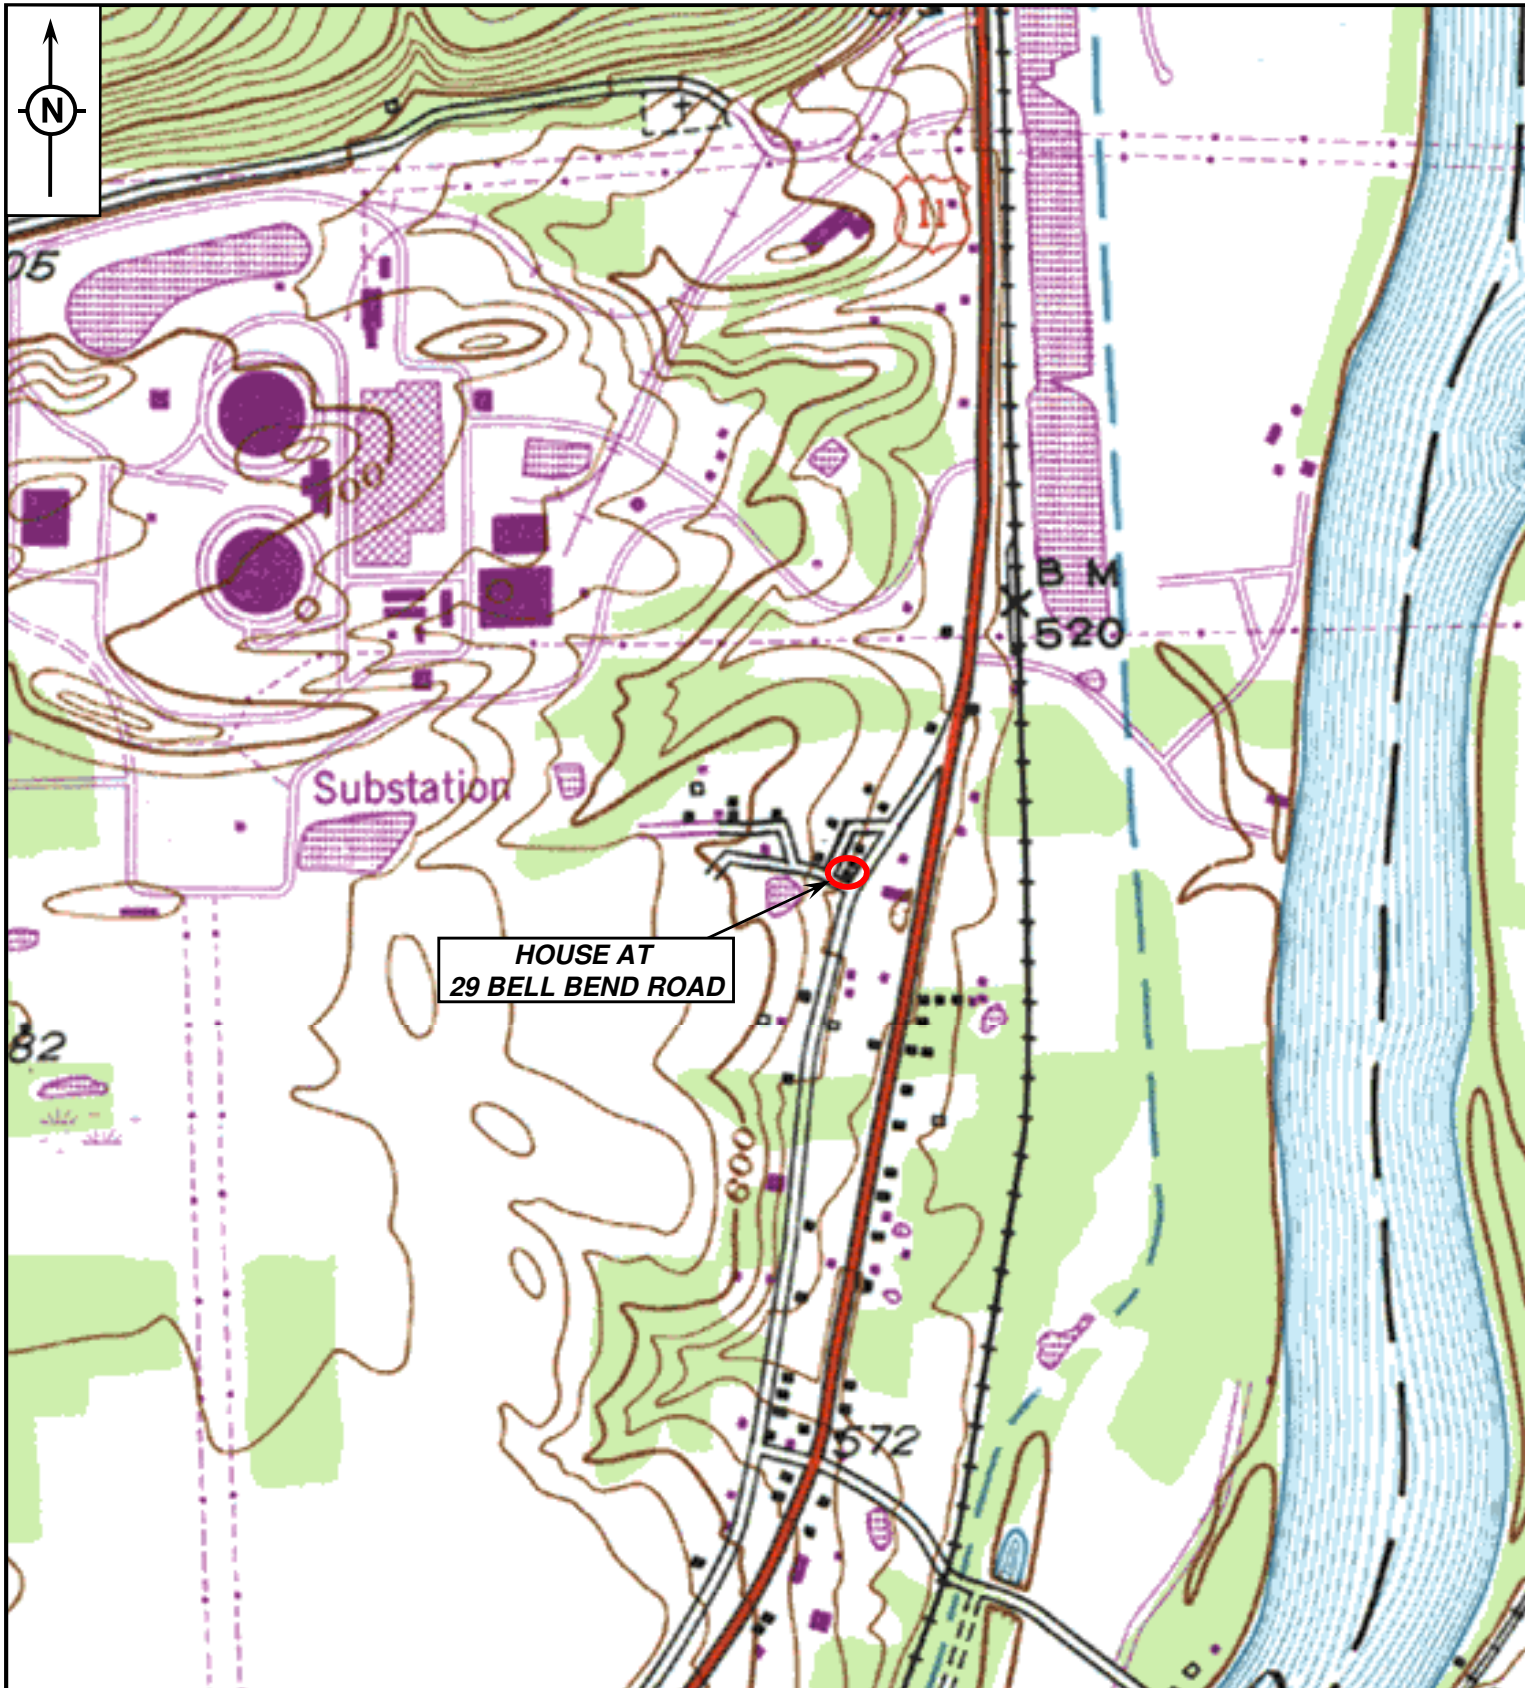
Standing 1.5 stories tall, this circa-1925 gable-roofed Bungalow style residence is constructed on a concrete block foundation. Its exterior is composed of rusticated concrete block on the first story and wood shingles on the attic story. The roof is clad in asbestos and composition shingles and has gable-roofed dormers on the side elevations that extend to meet projecting bays on the first story. The full-width porch has a hipped roof that is supported by tapered wood posts on rusticated concrete block bases, with a rusticated concrete block half wall topped by concrete coping. Additionally, the porch is arcaded, with shingle-trimmed arches, and the steps to the porch are flanked by rusticated concrete block knee walls with concrete coping. An enclosed, shed-roofed, wood shingle-clad porch is located on the rear of the house. The fenestration throughout consists of 3/1 double-hung wood framed sashes that are most often paired or grouped in threes. The first story windows have stone sills. An interior brick chimney rises from the pitched roof and has a corbelled cap.

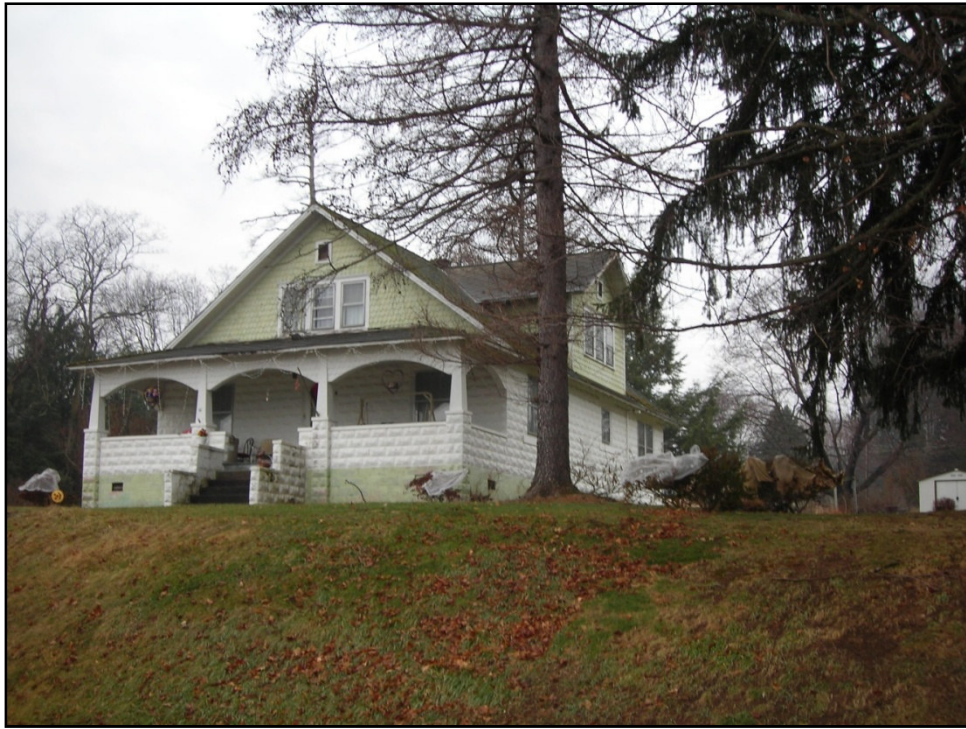
1. Photograph 1
2. House at 29 Bell Bend Road
3. Salem Township, Luzerne County
4. Facade and North Elevation, Facing West

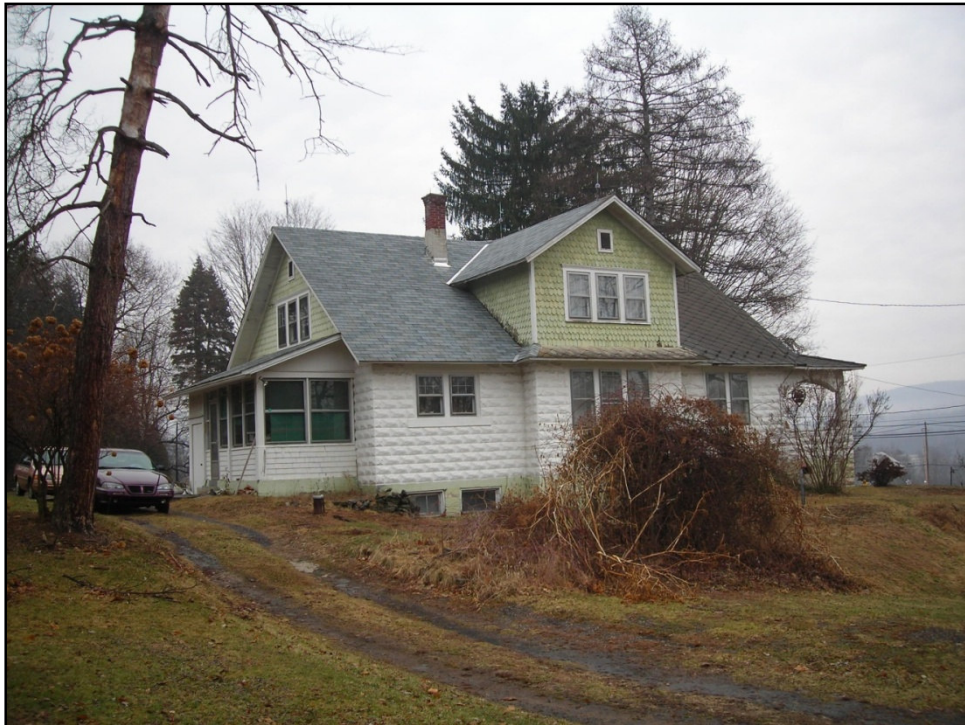
1. Photograph 2
2. House at 29 Bell Bend Road
3. Salem Township, Luzerne County
4. South and East Elevations, Facing North

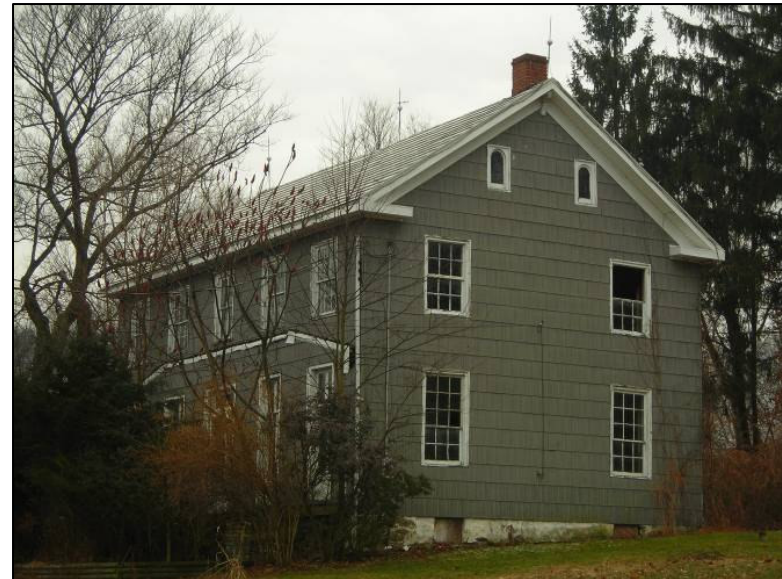
Number	Description of View	Direction of Camera
_____	<u>Facade and NE Elevation</u>	<u>SW</u>
_____	_____	_____
_____	_____	_____
_____	_____	_____
_____	_____	_____

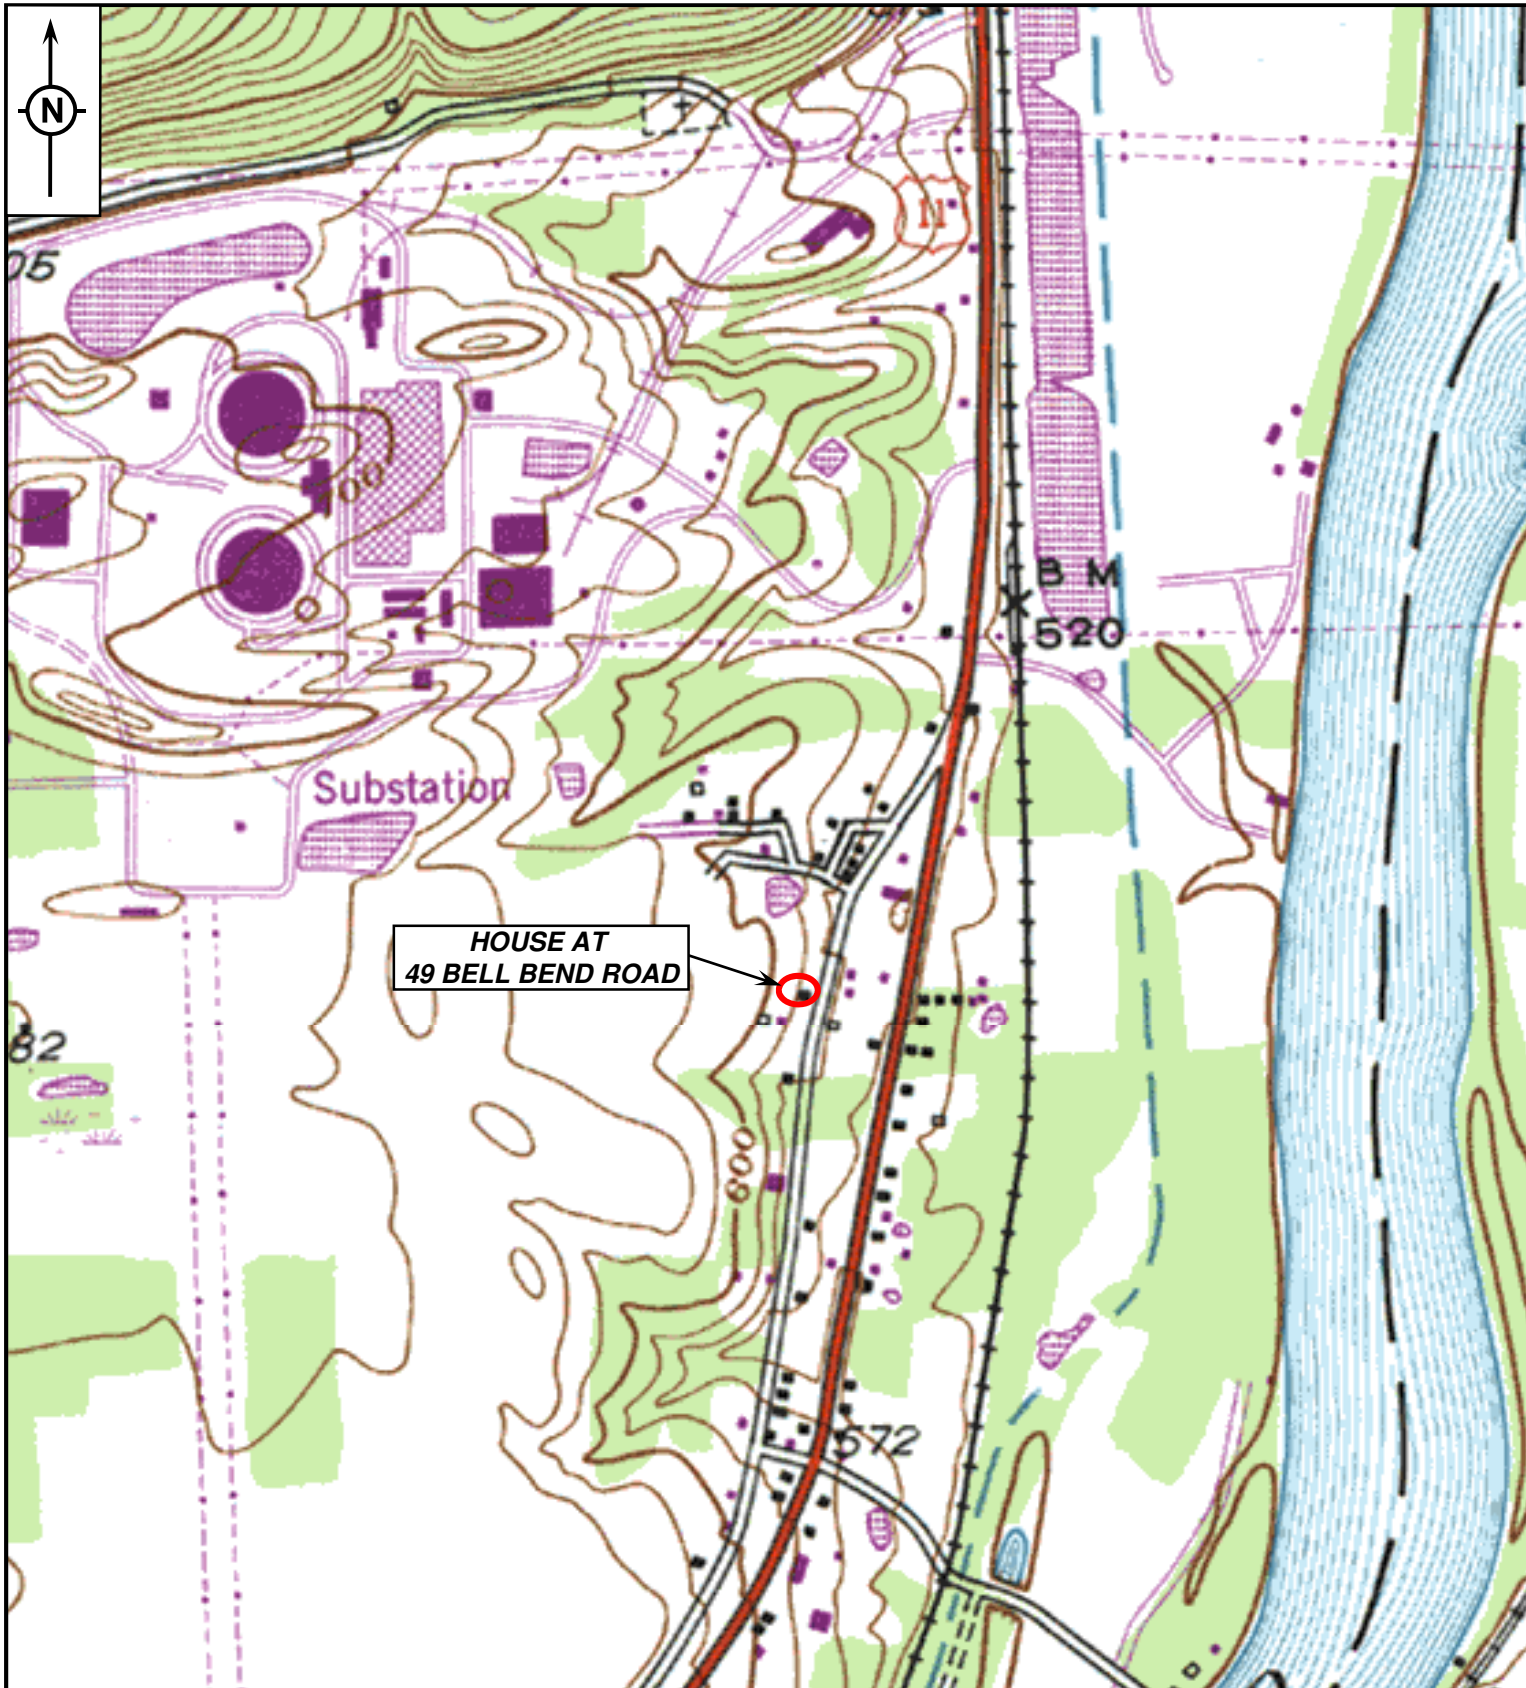
Built circa 1875, the house at 49 Bell Bend Road is a vernacular variant of the Georgian Revival style. This 2-story, gable-roofed house is built on a stone foundation and is clad in Masonite shingles. The shingle-clad gable roof has cornice returns at the gable ends. The fenestration consists of 2/4 and 9/6 double-hung, wood sash windows on the first story and 6/6 double-hung wood sash windows on the second story. Additionally, the attic story has two arch-shaped fixed sash windows on the north gable end and a single arched window on the south gable end. Also on the south gable end is a 2-story projecting polygonal bay and a small, 1-story, shed-roofed porch ell. The original hipped roof front porch has subsequently been removed. A brick interior chimney is located near the north gable end on the ridge.

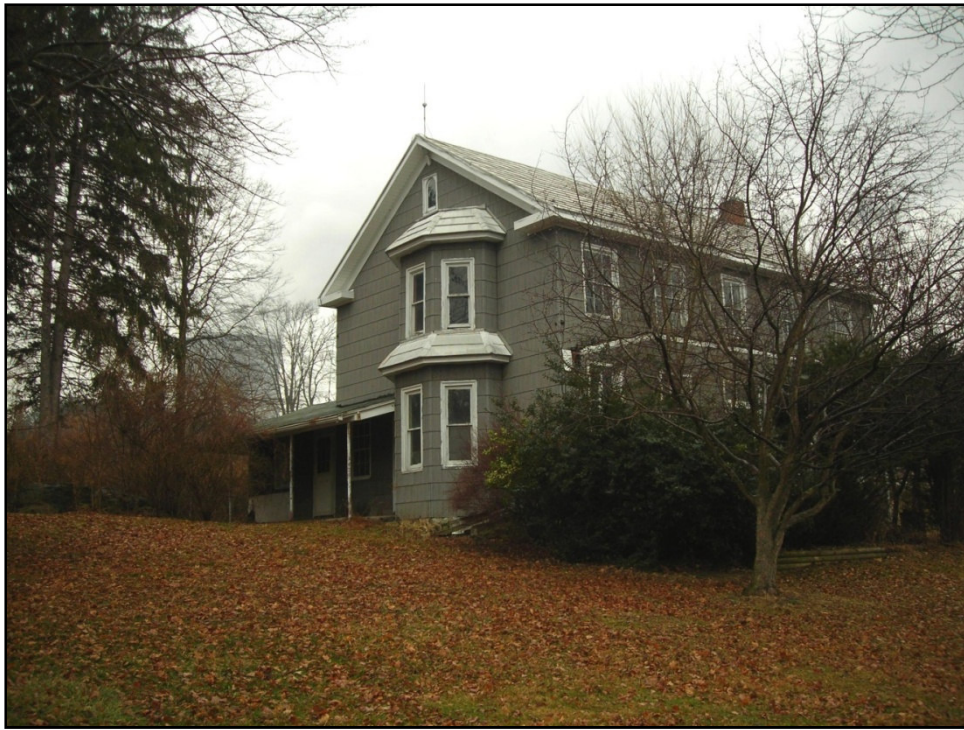
1. Photograph 1
2. House at 49 Bell Bend Road
3. Salem Township, Luzerne County
4. Facade and South Elevation, Facing North-Northwest

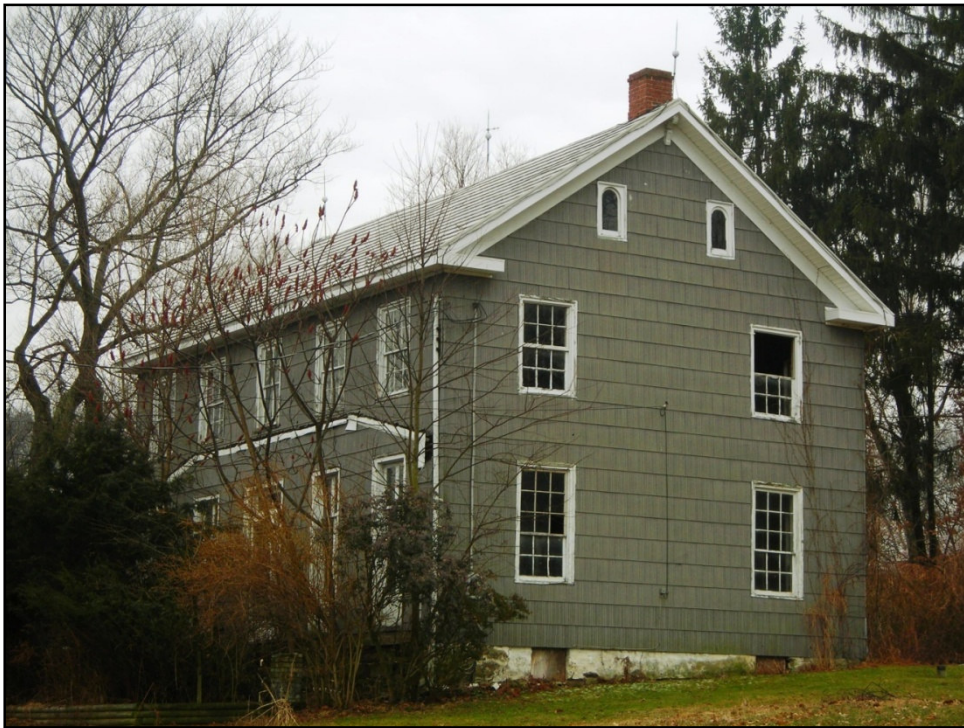
1. Photograph 2
2. House at 49 Bell Bend Road
3. Salem Township, Luzerne County
4. Facade and North Elevation, Facing Southwest

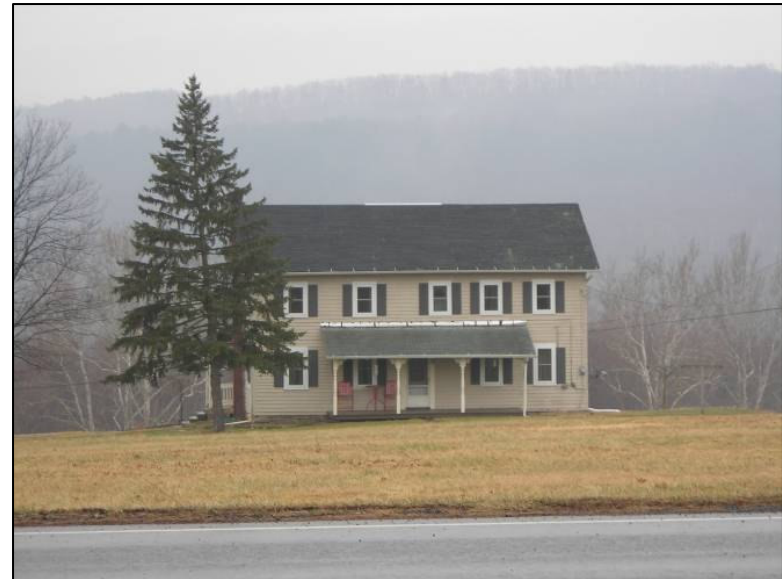
Number	Description of View	Direction of Camera
_____	Facade and NW Elevation	<u>SE</u>
_____	_____	_____
_____	_____	_____
_____	_____	_____
_____	_____	_____

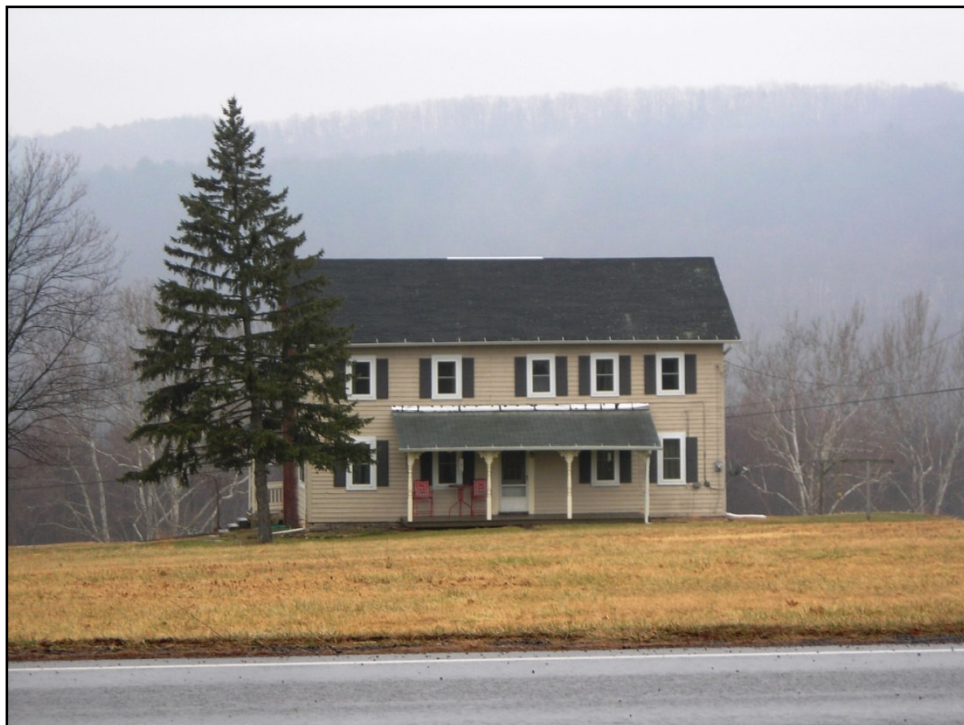
1. Photograph 1
2. Valley View Farm
3. Salem Township, Luzerne County
4. Main Dwelling-Facade, Facing Southeast
