PENNSYLVANIA HISTORIC RESOURCE SURVEY FORM – PHOTO/SITE PLAN SHEET

Survey Code / Tax Parcel / Other No.: _____ County: Luzerne 079
Municipality: Salem Township Address: 62 Kiliti Road
Historic Name / Other Name: Kiliti Farm

Date of Survey January 2008

Name of Surveyor Matthew G. Hyland

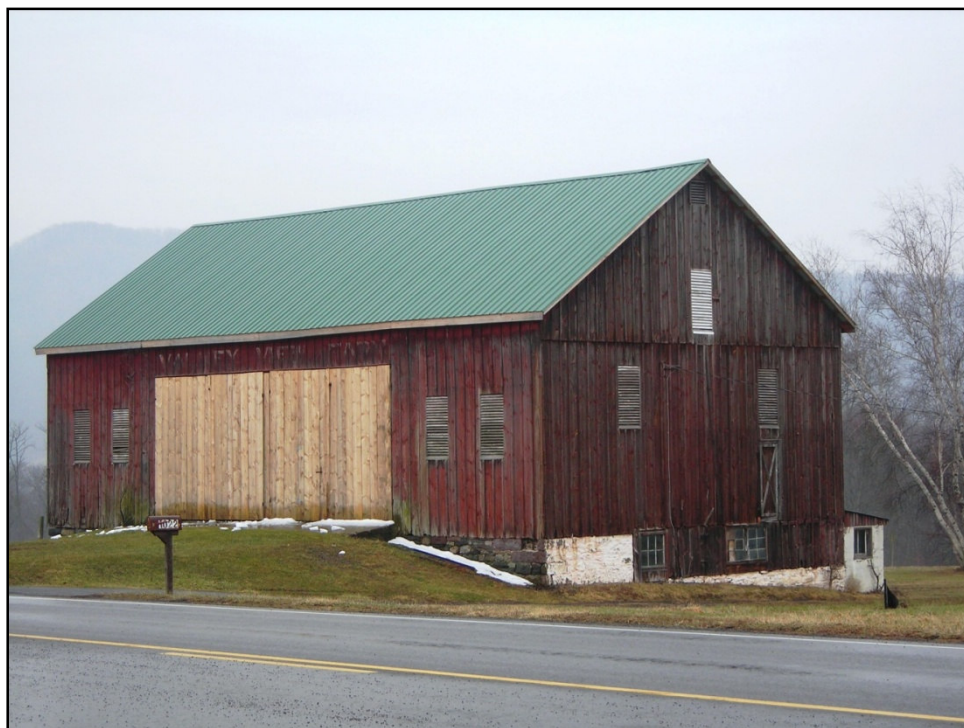
The heavy timber-framed bank barn is built on a stone foundation. The exterior of this barn is clad in vertical board siding and metal sheeting, and the gable roof is topped by modern V-crimp sheathing. The entrance doors have been recently replaced. Several window openings on the barn are marked by louvered vents, and basement-level fenestration includes 6-light windows. A small, concrete block, shed-roofed addition extends from the rear of the barn. The ell extension has been removed, based on the presence of ghost lines on the south elevation.

1. Photograph 2
2. Valley View Farm
3. Salem Township, Luzerne County
4. Barn-Facade and West Elevation, Facing East

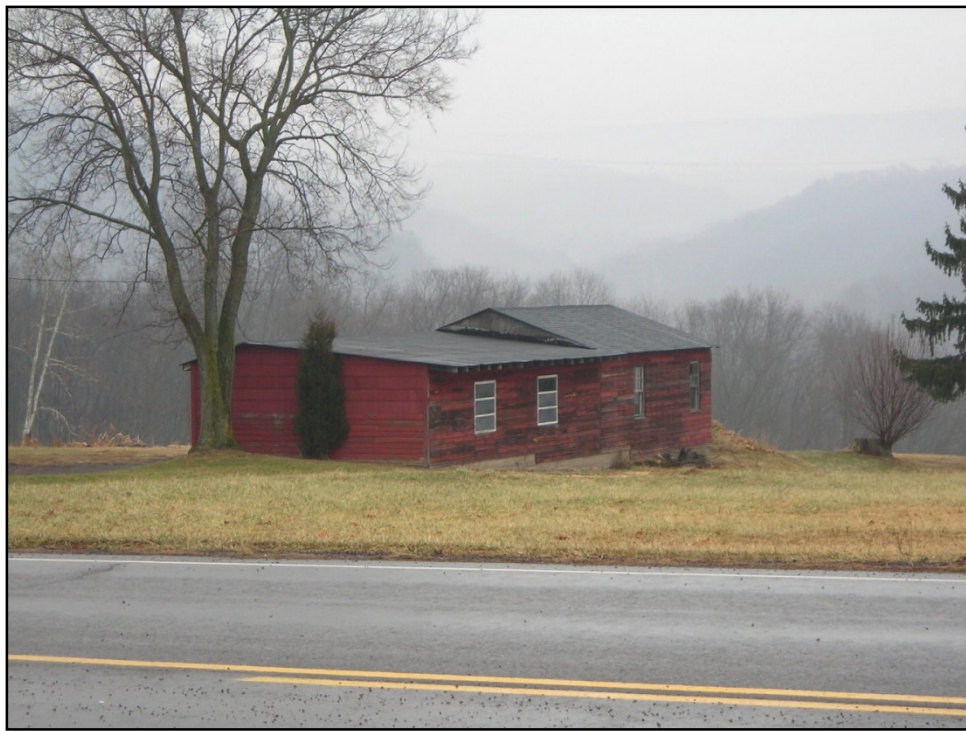
1. Photograph 3
2. Valley View Farm
3. Salem Township, Luzerne County
4. Poultry Shelter, Facing Southeast

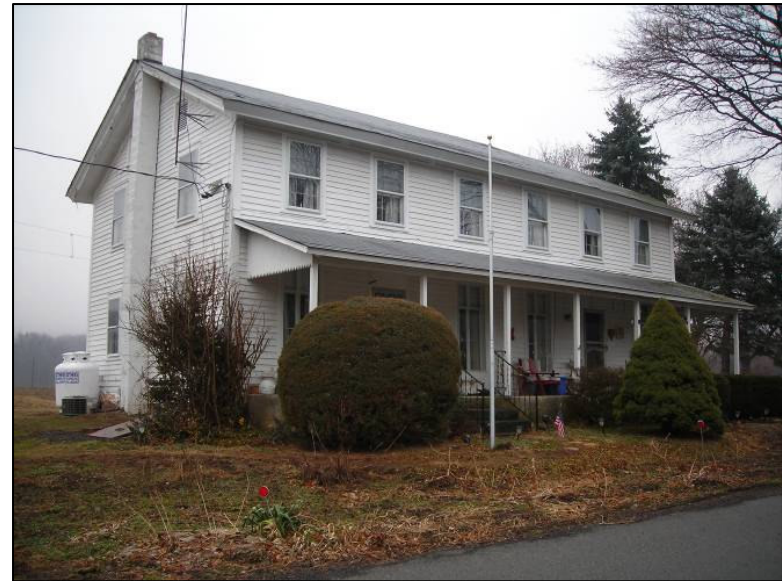
Number	Description of View	Direction of Camera
_____	Facade and SW Elevation	<u>NE</u>
_____	_____	_____
_____	_____	_____
_____	_____	_____
_____	_____	_____

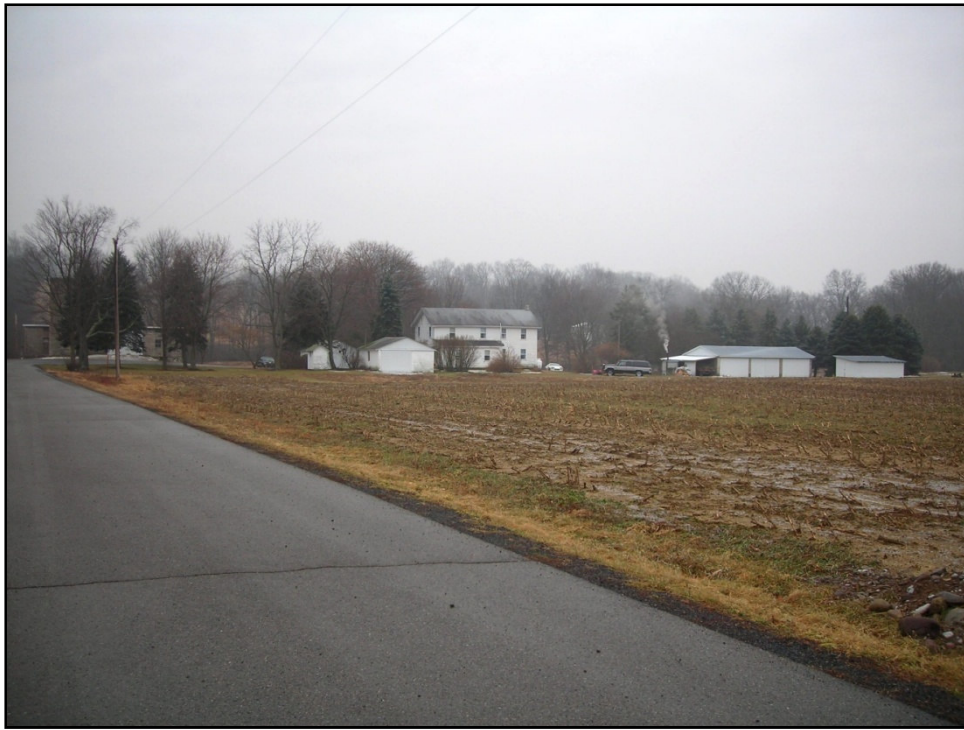
1. Photograph 1
2. Michaels Farm
3. Salem Township, Luzerne County
4. Farm Overview, Facing Southwest

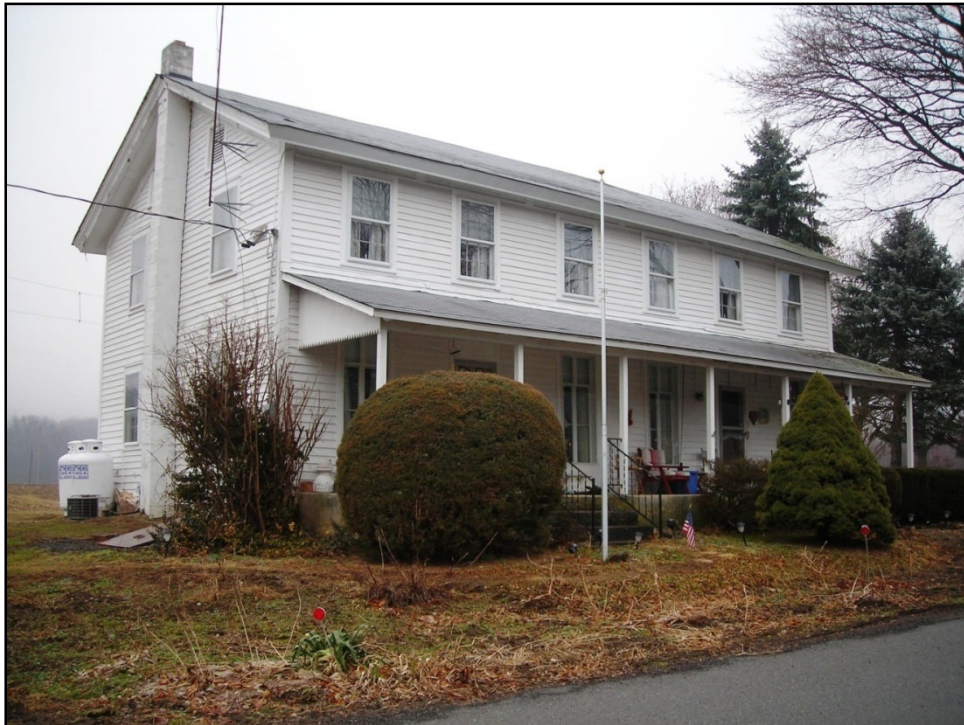
1. Photograph 2
2. Michaels Farm
3. Salem Township, Luzerne County
4. Main House-Facade and West Elevation, Facing Northeast

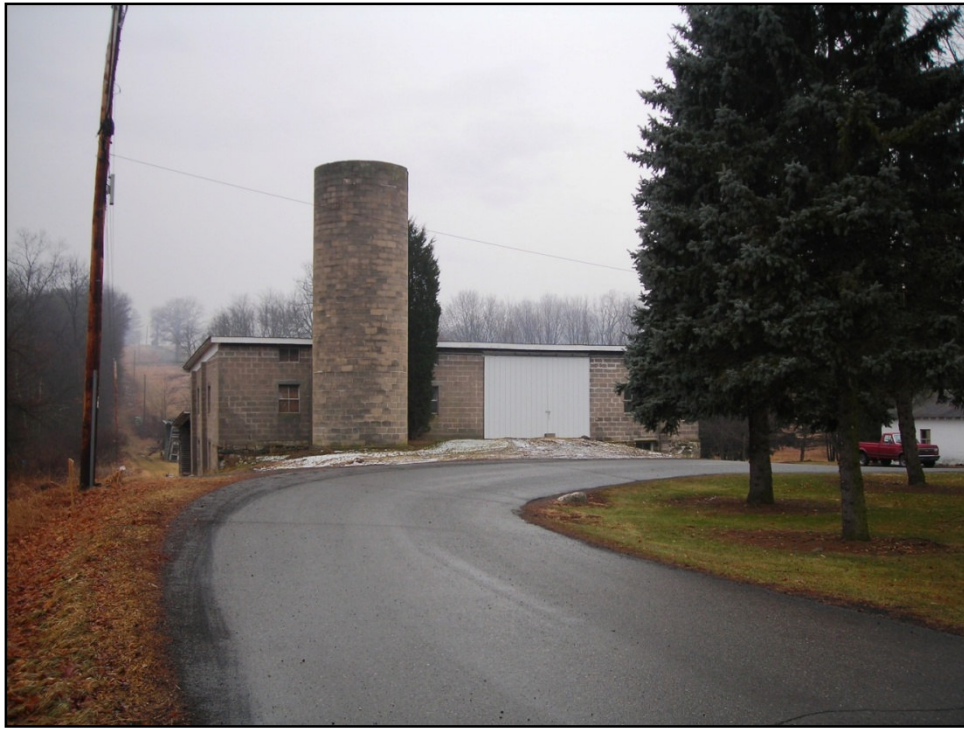
1. Photograph 3
2. Michaels Farm
3. Salem Township, Luzerne County
4. Barn and Silo, Facing South

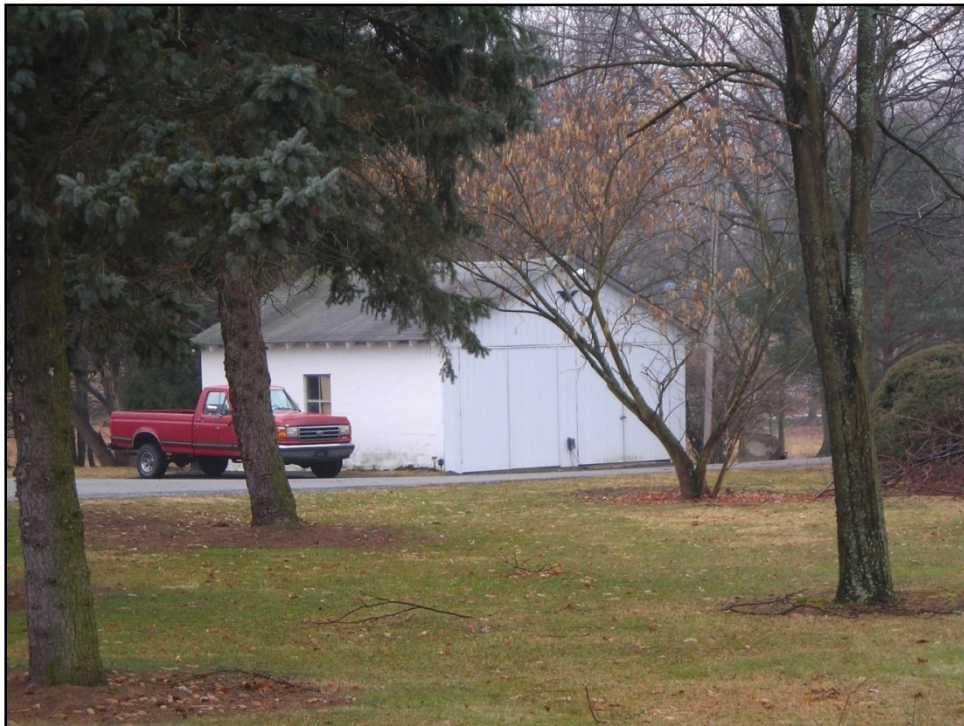
1. Photograph 4
2. Michaels Farm
3. Salem Township, Luzerne County
4. Garage, Facing Southwest

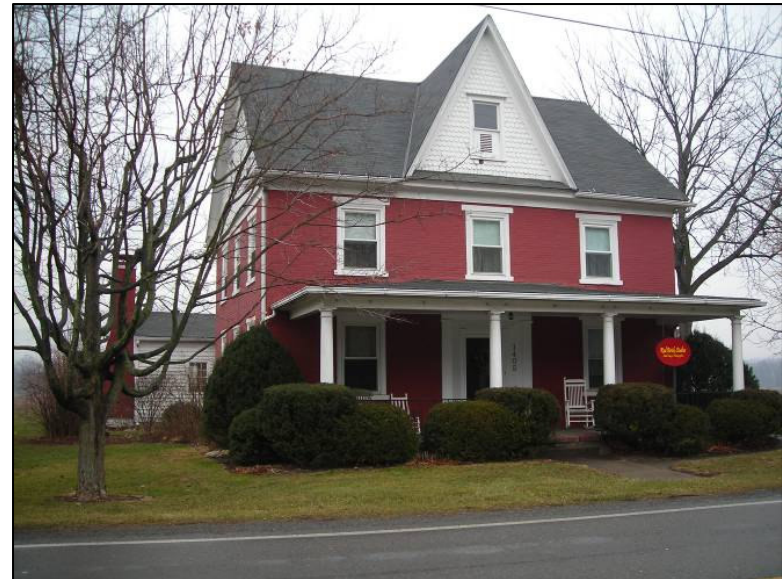
Number	Description of View	Direction of Camera
_____	<u>Facade and S Elevation</u>	<u>N</u>
_____	_____	_____
_____	_____	_____
_____	_____	_____
_____	_____	_____

Constructed circa 1880, this resource is a 2-story, gable-roofed, vernacular brick house with elements of the Gothic Revival style, built on a modified T plan. This house is built on a brick foundation and has common bond brick exterior walls. The steeply-pitched gable roof is clad in asphalt shingles, and it is marked by a steeply-pitched cross gable with pent eaves. This cross gable is clad in fish scale shingles, as are the gable ends. The roofline is marked by a molded frieze band and gable end returns. A full-width, hip-roofed porch with Doric columns is located on the façade. The centered door is flanked by squared pilasters with a splayed reveal and decorative door molding with cornerblocks. A shallow, screened side porch is also marked by Doric columns with decorative detailing similar to that of the principal entrance. The fenestration on the house includes 1/1 double-hung vinyl sash windows with splayed reveals and cut stone lintels and sills. The rear ell has a corbelled gable end chimney.

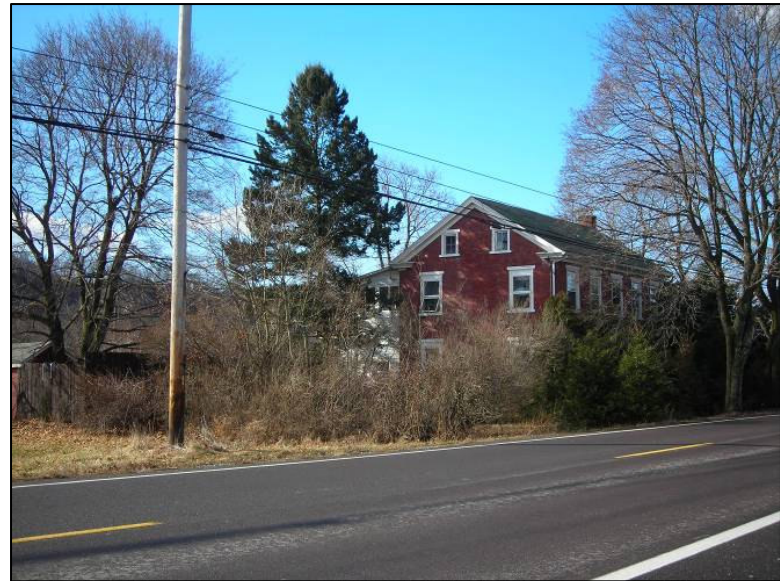
Number	Description of View	Direction of Camera
_____	<u>NE Elevation</u>	<u>SW</u>
_____	_____	_____
_____	_____	_____
_____	_____	_____
_____	_____	_____

Built circa 1870, this 2-story, gable-roofed brick house is a vernacular variant of the Georgian style. The foundation and exterior of this L-shaped house are constructed of common bond brick, and a 2-story, shed-roofed addition to the rear ell is clad in weatherboard. The gable roof is clad in asphalt shingles and is marked by a molded cornice with gable end returns. The fenestration throughout consists of modern 1/1 double-hung vinyl sash windows, with the exception of 4-light attic story windows. The window openings are marked by cut stone lintels and sills. A small gable-roofed portico on the west elevation of the house marks the location of a side entry. A modern wood ramp leads to the open front porch, which has no roof. Located to the rear of the house is a small brick gable-roofed outbuilding of unknown function. This building is partially obscured by a privacy fence built to surround the back yard.

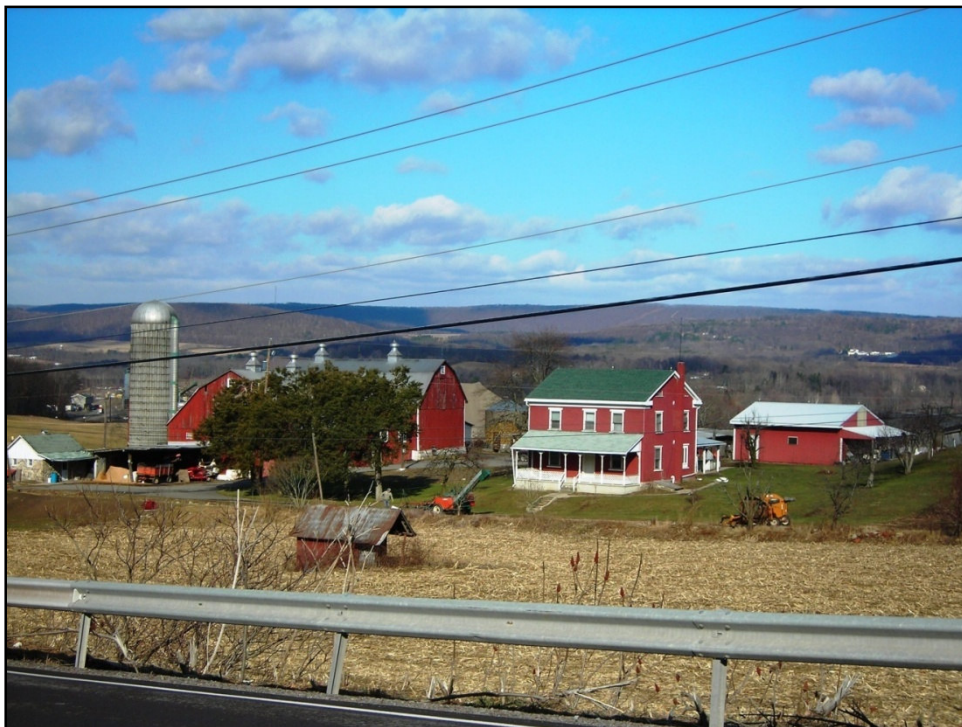
1. Photograph 1
2. Farm at 783 Berwick-Hazleton Highway
3. Nescopeck Township, Luzerne County
4. Farm Overview, Facing Northwest

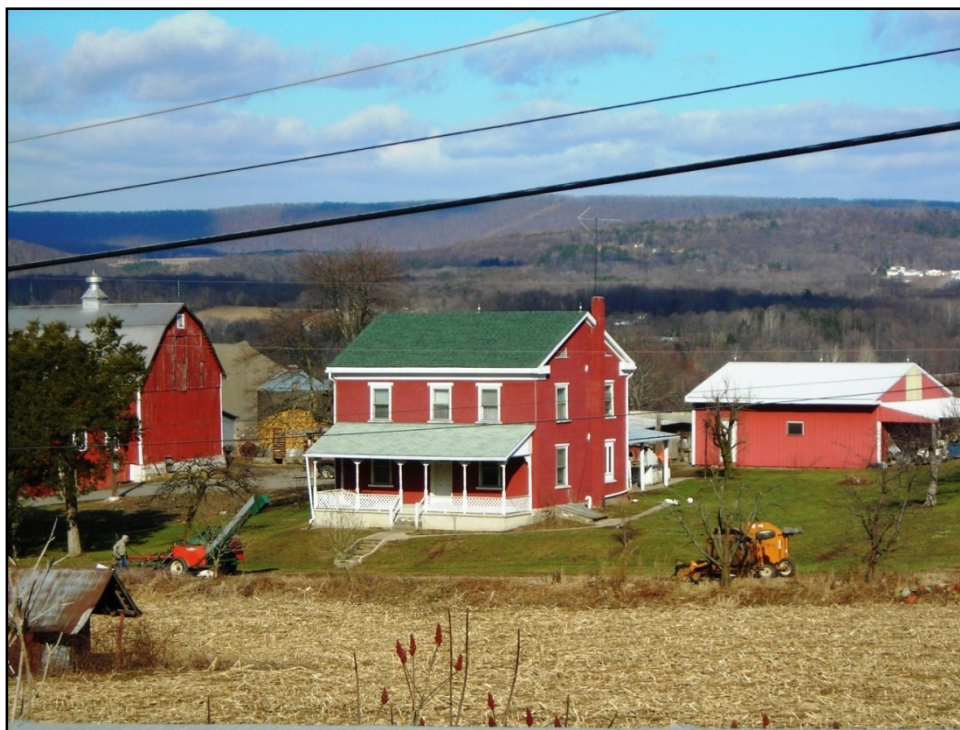
Description and dates of any known alterations: Many of the windows have been replaced, and a full-width front porch has been added.

Other house features (novelty/ornamental, siting, banked or not, etc.): The roof is trimmed with a molded frieze and cornice returns. The recently-constructed porch has a shed roof supported by turned posts with decorative brackets and a lattice balustrade. The windows throughout are primarily replacement 1/1 double-hung sashes trimmed with lintels and sills, and the gable ends have triangular attic story windows. An exterior brick chimney is located on the east elevation of the house.

1. Photograph 2
2. Farm at 783 Berwick-Hazleton Highway
3. Nescopeck Township, Luzerne County
4. Main House-Facade and East Elevation, Facing North

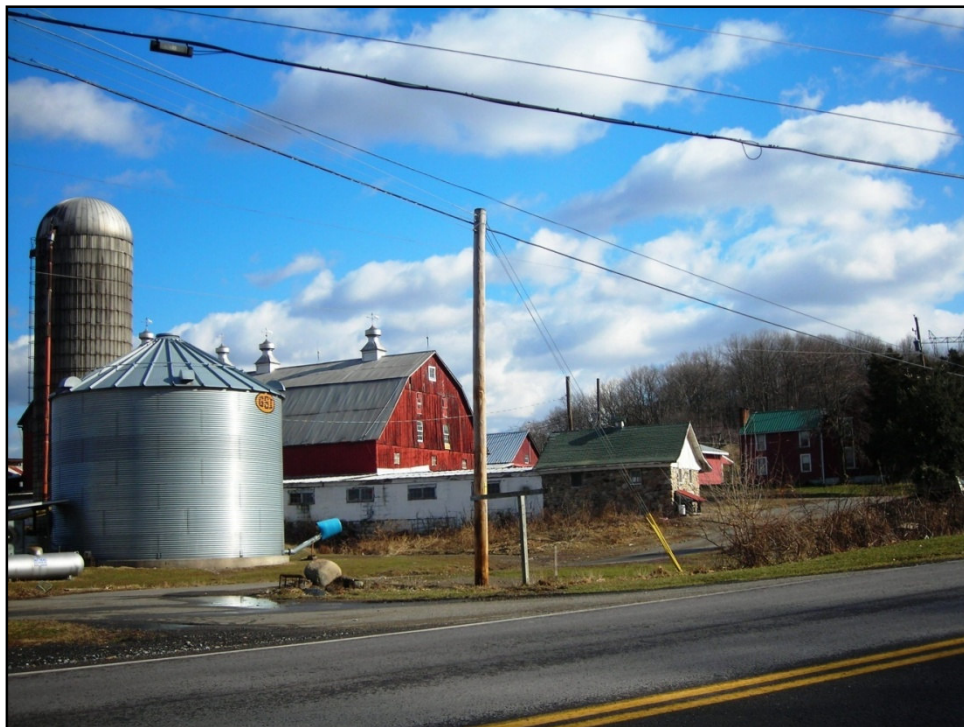
The circa-1880, Three Gable barn consists of a gambrel-roof and timber-frame. This T-shaped barn is built on a stone foundation and is clad in vertical wood siding. Its metal-clad roof is punctuated by four cupola vents. Its fenestration includes 6/6 double-hung sash windows. A mid-20th-century concrete stave silo stands adjacent to the barn, and a circa-1940 concrete block wing connects the barn to a circa-1930, gable-roofed stone outbuilding that may have once served as a milk processing building.

1. Photograph 3
2. Farm at 783 Berwick-Hazleton Highway
3. Nescopeck Township, Luzerne County
4. Barn and Milk Processing Building, Facing Northeast

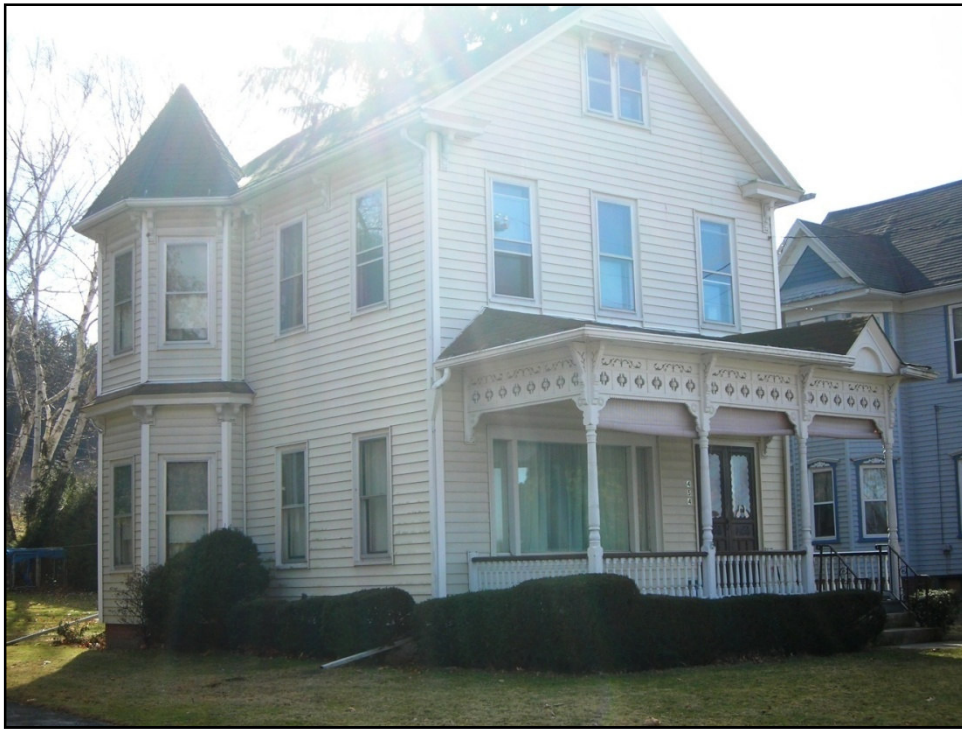
1. Photograph 1
2. Wapwallopen Historic District
3. Wapwallopen, Luzerne County
4. 454 South River Street, Facade and North Elevation, Facing South

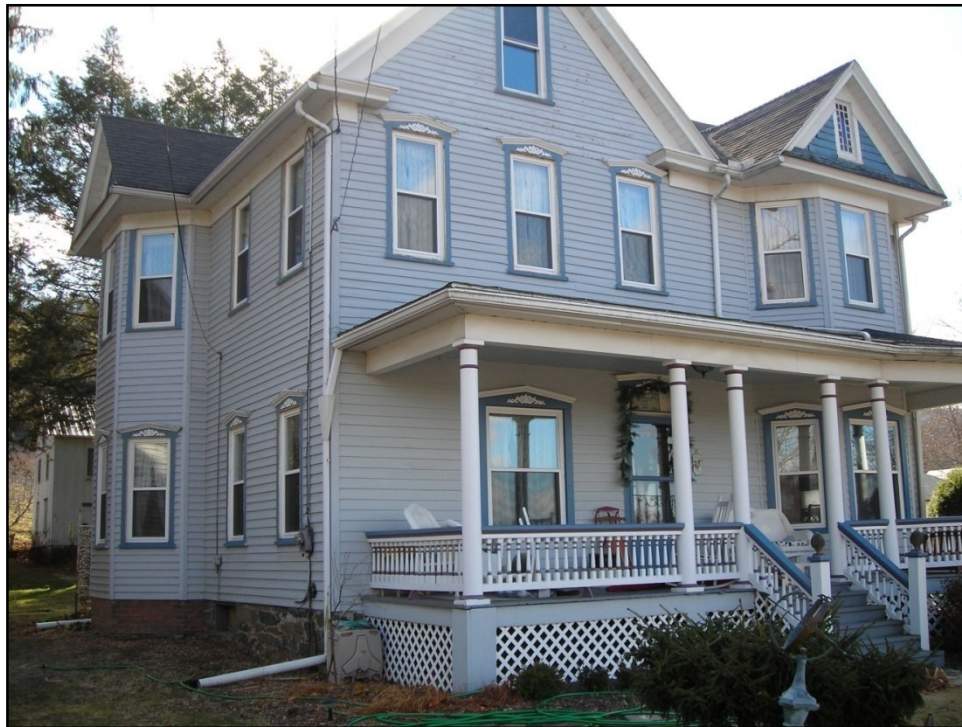
1. Photograph 2
2. Wapwallopen Historic District
3. Wapwallopen, Luzerne County
4. 458 South River Street, Facade and North Elevation, Facing South

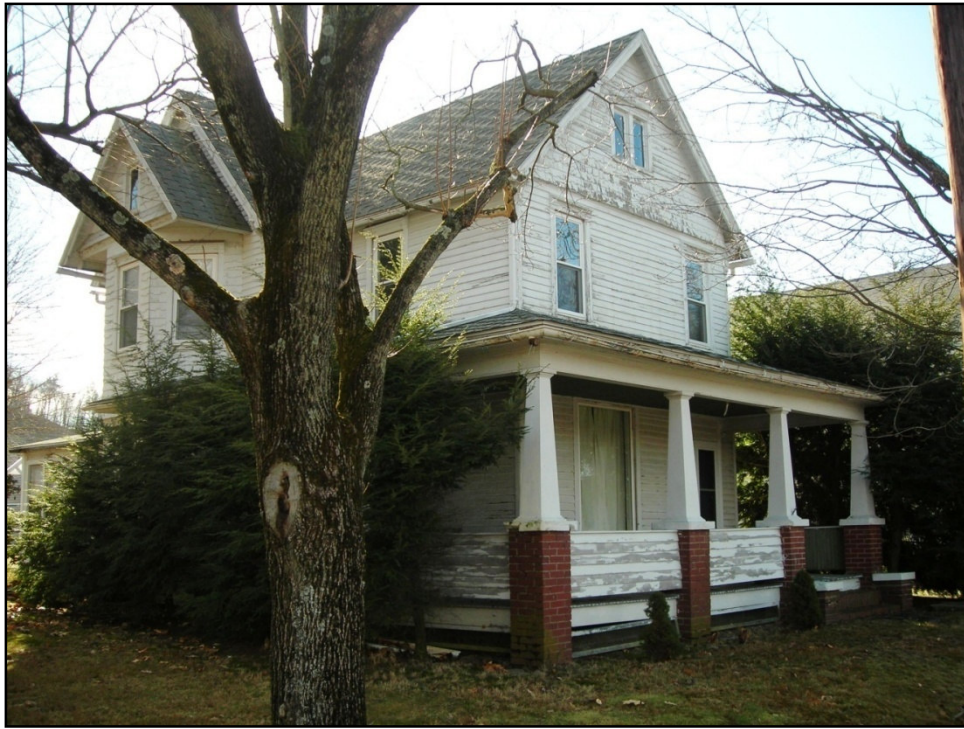
1. Photograph 3
2. Wapwallopen Historic District
3. Wapwallopen, Luzerne County
4. 460 South River Street, Facade and West Elevation, Facing Southeast

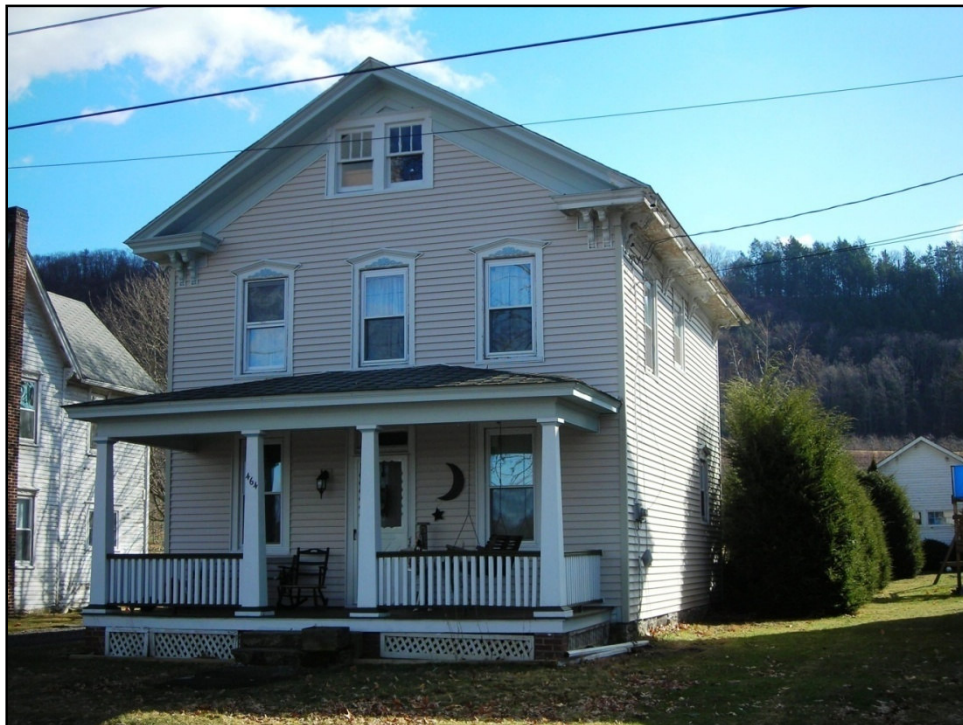
1. Photograph 4
2. Wapwallopen Historic District
3. Wapwallopen, Luzerne County
- 464 South River Street, Facade and West Elevation, Facing East

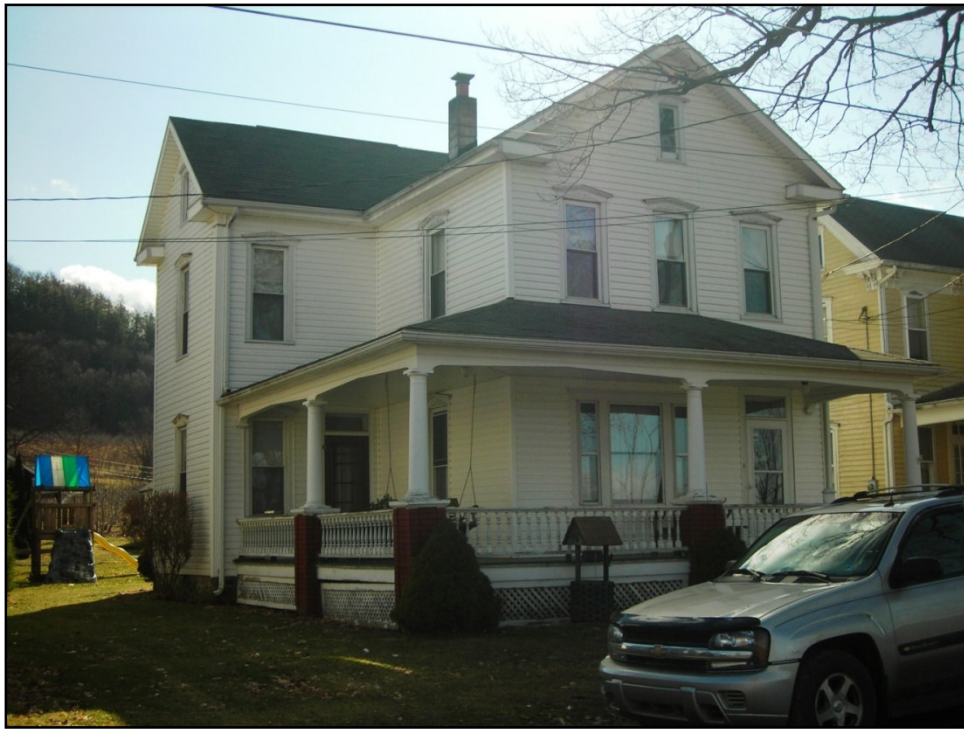
1. Photograph 5
2. Wapwallopen Historic District
3. Wapwallopen, Luzerne County
4. 466 South River Street, Facade and West Elevation, Facing Southeast

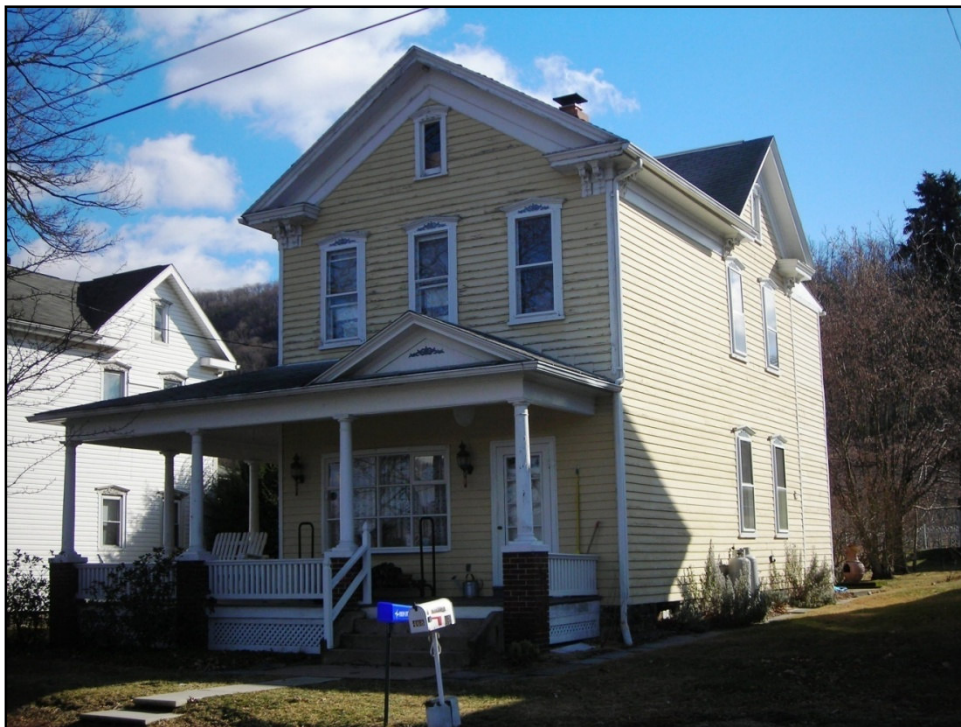
1. Photograph 6
2. Wapwallopen Historic District
3. Wapwallopen, Luzerne County
4. 468 South River Street, Facade and South Elevation, Facing East

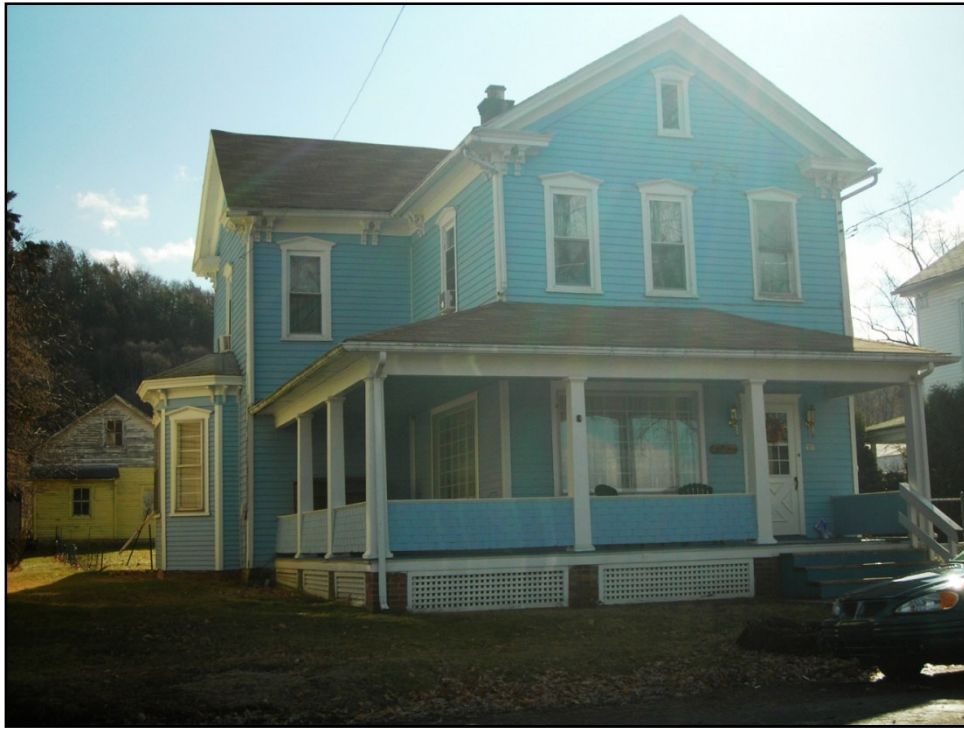
1. Photograph 7
2. Wapwallopen Historic District
3. Wapwallopen, Luzerne County
4. 470 South River Street, Facade and South Elevation, Facing East

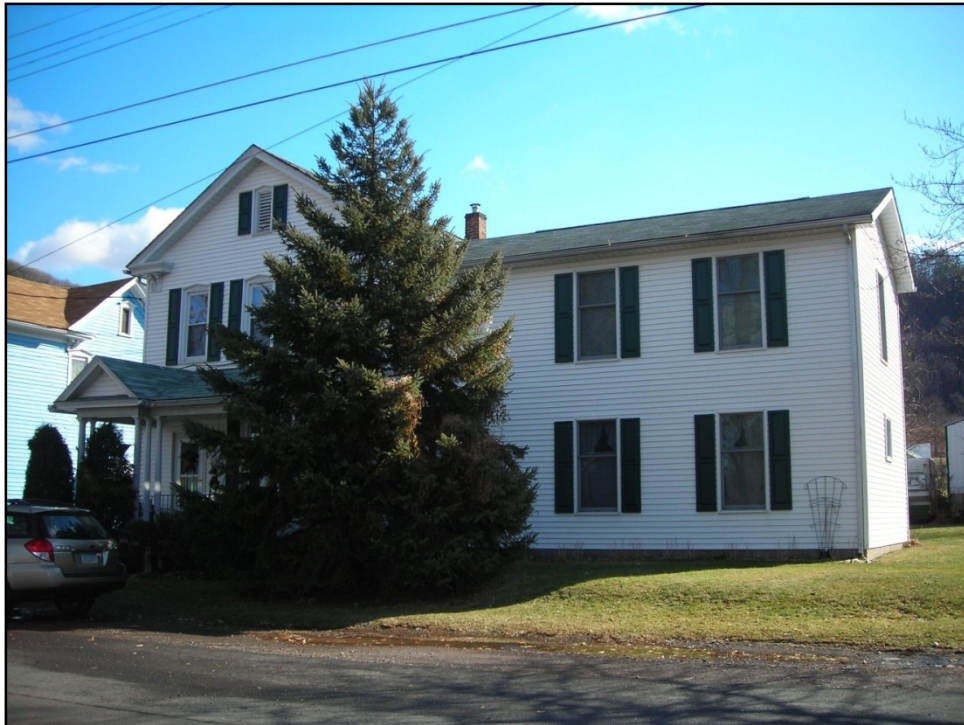
1. Photograph 8
2. Wapwallopen Historic District
3. Wapwallopen, Luzerne County
4. 472 South River Street, Facade and South Elevation, Facing East

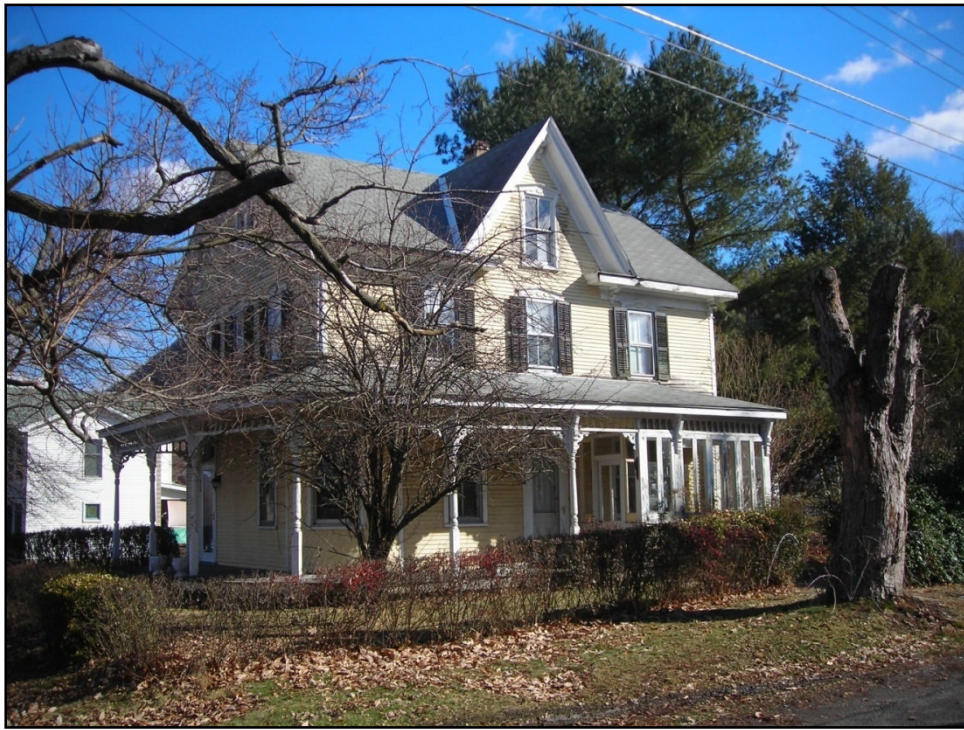
1. Photograph 9
2. Wapwallopen Historic District
3. Wapwallopen, Luzerne County
4. 476 South River Street, Facade and West Elevation, Facing Northeast

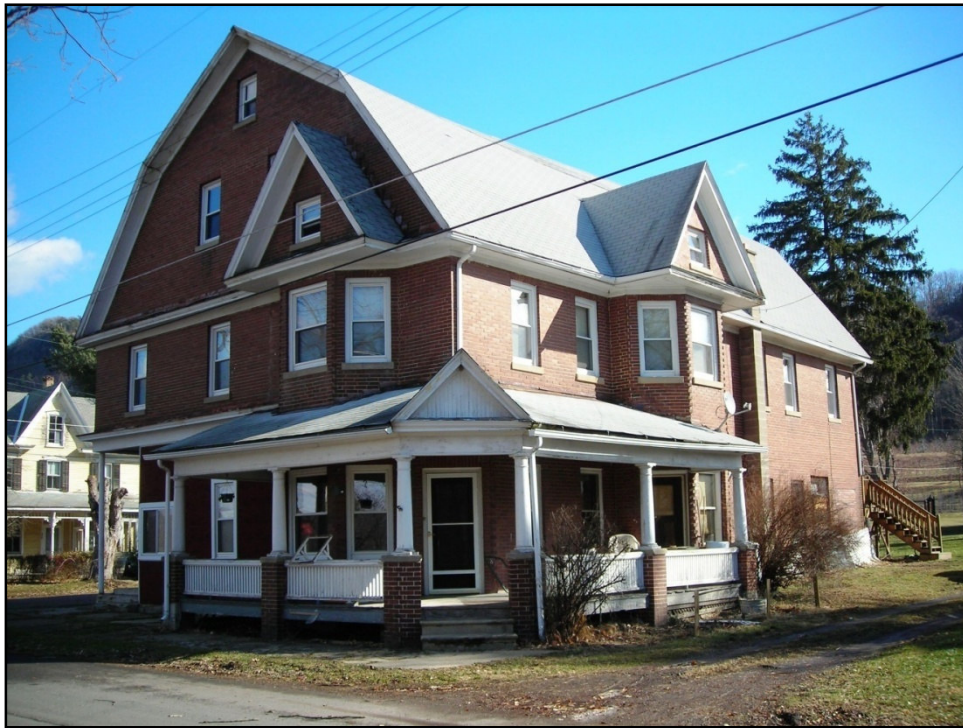
1. Photograph 10
2. Wapwallopen Historic District
3. Wapwallopen, Luzerne County
4. 480 South River Street, Facade and West Elevation, Facing Northeast

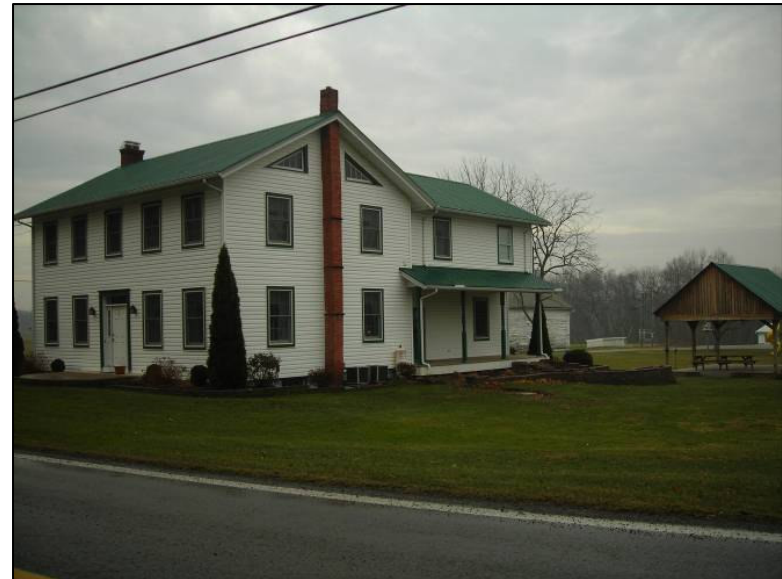
Number	Description of View	Direction of Camera
_____	<u>Facade and SE Elevation</u>	<u>NW</u>
_____	_____	_____
_____	_____	_____
_____	_____	_____
_____	_____	_____

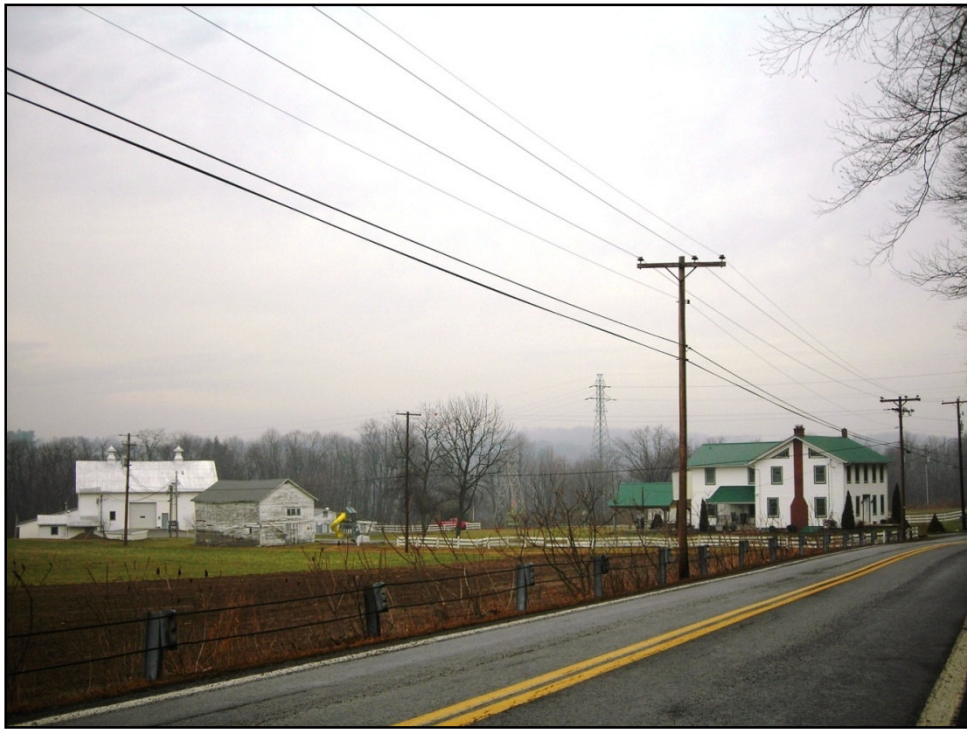
1. Photograph 1
2. Farm at 811 River Road
3. Nescopeck Township, Luzerne County
4. Farm Overview, Facing Northeast

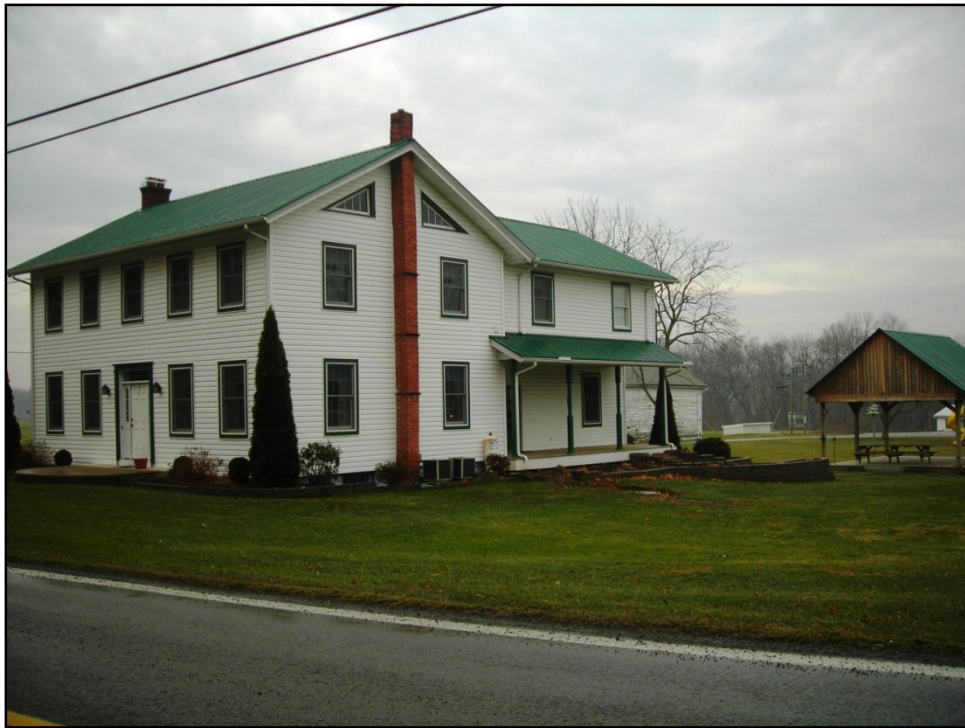
1. Photograph 2
2. Farm at 811 River Road
3. Nescopeck Township, Luzerne County
4. Main House and Picnic Pavilion, Facing Northwest

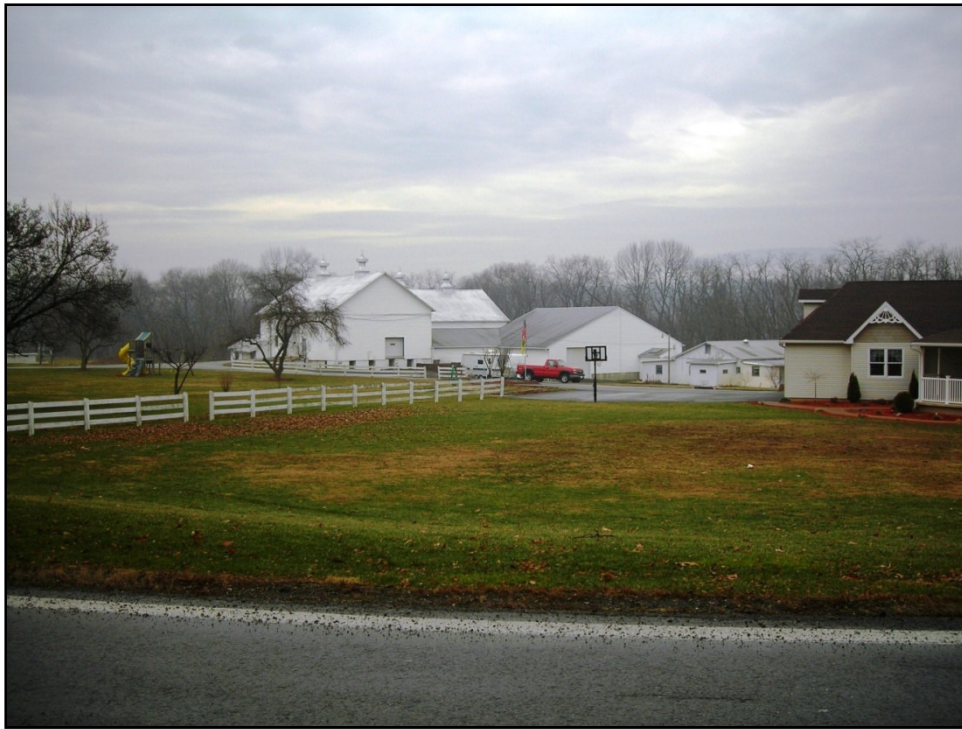
1. Photograph 3
2. Farm at 811 River Road
3. Nescopeck Township, Luzerne County
4. Outbuildings, Facing North

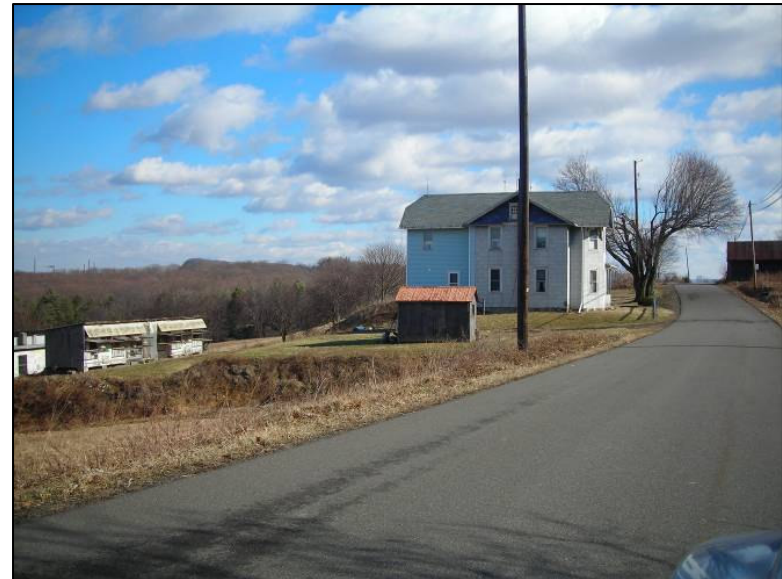
Number	Description of View	Direction of Camera
_____	Overview	<u>NE</u>
_____	_____	_____
_____	_____	_____
_____	_____	_____
_____	_____	_____

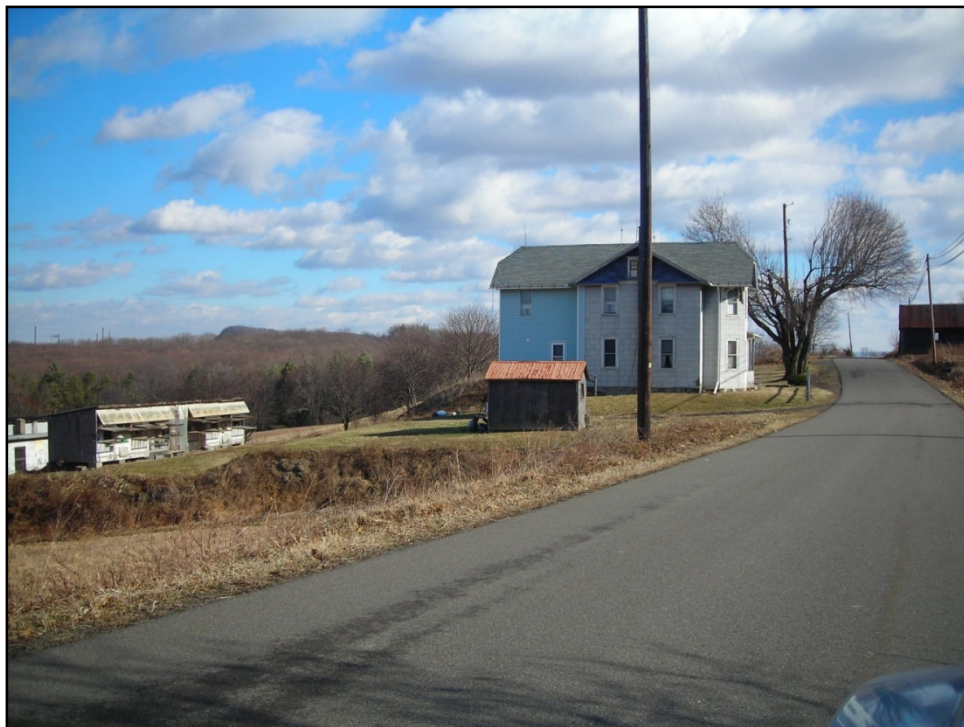
1. Photograph 1
2. Farm at 212 East Cherry Road
3. Nescopeck Township, Luzerne County
4. Overview, Facing Northeast

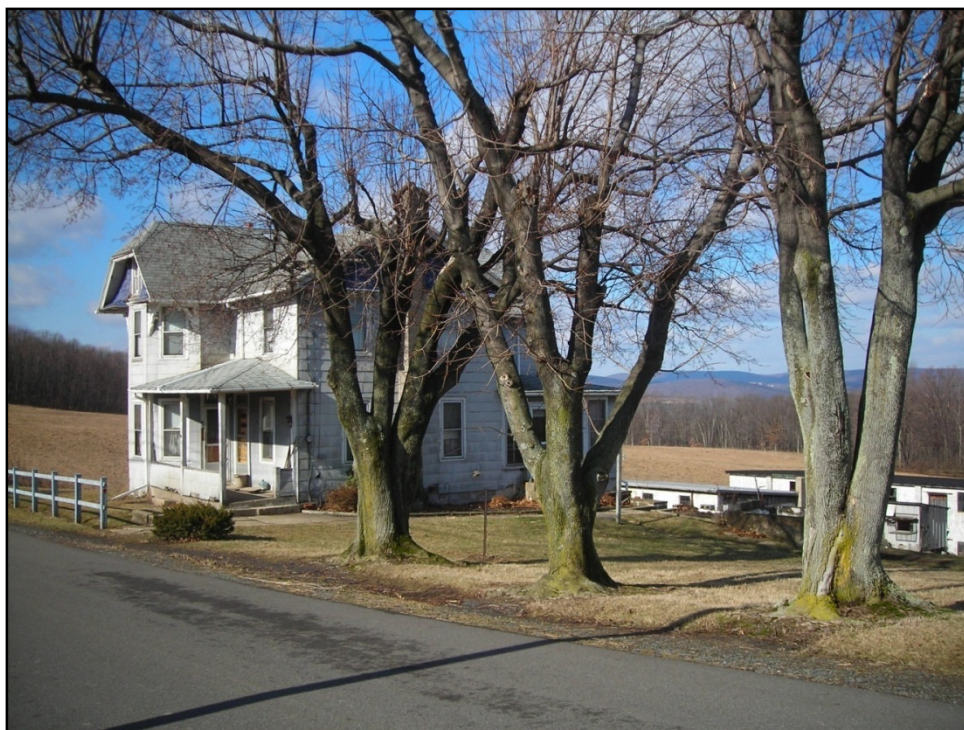
1. Photograph 2
2. Farm at 212 East Cherry Road
3. Nescopeck Township, Luzerne County
4. Main House-Facade and East Elevation, Facing Northwest

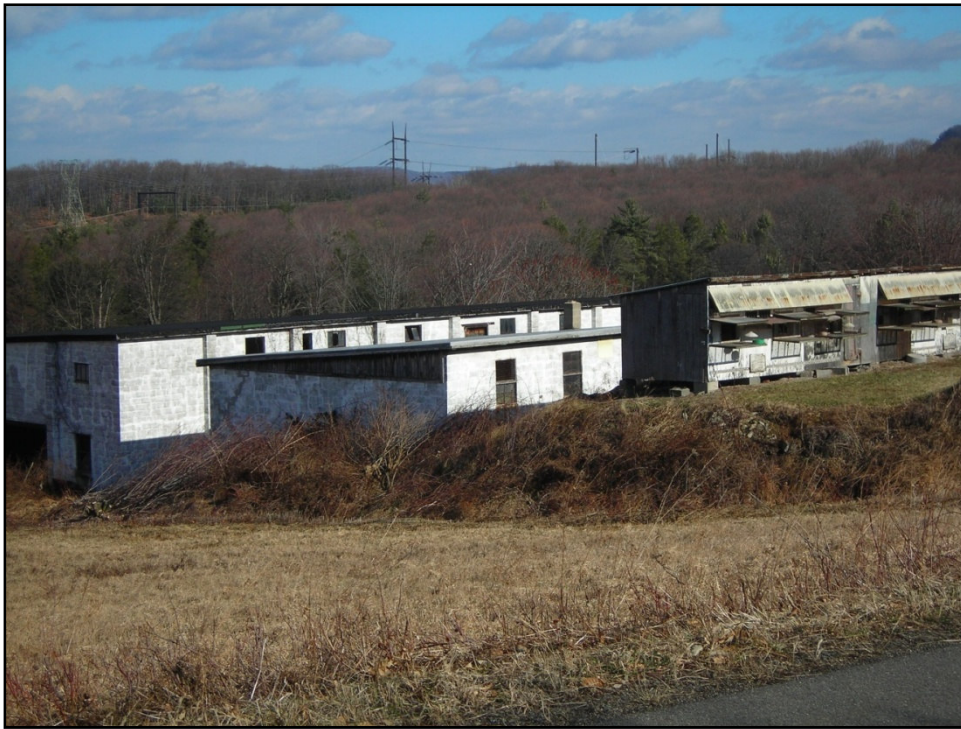
1. Photograph 3
2. Farm at 212 East Cherry Road
3. Nescopeck Township, Luzerne County
4. Poultry Shelters, Facing Northeast

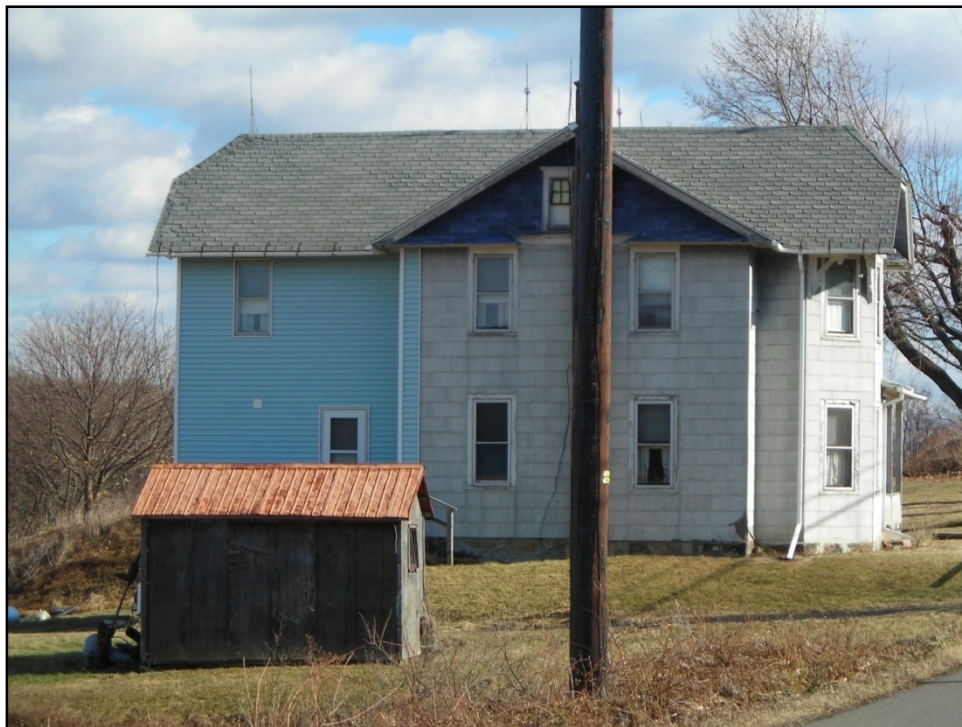
1. Photograph 4
2. Farm at 212 East Cherry Road
3. Nescopeck Township, Luzerne County
4. Main House and Wood Shed, Facing Northeast
