PNNL-21502

Prepared for the  
U.S. Nuclear Regulatory Commission  
under a Related Services Agreement  
with the U.S. Department of Energy  
Contract DE-AC05-76RL01830

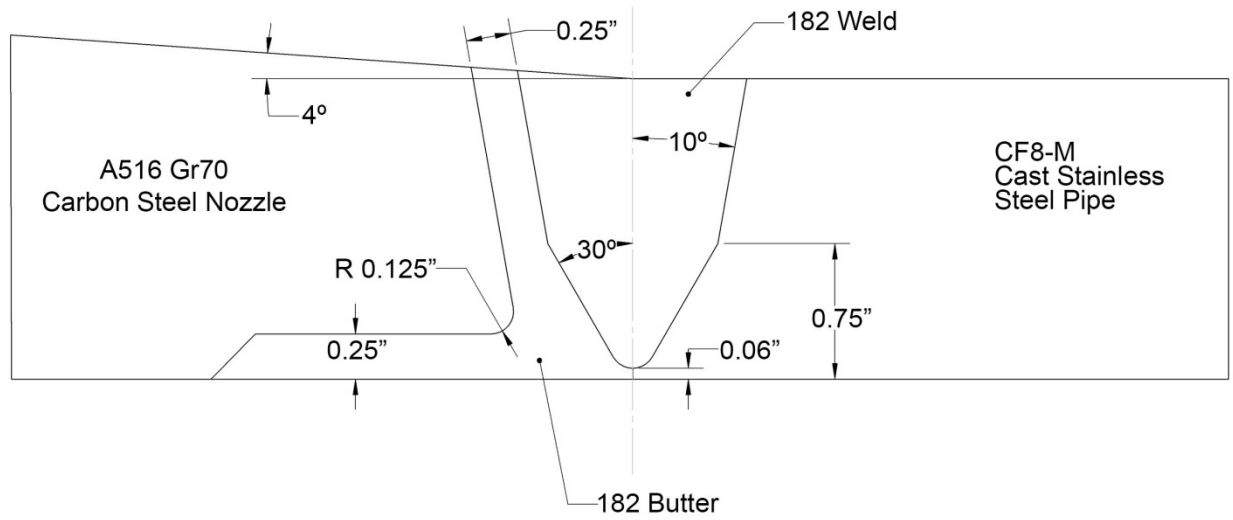
**Figure 2.1.** Dissimilar Metal Weld Profile for Specimen 9C-034

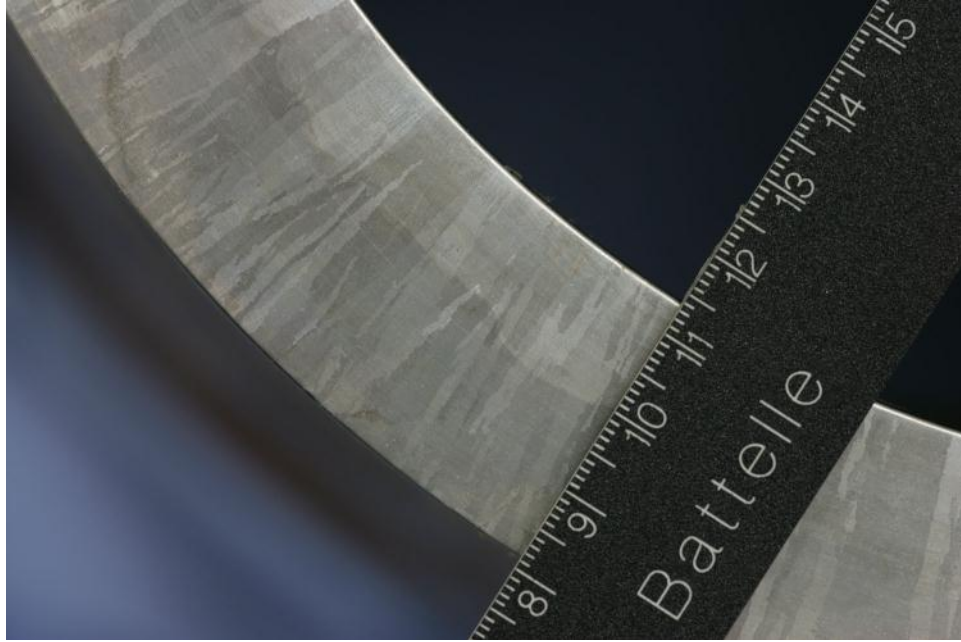
**Figure 2.3.** Polished and Etched Surface of Specimen 9C-034 Showing a Columnar Microstructure

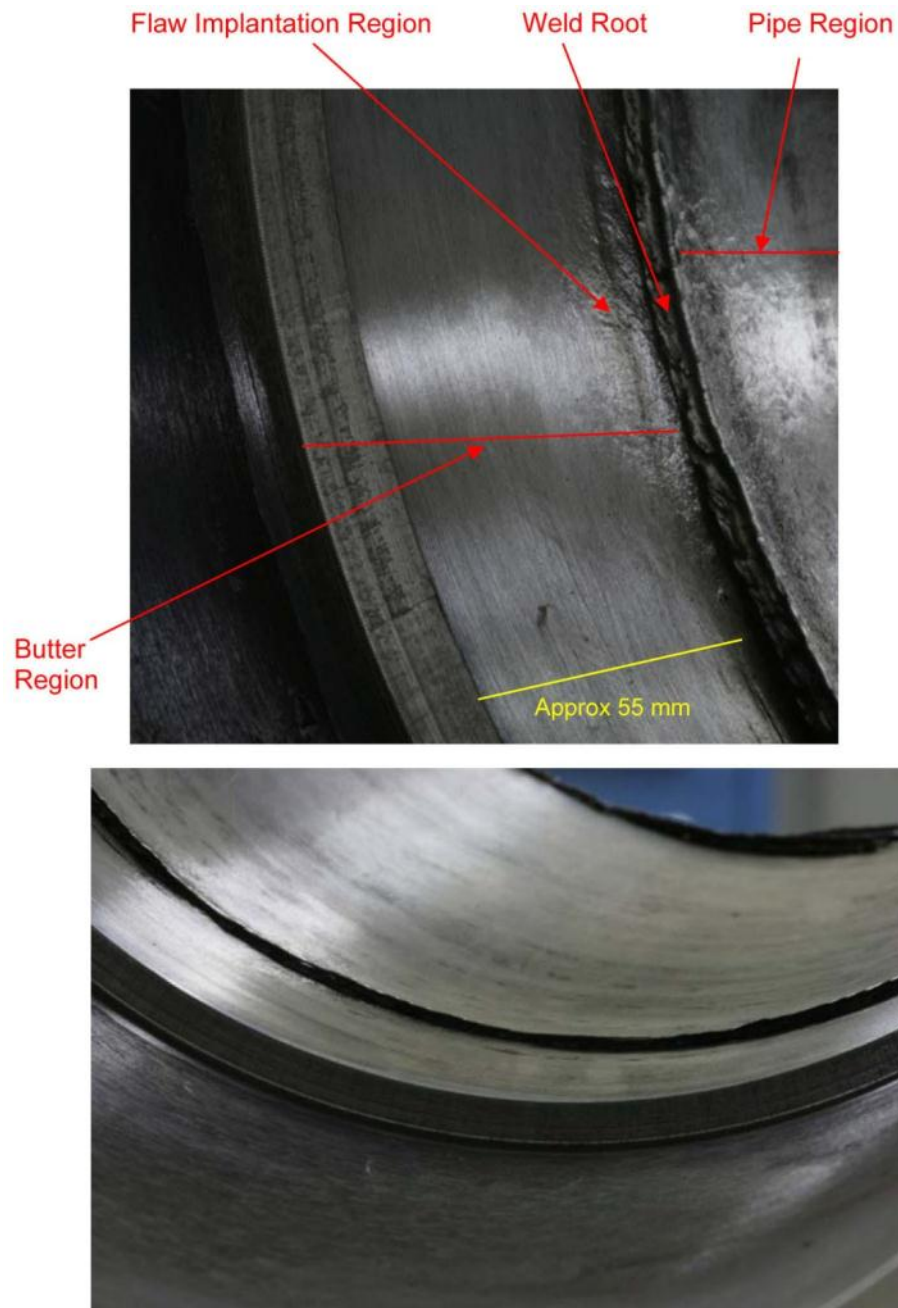
**Figure 2.4.** Photographs of the ID Surface of DMW Mock-up Specimen 9C-034 Depicting Various ID Surface and Weld Geometries

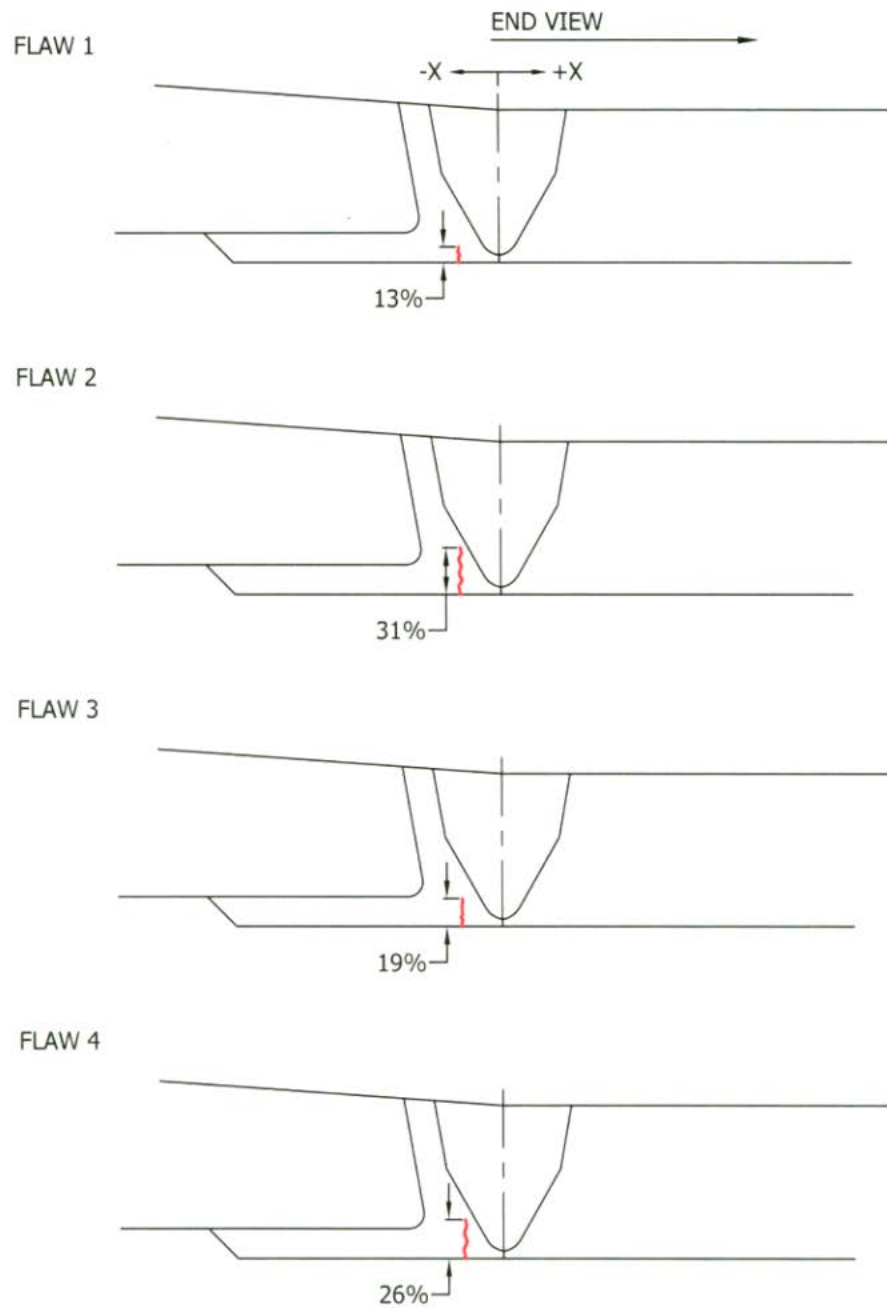
**Figure 2.5.** Side-View Illustration of All Four Thermal Fatigue Cracks Implanted into DMW Mock-Up Specimen 9C-034

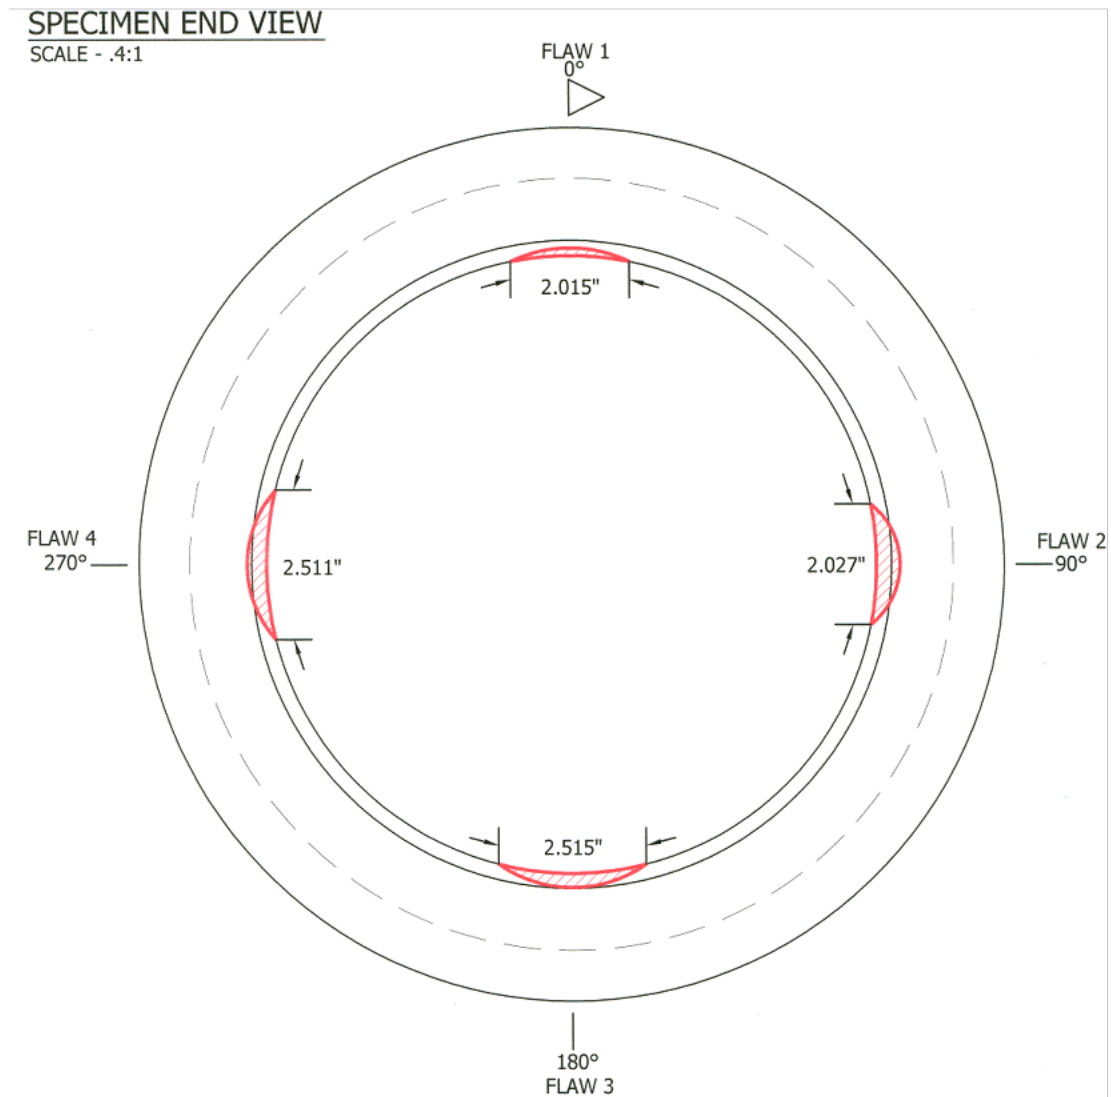
**Figure 2.6.** End-View Illustration of All Four Thermal Fatigue Cracks Implanted into DMW Mock-up Specimen 9C-034

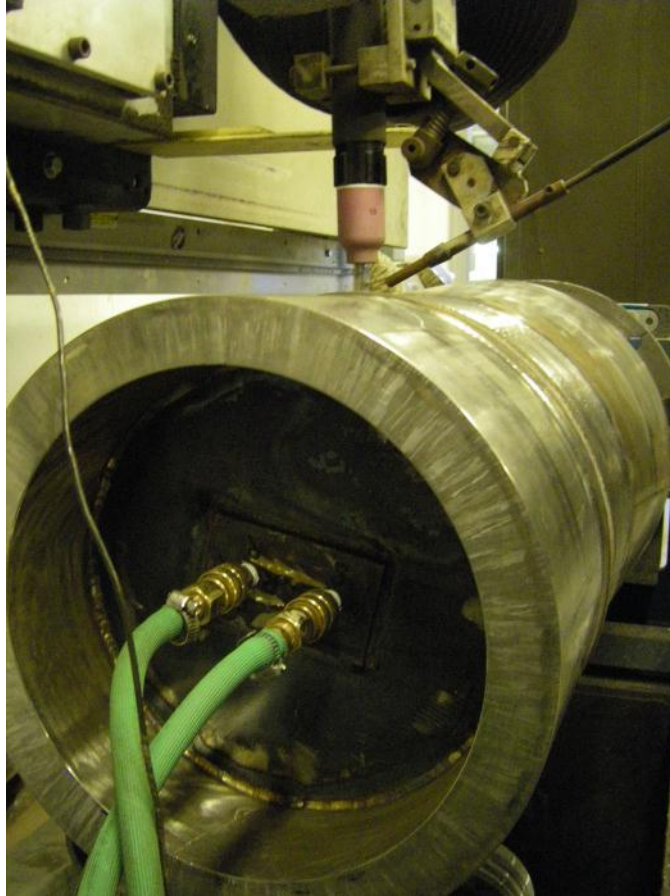
**Figure 2.7.** Photograph of Specimen 9C-034 with Water Backing During the Application of the Weld Overlay

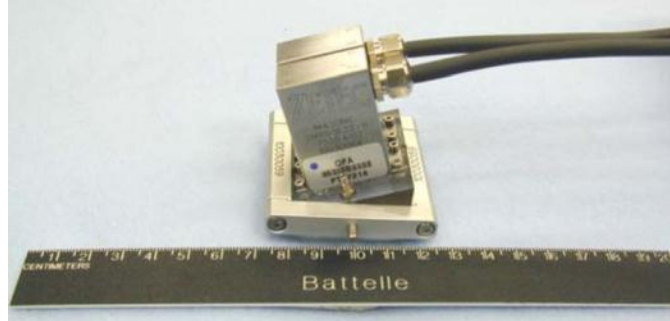
**Figure 3.1.** Photograph of the 2.0-MHz, Phased-Array Probe, Originally Developed for Inlays, Onlays, and Overlays

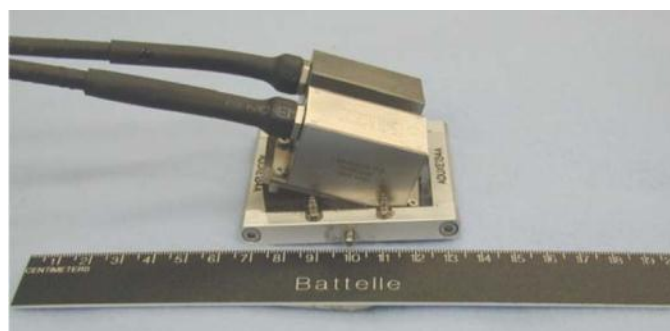
**Figure 3.2.** Photograph of the 1.5-MHz TRL Probe Originally Designed for Wrought Stainless Steel Welds

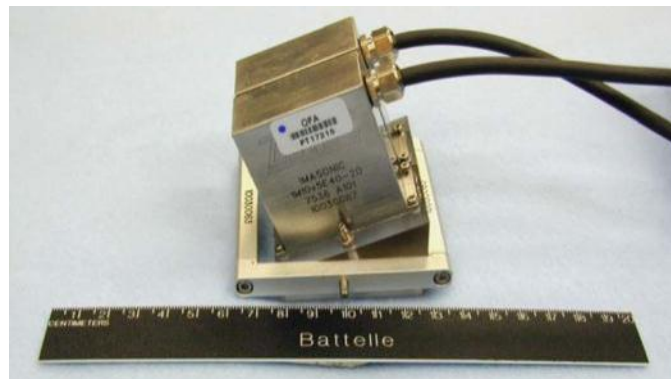
**Figure 3.3.** Photograph of the 1.0-MHz, Phased-Array Probe, Originally Developed for Inlays, Onlays, and Overlays

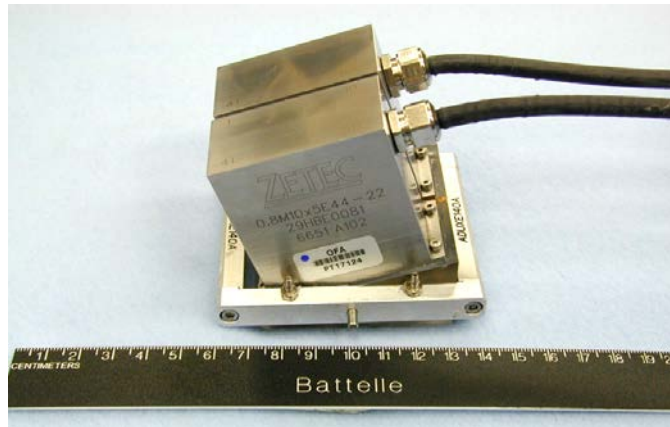
**Figure 3.4.** Photograph of the 0.8-MHz TRL Probe

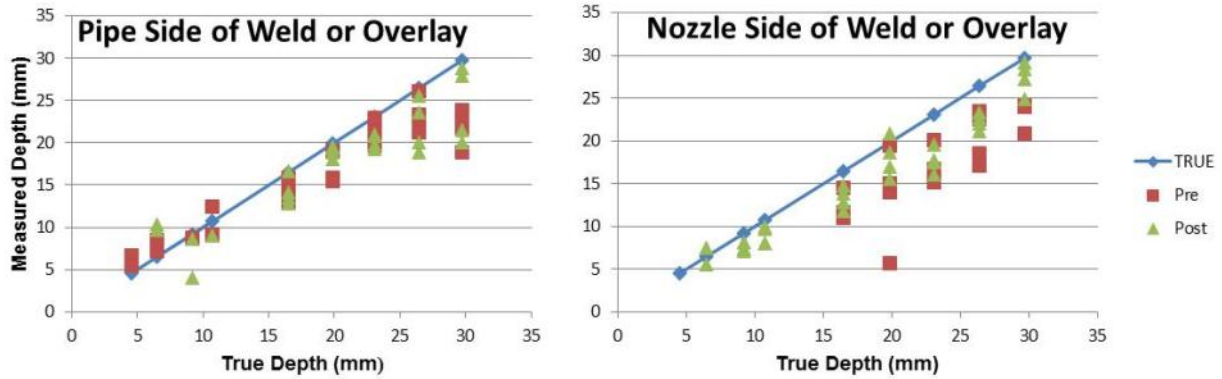
**Figure 4.2.** Measured Flaw Depths from Raster Data Acquired from the Pipe Side (left) and the Nozzle Side (right). The shallower first four flaws are from Specimen 9C-034. Pre-WOL raster data were not acquired from the nozzle side on the 9C-034 specimen, flaws 1–4.

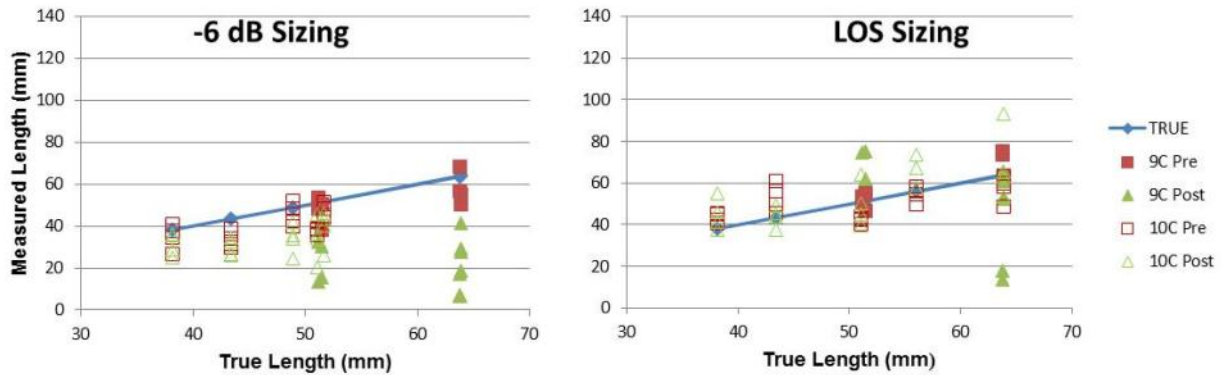
**Figure 4.4.** Length Sizing Results from Raster Data Acquired from the Pipe Side at the -6 dB Amplitude Level (left) and the LOS Level (right)
