NRC LOCA tests at Studsvik

Design and construction of test train device and
tests with unirradiated cladding material

Studsvik Report

2012-07-02

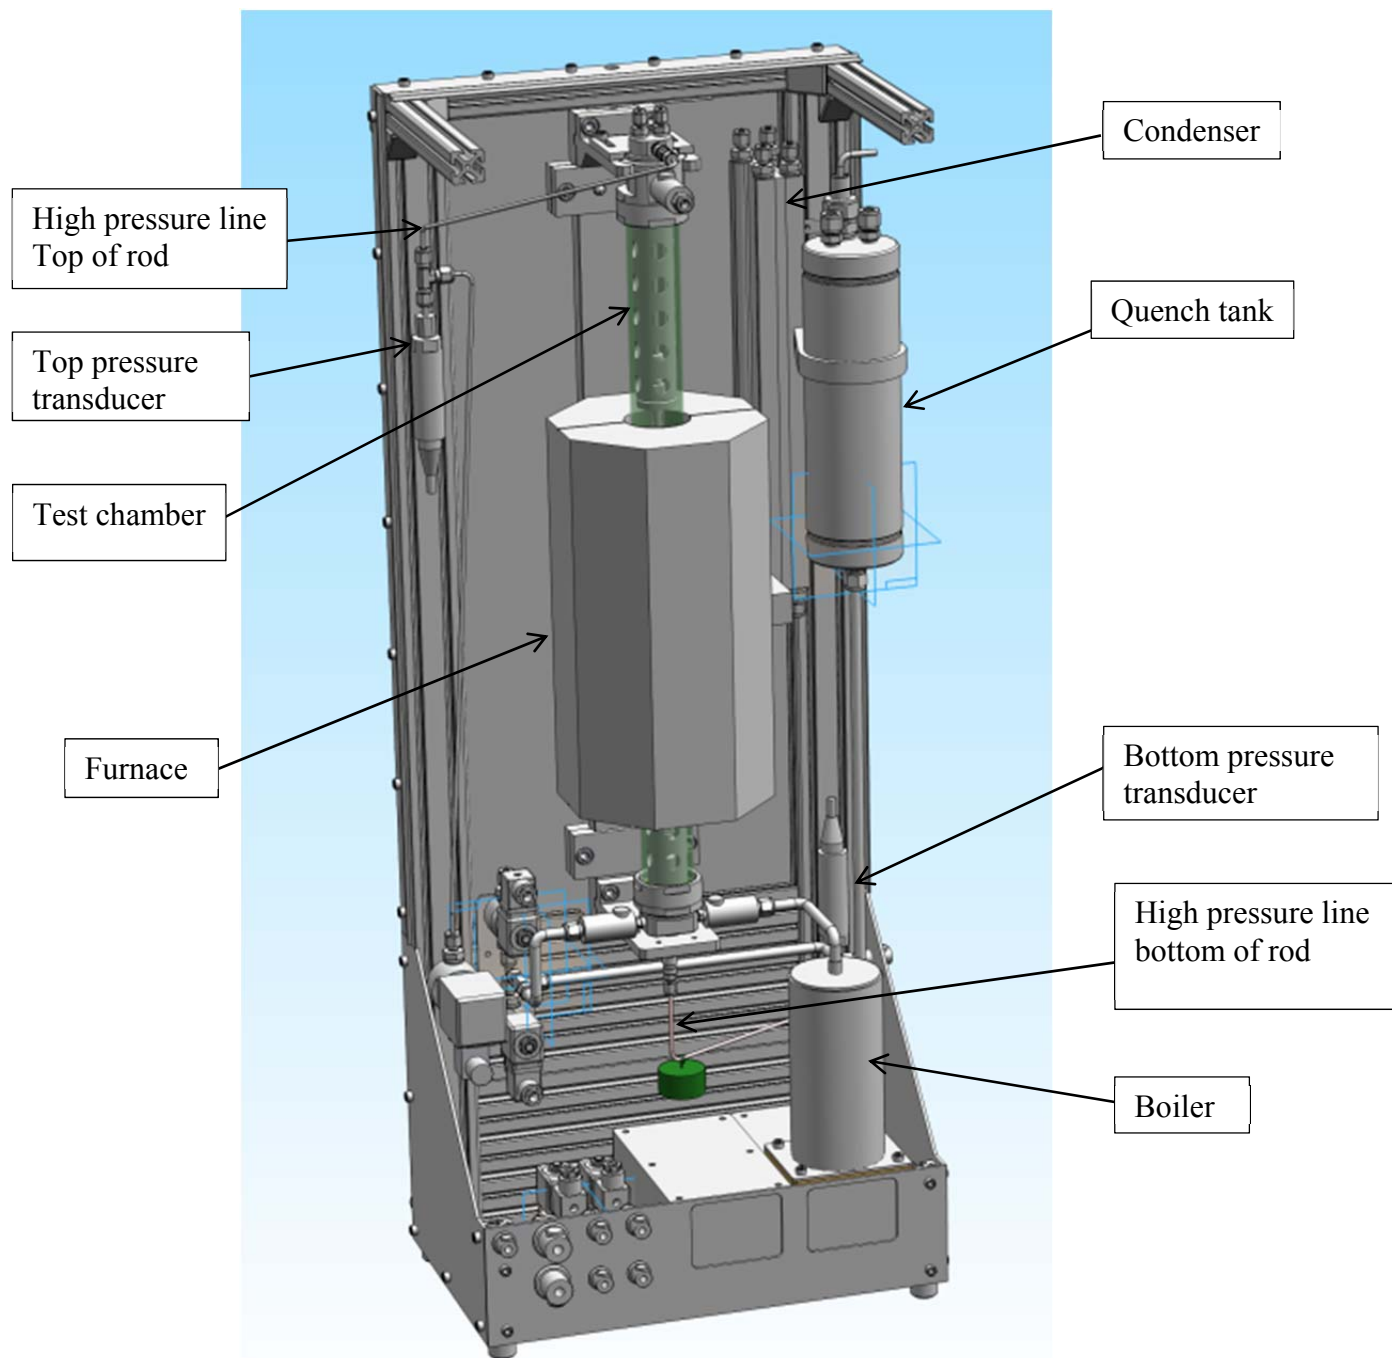
**Figure 1**

A front view of the LOCA apparatus showing the main parts. The total height of the apparatus is 1145 mm.

The LOCA apparatus is designed to externally heat a 30 cm long fuel segment up to 1200 °C by infra-red (IR) radiation. The test segment temperature is measured with a thermocouple attached on the rod approximately 50 mm above the axial mid plane. The test segment is pressurized with helium and placed in a quartz glass chamber in a flowing steam environment. A drawing showing the main parts of the apparatus is shown in Figure 1.

Identical pressure transducers were used both at the bottom and at the top of the apparatus (Figure 1).

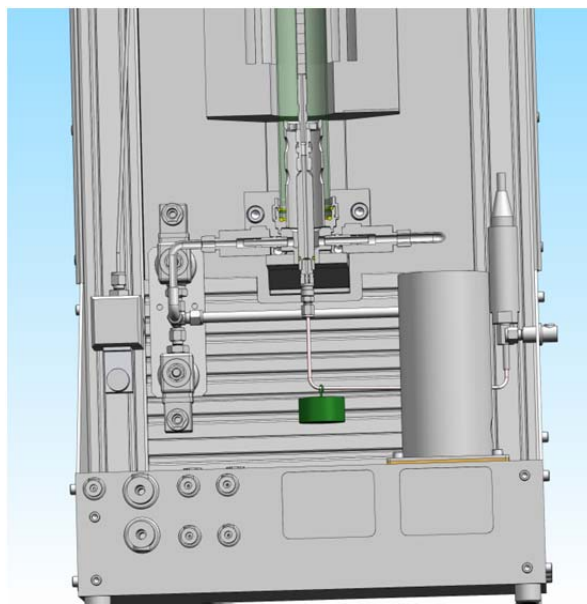
Figure 2

The location and attachment of the hanging weight on the LOCA apparatus

During benchmarking testing, there were tests in which rod bending was observed following the LOCA simulation. It was speculated that this rod bending was a result of a small axial constraint on the rod that was introduced by the friction force of the o-ring at the bottom of the test train. Therefore, a small hanging weight was attached in the lower part of the rod in order to balance the friction of the rod lower o-ring. The friction force induced by the o-ring was measured in shop by weights to be 2 N. Because of some uncertainties (due to temperature, etc) the hanging weight of 3 N was chosen. The location and attachment of the hanging weight are shown in Figure 2.

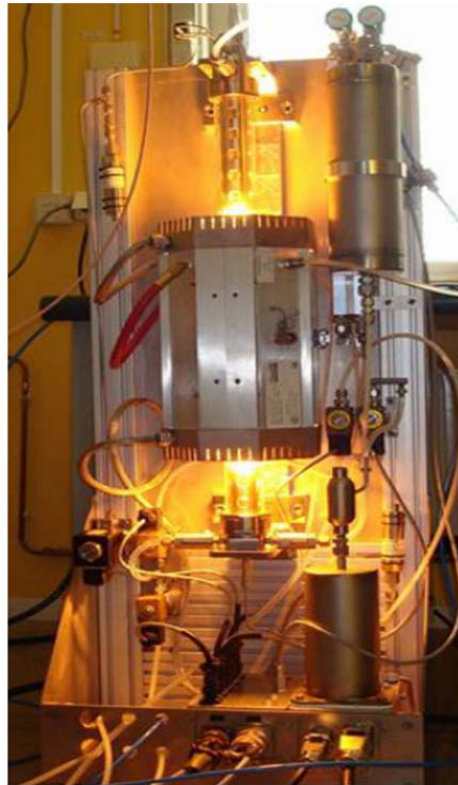
**Figure 3**

A photograph of the LOCA apparatus during a test.

A front view photo of the LOCA apparatus is shown in Figure 3. This photo was taken when the rod was heated up to 1200 °C.

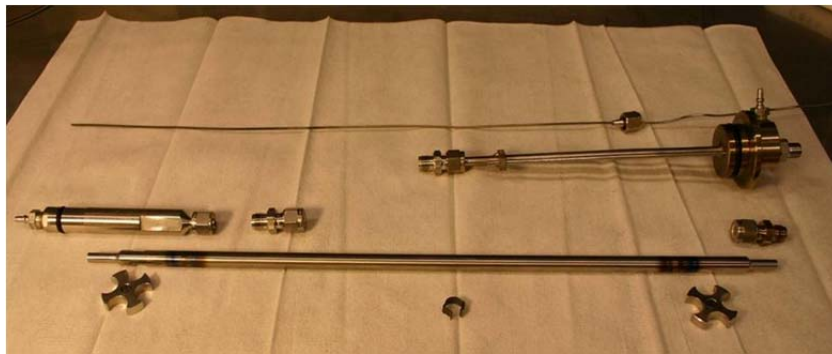
Figure 4
LOCA test train device disassembled on a table.

A test train device comprises a fuel rod, supports for a rod, O-rings, top plug, holder, springs and pipes. The main components of the LOCA test train device are shown in Figure 4 and an assembled full-length test train device in Figure 5.

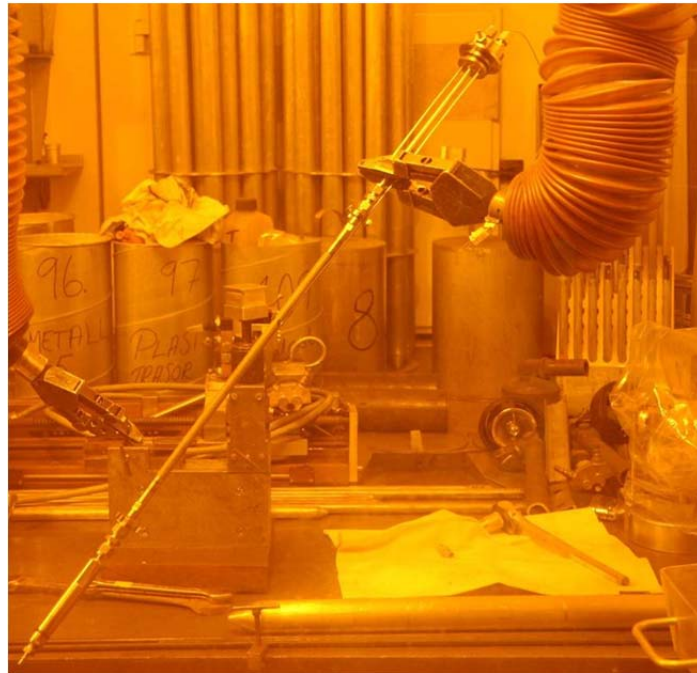
**Figure 5**

An assembled full-length test train device in a cell. A detailed drawing of the LOCA test train device with the main dimensions is shown in Figure 6.

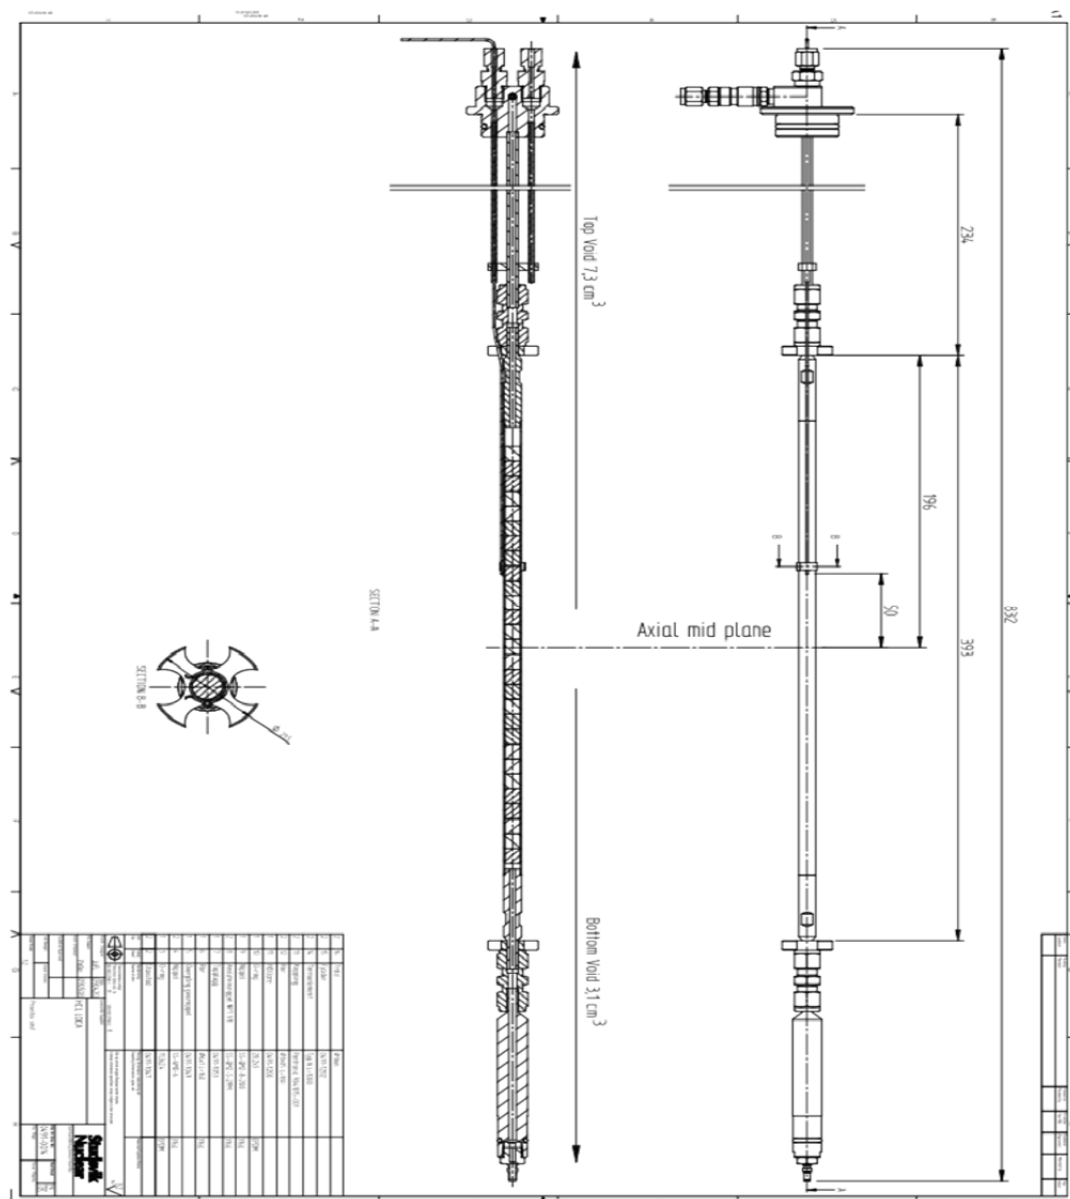
**Figure 6**

A detailed drawing of the LOCA test train device. The void volumes of the device are: 7.3 cm³ above the rod (~6.1 cm³ in the upper pressure line and ~1.2 cm³ in the upper rod plenum) and 3.1 cm³ below the rod (~2.4 cm³ in the lower pressure line and ~0.7 cm³ in the lower rod plenum). Thus, the total void volume is approximately 10.4 cm³.

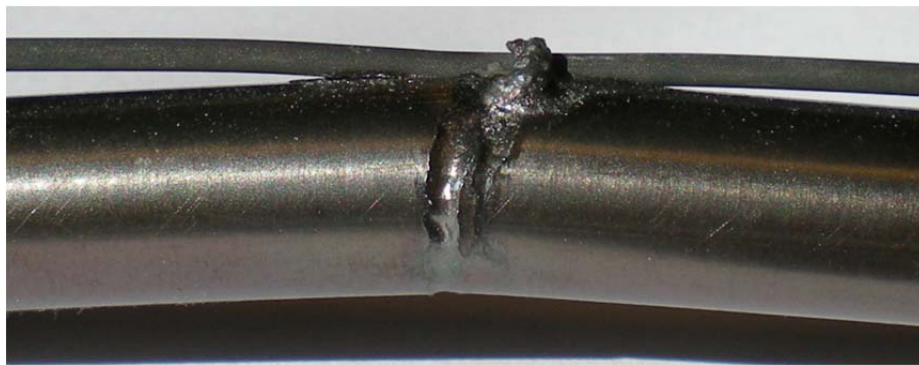
Figure 7

A clear reaction between Inconel 600 wire and Zircaloy cladding occurred when the cladding was heated up to 1200 °C.

The first solution tested was to use Inconel 600 wire to join a TC to the test rod. When this was tested with unoxidized Zircaloy-cladding, a strong reaction between nickel-based Inconel 600 and Zircaloy was observed (Figure 7). Thin wire is also very difficult to handle with manipulators so due to these drawbacks, this construction was rejected.

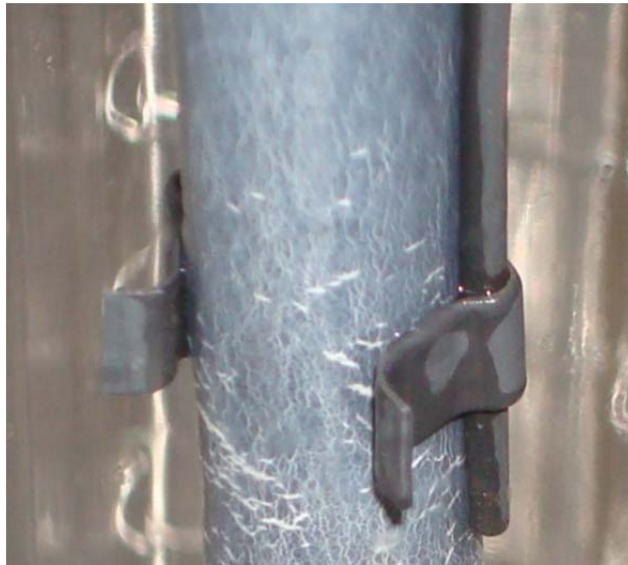
**Figure 8**

An Inconel X-750 clamp with an oxidized rod after a test at 1200 °C.

When the Inconel 718 clamps were subjected to temperatures around 1200 °C, they deformed. Due to the deformation of the Inconel 718 clamp, Inconel X-750 was chosen as a clamp material, since it did not show any pronounced reaction with cladding or deformation when tested at 1200 °C (Figure 8). However, in order to avoid Zircaloy-Inconel reaction, the TC clamp must be pre-oxidized before using it in the high-temperature experiments.

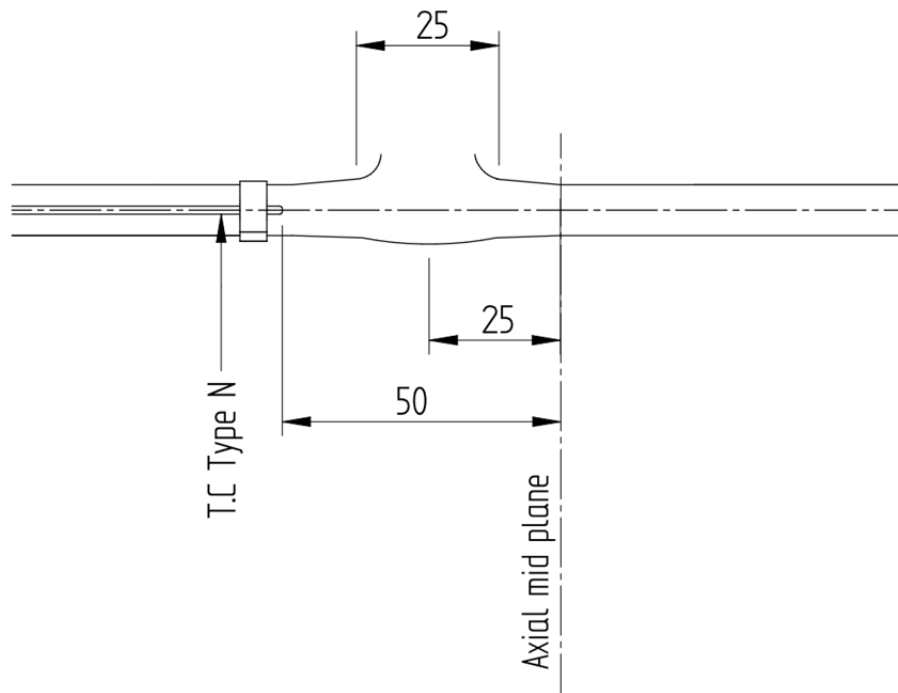
**Figure 9**

A schematic figure of normal balloon size and location relative TC clamp

Several axial locations for the thermo couple were tested. For fresh cladding sometimes the balloon was wider and interfered with the TC and the TC clamp. However for pre oxidized cladding (and later for irradiated) cladding it was found the best location for the TC was 50 mm above axial mid plane, as illustrated in Figure 9. At this location the measurement was accurate and the balloon did not interfere with the TC or the TC clamp.

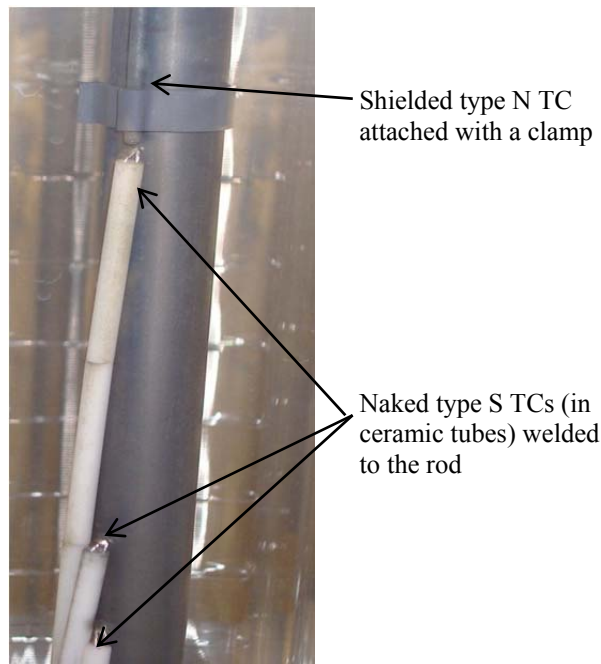
Figure 10

The location of three spot welded “naked” type S TCs (in grey ceramic tubes) along the cladding and one shielded type N TC attached with a clamp to the cladding.

Three spot welded thermocouples (TC) to monitor fuel rod temperature are shown in Figure 10. These TCs are naked type S TCs. It can be seen in Fig. 10 that they cover quite a lot of the rod surface area. It was assumed that the presence of several TCs caused partial shielding of the rod since the test rod is heated up with IR-radiation, resulting in unequal heating of the rod. Such unequal heating of the rod was not desirable in this test program.

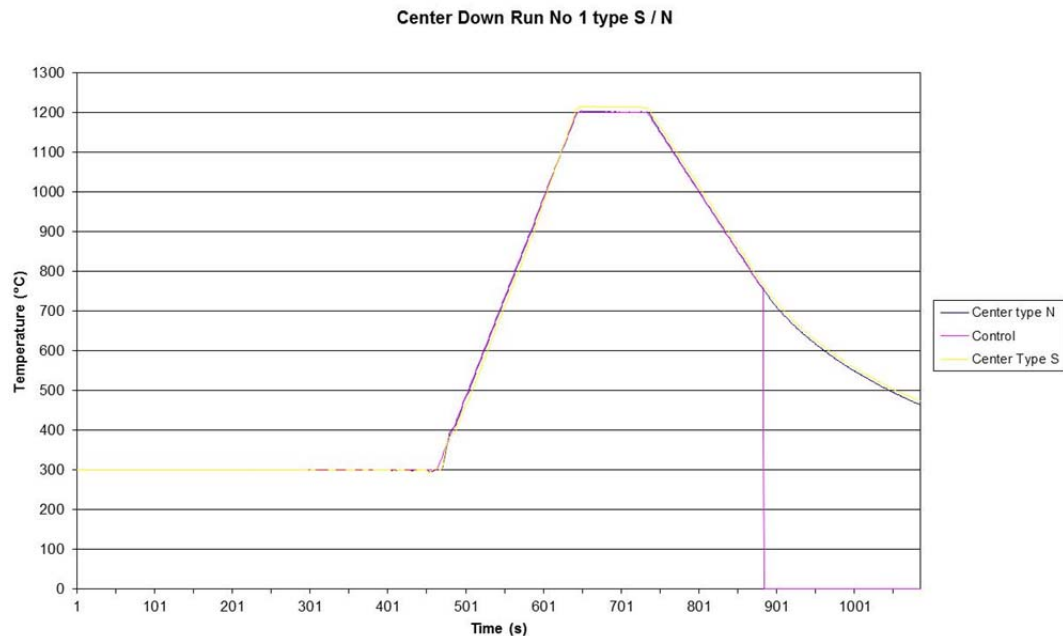
A comparison of type N and type S TCs in simulated LOCA test conditions.

Both types of TCs, S and N, are known to be suitable for high-temperature temperature monitoring. However, the N-type TCs are only effective if sufficient contact can be maintained throughout the test. The performance of both types of TCs was tested in conditions prevailing in LOCA tests in order to ensure that the clamp design provided sufficient contact for the N-type TC for the duration of the test. Figure 11 shows that both TCs gave very similar response in a test where they were installed at the axial midplane of the test rod (pink line shows the programmed temperature). The comparison of the welded and clamped thermocouples confirms that both methods of temperature monitoring provide equivalent temperature measurement for the conditions of

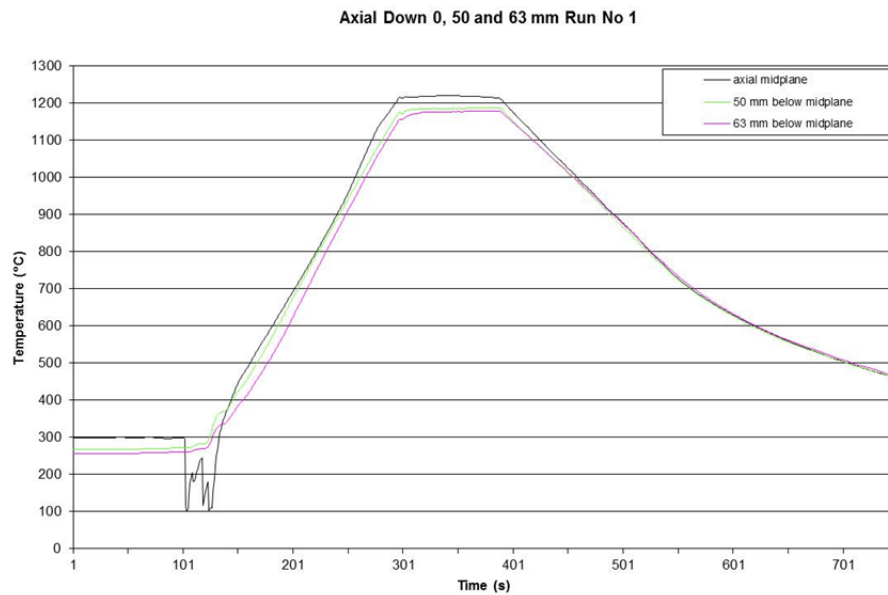
Figure 12

The effect of axial elevation of the thermocouple (Type S) on the measured temperature.

As described above, the dependence on the axial elevation of the thermocouple was investigated to optimize the temperature measurement. An example of such test is shown in Fig. 12. In this experiment type S naked thermocouples were positioned at three axial elevations, at the axial midplane, and 50 mm and 63 mm below it, as shown in Fig. 13. When the measured temperature at the axial midplane was about 1220 °C (plateau), the temperatures at 50 mm and 63 mm below the midplane

were ~ 35 and 45 °C lower, respectively. It was assumed that part of the temperature deviation was because of the shielding of the TCs mentioned above, because, as described later, oxide thickness measurements examined on rods without shielded TCs indicated a far less significant axial temperature gradient.

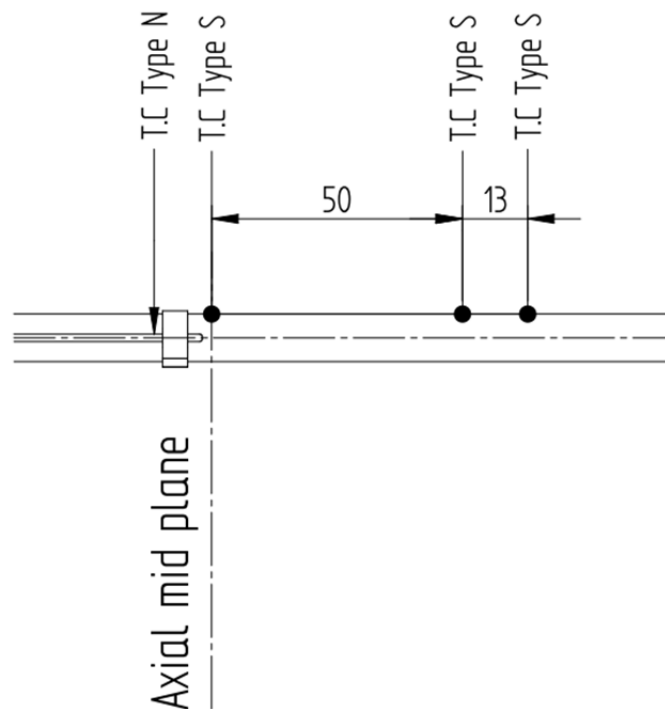
**Figure 13**

The location of TCs in relation to the axial midplane during the experiment shown in Fig. 12.

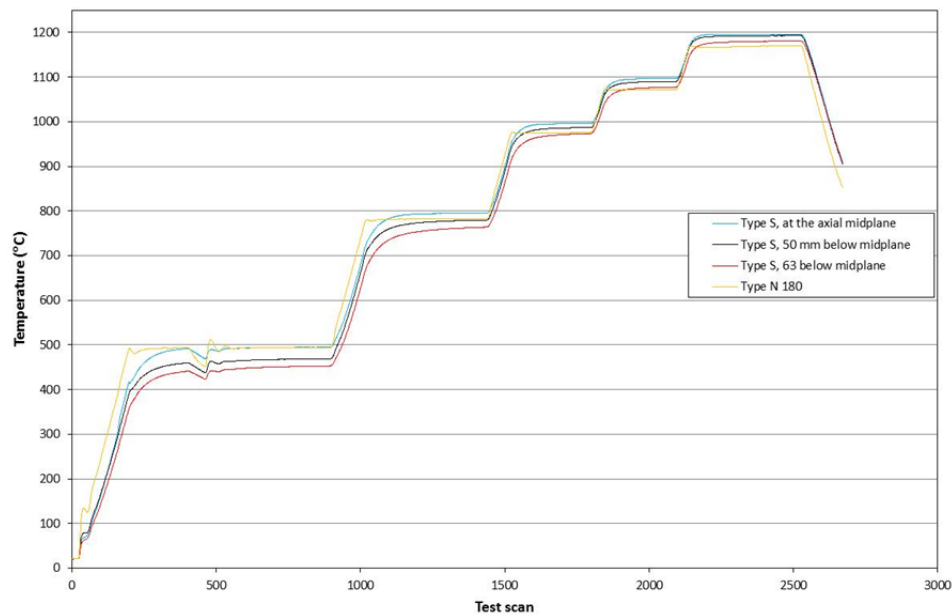
**Figure 14**

The effect of axial elevation of the welded type S naked thermocouples on the measured temperature. The results obtained with one clamped type N TC (located on the opposite side of the rod as type S TCs) are also presented.

The maximum temperature difference between the type S TCs is ~ 15 °C (1.3 %) and between the type S and type N TCs ~ 20 °C (1.7 %) at 1200 °C.

Another plot from thermocouple calibration studies is shown in Figure 14, where type S thermocouples were tested at three different axial elevations and one clamped type N thermocouple was positioned at the same axial elevation as the uppermost type S TC and on the opposite side of the rod (180°).

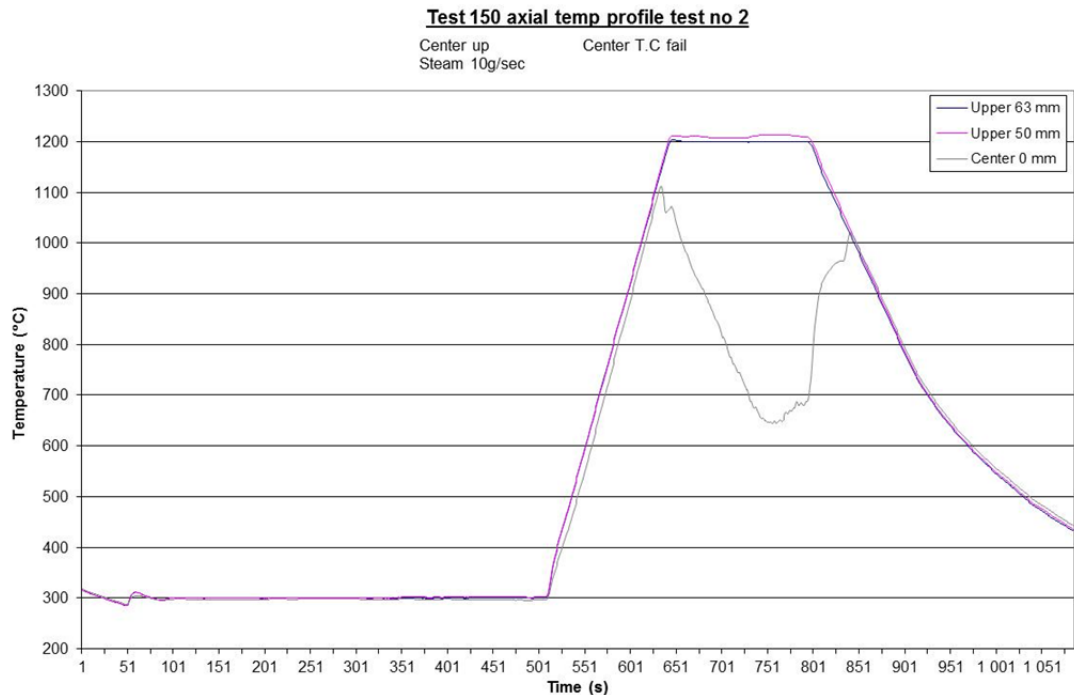
**Figure 15**

A test where type S naked TCs located at the elevations of 50 and 63 mm above the axial midplane. The center TC failed during the test.

Tests where type S naked TCs located above the axial midplane were also performed. The results of one such test are illustrated in Figure 15 where two TCs were at the elevations of 50 and 63 mm above the axial midplane and one at the midplane. Unfortunately, the TC at axial midplane failed at ~ 1100 °C due to short-circuit (condensed water), but showed very consistent results with the two other TCs before failing.

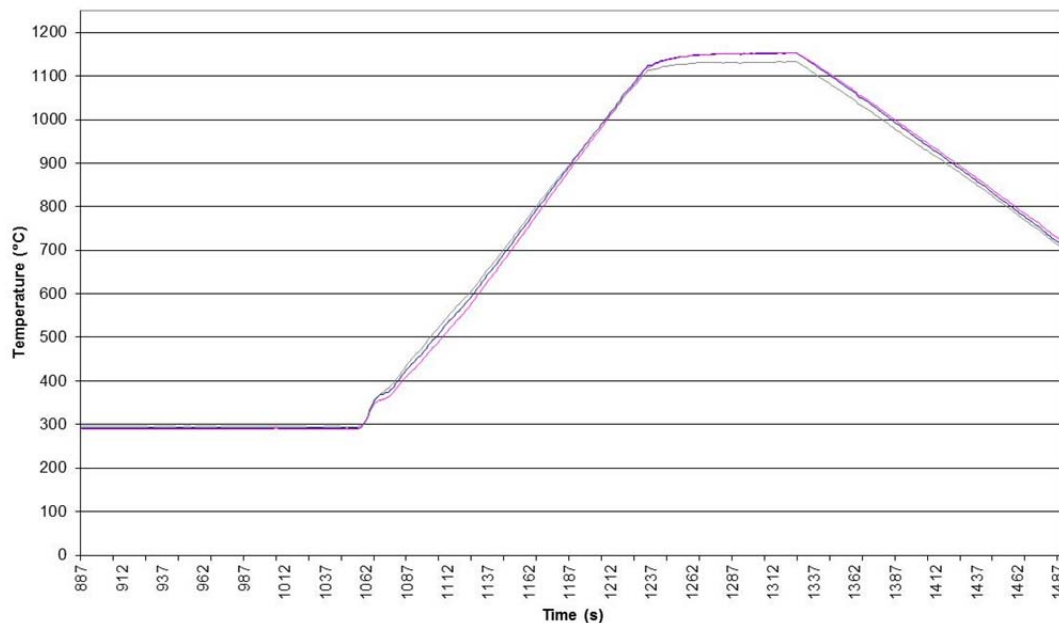
**Figure 16**

Circumferential comparison of three different TCs at 120°.

The dependence of the temperature on the circumferential location of the thermocouple was also investigated. This was done by installing the TCs at an angle of 120 ° relative to each other. An example of such measurement is presented in Figure 16, where three different TCs were compared with each other. The temperature difference between TCs 1 and 2 is negligible and the difference between these two TCs and TC3 is about 20 °C at the plateau (~1130 – 1150 °C). A more detailed examination of the circumferential temperature gradient was later performed by observation of the oxide thickness in metallography, which will be discussed in section 2.5.

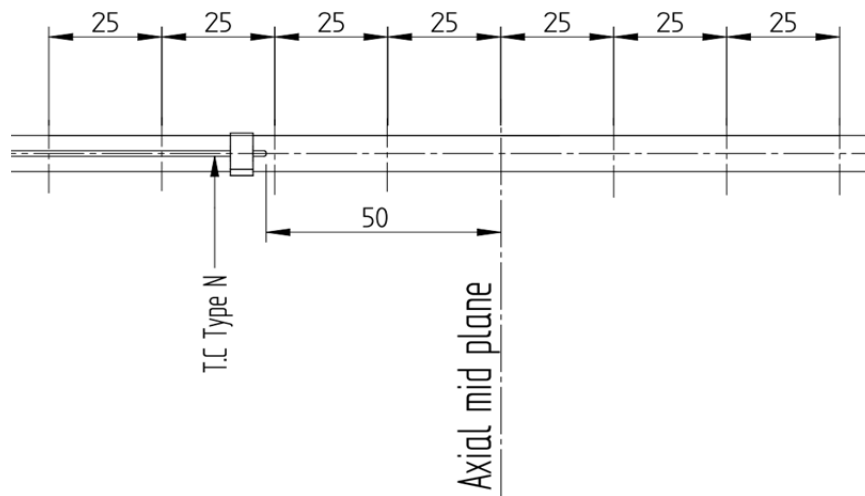
**Figure 17a**

Axial locations of oxide thickness measurements

For the test to investigate the thermocouple calibration using oxide measurements, a single N-type, clamped TC was used. The cladding was steam oxidized at 1200 °C for 200 s without pressurization and the cladding was not water quenched after the oxidation (due to an anticipated temperature variance of approximately ± 10 °C between the temperature at the axial midplane and the temperature 50 mm above the axial midplane where the control TC was located, the programmed ramp was set to 1190 °C). After the test, the cladding was cut and oxide thicknesses were measured with metallography at 7 axial elevations as shown in Figure 17a. The presented values in Figure 17b are averages of 4 circumferential (0, 90, 180 and 270°) measurements.

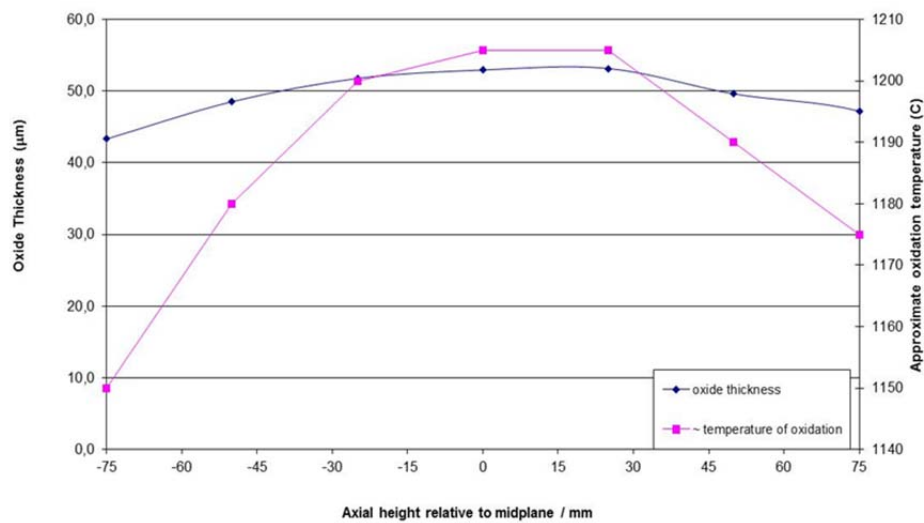
**Figure 17b**

A graph showing measured oxide thickness as a function of axial elevation. Oxidation temperature set point was 1190 °C. The approximate oxidation temperatures were calculated on the basis of measured oxide thicknesses by using Cathcart-Pawel equation and considering the programmed heat up ramp, a 200 second hold time and the observed cool down.

For this test program, the criterion for a uniform heating zone was defined as ± 20 °C from the target temperature. The target temperature (i.e., programmed TC set point) for this test was 1190 °C. The TC at +50 mm indeed indicated a value of oxidation temperature of 1190 °C, while measurements at the mid-plane and +25 mm indicate oxidation temperatures above 1200 °C. The results presented in Figure 17b indicate that the zone from approximately -40 mm to +50 mm was subjected to an oxidation temperature of 1200 ± 10 °C and this was considered the uniform heating zone.

When the oxide measurements as a function of axial location were examined, they indicated that the mid-plane of the fuel rod was subjected to a higher temperature than anticipated. The mid-plane of the fuel rod was subjected to a temperature greater than 1200 °C, even when the programmed ramp was set to 1190 °C. Other calibration tests indicated that the temperature deviation between the mid-plane and the TC located +50 mm above the mid-plane could deviate even more than the values shown in Figure 17b. Using the uniform heating zone criterion of ± 20 °C, the observed deviation from the target temperature were

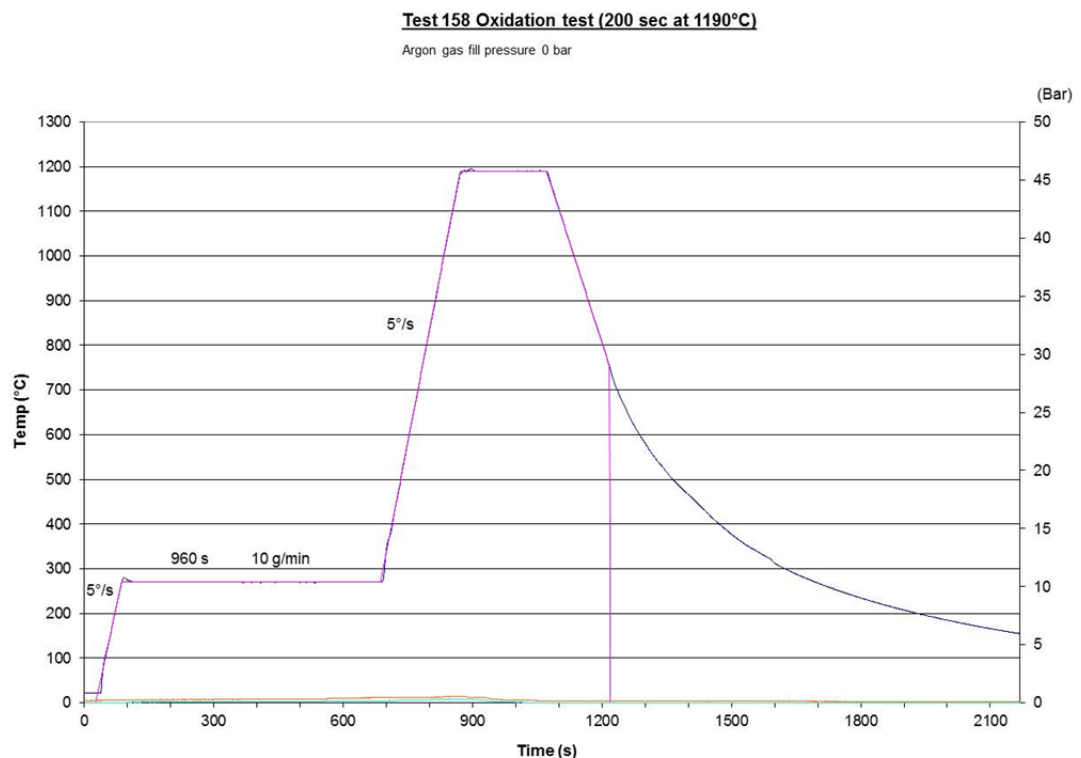
**Figure 17c**

The programmed temperature profile for the test 158 (Figure 17b).

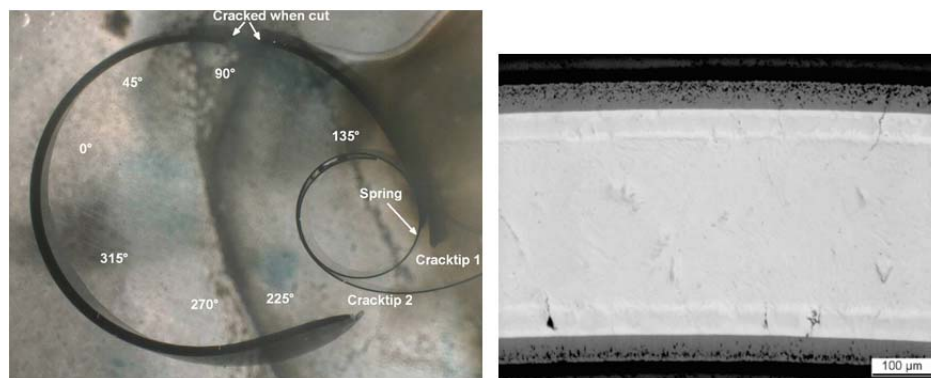
Figure 18b

An example of metallographic oxide thickness determination.

Oxide thickness measurements were also made on the ballooned and ruptured piece of cladding (not used for the calibration purposes). An example is shown in Figure 18b. Measured values are shown in the Table below.

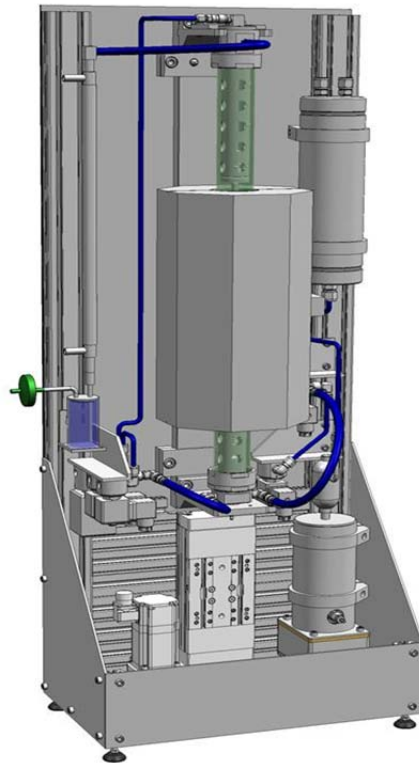
**Figure 19**

A schematic drawing of the LOCA apparatus showing the quartz pipe (green) and the pressure line (blue).

The test fuel rod section is covered with a quartz pipe (shown green in Figure 19) forming the primary coolant system for the test rod.

The void volume of the pressure line plus the void volume in rod plenum was approximately 10 cm^3 in the ANL design and this was also used as a design basis for Studsvik's LOCA apparatus. The volume is minimized in order to avoid the relative plenum volume becoming too big compared to a real fuel rod. In the Studsvik design, the void volume in the upper pressure line is approximately 6.1 cm^3 , in the rod upper plenum approximately 1.2 cm^3 , in the lower pressure line approximately 2.4 cm^3 and in the rod lower plenum approximately 0.7 cm^3 .

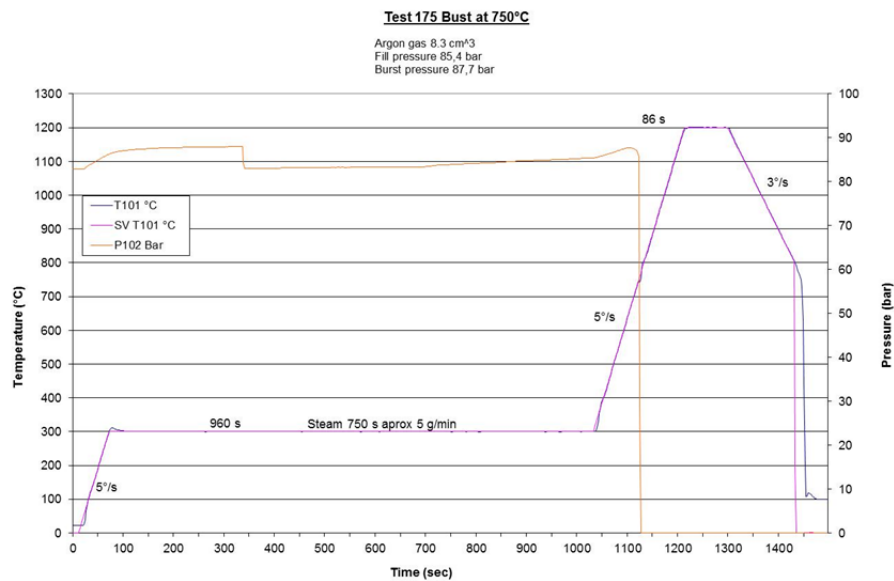
Figure 20
 Results of LOCA performance test 175.

During the test 175 the cladding was first heated up to 300 °C with a rate of 5 °C /s, then steam was added for ~ 960 s after which temperature was further increased (5 °C /s) up to 1200 °C (Figure 20). The burst occurred at ~750 °C with the burst pressure of 87.7 bar. The pink line shows the programmed temperature profile and the blue line the actual measured temperature. The correspondence between these is very good.

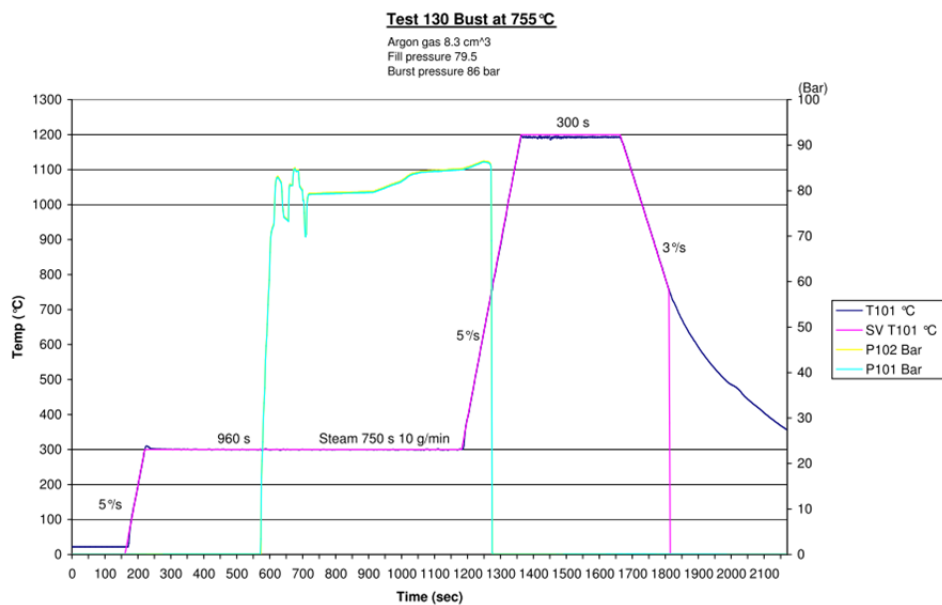
Figure 21
 Results of LOCA performance test 130.

Another example of a performance test with unirradiated cladding with ceramic pellets is shown in Figure 21. In this experiment the pressure was measured with two independent monitors, one monitored at the bottom of the test segment and one monitored at the top of the test segment, and they show very reproducible results. The correspondence with the programmed and measured temperature is again very good.

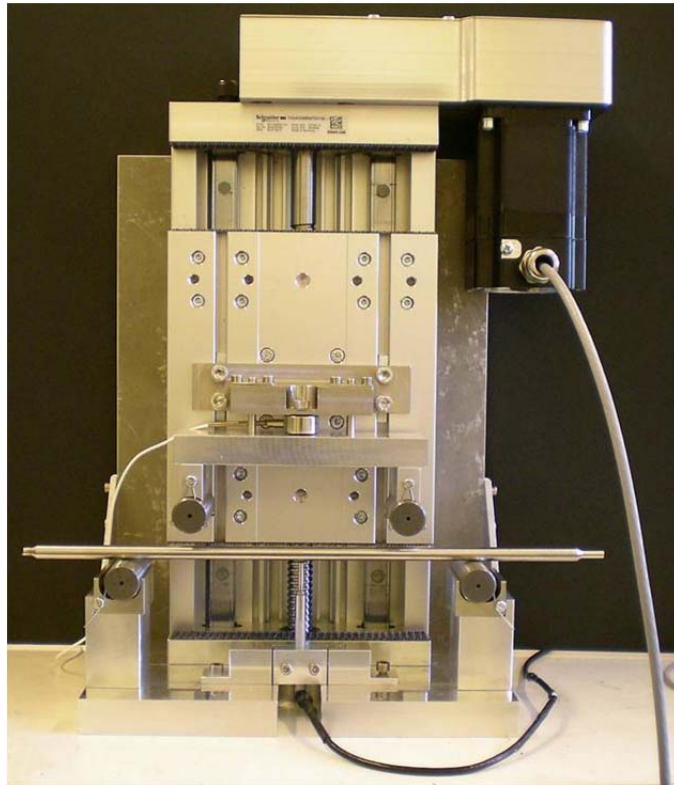
Figure 22
4-PB equipment before starting the tests.

The 4-point-bend equipment (4-PB) has a similar design as ANL's corresponding device. The 4-point-bend technique is used in order to induce a uniform bending moment to the area surrounding the midsection of the test segment, thus making it possible for the segment to not necessarily break in mid balloon/rupture opening but also at the balloon neck if this location is the weakest. The device comprises a 2200 N load cell and a 10 mm displacement recorder.

Load and deflection vs. time are recorded during a test, and ductility, strength and toughness of a cladding material are evaluated from the load displacement data. Figure 22 shows an overview of the 4-PB equipment.

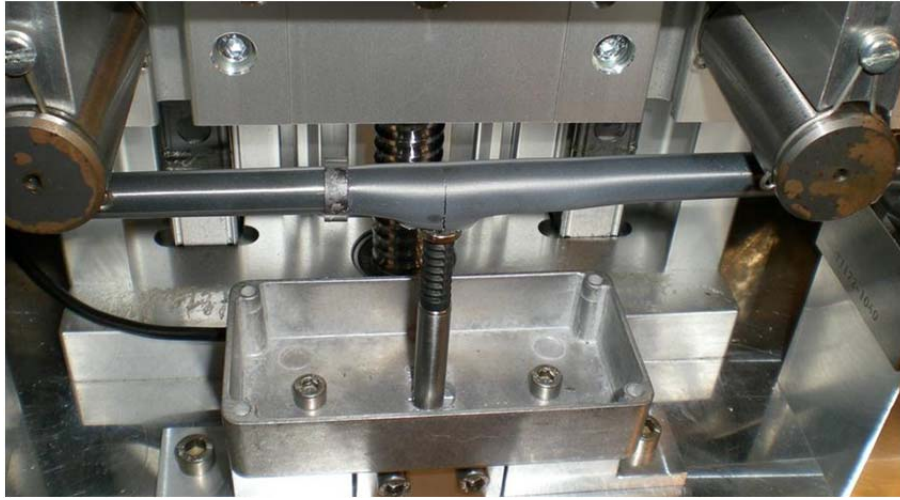
Figure 23
4-PB equipment during testing.

Figure 23 shows the 4-PB machine during a test where a test rod is just about to bend.

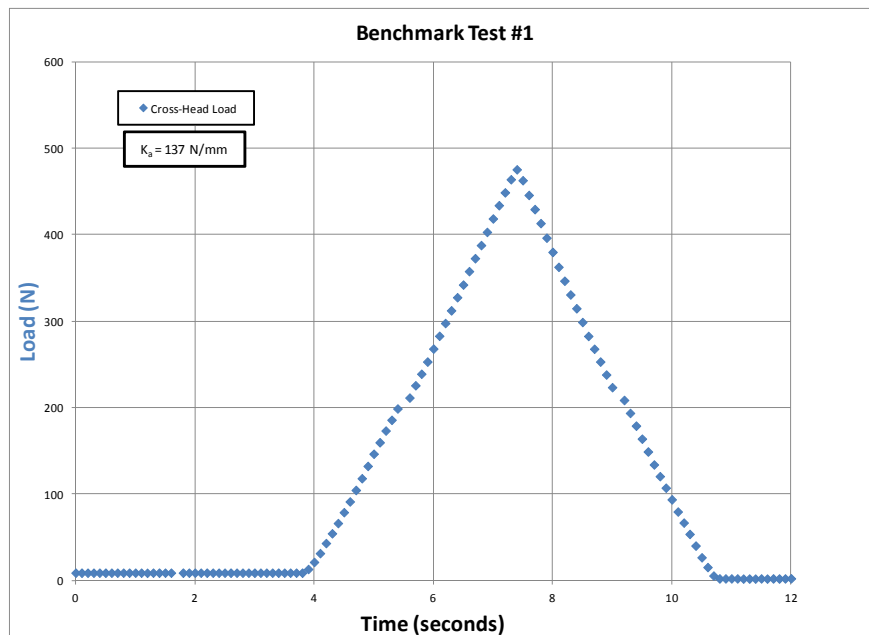
Figure 24
Results from benchmark test #1.

In the first loading stiffness check, the LVDT and TC clamp were not used. The test was run for a maximum displacement of 3 to 4 mm, which should be in the elastic regime for 17×17 ZIRLO. The linearized loading slope illustrated in Figure 24 (137 N/mm) was compared to the predicted value of 130 N/mm. The measured value falls in the acceptable range of 117 to 143 N/mm.

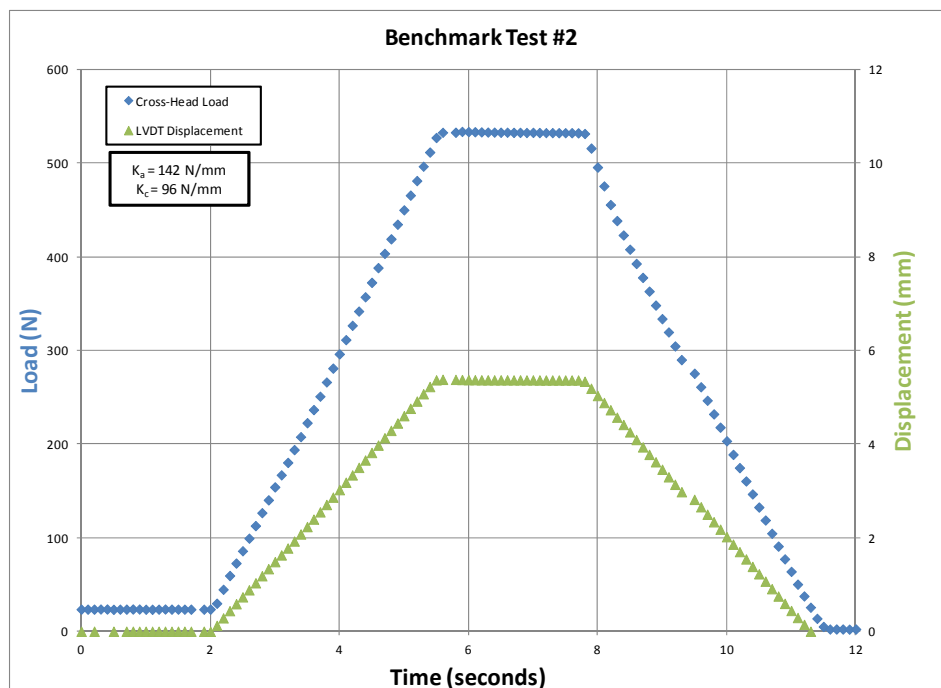
**Figure 25**

Results from benchmark test #2.

A test was rerun in the same test conditions as test #1, but with the LVDT at mid-span in order to determine if the LVDT influenced measured K_a . P_a vs. δ_c (LVDT-recorded displacement) was plotted (Figure 25) and the linearized loading slope from this curve was computed. The linearized loading slope illustrated in Figure 25 (142 N/mm) was compared to the predicted value of 130 N/mm. The measured value is at the maximum, but within the acceptable range of 117 to 143 N/mm. Measured values of $\Delta P_a / \Delta \delta_c$ were used to calculate a value of $K_c = 96$ N/mm, which is slightly higher than the predicted value of 81 N/mm. Measured values in the range of 73 to 89 N/mm are acceptable.

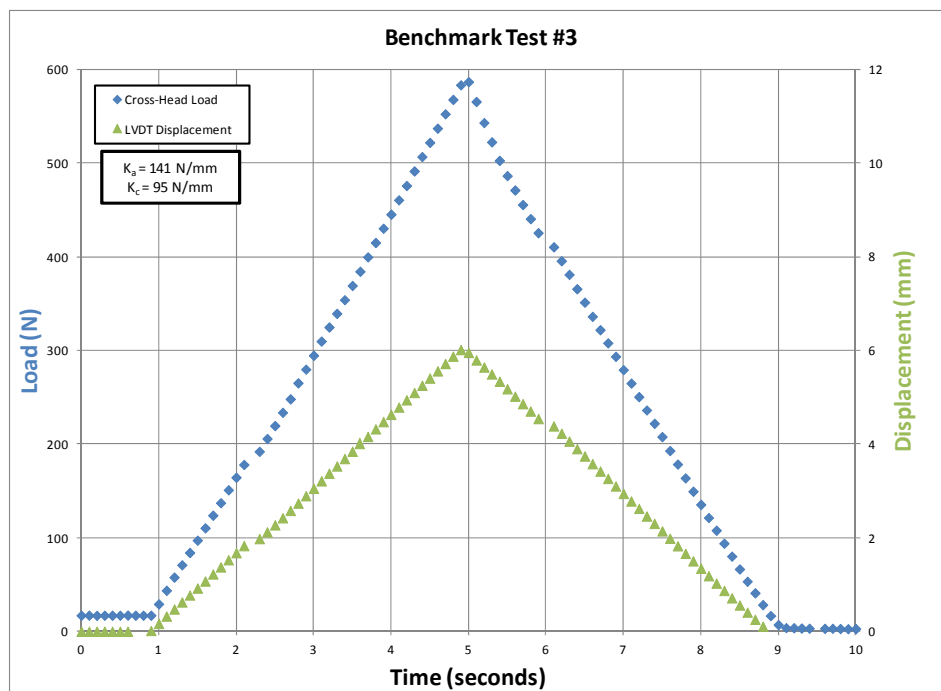
Figure 26
Results from benchmark test #3.

A third test was run in the same test conditions as test #1, but with the LVDT at mid-span and the TC clamp positioned about 50 mm from sample mid-span. The purpose was to determine if clamp influences measured values of K_a and K_c . The linearized loading slope illustrated in Figure 26 (141 N/mm) was compared to the predicted value of 130 N/mm. The measured value falls in the acceptable range of 117 to 143 N/mm. Measured values of $\Delta P_a / \Delta \delta_c$ were used to calculate a value of $K_c = 95 \text{ N/mm}$ and compared to the predicted value of 81 N/mm. Measured values in the range of 73 to 89 N/mm are acceptable.

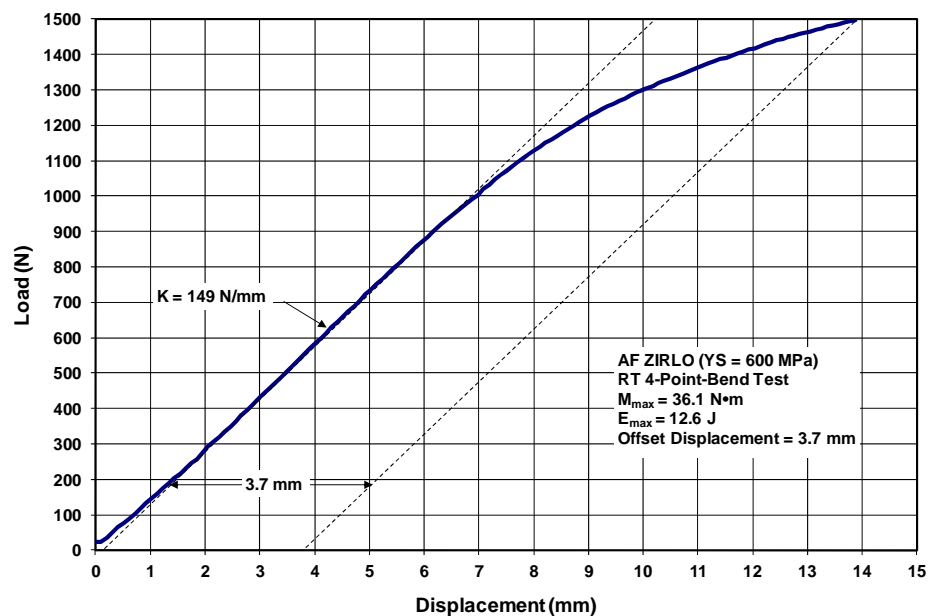
**Figure 27**

Results from benchmark test #4.

Benchmark #4 was run as tests would be conducted in-cell without the LVDT and with the TC clamp. Also, displacement was increased so that sample experienced plastic as well as elastic displacement. Figure 27 provides the Load-Displacement data from benchmark test #4.

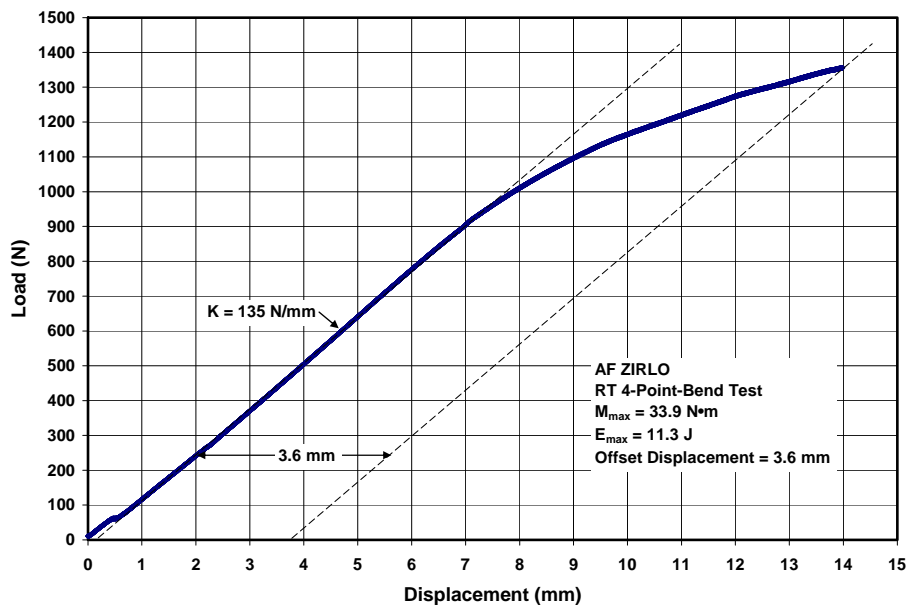
**Figure 28**

Load-displacement curve for Argonne National Laboratory four-point bend test benchmark conducted with AF ZIRLO-2003 at RT and 1 mm/s.

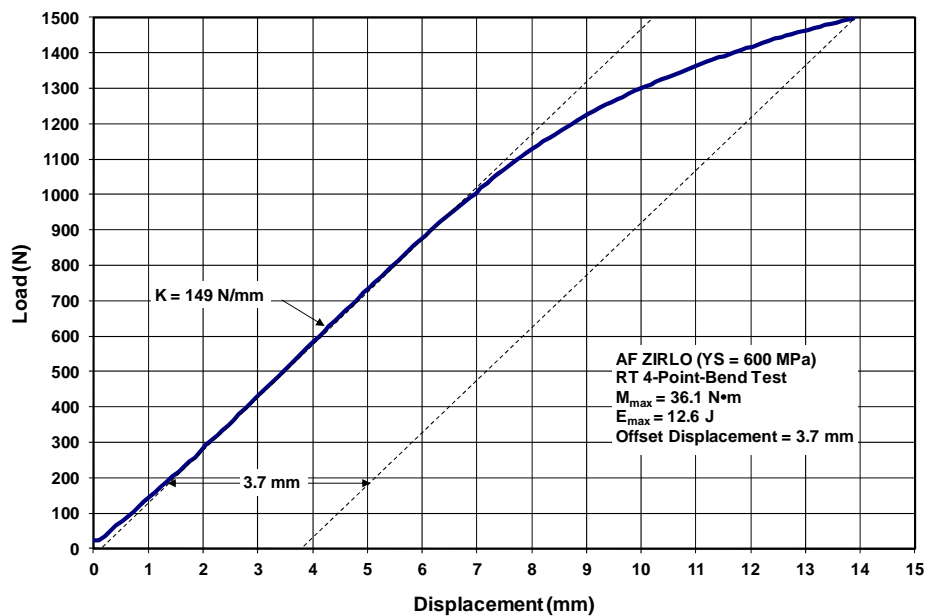
**Figure 29**

Load-displacement curve for Studsvik four-point bend test benchmark conducted with AF ZIRLO at RT and 1 mm/s.
