EFFECT OF THE CHROMIUM CONTENT AND STRAIN ON THE CORROSION OF NICKEL BASED ALLOYS IN PRIMARY WATER OF PRESSURIZED WATER REACTORS

Abstract

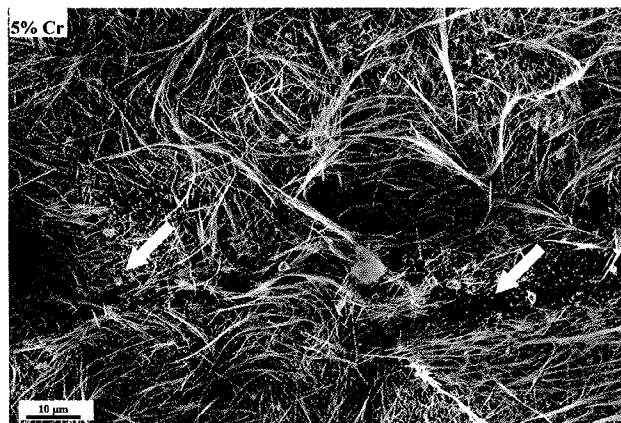
The microstructures of the external corrosion layer produced on coupons are first examined by SEM for the different alloys. The alloys presenting the lowest chromium contents (5 and 10%) exhibit oxides in filaments shaped on their surface. The filament density increases with decreasing chromium content until the surface is completely covered for the 5 wt% Cr alloy (Figure 1a).

Figure 1. SEM images of the oxide scale developed in simulated primary water on alloys with various Cr contents (a) 5% Cr, (b) 15% Cr and (c) 30% Cr.

Two categories of filaments are detected; nickel-rich filaments, and filaments containing both iron and nickel (probably NiFe_2O_4 spinels). Beneath the filament layer small discrete crystallites are observed, as indicated by the white arrows in Figure 1a. The filaments disappear with increasing chromium content and are replaced by a distribution of crystallites as illustrated in Figures 1b (15% Cr) and 1c (30% Cr). The crystallites present a bimodal size distribution of small crystallites in the order of 10nm, and large ones ranging from 100 nm to few microns (randomly distributed) (Figure 1c). The average size of the small crystallites decreases with chromium content

Figure 2 illustrates the entire thickness of the oxide formed on the 5% Cr alloy. The filaments observed in Figure 1a, can be seen on the coupon surface although they are somewhat damaged due to the TEM sample preparation. The crystallites seen in SEM are also visible beneath the filaments and do not form a continuous layer. An inner oxide layer can be seen below the crystallites. This consists of chromium rich oxide grains that have penetrated into the metal as opposed to oxide grains that have grown outwards from the metal surface.

The layered structure of the oxide scale developed on the 30 % alloy is shown in Figure 4. The outer surface displays crystallites as observed by SEM (Figure 1.a). This layer is not continuous, consisting of discrete separated grains, meaning it is unlikely that this layer acts as a protective layer. A second layer, 10nm thick, consisting of very small oxide grains is observed below the outer surface. The structure of the oxide layers is more clearly defined in the X ray profile analysis (Figure 5). The outer crystallites are enriched in chromium and iron (40% of Cr and 40% of Fe). The second oxide layer is highly enriched in chromium, reaching levels of up to 70%. The parent metal is impoverished of chromium over a thickness of 30nm below the second oxide layer.
