Seismic Walkdown Checklist (SWC)

Equipment ID No.: 2E12-C002B

Equipment Description: 2B RESIDUAL HEAT REMOVAL PMP

Project: LaSalle 2 SWEL

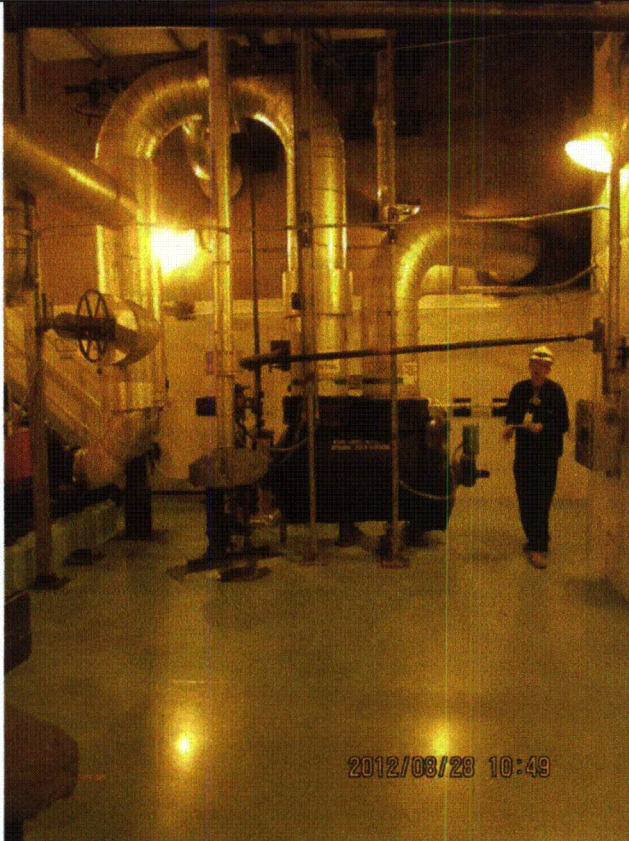
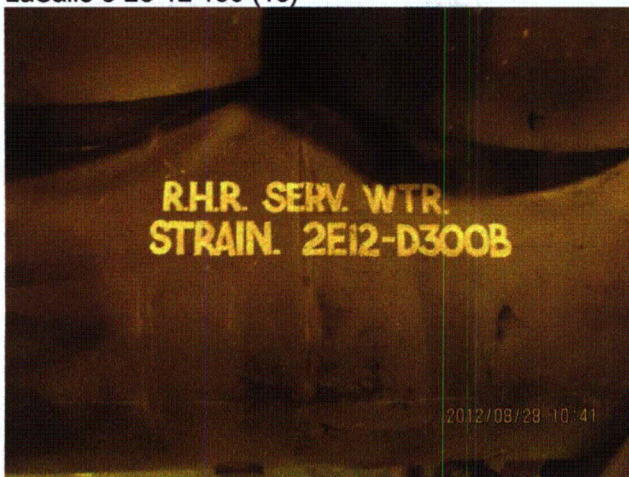
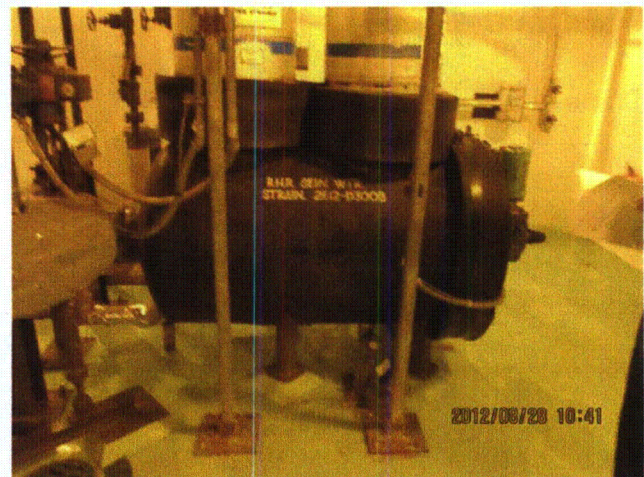
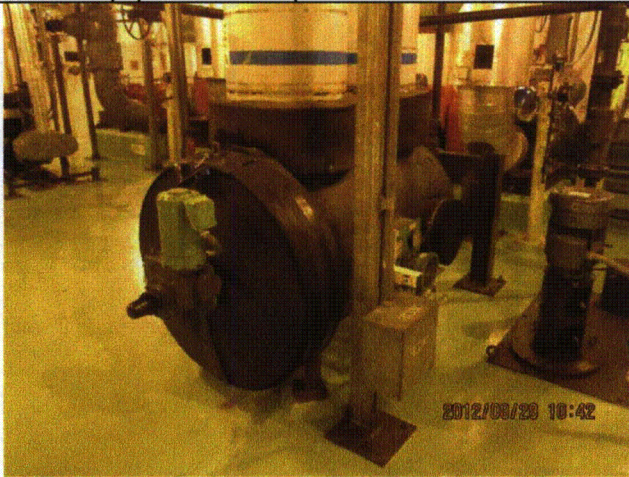
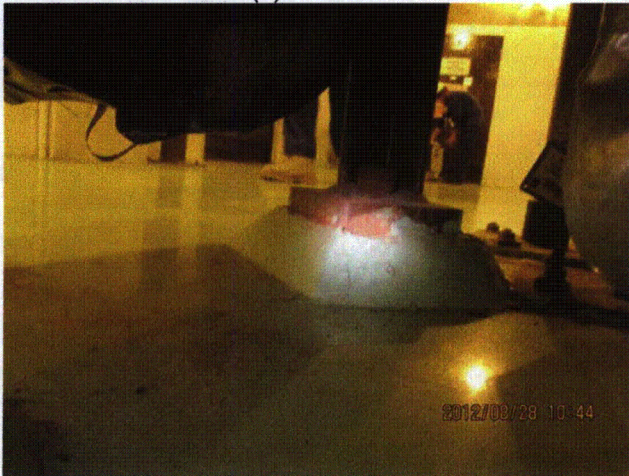
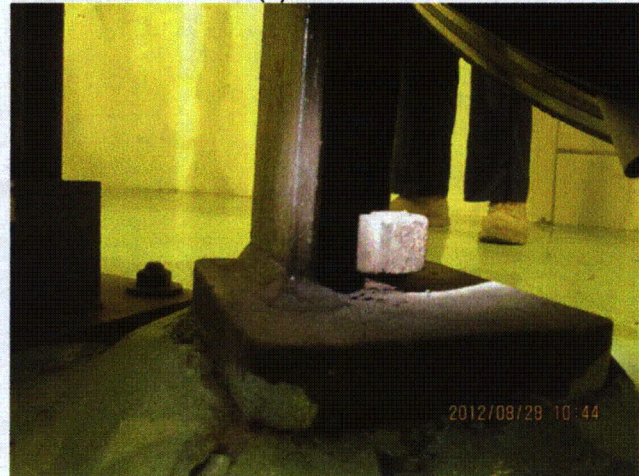
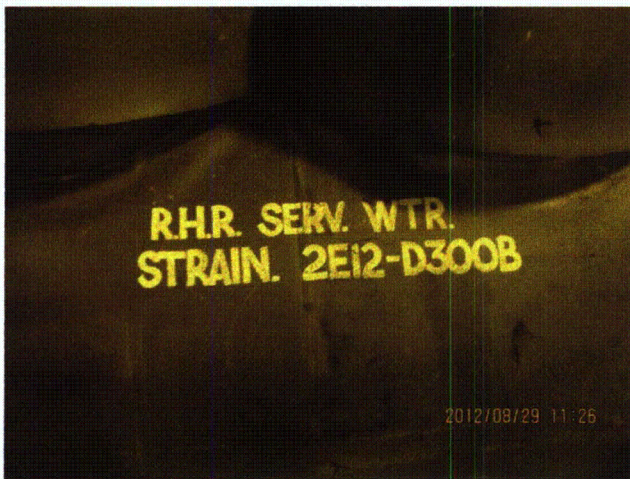
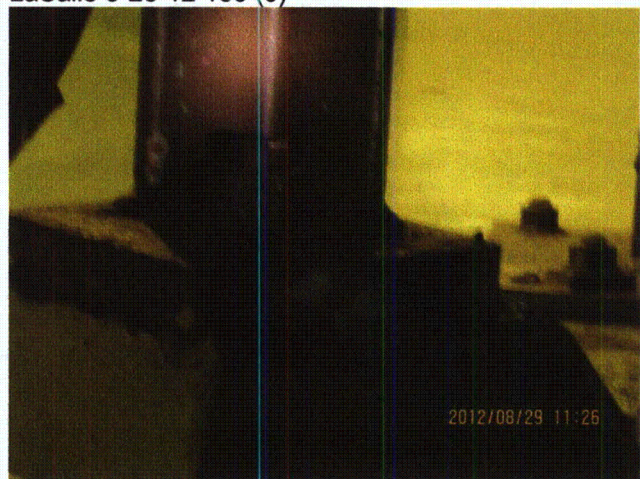
1. Is anchorage configuration verification required (i.e., is the item one of the 50% of SWEL items requiring such verification)? Yes
2. Is the anchorage free of bent, broken, missing or loose hardware? Yes
2 anchors at end bell (south) end with nut not tightened against base plate (maximum 1/2" gap between bottom of nut and top of base plate). Judged to be acceptable per station Engineering department. Station Maintenance department tightened nuts against base plates. See IR 1406061.

3. Is the anchorage free of corrosion that is more than mild surface oxidation? Yes
4. Is the anchorage free of visible cracks in the concrete near the anchors? Yes
Minor spalling in grout pads judged to be acceptable.

5. Is the anchorage configuration consistent with plant documentation? (Note: This question only applies if the item is one of the 50% for which an anchorage configuration verification is required.) Yes
Anchorage shown on drawings M-1573, Rev. G and M-1591, Sheet 11, Rev. E.

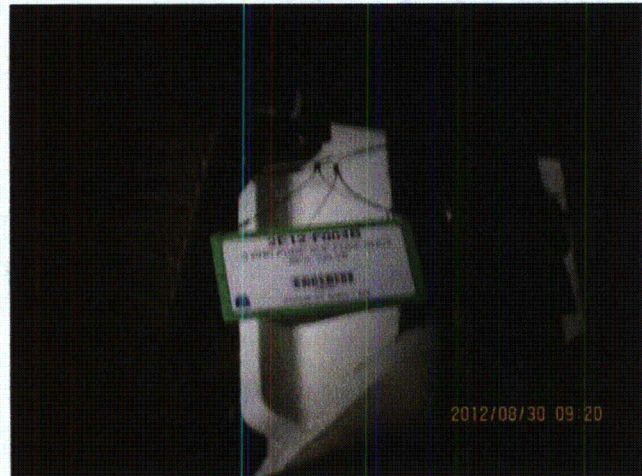
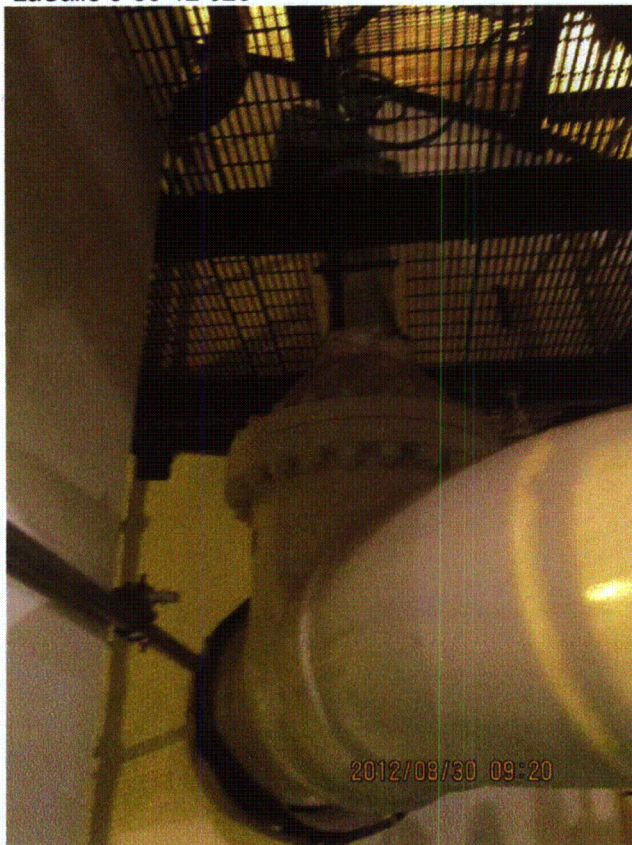
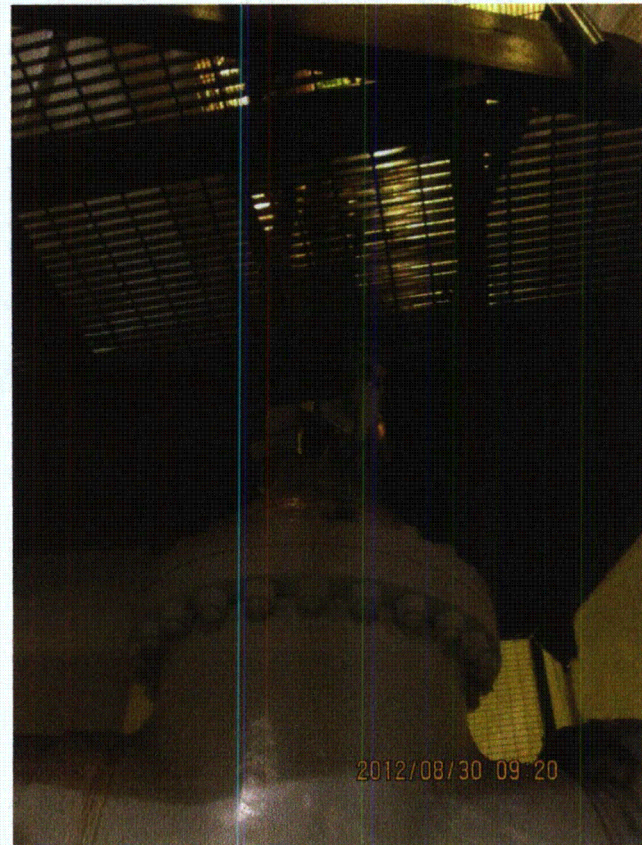
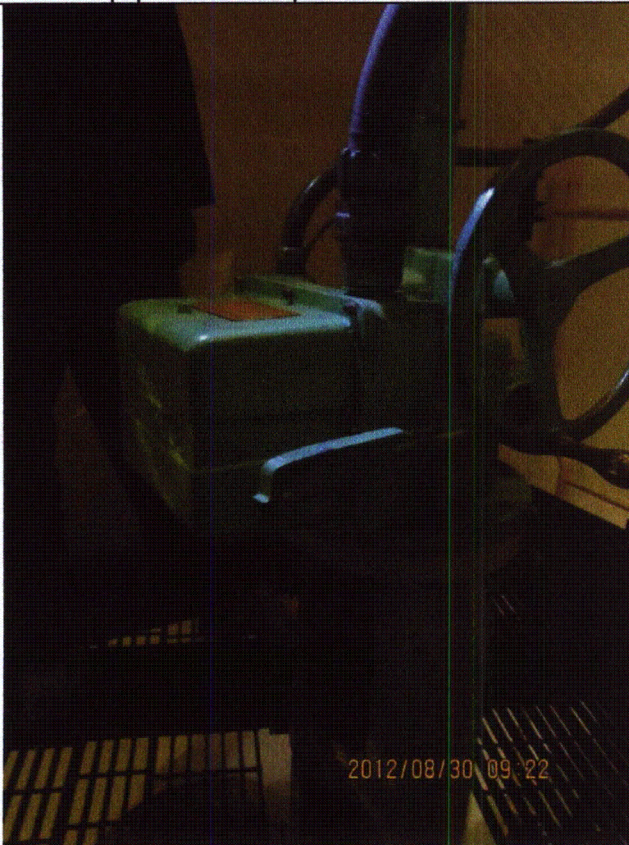
11. Have you looked for and found no adverse seismic conditions that could adversely affect the safety functions of the equipment? Yes
Clearance between valve yoke and adjacent gallery grating is judged to be adequate.
