**Seismic Walkdown Checklist (SWC)**

Equipment ID No.: 1VQ034

Equipment Description: DW VENT/PURGE OTLT UPSTRM ISOL

Project: LaSalle 1 SWEL

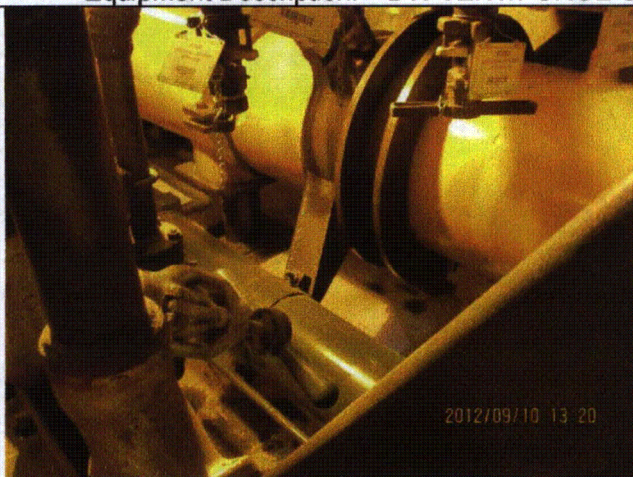
20120910-Lasalle 187

11. Have you looked for and found no adverse seismic conditions that could adversely affect the safety functions of the equipment? Yes  
*Approximate 1" clearance between flexible conduit connection to valve operator and floor judged to be acceptable.*

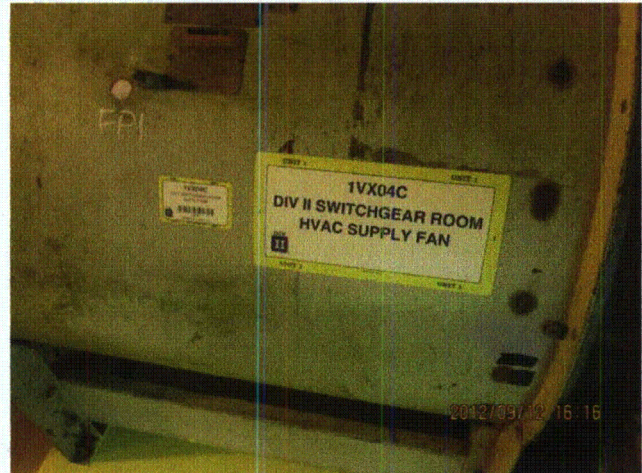
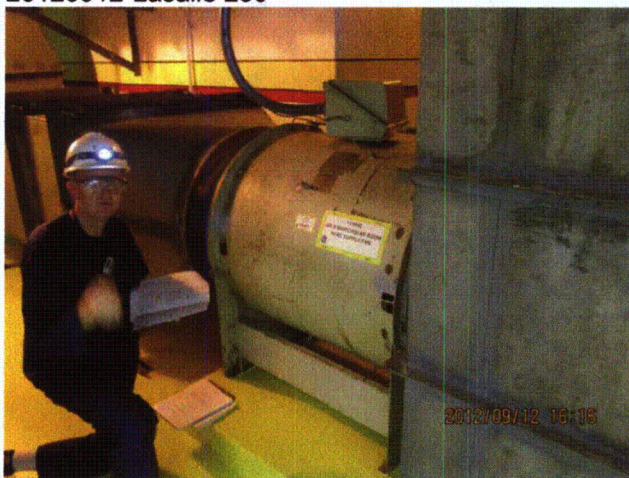
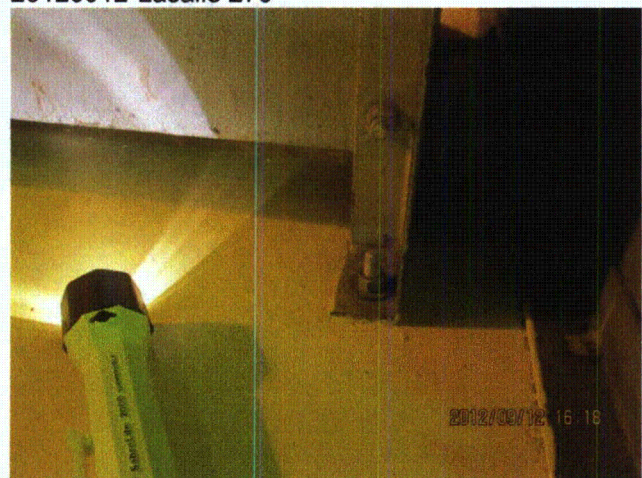
5. Is the anchorage configuration consistent with plant documentation? (Note: This question only applies if the item is one of the 50% for which an anchorage configuration verification is required.) Yes  
*Anchorage shown on drawings M-1566, Rev. E and M-1592, Sheet 19, Rev. E.*

7. Are soft targets free from impact by nearby equipment or structures? Yes
8. Are overhead equipment, distribution systems, ceiling tiles and lighting, and masonry block walls not likely to collapse onto the equipment? Yes  
*Adjacent masonry column pilaster (column L-11) with running bond construction judged to be acceptable.*
9. Do attached lines have adequate flexibility to avoid damage? Yes
10. Based on the above seismic interaction evaluations, is equipment free of potentially adverse seismic interaction effects? Yes

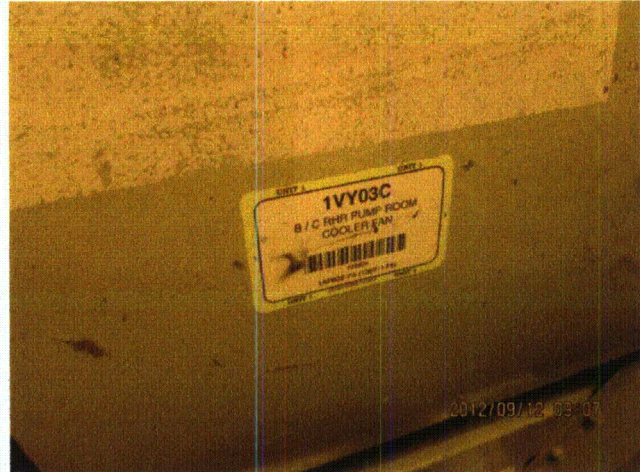
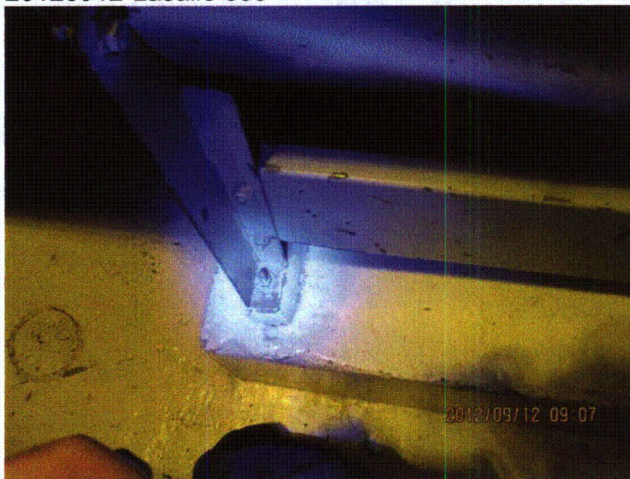
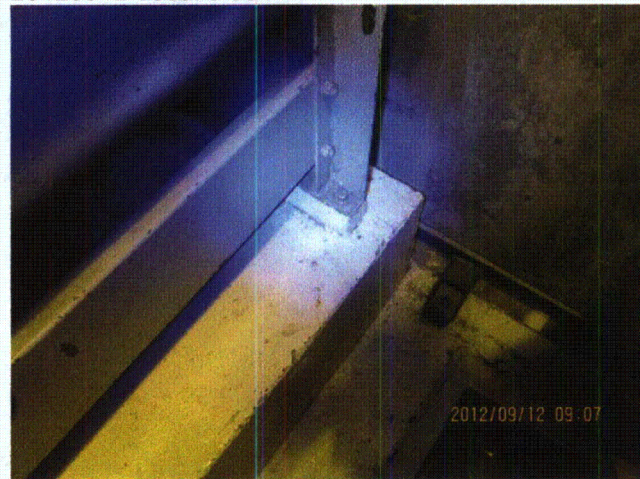
1. Is anchorage configuration verification required (i.e., is the item one of the 50% of SWEL items requiring such verification)? Yes
2. Is the anchorage free of bent, broken, missing or loose hardware? Yes  
*Minor lack of thread engagement on one anchor judged to be acceptable.*

3. Is the anchorage free of corrosion that is more than mild surface oxidation? Yes
4. Is the anchorage free of visible cracks in the concrete near the anchors? Yes  
*Minor shrinkage cracking in grout pad judged to be acceptable.*
