**WATTS BAR NUCLEAR PLANT, UNIT 1  
FUKUSHIMA NEAR-TERM TASK FORCE RECOMMENDATION 2.3:  
SEISMIC RESPONSE REPORT**

# **WATTS BAR NUCLEAR PLANT – UNIT 1 FUKUSHIMA NEAR-TERM TASK FORCE RECOMMENDATION 2.3: SEISMIC RESPONSE REPORT**

12-November 2012

REV	DESCRIPTION	ORIG	REVIEW	WORLEY- PARSONS APPROVAL	DATE	CLIENT APPROVAL	DATE
0	WBN Unit 1 Seismic Walkdown Report

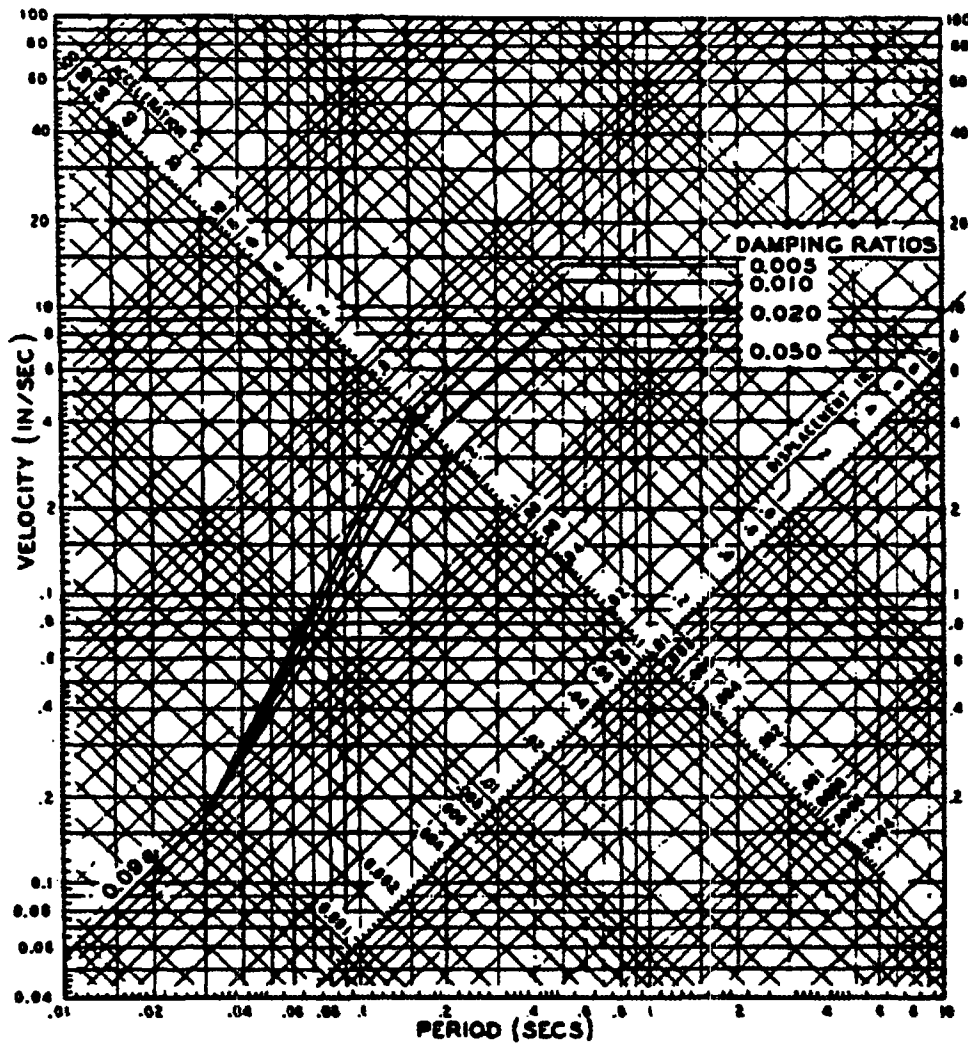
Figure 1 – OBE Response Spectrum for Rock Support Structures

The original site seismic design response spectra which define the vibratory ground motion of the Operating Basis Earthquake (OBE) and the Safe Shutdown Earthquake (SSE) for rock supported structures are shown in Figures 1 and 2. The maximum rock acceleration for the SSE is 0.18g for horizontal motion and 0.12g for vertical motion. The OBE is equal to one-half the SSE, with maximum horizontal and vertical rock accelerations of 0.09g and 0.06g, respectively.

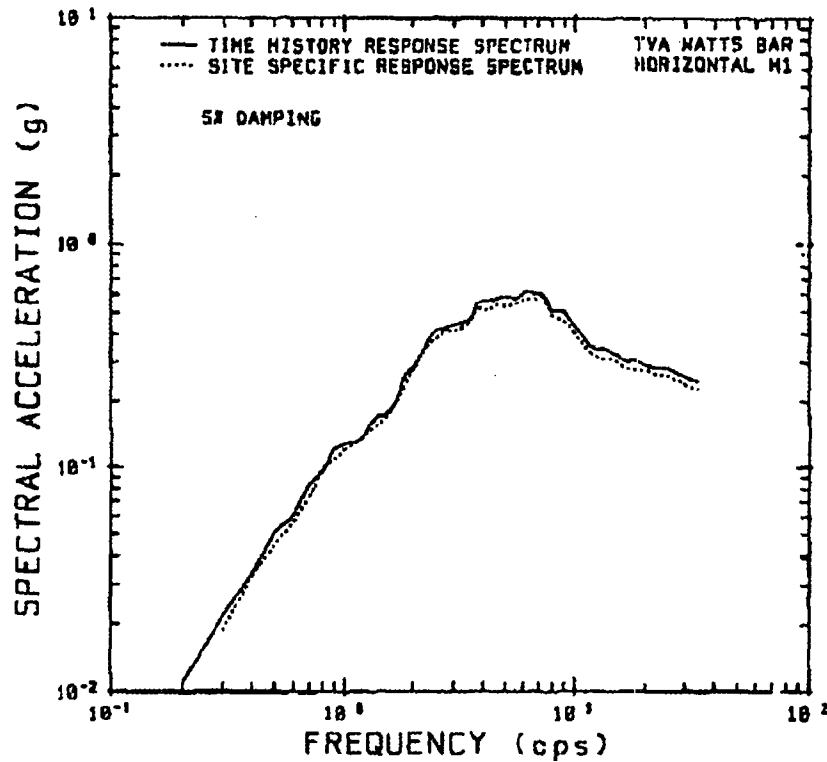
Figure 3 – N-S SSE Response Spectrum at 5% Damping

Seismic input motions for the evaluation of existing structures, systems, and components are defined by the top-of-rock SSRS shown in Figures 3 through 5. Peak SSE and OBE top-of-rock accelerations are 0.215g (horizontal SSE), 0.15g (vertical SSE), 0.09g (horizontal OBE), and 0.06g (vertical OBE).
