Evolution of Bulk Permeability

Intermediate-Scale Alternative 1

Reducing-Grout Specimen: Preparation & Observations

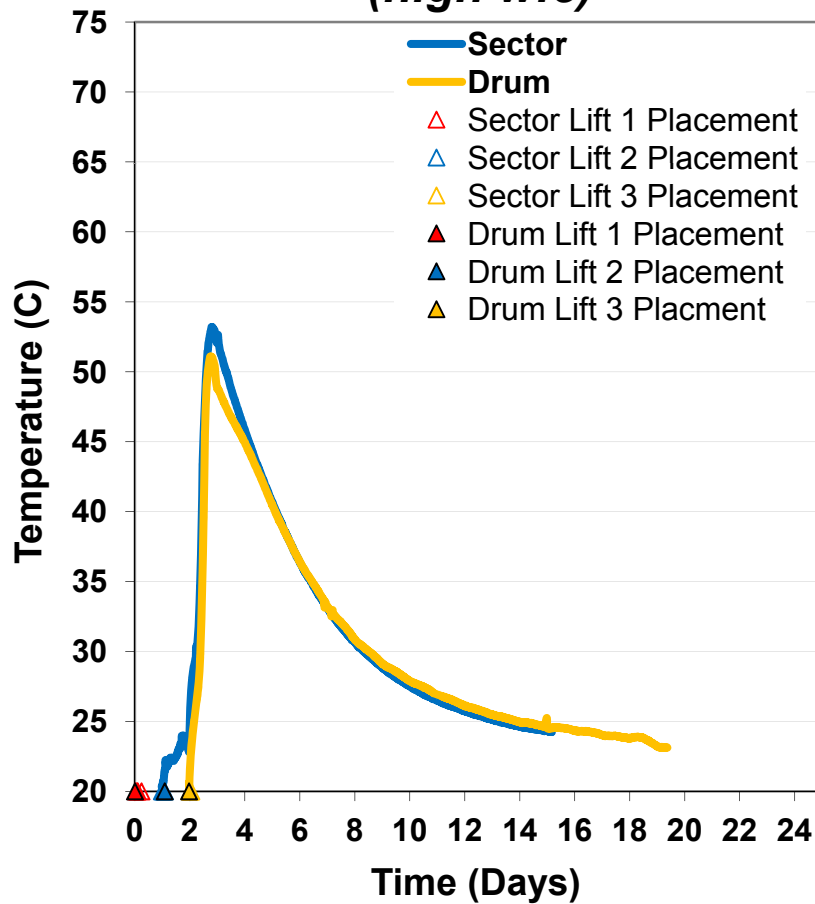
**SRS-like Strong Grout
(high w:c)**

Peak Temperatures Scale with Specimen Size

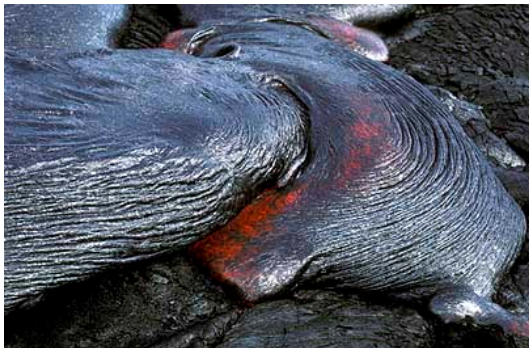
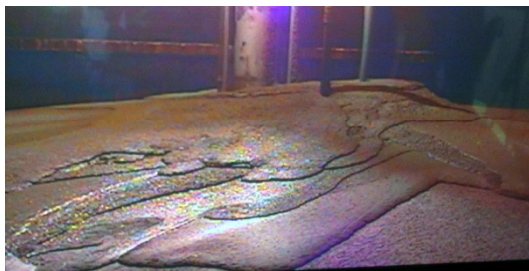
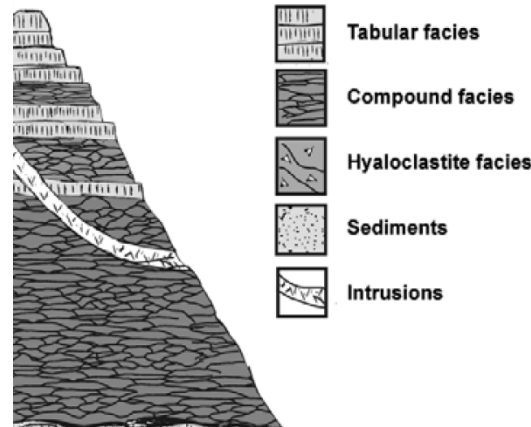
Grout Facies Architecture & Heterogeneity: Insights From Compound-Braided Basaltic Flows

The rheology of pahoehoe basaltic lava is somewhat similar to ropy grout; its facies architecture consists of thin, interfingering, compound-braided lava flow sheets and channels sourced by an episodic supply of magma.

Likewise, grout monoliths of non-self-leveling grout are laterally/vertically heterogeneous, consisting of thousands of grout flow lobes prone to localized shrinkage and fast flow at their seams

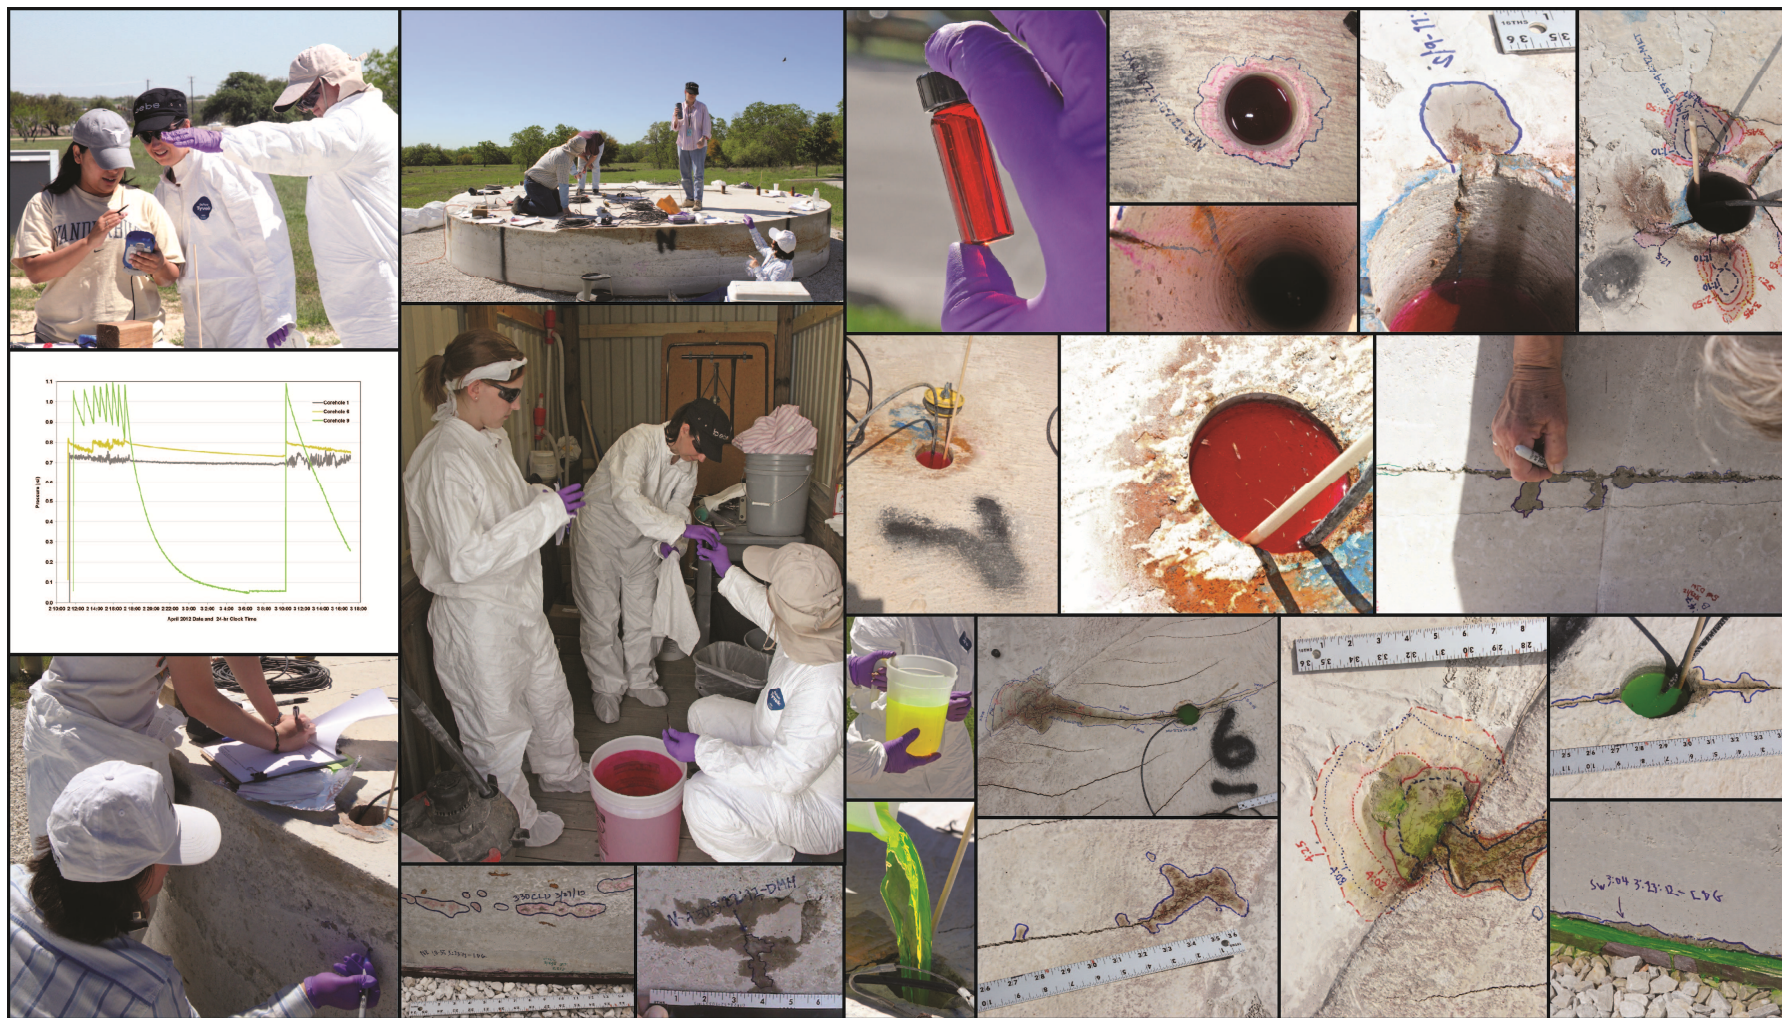
Faults May Develop from Differential Loading of Non-Self-Leveling Grout

Permeable
cracks or faults
($K \sim 10^{-2}$ cm/s;
 $k \sim 10^{-11}$ m²)
developed late through
coreholes on the S/SW
side of the monolith

A larger load was applied
to the monolith on the
southern side; faults may
have accommodated
movement of mounded
grout to the low side of
the monolith
