Facility Locations - Comparison of DEP and DOH Data

FINAL REPORT
COPELAND SITE, ALACHUA, FLORIDA
for the
UNIVERSITY OF FLORIDA FOUNDATION

**PRELIMINARY CONTAMINATION
ASSESSMENT PLAN**

EXHIBIT D
INTERIM LETTER REPORT

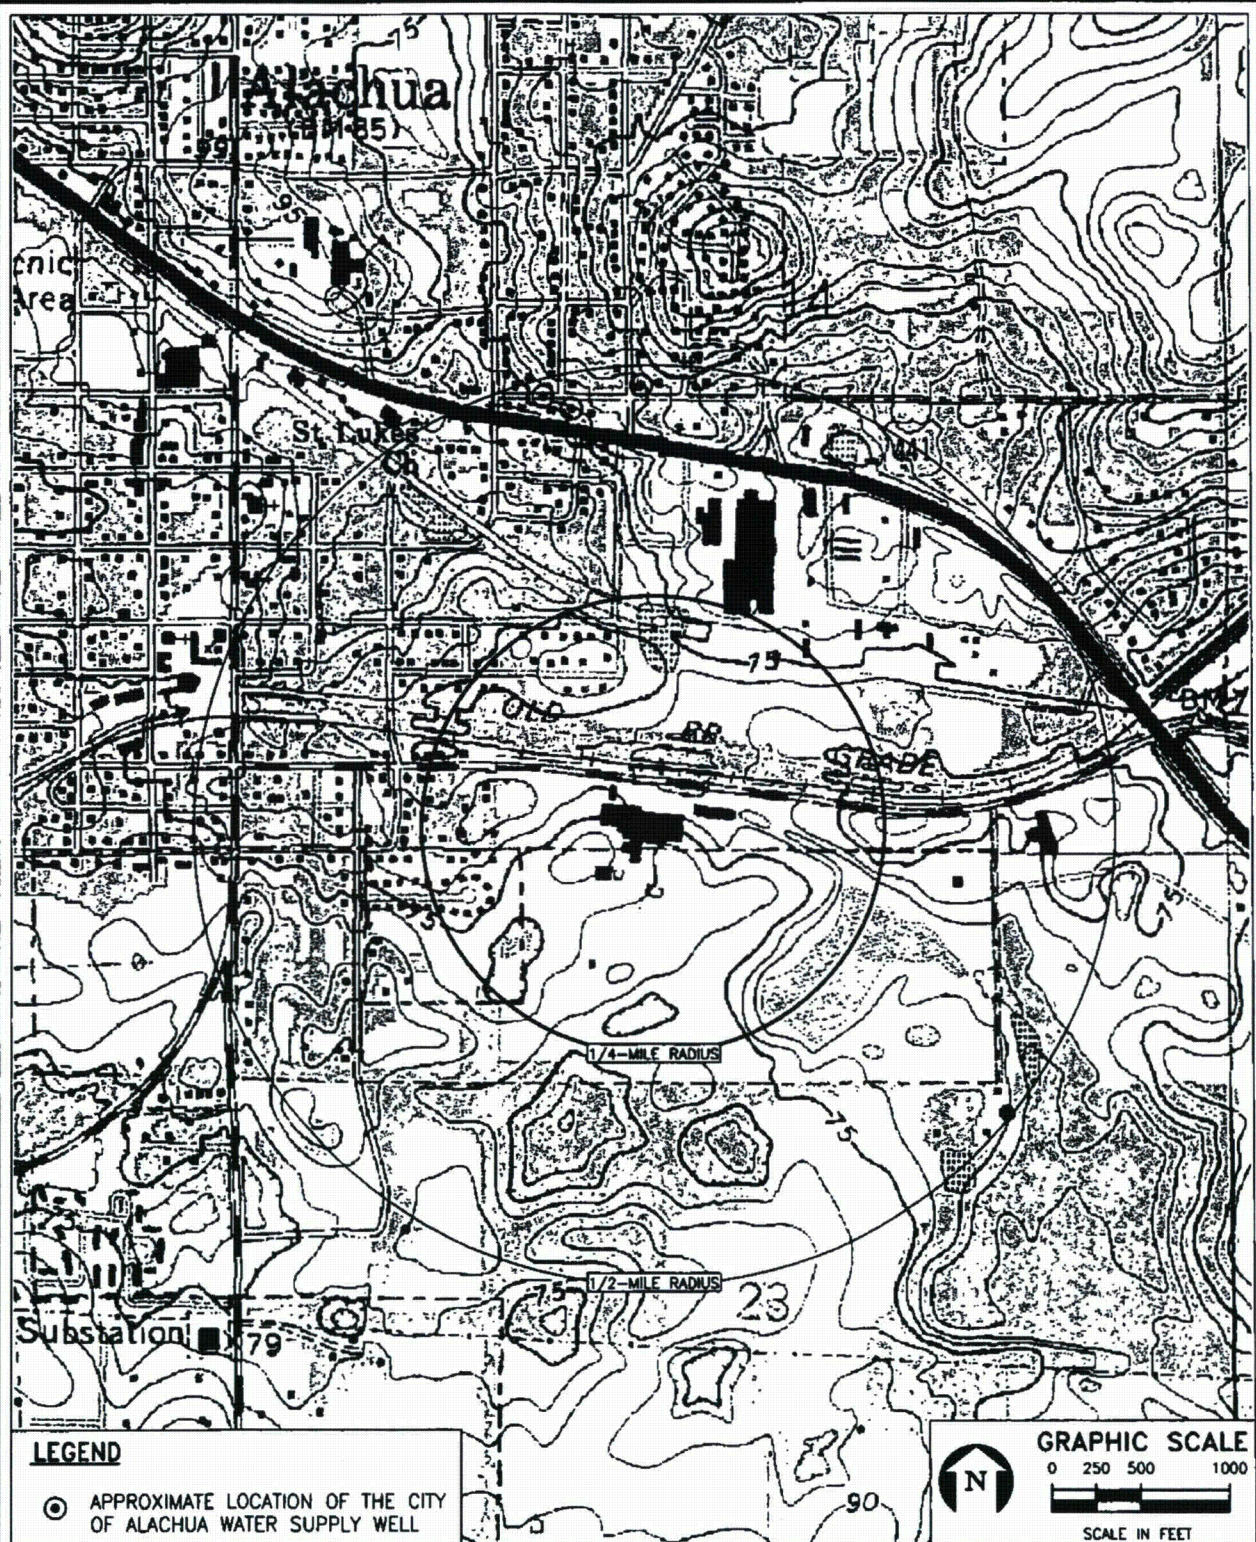
FIGURE 1.
SITE LOCATION MAP
OLD COPELAND SAUSAGE PLANT, ALACHUA, FLORIDA
FACILITY ID 01/8841779

Sources: Quads: Alachua, FL, 1993; ECT, 2004.

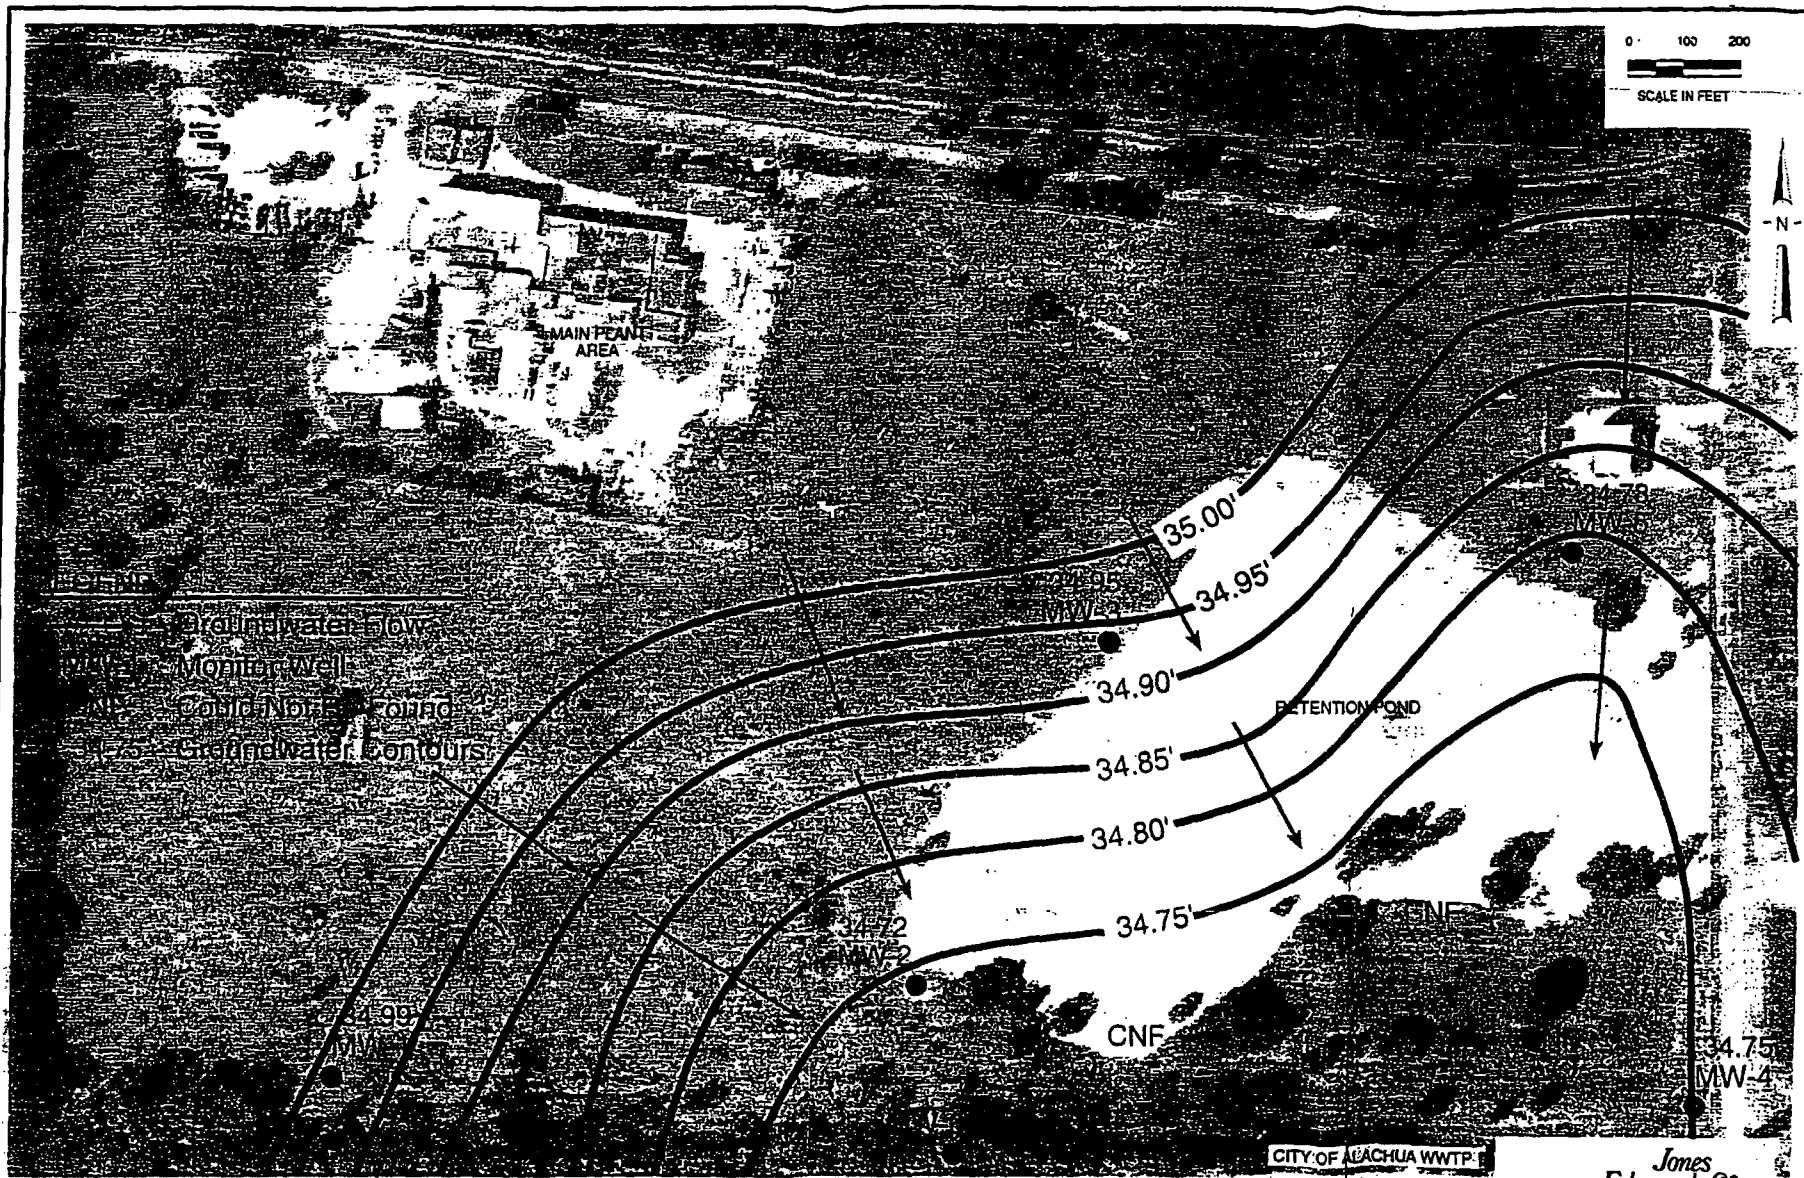
Proposed Monitor Wells and Preliminary Estimate of Groundwater Flow Direction

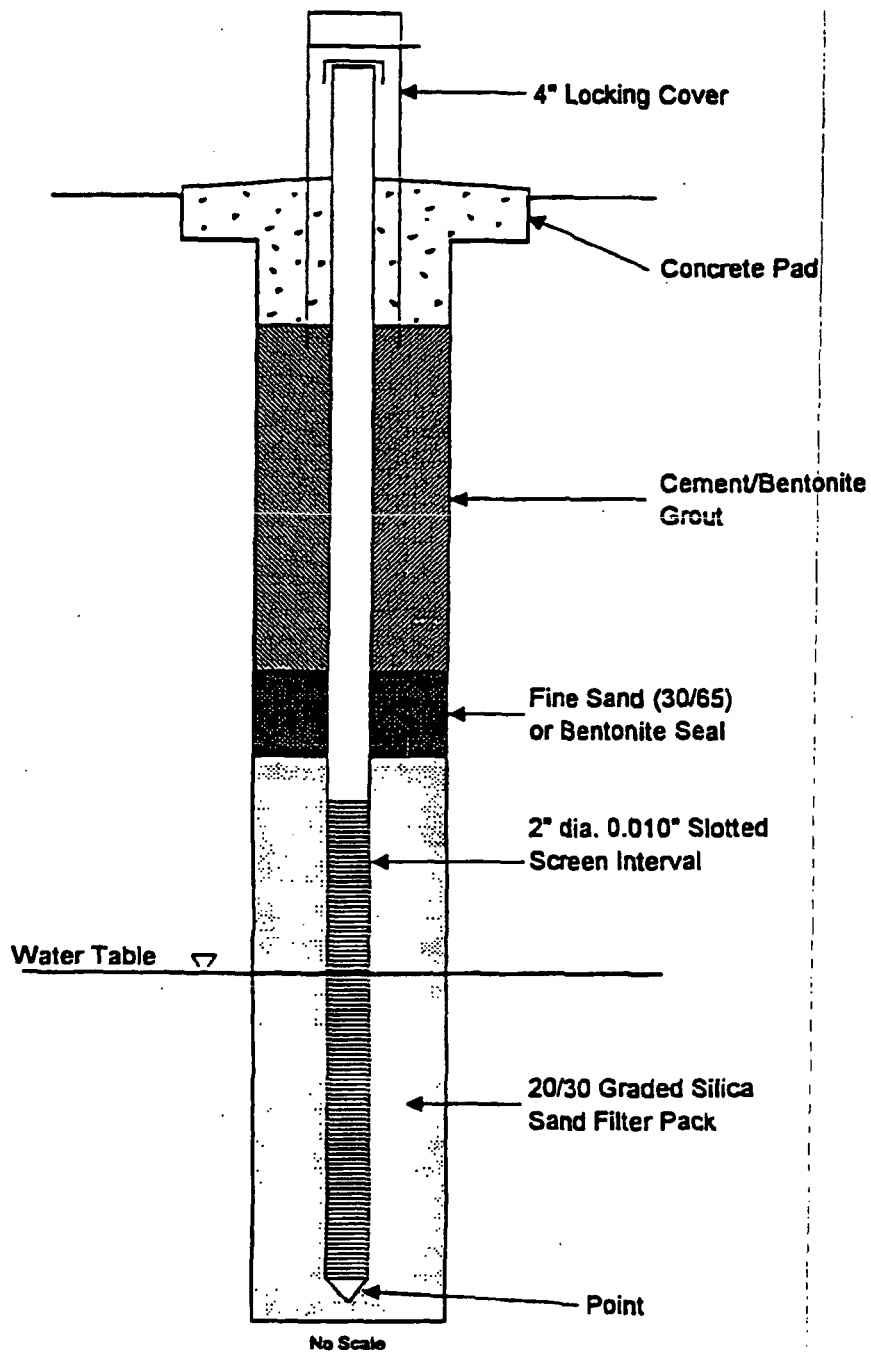
MONITORING WELL DESIGN

- A. Well Construction. In the event that additional monitor wells are required, JEA will use the standards which it commonly employs (Exhibit 1). Well construction details for the existing onsite wells are being sought, and construction details for all of the City of Alachua monitor wells and peizometers are in hand at this time.
- B. Soil/Sediment. There are no sediments (i.e., water related or derived) on site. Soil has been sampled with stainless steel equipment for OVA screening and similar equipment will be used to secure soil samples for further chemical analysis, if needed.

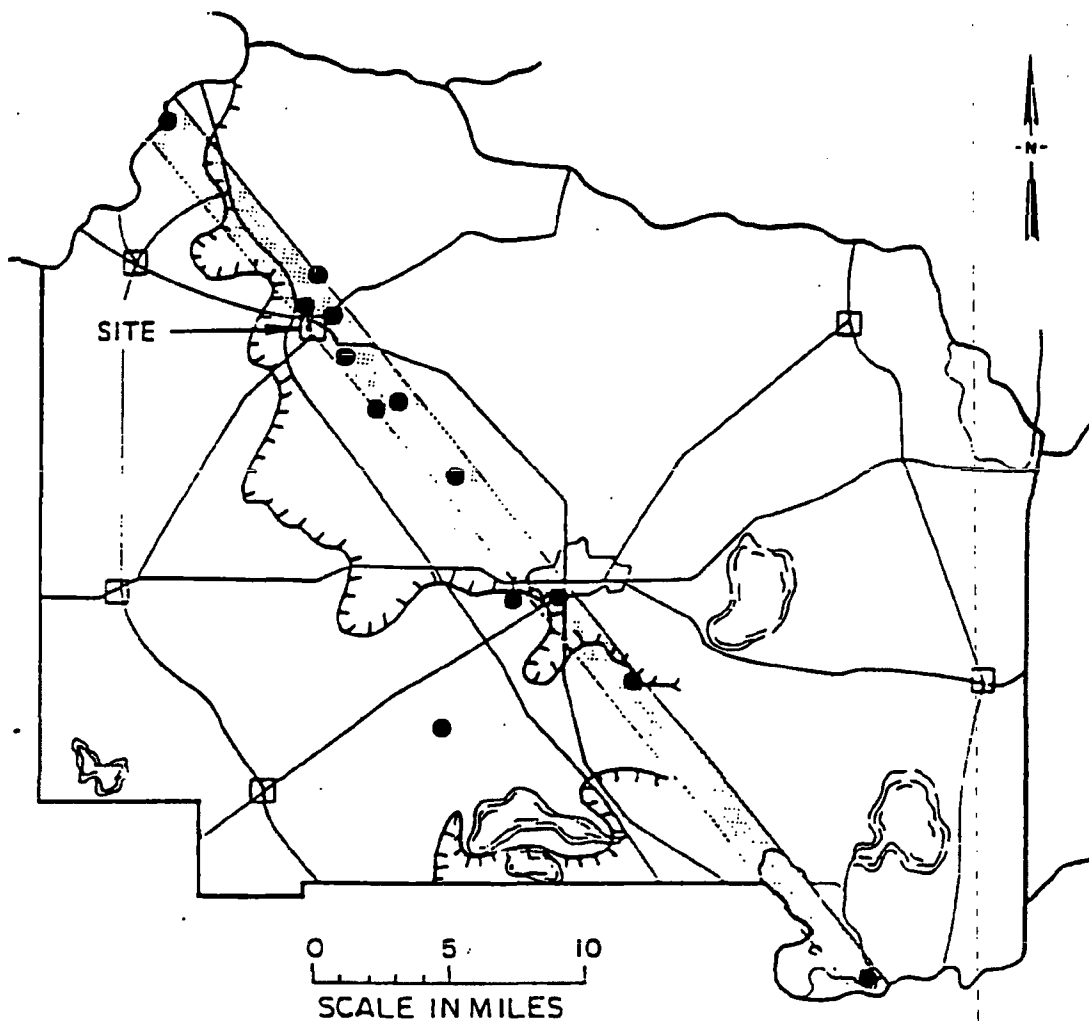
EXHIBIT 2

PRELIMINARY LOCAL GEOLOGICAL FEATURES

EXTENSIVELY FRACTURED ZONE

Cross-County Fracture Zone

A southeasterly groundwater flow direction is not outside of the realm of possibility considering the strong fractures and numerous named drains which are located east and southeast of the site. Please see Exhibit 2.

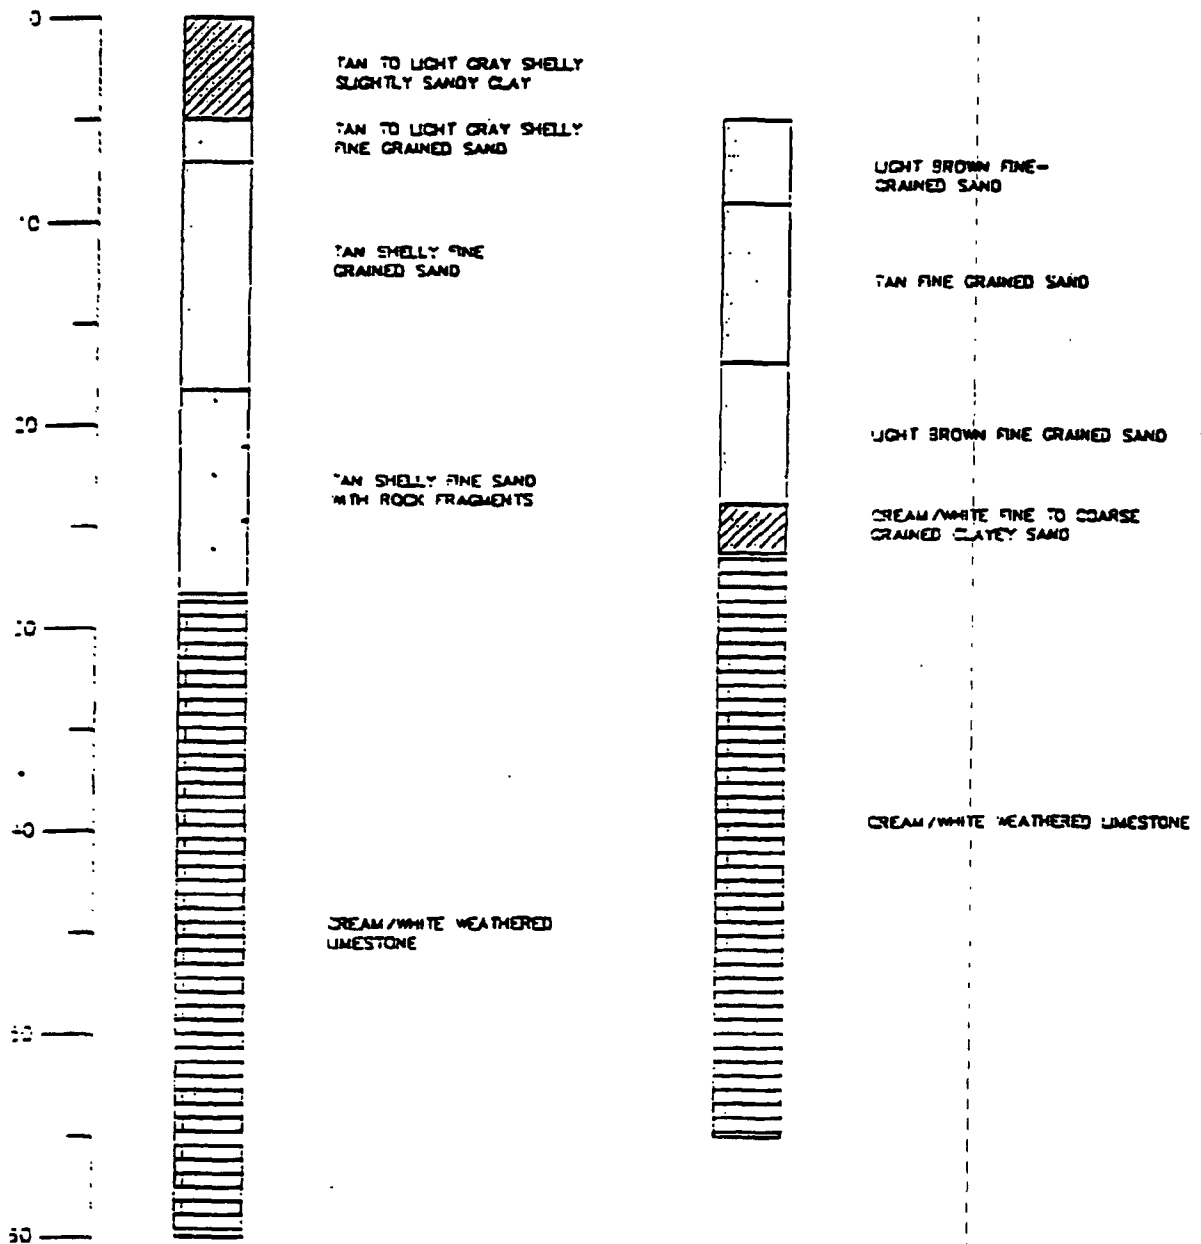
DRAWN BY:	RLL	SCALE:	N.T.S.	PROJECT NO.:	104-1581
CHECKED BY:	AL	REVISION DATE:	7/28/95	FIGURE NO.:	9

TYPICAL SOIL PROFILE
FROM THE AREA OF THE
MAIN COPELAND PLANT

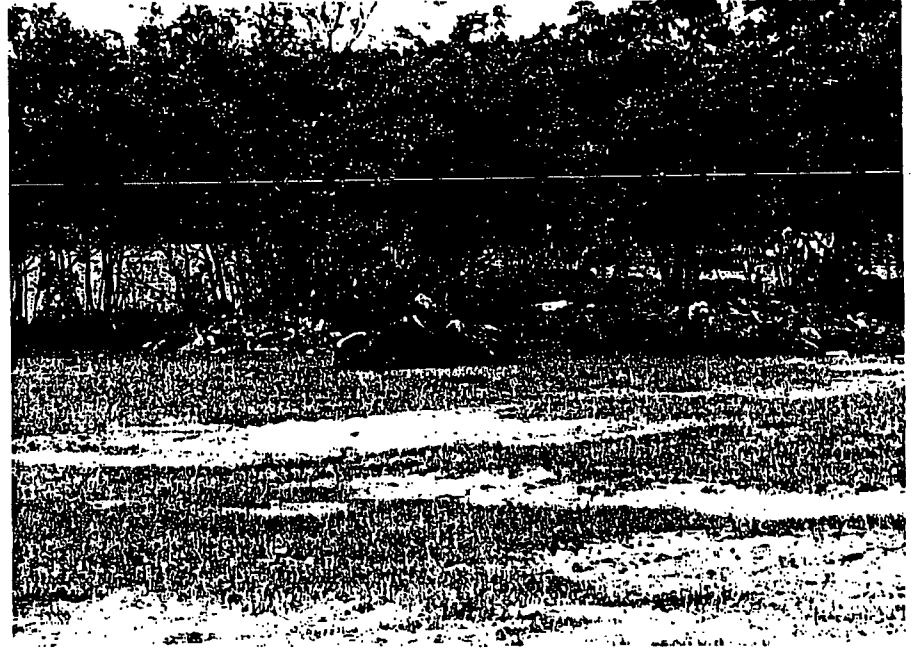
30

30. Rubber materials sorted and stockpiled prior to disposal offsite.
31. Unused bundles of plastic food wrappers (removed as practical prior to burial).
