**Smith Ranch Storage Ponds
Investigation Report
Permit to Mine 633**

Prepared For
**Cameco Resources
Smith Ranch-Highland Operation
PO Box 1210
Glenrock, WY 82637**

Prepared By
**Wright Environmental Services Inc.
227 Jefferson Street
Fort Collins, CO 80524**

March 12, 2013

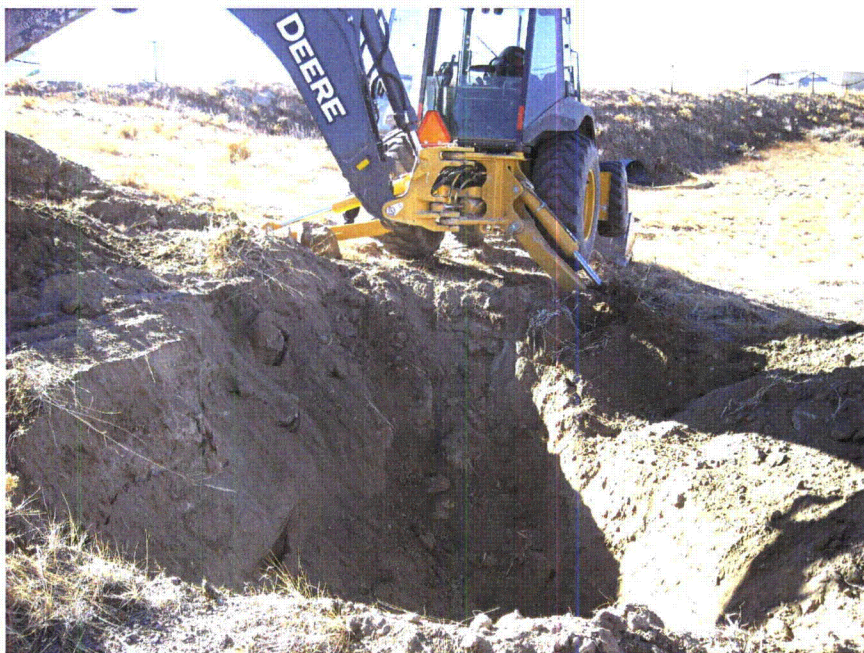
NOVEMBER 15, 2012
EP-1

Test pit EP-1 encountered a buried historical debris pile and excavation was discontinued at a depth of 10 feet.

* concrete, rebar, some sort of orange line
encountered @ 10ft.

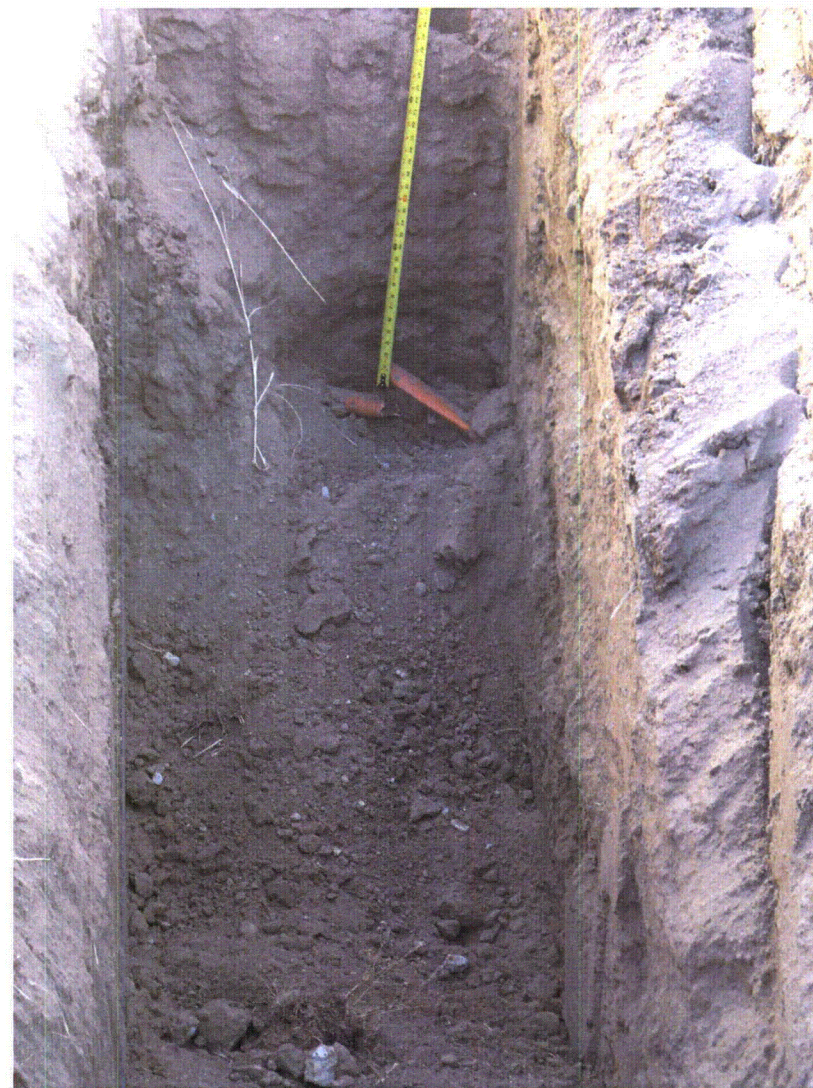
NOVEMBER 16, 2012
EP-1

- NO water or moisture in pit
- Not a lot of collapse, b/c wide
- Dimensions 14' x 15' narrowing to 3' x ~6'
- GPS taken near center Name = EP-1
- Pictures taken

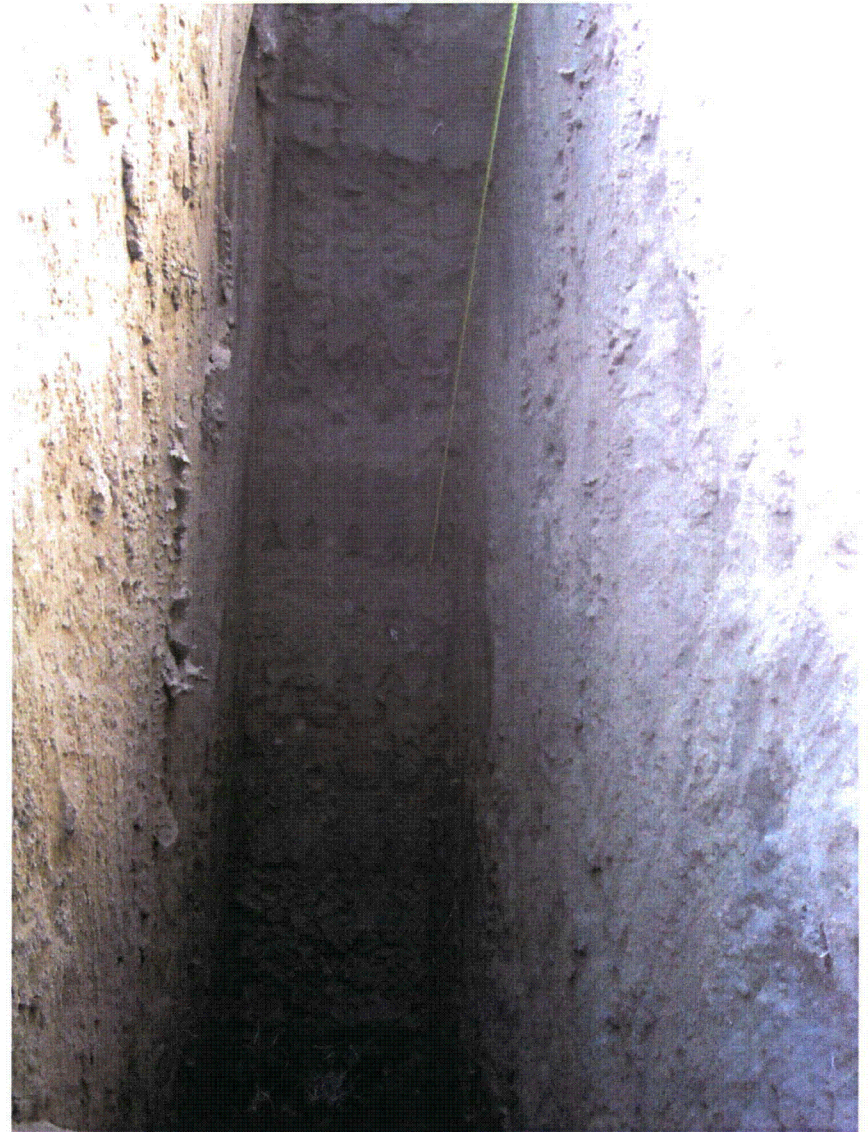
NOVEMBER 16, 2012
EP-2

- NO water or moisture, pit walls have dried out
- low amount of collapse in pit
- Dimensions 3' x 16'
- GPS taken Name = EP-2
- Pictures taken

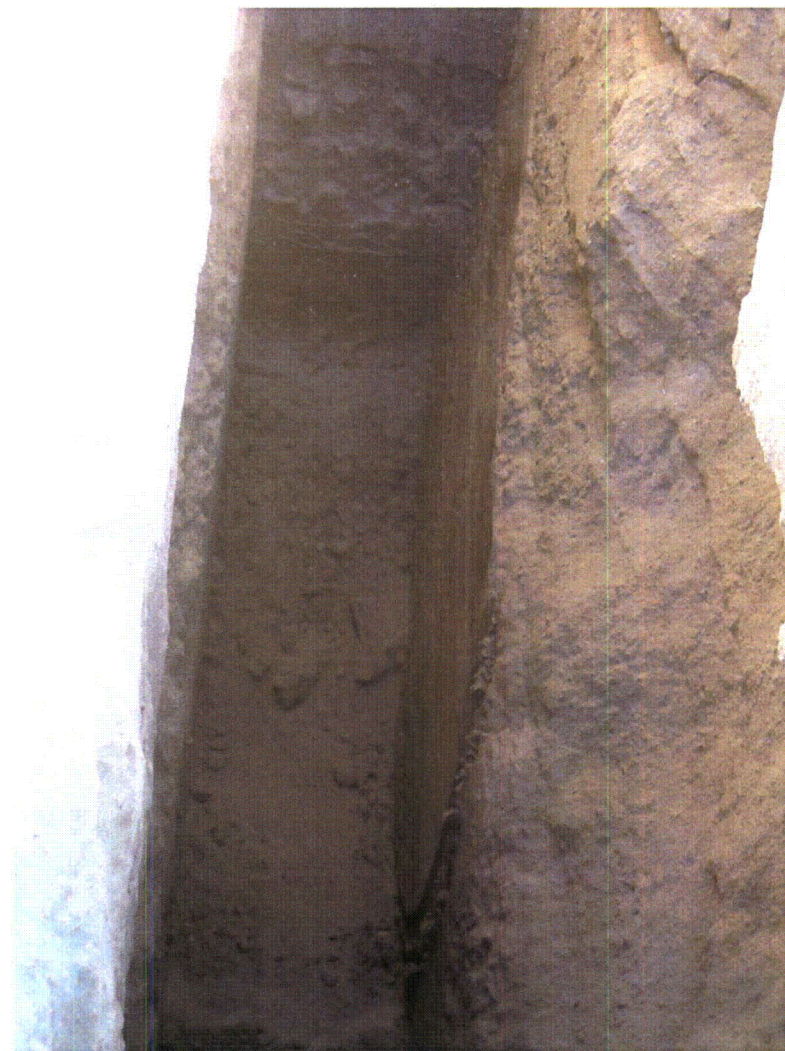
NOVEMBER 16, 2012
SP-1

- NO Water or moisture
- Some collapsing within pit
- Dimensions 3' x 15'
- ~ 1 ft below surface on north side red brown mottling.
- GPS taken Name = SP-1
- Pictures taken

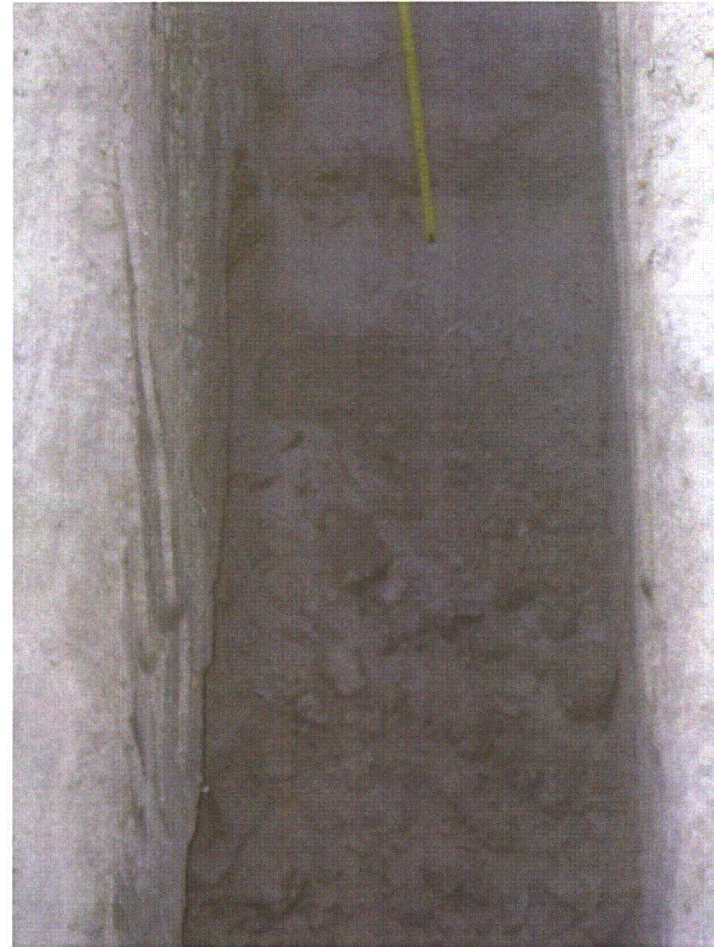
NOVEMBER 16, 2012
SP-2

- NO Water or moisture
- Some collapsing within pit
- Dimensions 3' x 14'
- GPS taken Name = SP-2
- Pictures taken

* Pic note: 671
cracks in ground surface

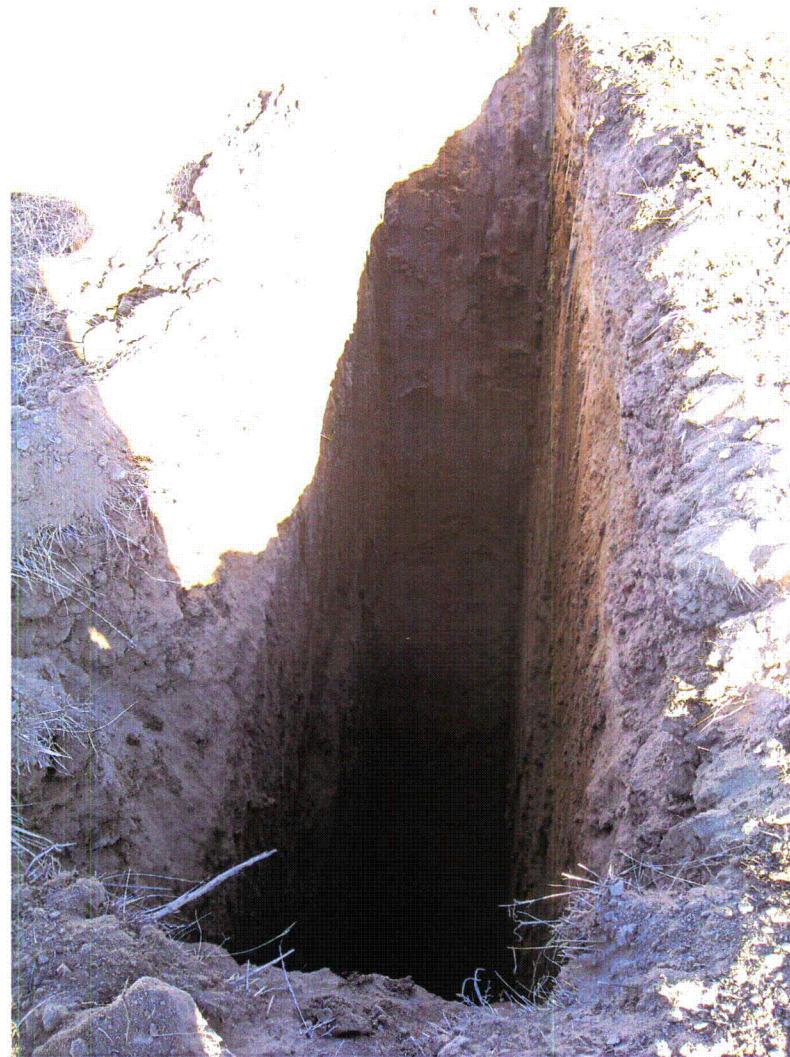
NOVEMBER 16, 2012
SP-3

- NO water or moisture
- large cracks formed in clay walls and collapsing in
- Dimensions 3' x 15'
- GPS taken Name = SP-3
- Pictures taken
