Area Walk-By Checklists (AWCs)

Table D-1. Summary of Area Walk-By Checklists

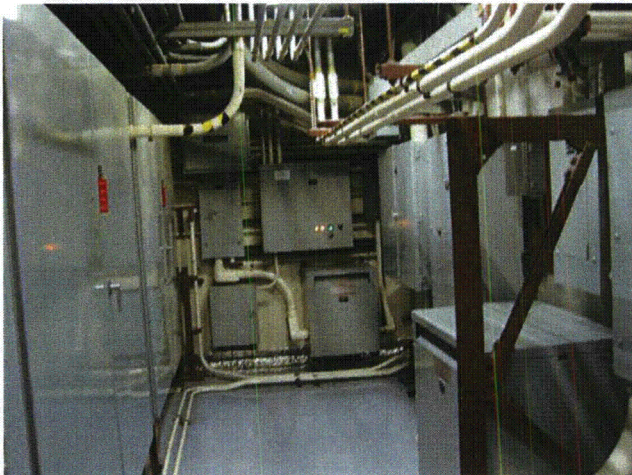
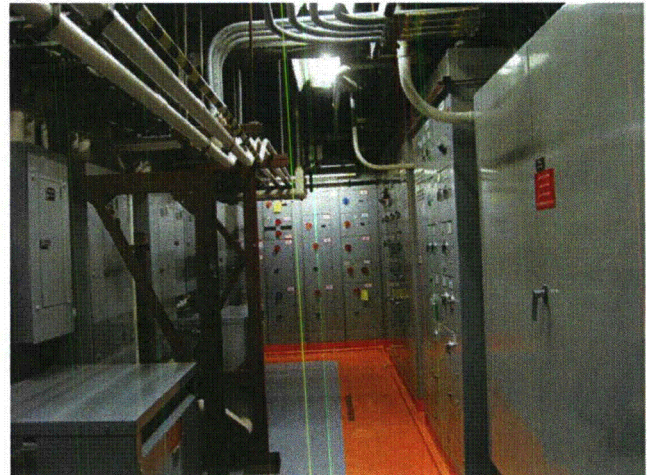
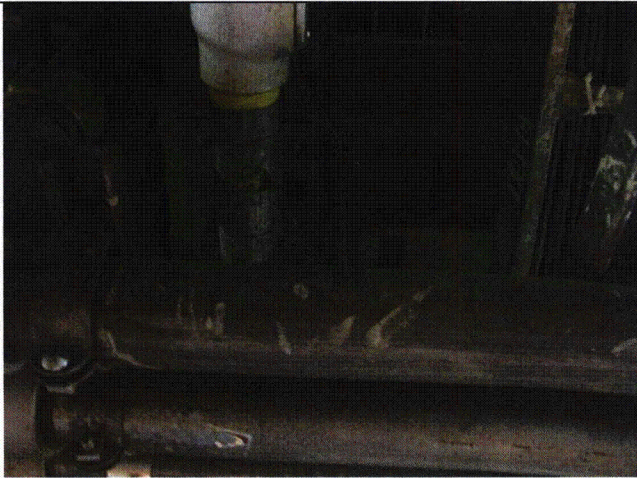
One bend conduit support rod above Disconnect Panel B-2. However, adjacent support rods are within 3 feet, which is close enough to preclude failure of the conduit if the rod fails. This is tracked by IR 1403359.
