### **A.2.2     *Effects of peening to metal surface with pre-existing flaws***

#### A.2.2.2 Effectiveness of peening in mitigating further growth of pre-existing SCC cracks

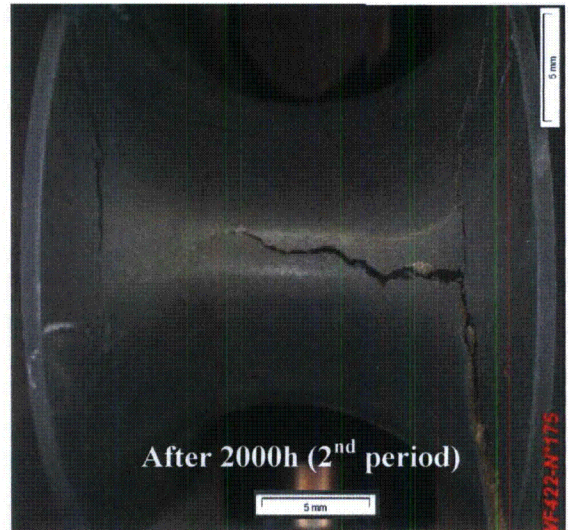
**Figure A-133**  
RUBs from SG tube WF422 after 1000h and 2000h of exposure to PWR Primary Water at 360°C.

After each period of 1000 and 2000h at 360° C, the control RUB specimens (new RUB for each test period) exhibited large cracks (Figure A-133) thus showing that the simulated PWR primary water test conditions were as severe as expected.

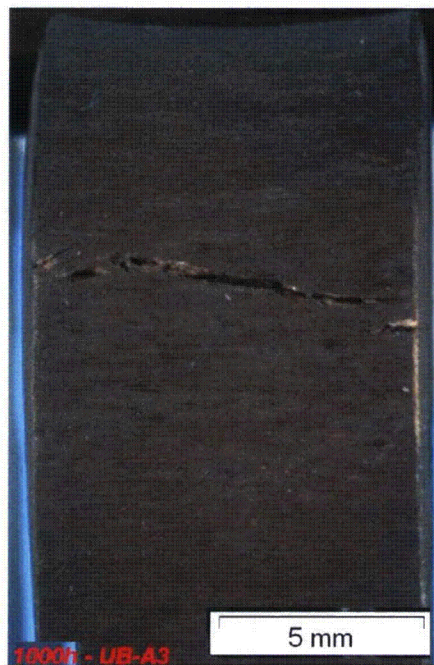
**Figure A-139**  
UB-A3 with “heavily ground” surfaces after 1000 h exposure to PWR primary water at 360°C.

Surface Condition	Thickness	Loading Type	Specimen reference	Initial surface defects	After 1000 h in PWR conditions	After 3000 h in PWR conditions
Reference "Heavy Grinding" (HG)	2 mm	spring	UB-A2	Yes	Large cracking	Large cracking
			UB-A3	Yes	Large cracking	Large cracking
			UB-A4	No	Large cracking at the apex	Large cracking at the apex
	3 mm	spring	UB-A6	No	Small cracks	Small cracks
			UB-A7	No	No crack	No crack
			UB-A8	No	Large cracking at the apex	Large cracking at the apex
HG + Under-water Laser Peening (Toshiba)	2 mm	spring	UB-B3	No	No crack	No crack
			UB-B4	No	No crack	No crack
			UB-B5	No	No crack	No crack
	3 mm	spring	UB-B8	No	No crack	No crack
			UB-B10	No	No crack	No crack
			UB-B11	No	No crack	No crack
HG + Water Jet Peening (MHI)	2 mm	spring	UB-C1	No	No crack	No crack
			UB-C2	No	No crack	No crack
			UB-C3	No	No crack	No crack
	3 mm	spring	UB-C8	No	No crack	No crack
			UB-C9	No	No crack	No crack

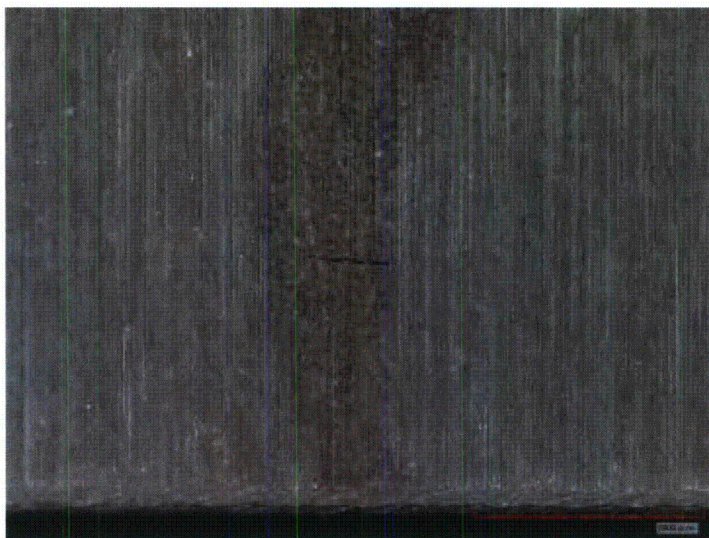
**Figure A-140**  
UB-D3 with "Water Jet Peening" surfaces after 3000 h exposure to PWR primary water at 360°C.

UB-C10	No	No crack	No crack
HG + Water Jet Peening (Hitachi-GE)	2 mm	spring	UB-D7	No	No crack	No crack
			UB-D2	No	No crack	No crack
			UB-D3	No	No crack	Defect in Z6 that was not initially identified
	3 mm	spring	UB-D8	No	No crack	Slag inclusion in Z4
			UB-D9	Yes – Very shallow	No crack	No crack
			UB-D10	No	No crack	No crack

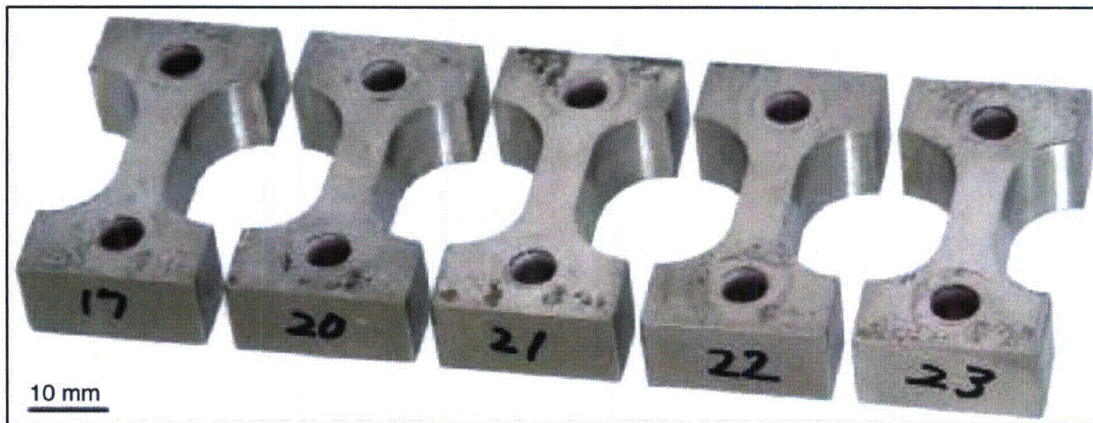
**Figure B-32**  
Samples prepared for exposure after water jet peening, Mitsubishi

Appearance of all samples after peening is shown in Figure B-32. The color of the peened surface is not changed compared to as-manufactured samples; the surface is slightly uneven. This is seen better in Figure B-33, showing surface appearance before and after exposure in detail.
