**Seismic Walkdown Checklist (SWC)**

Equipment ID No.: D00-ACP

Equipment Description: CONTROL PANEL/ Unit 2/3 Auxiliary Control Panel

Project: Dresden 3 SWEL

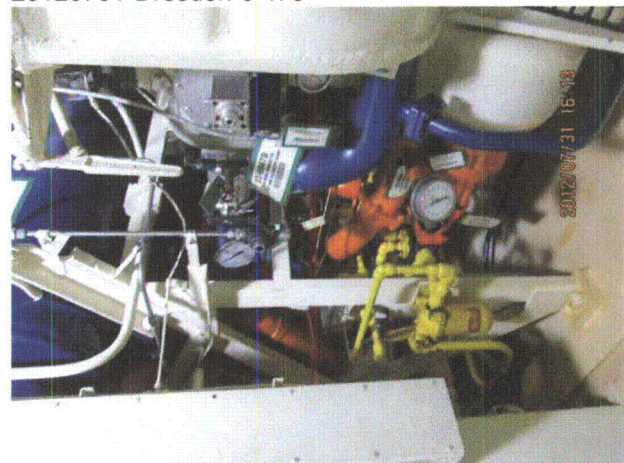
| 11. | Have you looked for and found no adverse seismic conditions that could adversely affect the safety functions of the equipment?<br><i>Several tubes and conduits are in close proximity to one another. All are flexible and all have the same driver (Diesel Generator skid). Tubes and conduits are judged acceptable.</i> | Yes |

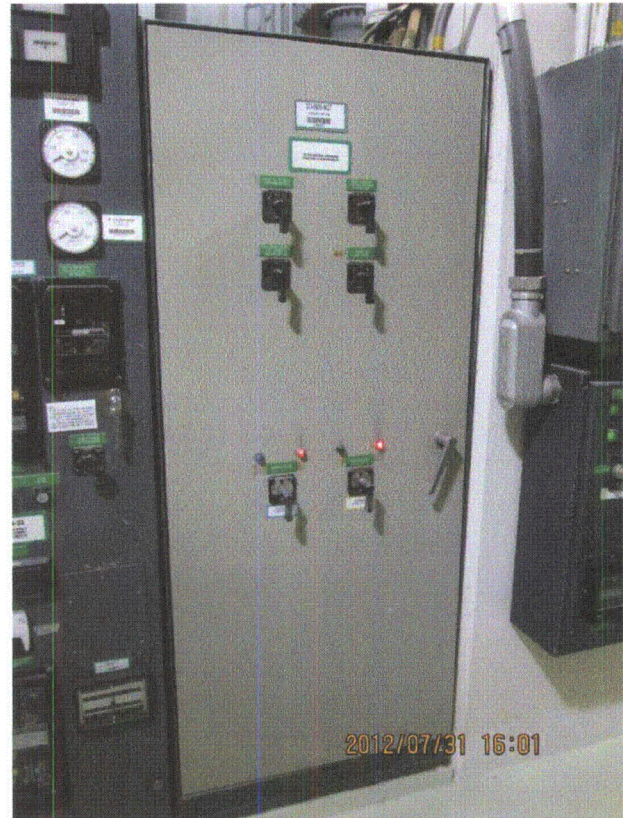
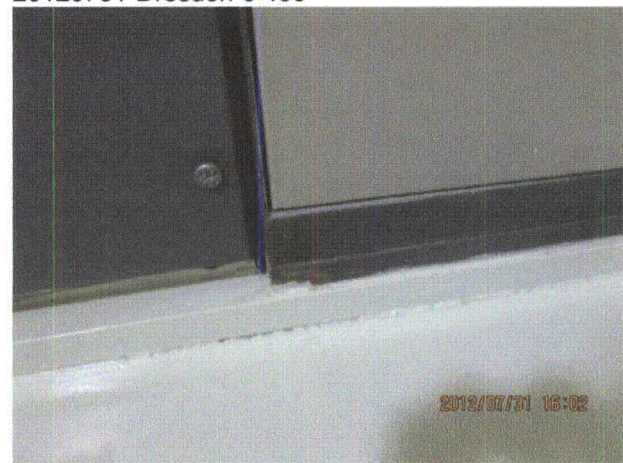
7. Are soft targets free from impact by nearby equipment or structures? Yes  
*Cabinet restrained at top to column and Cabinet 2223-33 via 2 clips on each side. Judged to be acceptable.*
8. Are overhead equipment, distribution systems, ceiling tiles and lighting, and masonry block walls not likely to collapse onto the equipment? Yes
9. Do attached lines have adequate flexibility to avoid damage? Yes
10. Based on the above seismic interaction evaluations, is equipment free of potentially adverse seismic interaction effects? Yes

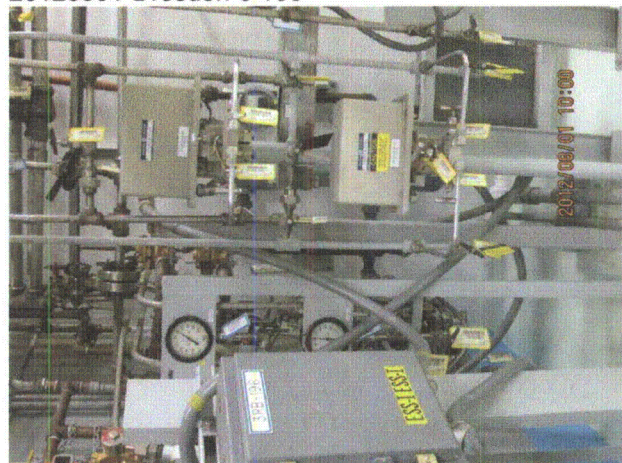
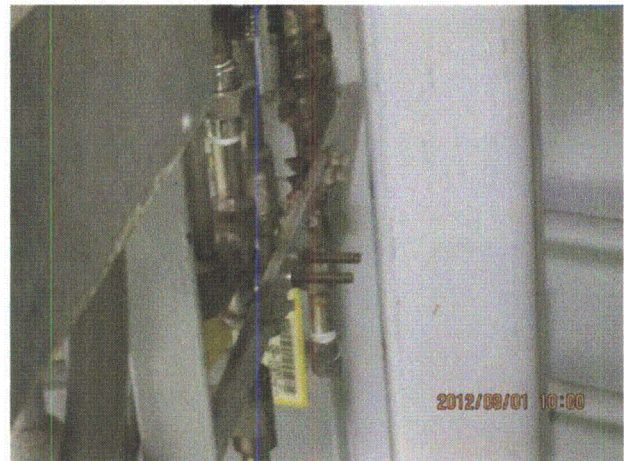
Missing support clamp on copper pipe near Valve 3-302-20B. Condition judged to be acceptable based on totality of piping system support. See IR 1395804.

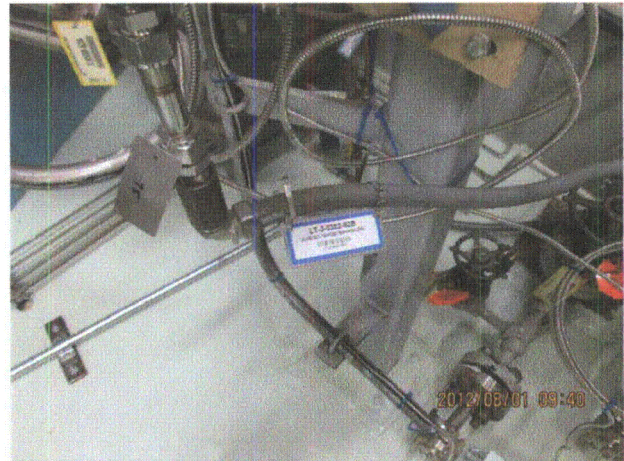
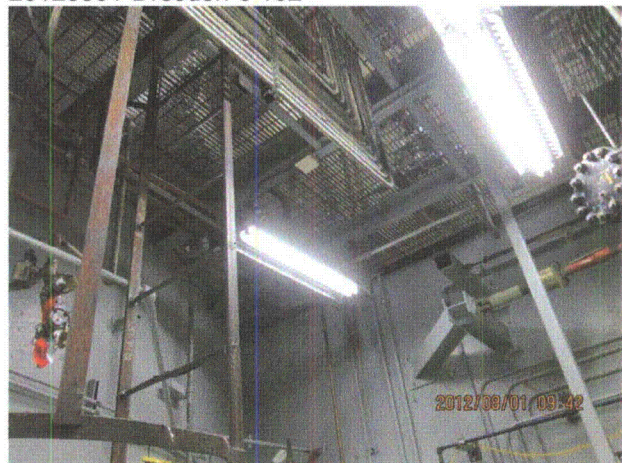
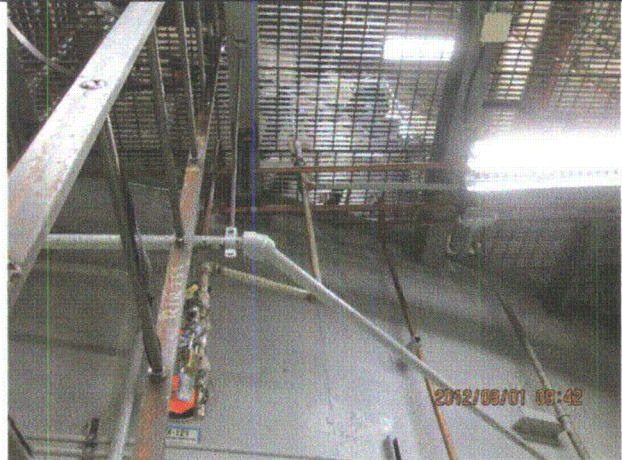
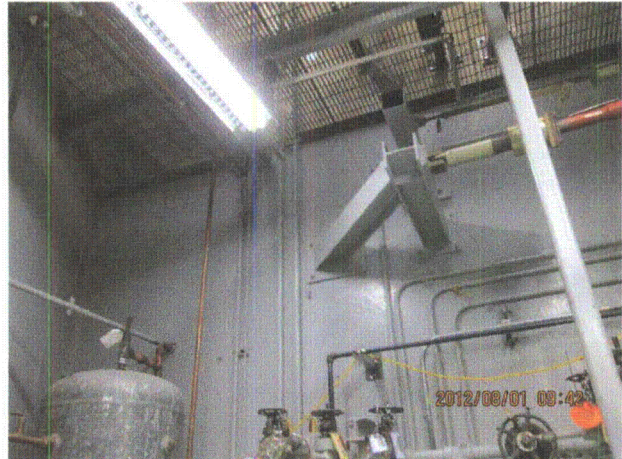
4. Is the anchorage free of visible cracks in the concrete near the anchors? Yes  
*Minor shrinkage cracks in wall judged to be acceptable.*
