Seismic Walkdown Checklist (SWC)

Equipment ID No.: D03-83125-----P06

Equipment Description: 125V DC/ RB 125V DC Distribution Panel #3

Project: Dresden 3 SWEL

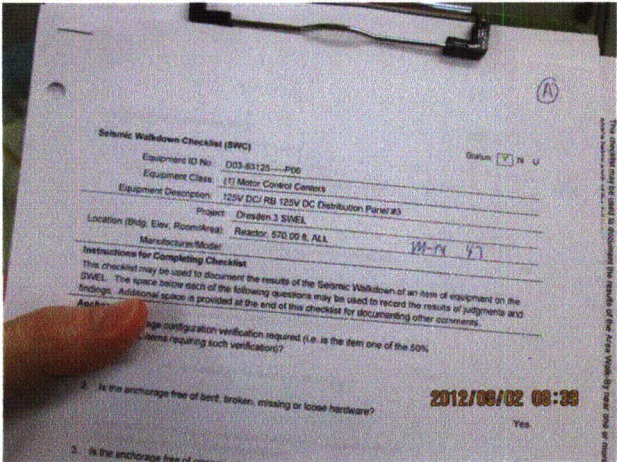
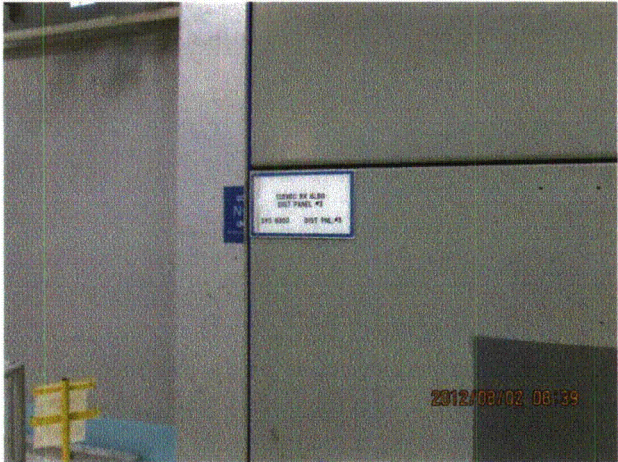
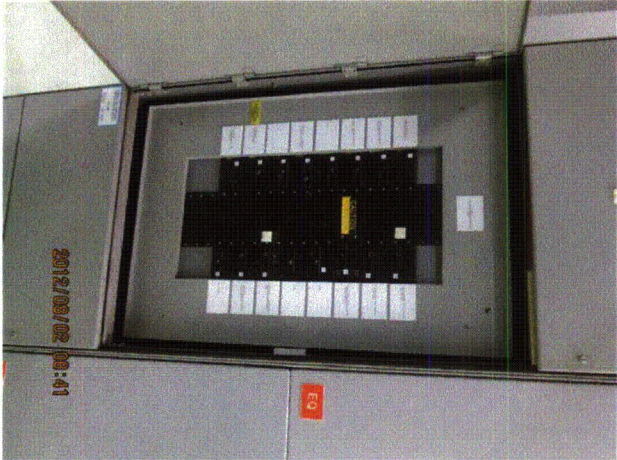
MCC stitch welded to edge angle embedded in concrete.

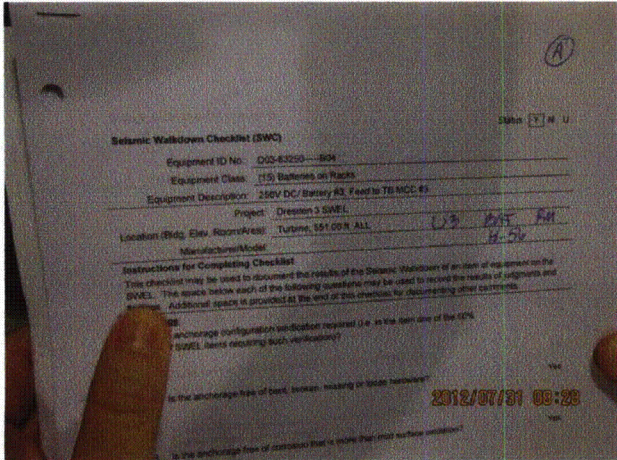
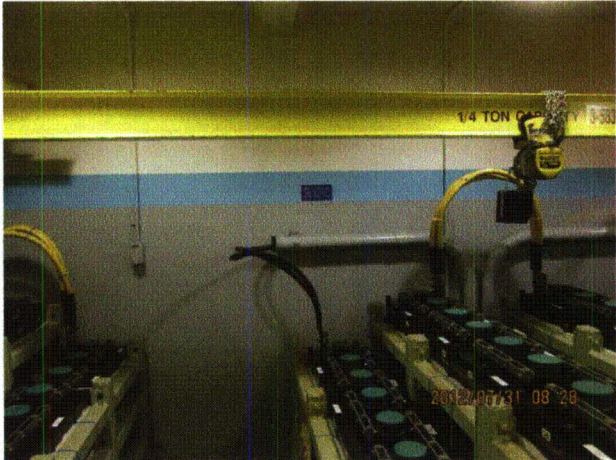
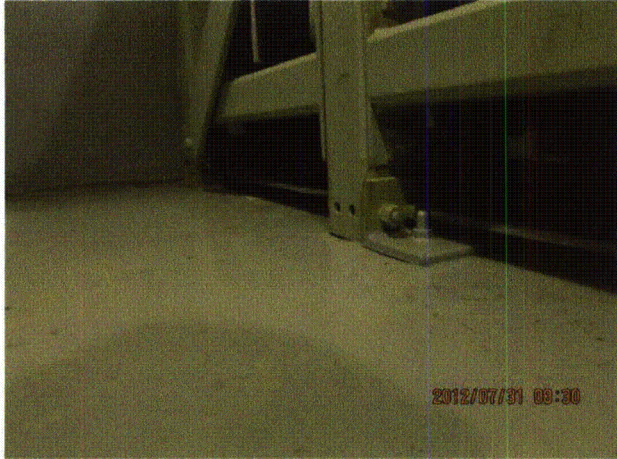
11. Have you looked for and found no adverse seismic conditions that could adversely affect the safety functions of the equipment? Yes
Trolley stops prevent trolley contact with jumper cable.

Each post leg is thru-bolted to an angle iron clip which is anchored by one or two 1/2" wedge expansion anchor to the concrete floor.

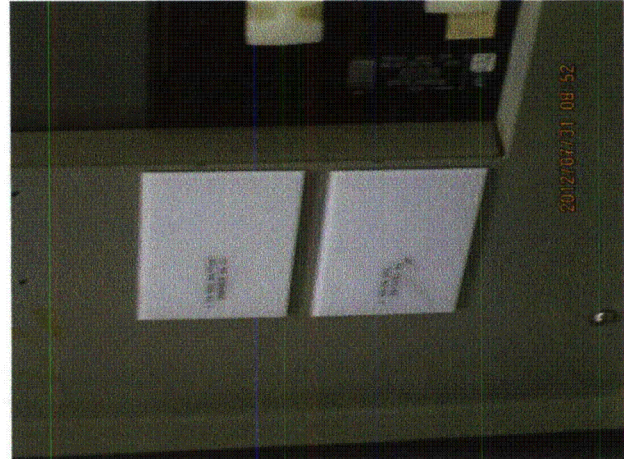
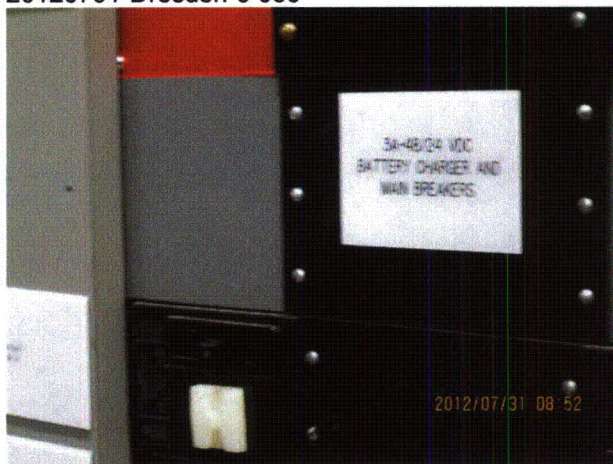
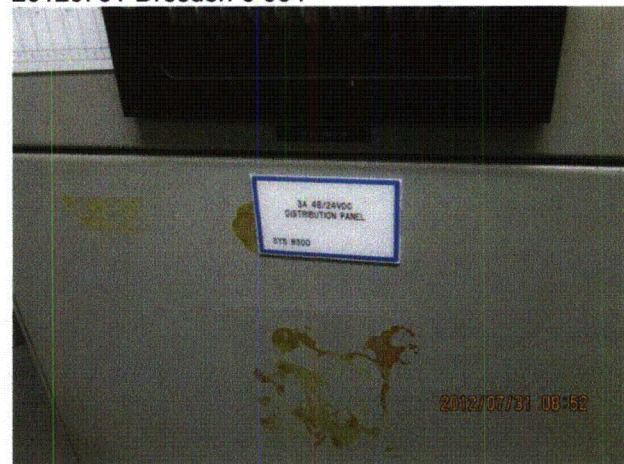
Panel 3A 48/24VDC with doors that do not latch

Panel 3A 48/24VDC was found partially latched. Only one of three latches were engaged (the door was out of plane with the rest of the item).

Communication from the shift manager informed Engineering that Operations personnel had secured the latches on 7/30/2012 at approximately 17:55 hours. Therefore, door is not a seismic concern.

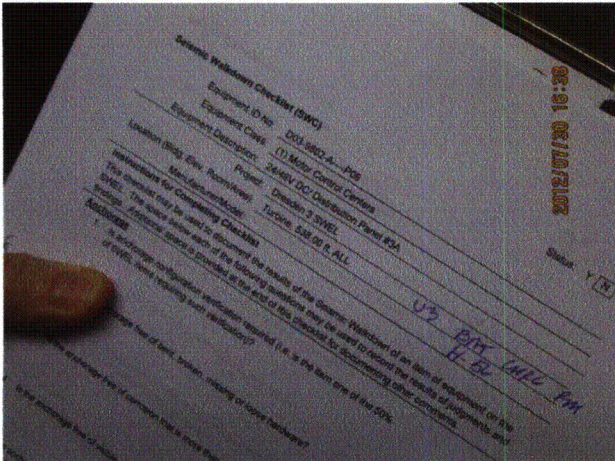
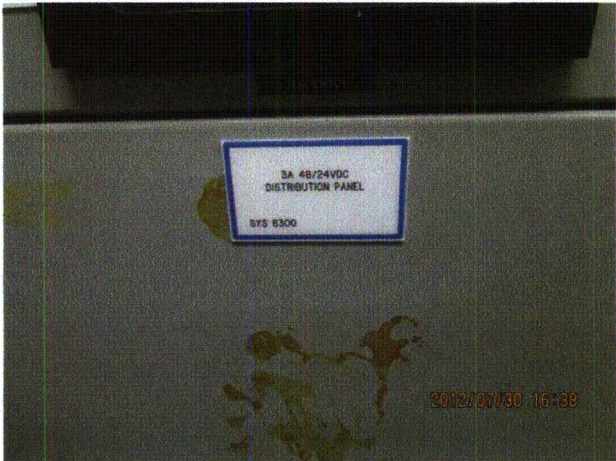
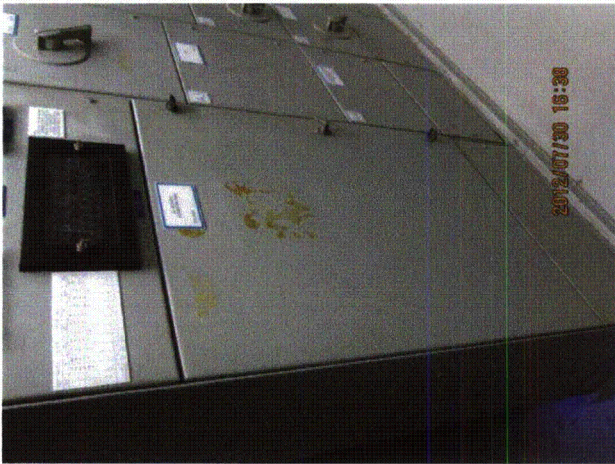
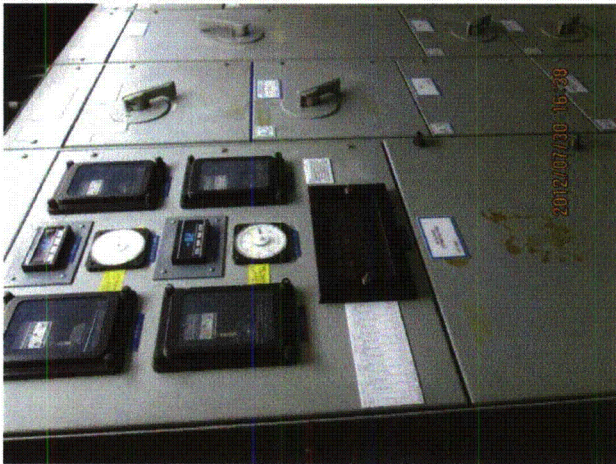
Panel 3A 48/24VDC with doors that do not latch

Panel 3A 48/24VDC was found partially latched. Only one of three latches were engaged (the door was out of plane with the rest of the item).

Communication from the shift manager informed Engineering that Operations personnel had secured the latches on 7/30/2012 at approximately 17:55 hours. Therefore, door is not a seismic concern.
