SPIE Smart Structures/NDE 2012

Ultrasonic Phased Array Evaluation of Control Rod Drive Mechanism (CRDM) Nozzle Interference Fit and Weld Region NDE Results and Destructive Analysis

Pacific Northwest National Laboratory, Richland, WA, USA

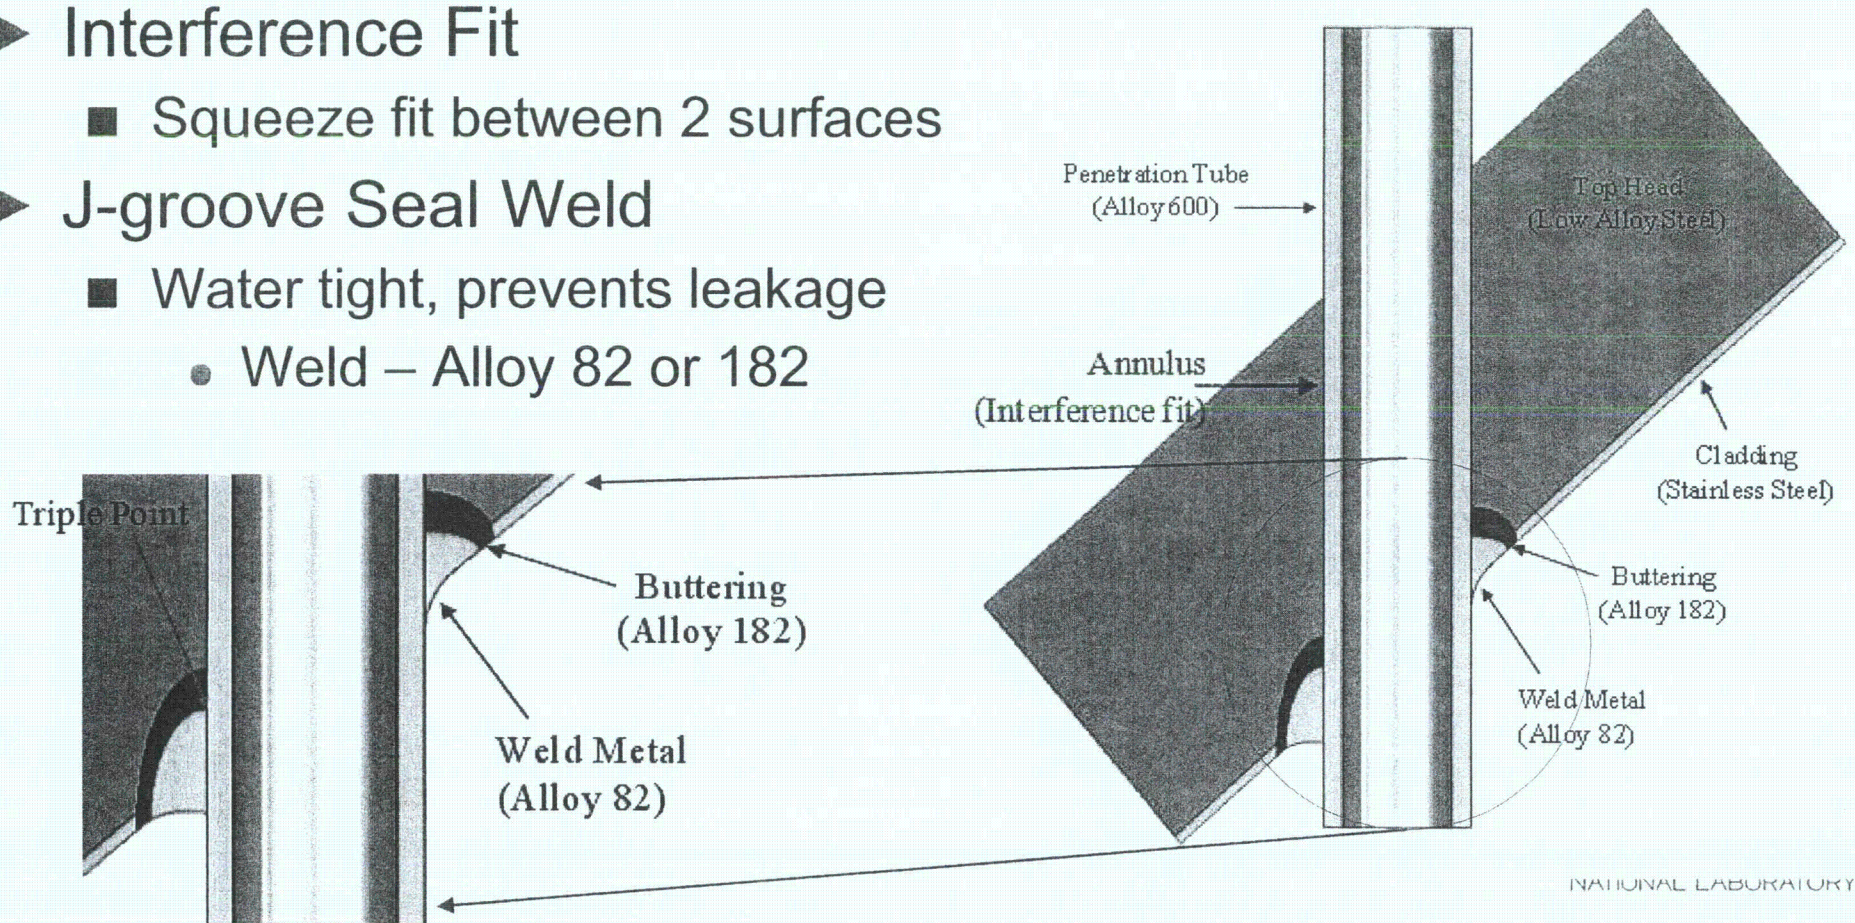
CRDM Nozzle/Fit/Weld Design

- ▶ Vessel Head Penetration (VHP) nozzle
 - Nickel-based alloy, Alloy 600 (Inconel) tube
 - Low Alloy Steel Reactor Vessel Head (RVH)
 - Interference fit and J-groove weld hold nozzle in place
- ▶ Interference Fit
 - Squeeze fit between 2 surfaces
- ▶ J-groove Seal Weld
 - Water tight, prevents leakage
 - Weld – Alloy 82 or 182

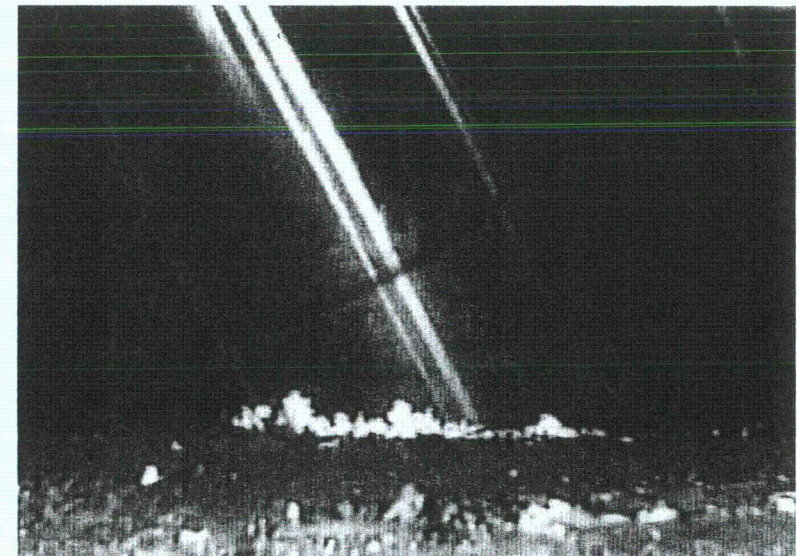
- ▶ Obtained from the original North Anna Unit-2 Nuclear Power Plant (NPP)
- ▶ In the 2001 refueling outage, Nozzle 63 was repaired
- ▶ In the 2002 outage, significant flaw indications and weld cracks resulted in the decision to replace the entire RVH
- ▶ Nozzle 63 was cut from the RVH and saved for research
- ▶ Previous Nozzle 63 characterizations (Industry)
 - Bare metal visual (BMV) results were inconclusive (masked)
 - Volumetric NDT revealed a probable leak path

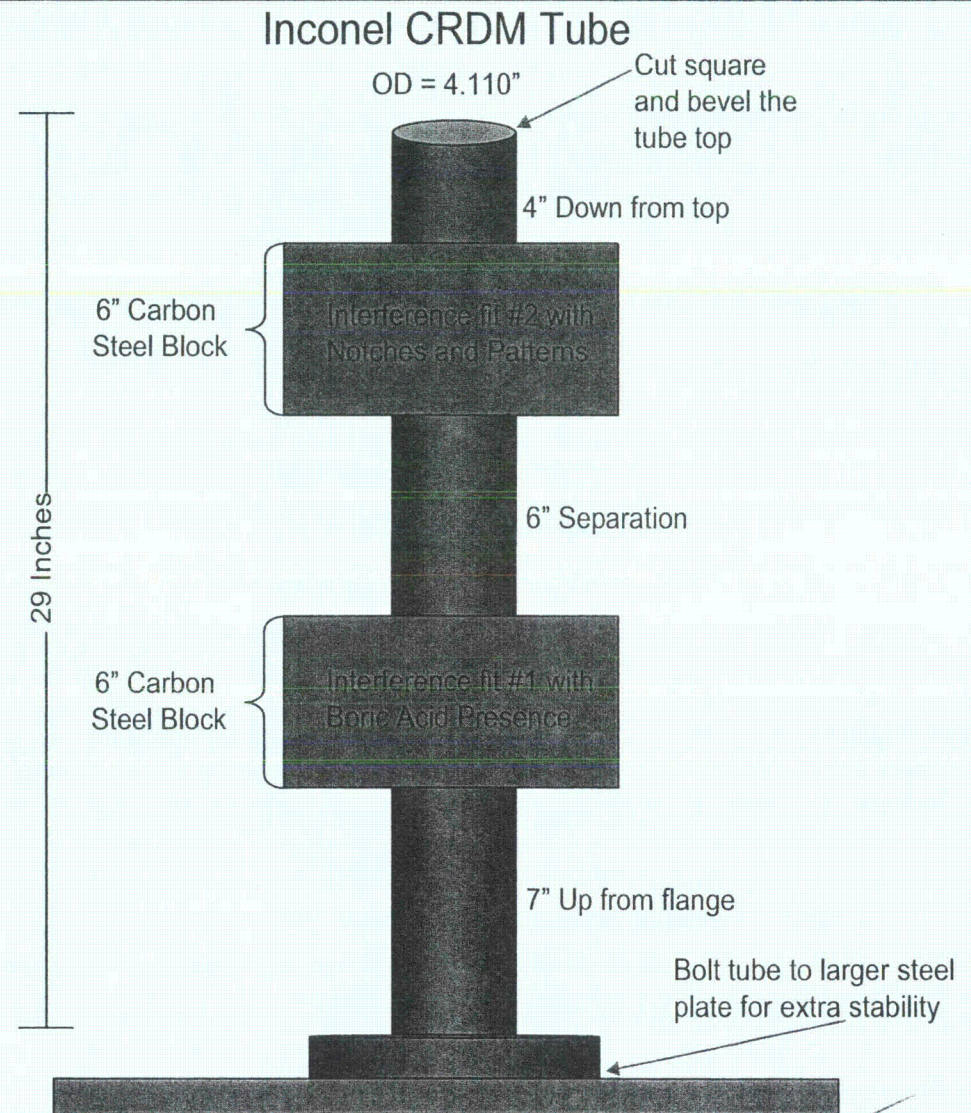
Mock-up Calibration Specimen Design

- ▶ Goal: Mimic actual field interference fits
 - Inconel tubing and RVH material
 - Used similar assembly procedures
 - 3 mil fit
- ▶ Components:
 - Inconel tube (OD = 4.110")
 - Two 6" thick carbon steel blocks
 - Machined holes (D = 4.107")
- ▶ Created 2 fit regions
 - Boric acid presence
 - Precision EDM notch presence
- ▶ Designed for specific signal responses
 - Inspection resolution
 - Leak path characteristics

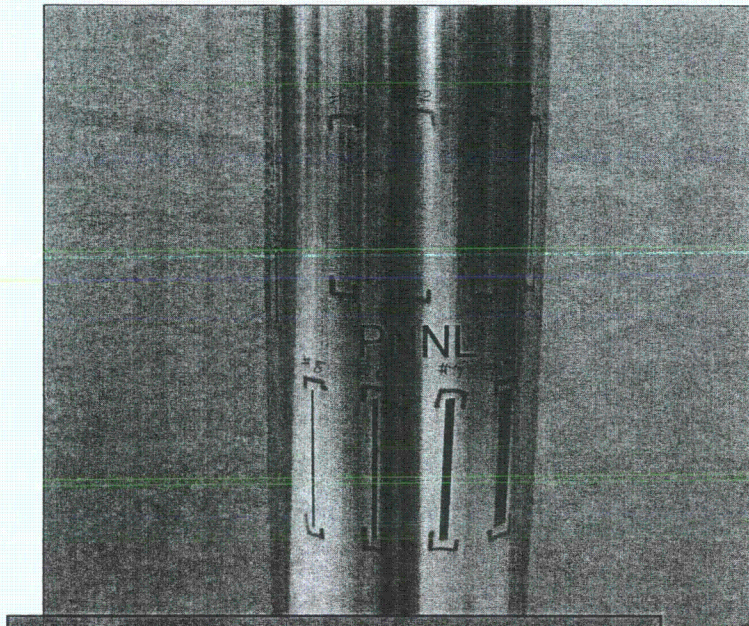
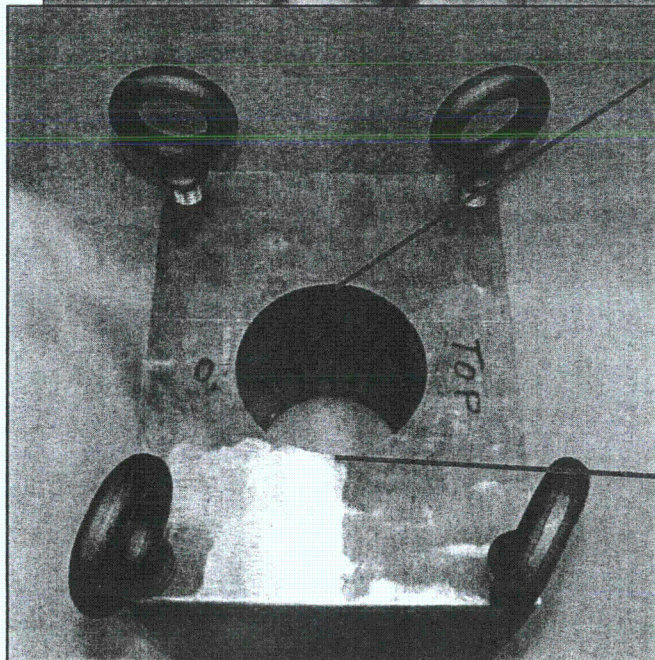
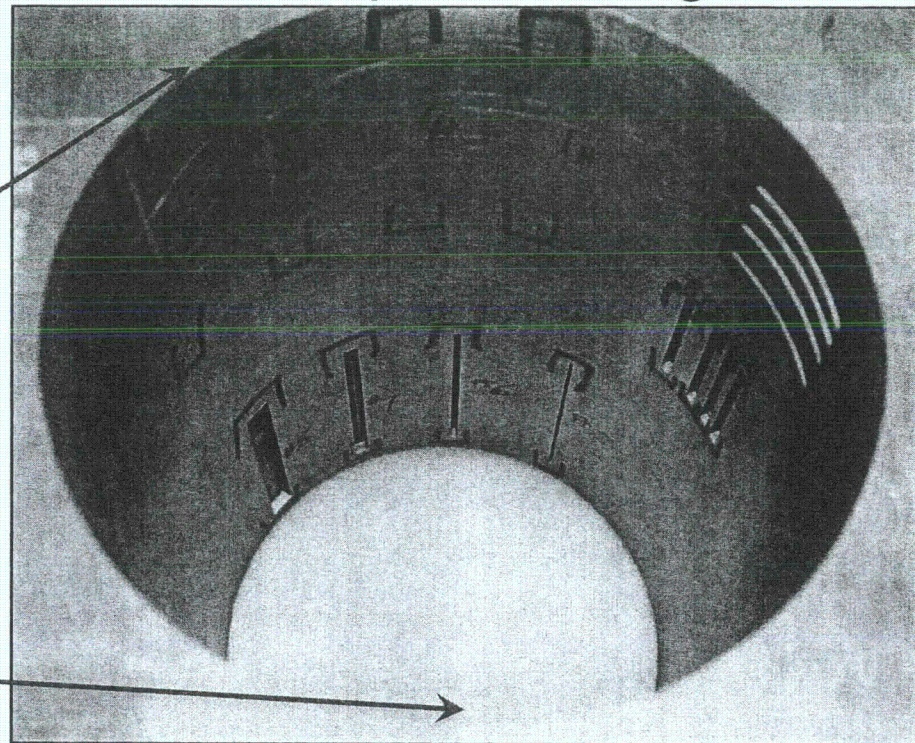
Notches and Patterns

- ▶ Precision EDM notches
- ▶ Machined in two materials
 - Inconel tube OD
 - Carbon steel block ID
- ▶ 'PNNL' pattern engraved

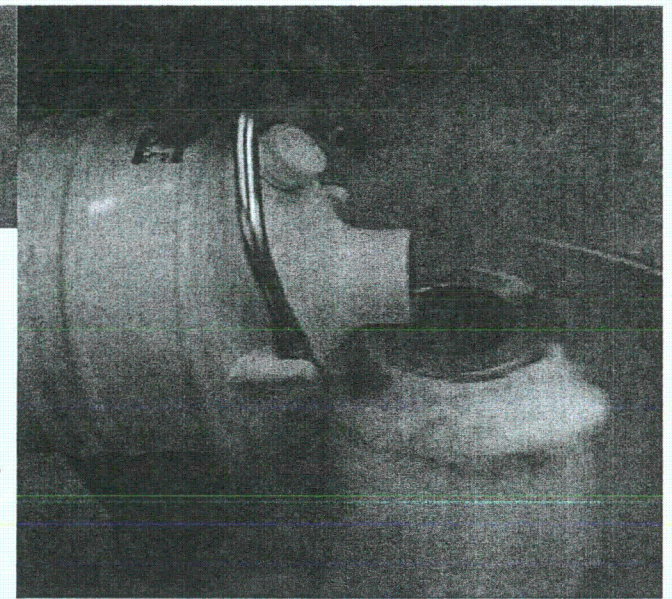
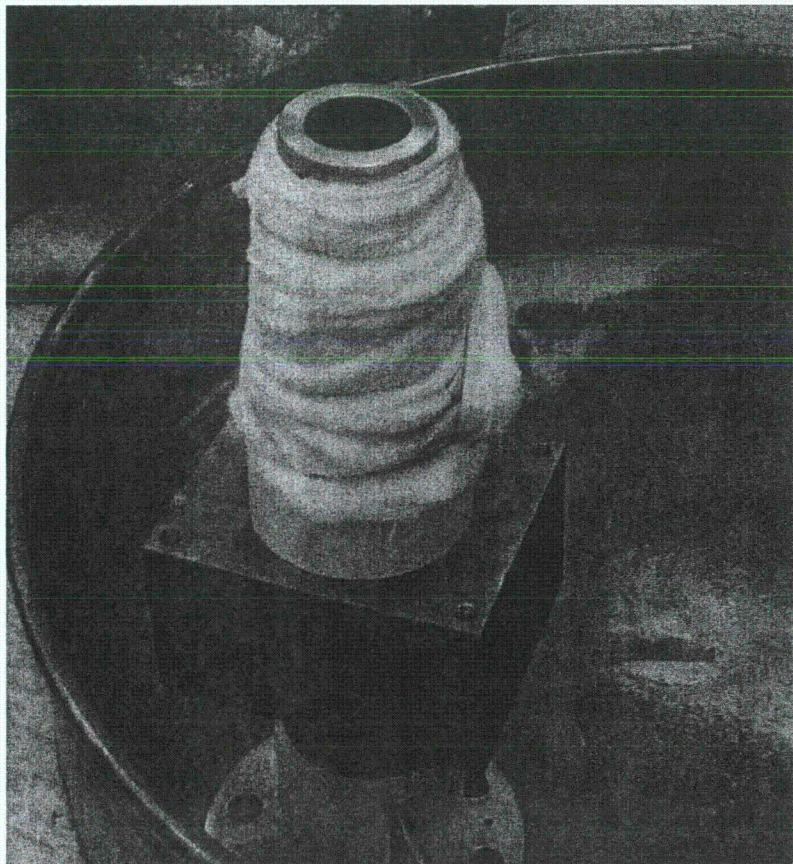
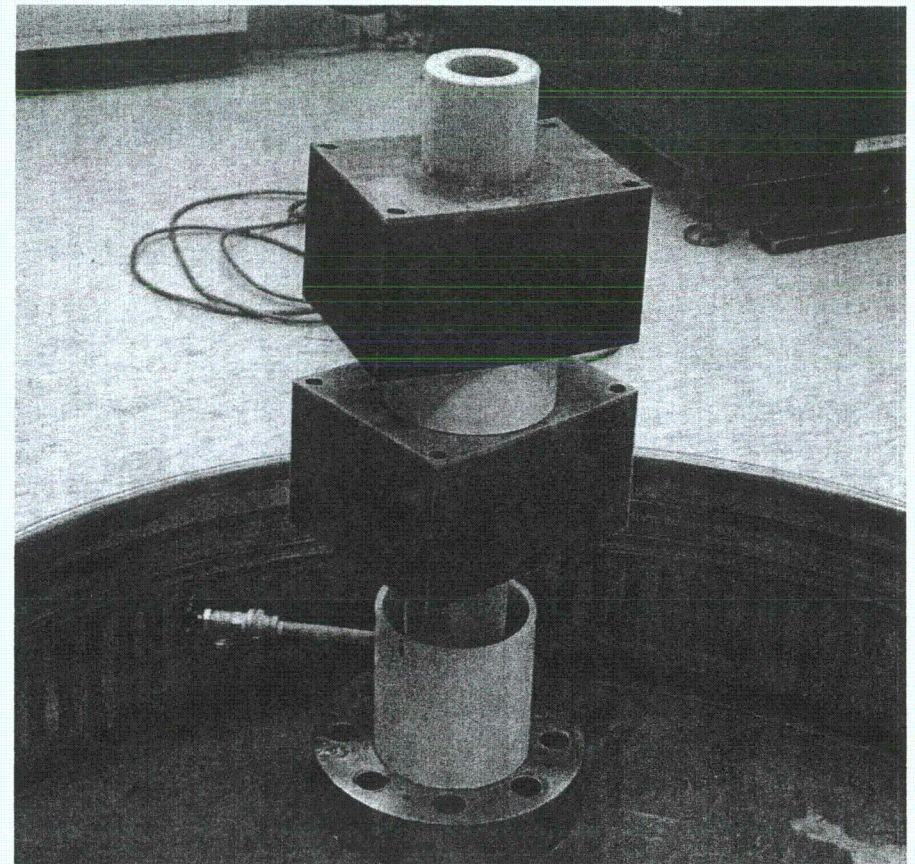
Mock-up Assembly

- ▶ Shrunk Inconel tube to allow assembly
 - Filled tube with liquid nitrogen
 - Monitored tube diameter during cooling process
- ▶ Lowered carbon steel blocks into position

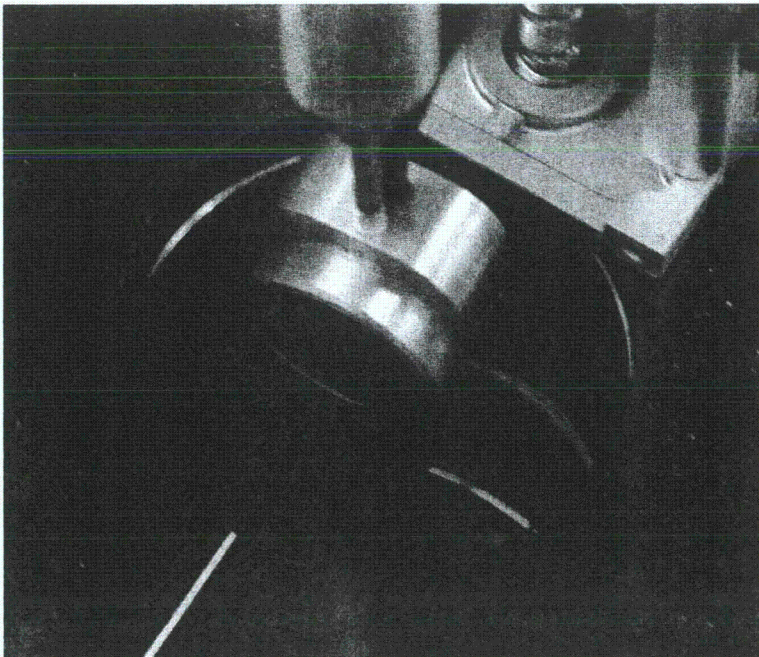
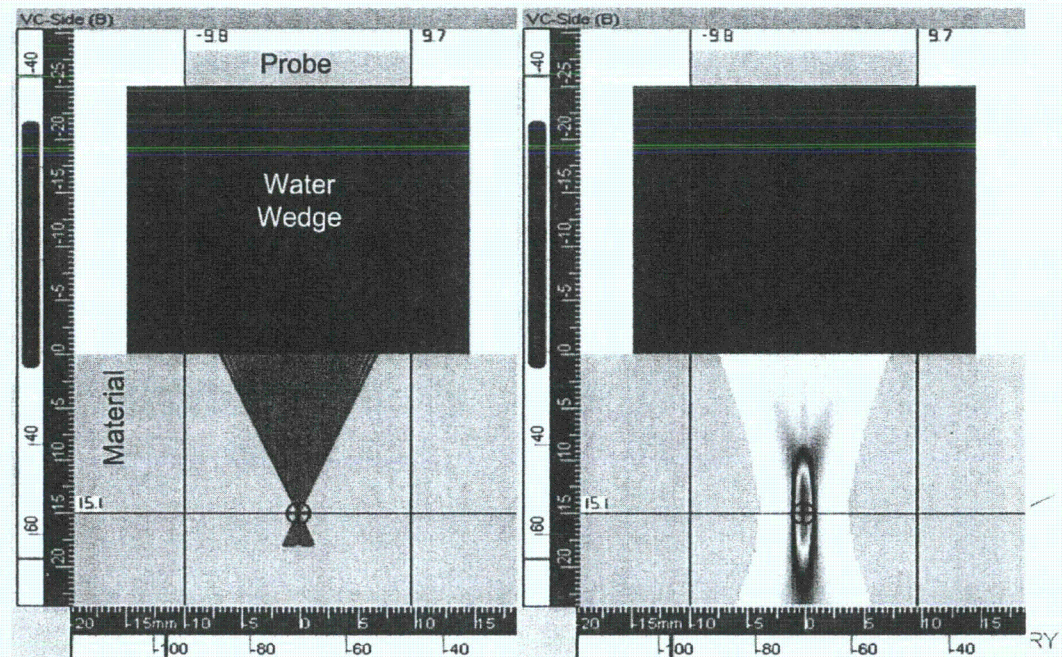
Ultrasonic Phased Array Probe

- ▶ Custom pulse-echo (PE) immersion phased array probe
 - Center frequency – 5 MHz
 - 1-D annular Fresnel configuration
 - 8 elements
 - Element radii from 3 to 9.72 mm
 - 296.81 mm² total aperture
- ▶ Designed for variable depth focusing capabilities

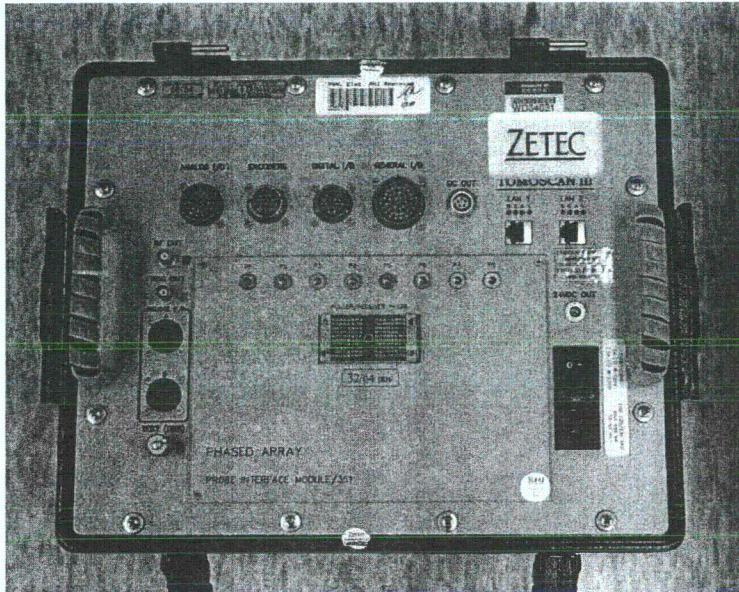
Tomoscan III PA System 0.7 – 20 MHz

- ▶ Accommodates a maximum of 64 channels
- ▶ Controlled by UltraVision 1.2R4 software
- ▶ Accepts multiple axis positional information

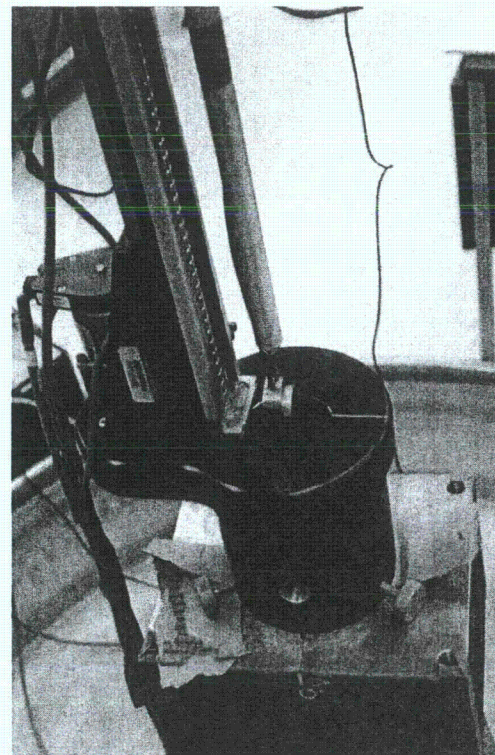
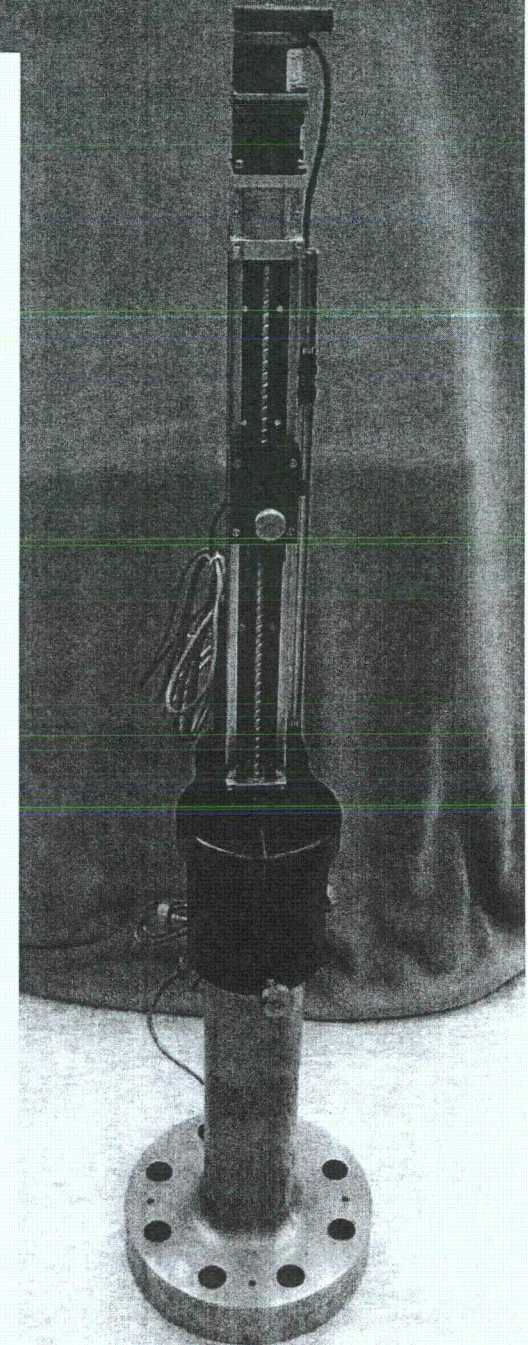
Custom Pulse Motor Scanner

- ▶ 2 axes of motion
 - Axial 0 - 18"
 - Circumferential 0 - 360 degrees
- ▶ Mounts directly on nozzle

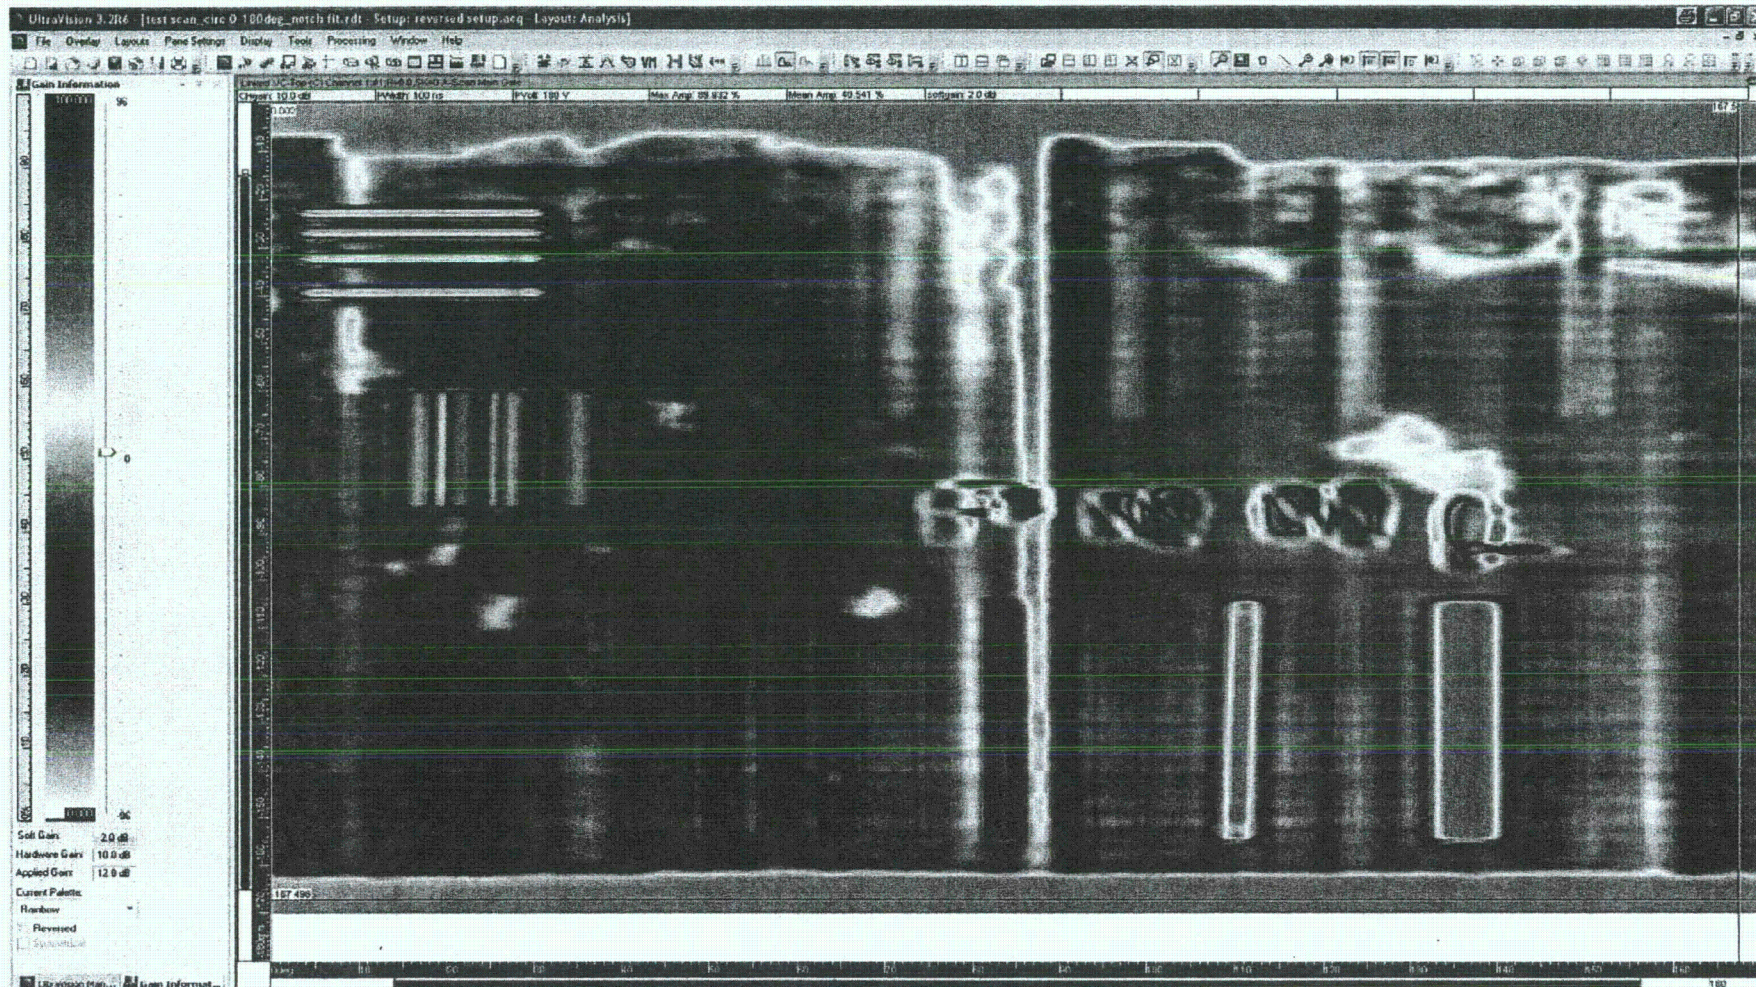
Ultrasonic Data: Mock-up Notches

0 to 170 deg. Circumference

► C-Scan view: Calibration notches in the Inconel tube

- ▶ All EDM notches were detected
 - Difficult to depth size the 'depth variation notches'
 - Both resolution sets (axial and circumferential) were detected and clearly distinguishable in both Inconel and carbon steel
 - Width variation notches sized within 1 mm
- ▶ Boric Acid presence was easily detected with ultrasound
 - Acid presence created regions of low ultrasonic reflection at the interference fit zone
 - Served as a couplant medium for ultrasonic energy

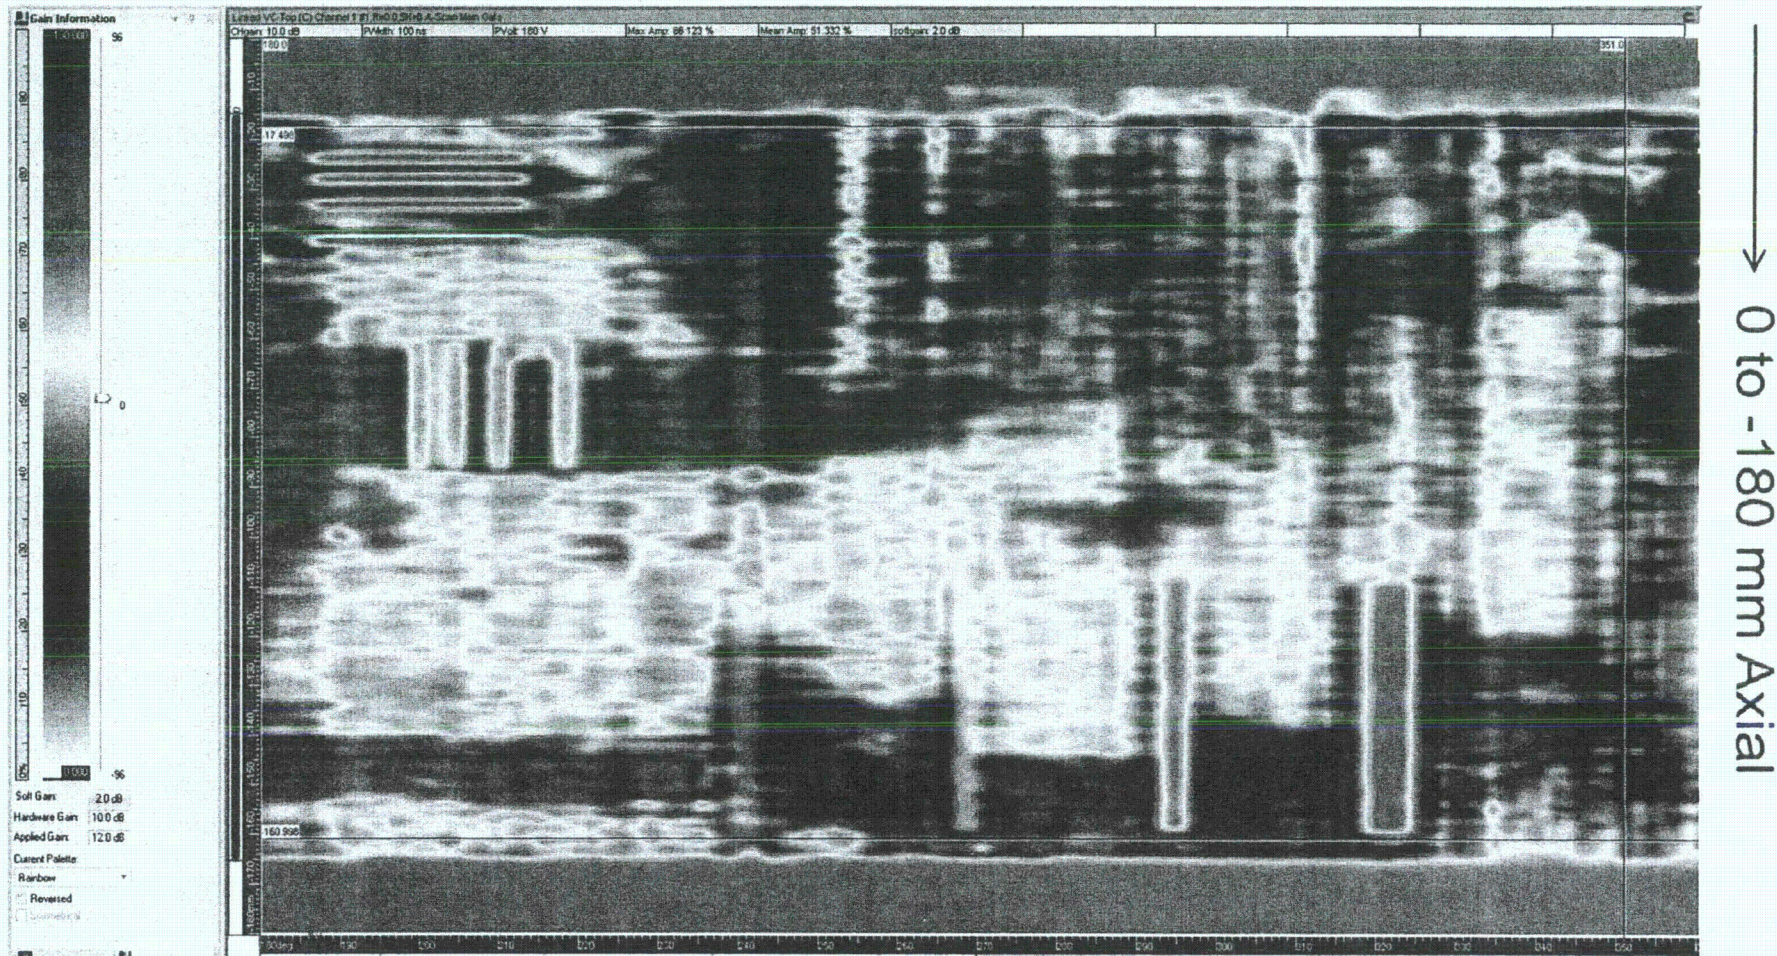
Ultrasonic Data: Mock-up Notches

- C-Scan view: Calibration notches in the carbon block

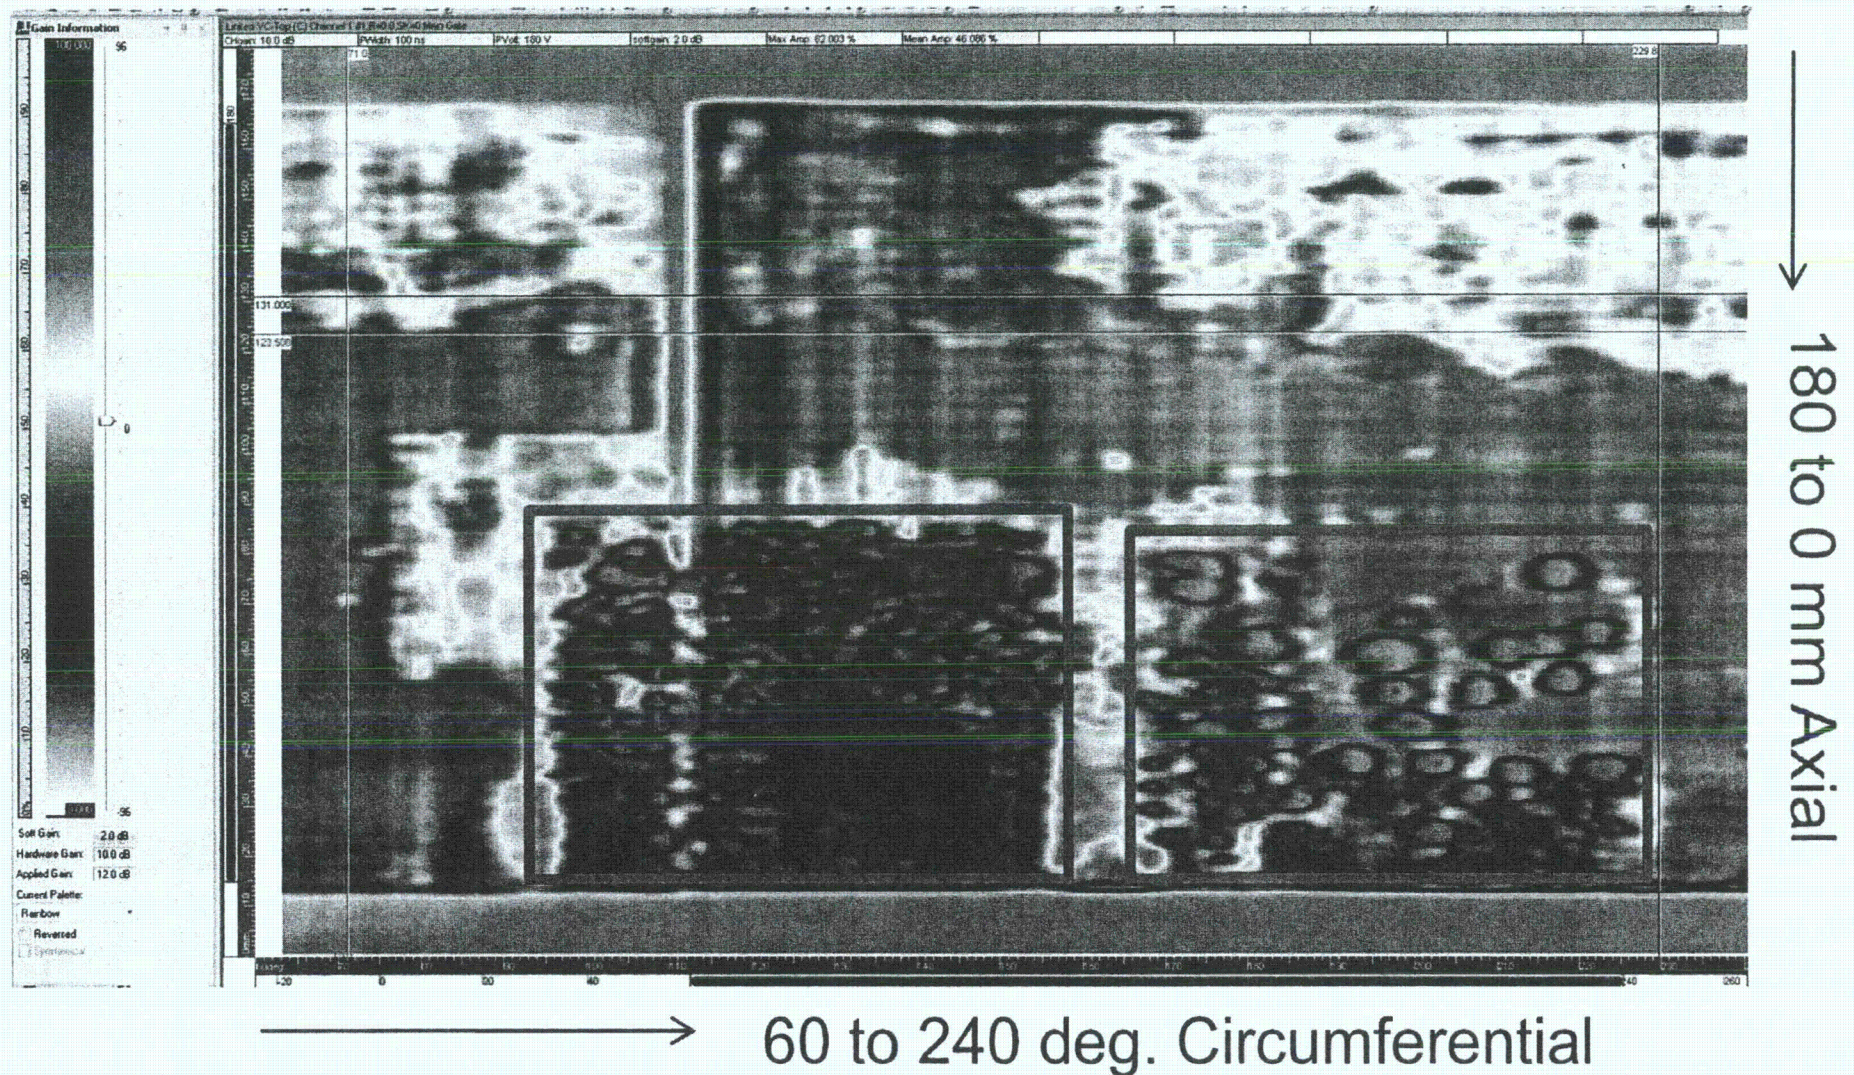
Ultrasonic Data: Mock-up Boric Acid

- C-Scan view: Boric acid presence in fit region

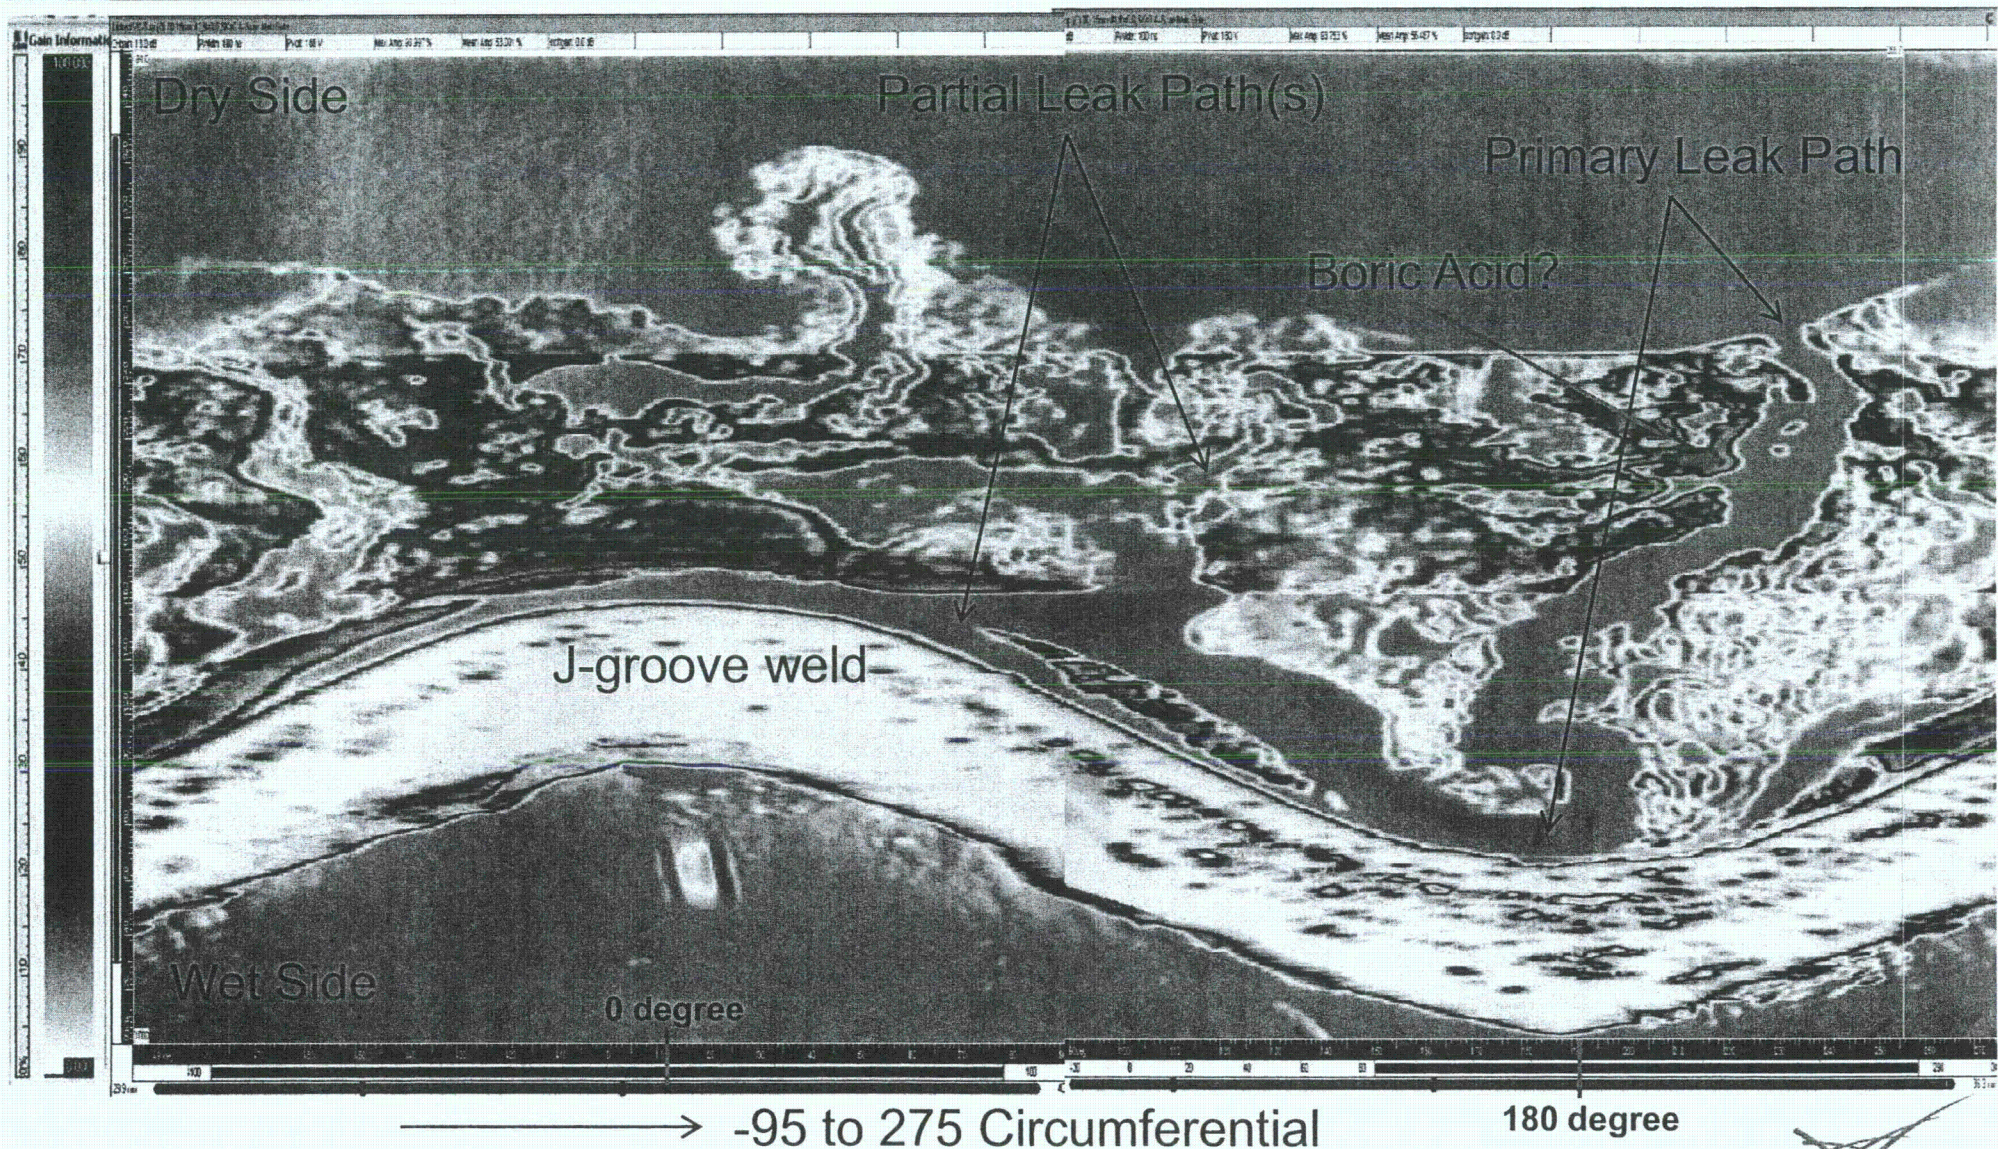
Ultrasonic Data: Nozzle 63

19 ► C-Scan view: Full weld and fit region

- A strong reflection pattern extended from the weld region through the interference fit
- Corresponded to the previous industry assessment
- Surrounding regions showed enhanced ultrasonic transmission
 - Indicative of boric acid trapped in the fit region

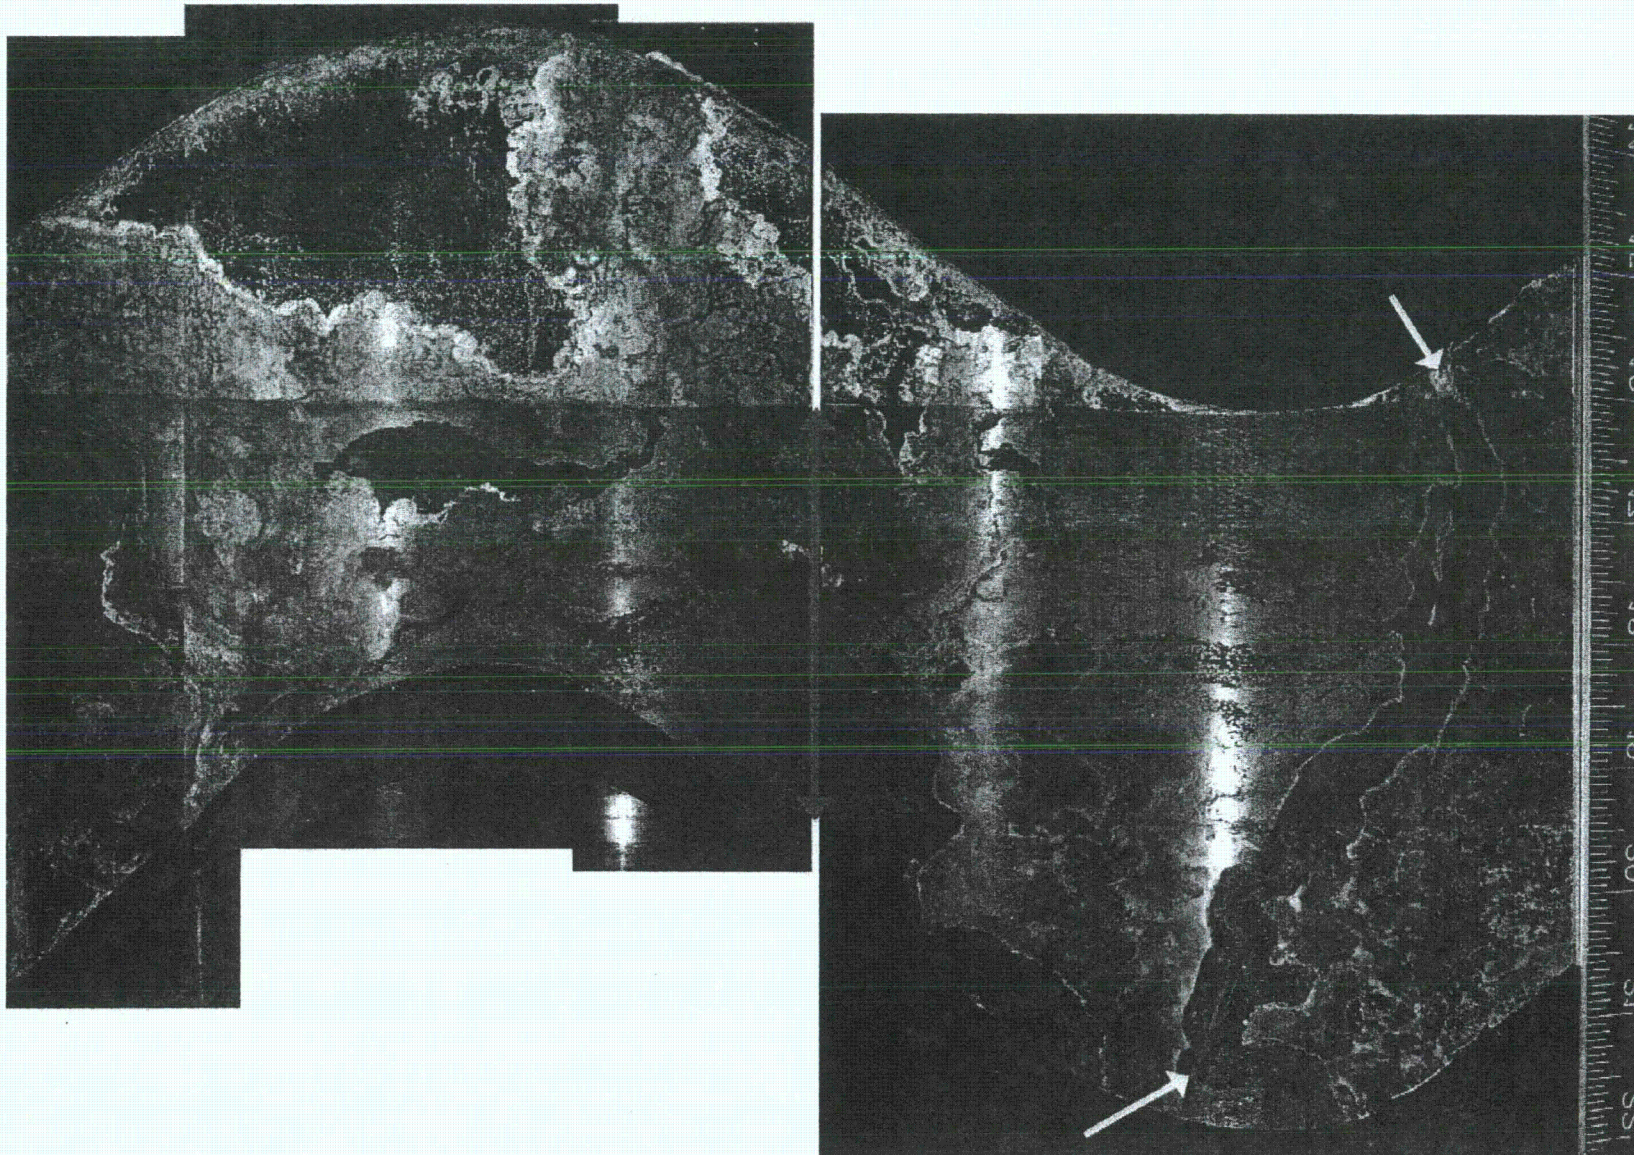
Destructive Verification

► RVH annulus view montage

► The Leak path in Nozzle 63 was confirmed via destructive analysis

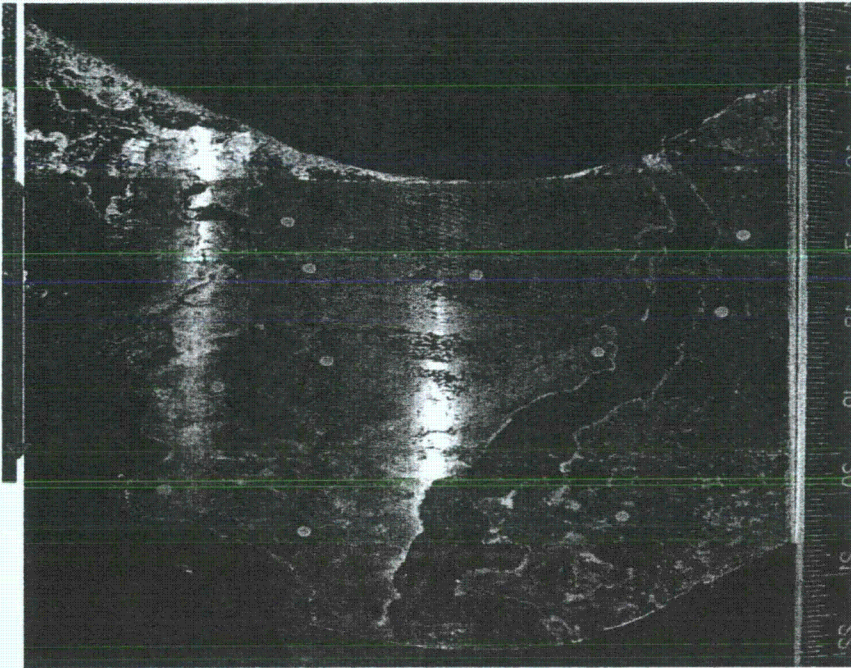
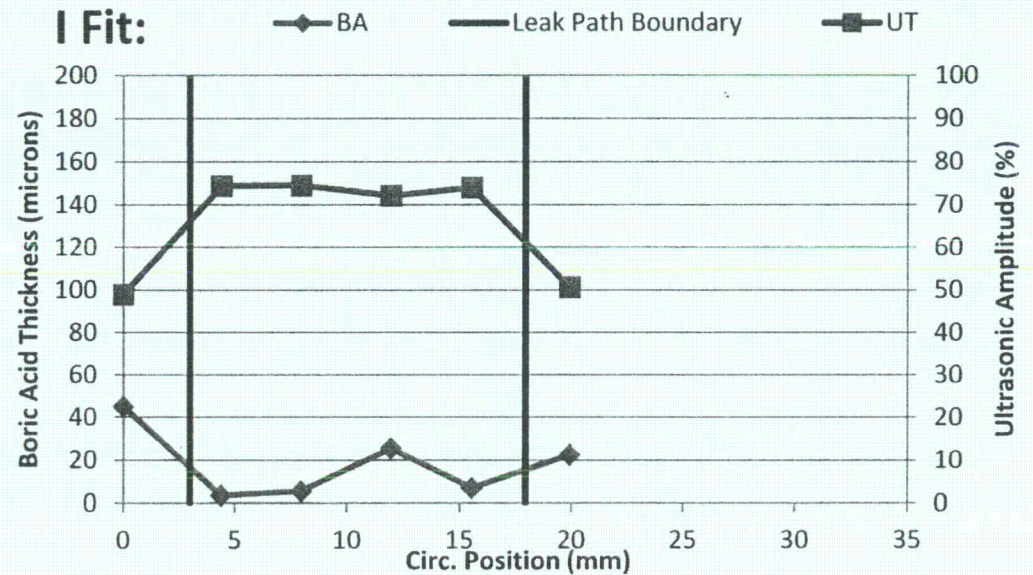
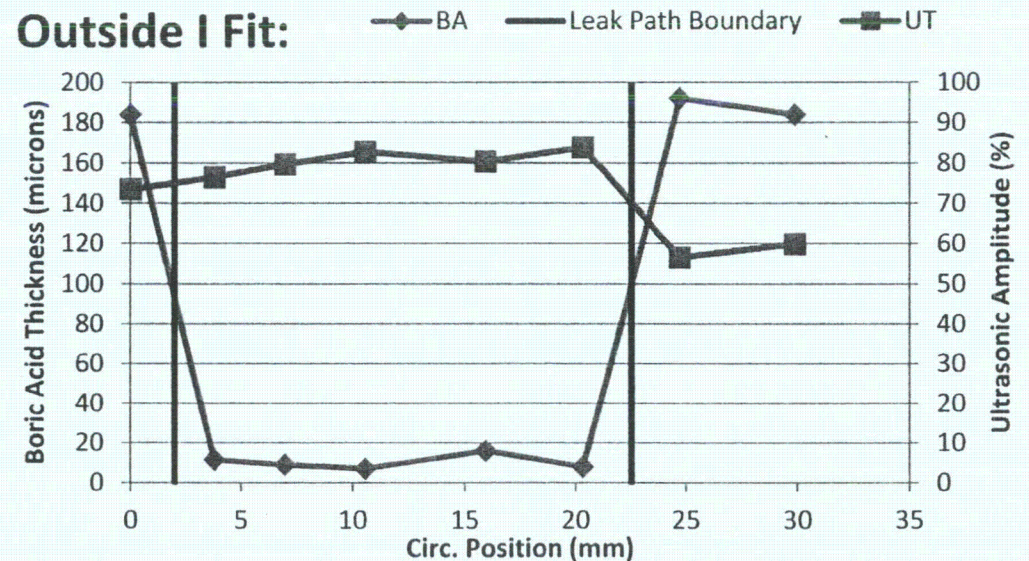
Boric Acid/Corrosion Product Assessment (Leak Path Region)

- ▶ Eddy current point probe
 - Accurate to 2.5 microns
 - Measure boric acid/ corrosion product layer thickness
- ▶ Inverse relationship with ultrasonic response

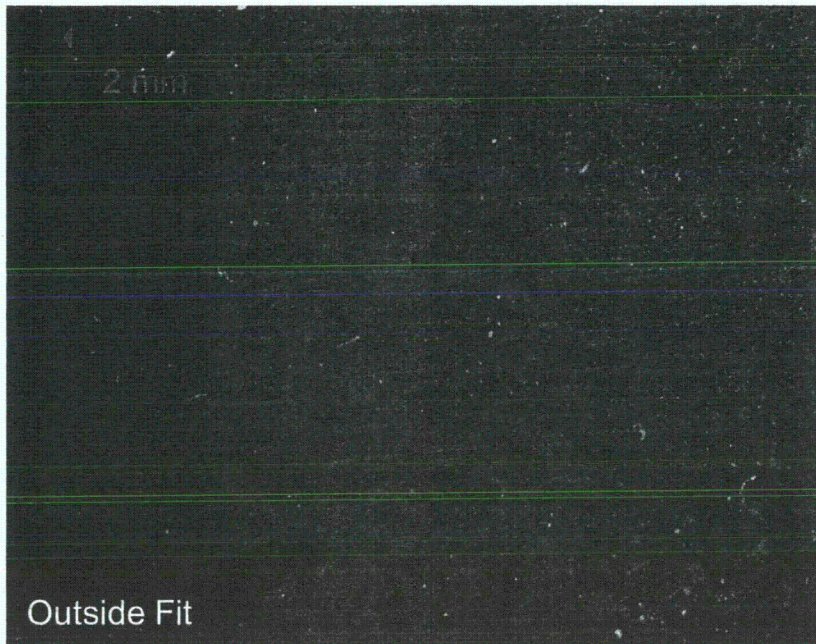
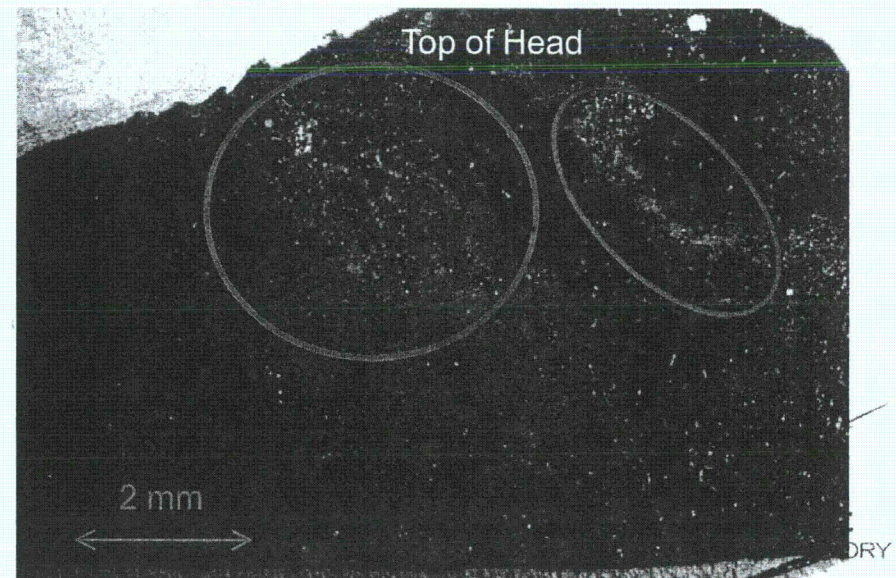
Microset Analysis

- ▶ Replicas made on RPV annulus main leak path region
- ▶ Machining striations present
 - Minimal corrosion/wastage
- ▶ Minor Corrosion visible at top of head region
 - Leak exit point
