SPIE Smart Structures/NDE 2012

Ultrasonic Phased Array Evaluation of Control Rod Drive Mechanism (CRDM) Nozzle Interference Fit and Weld Region NDE Results and Destructive Analysis

Pacific Northwest National Laboratory, Richland, WA, USA

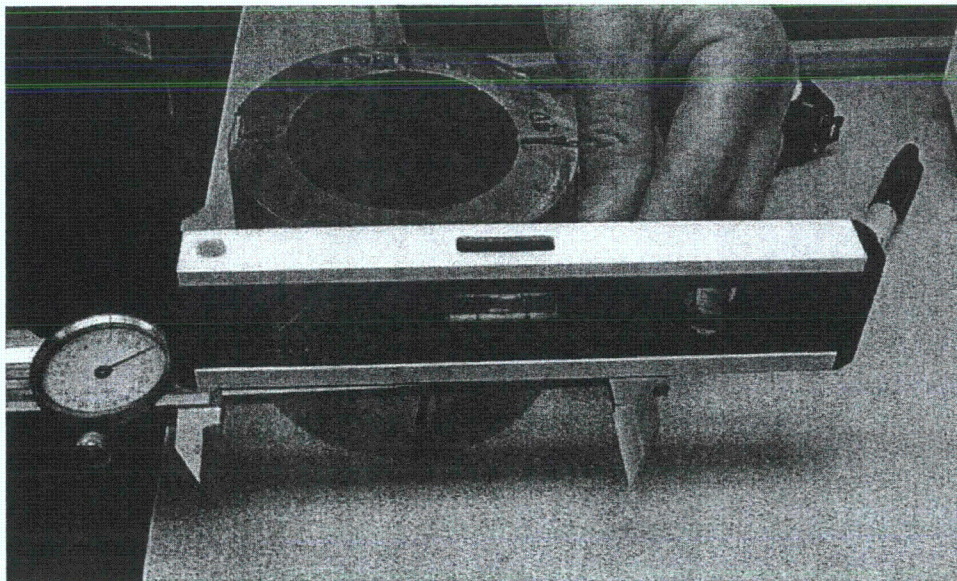
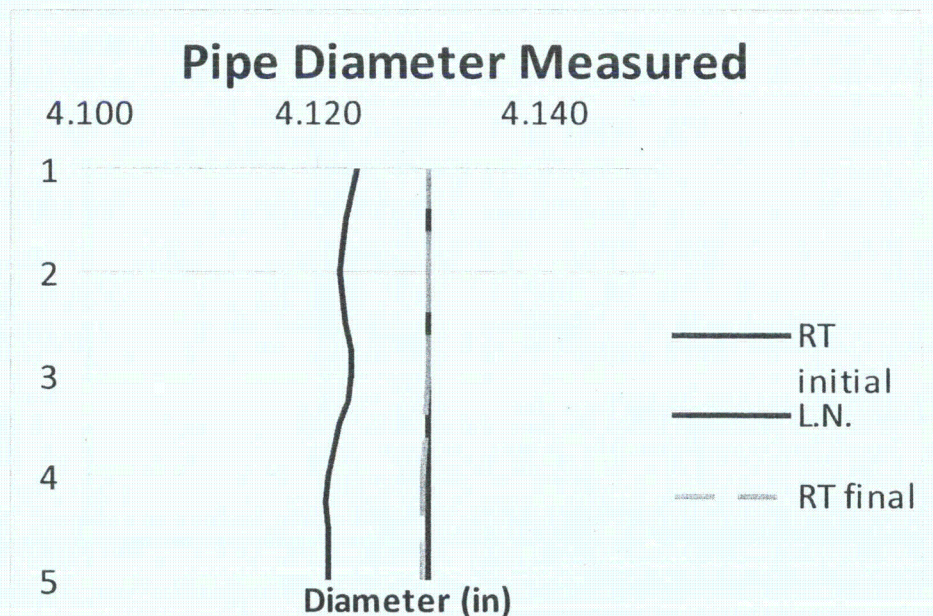
Mock-up Assembly: Inconel Shrinkage

- ▶ Test Inconel tube achievable shrinkage
 - Theory predicts 9 mils
- ▶ Use representative Inconel tube section
 - Measure initial room temperature (RT) diameter (5 axial locations)
- ▶ Cool tube in liquid nitrogen (LN) (77.2°K)
 - Measure diameter at cryogenic temperature
- ▶ Natural equilibration to room temperature
 - Important that tube diameter returns to initial state

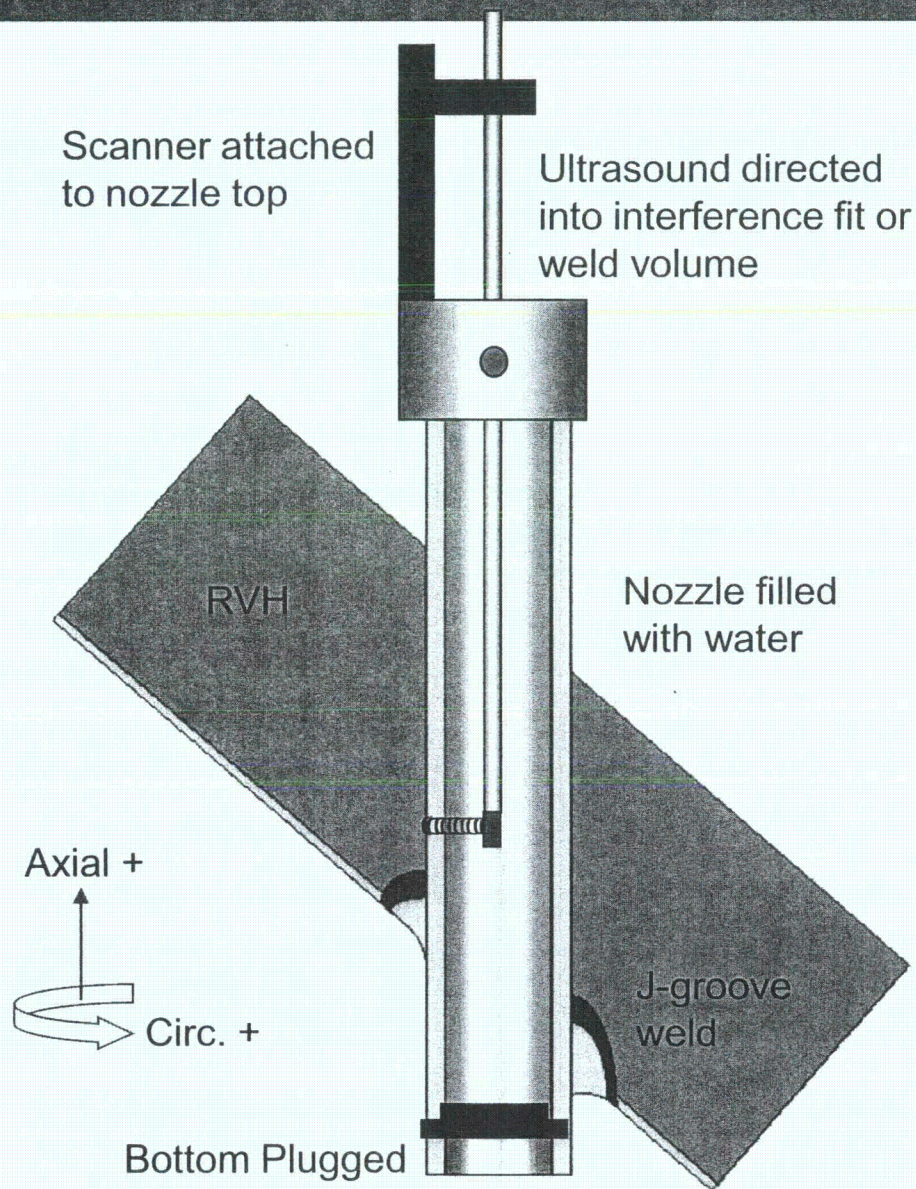
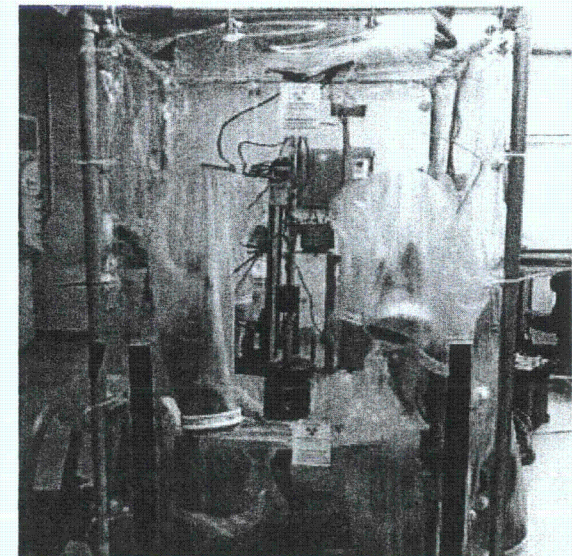
Ultrasonic Data Acquisition

- ▶ Multiple depth focal laws implemented
 - Tube ID
 - Tube OD/interference fit region
- ▶ Raster scan protocol
 - 'Scan' in circumferential direction
 - 'Index' in axial direction
- ▶ Resolution
 - 0.5° in scan by 0.5 mm in index
- ▶ Positional information relayed via shaft encoders

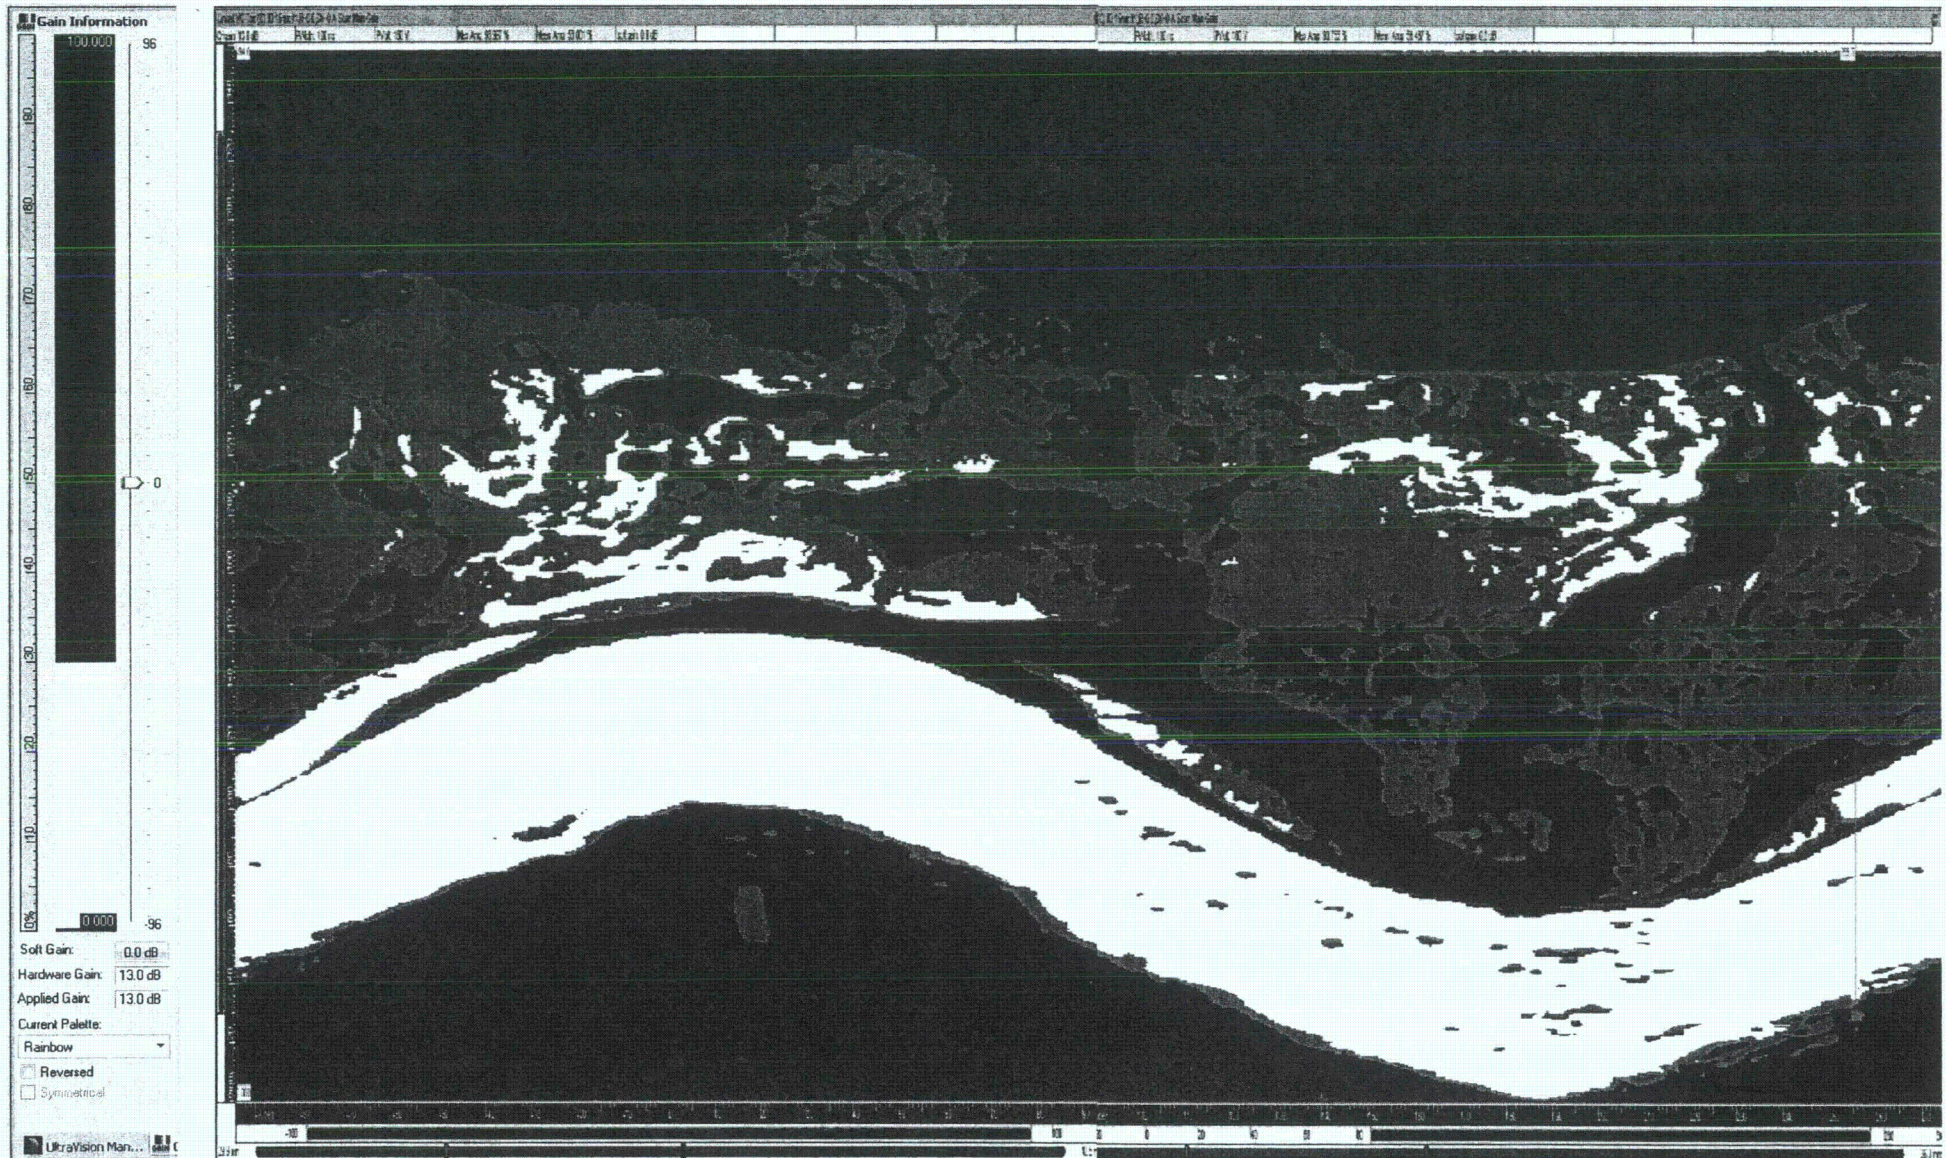
Ultrasonic Data: Nozzle 63 (cont'd)

28 ► C-Scan view: Custom color bar
