**Ultrasonic Phased Array
Assessment of the Interference
Fit and Leak Path of the
North Anna Unit 2 Control Rod
Drive Mechanism Nozzle 63 with
Destructive Validation**

Prepared by
S. L. Crawford, A. D. Cinson, P. J. MacFarlan, B. D. Hanson,
R. A. Mathews

Pacific Northwest National Laboratory
P.O. Box 999
Richland, WA 99352

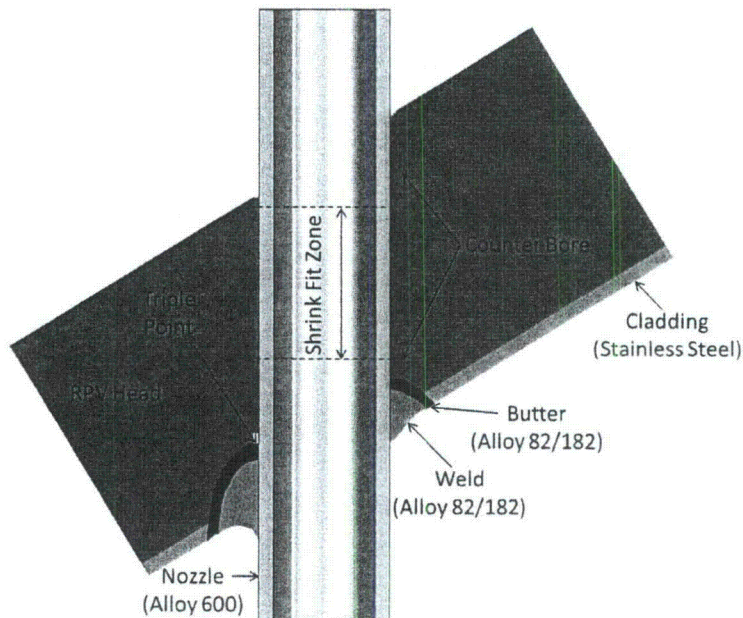
Figure 1.1 CRDM J-groove Weld Schematic

Leakage of borated water to the RPV head may occur as cracks initiate on the J-groove weld surface, propagate through the weld to the triple point, and allow water into the annulus region between the nozzle outer diameter (OD) and the RPV head. The triple point is diagrammed in Figure 1.2 and is the point at which the RPV head, buttering, and Alloy 600 CRDM tube meet. Once the boundary formed by an intact J-groove weld is compromised, there is the potential for a leakage path through the interference fit allowing reactor coolant to reach the outer surface of the RPV. The coolant can flash to steam, leaving boric acid deposits on the head and in the interference fit region around the leakage path. Additionally, a steam-cut leakage path through the interference fit and annulus may also be produced at operating temperature and pressure in a plant when a gap in the carbon steel RPV head at the uphill and downhill positions opens due to material expansions.

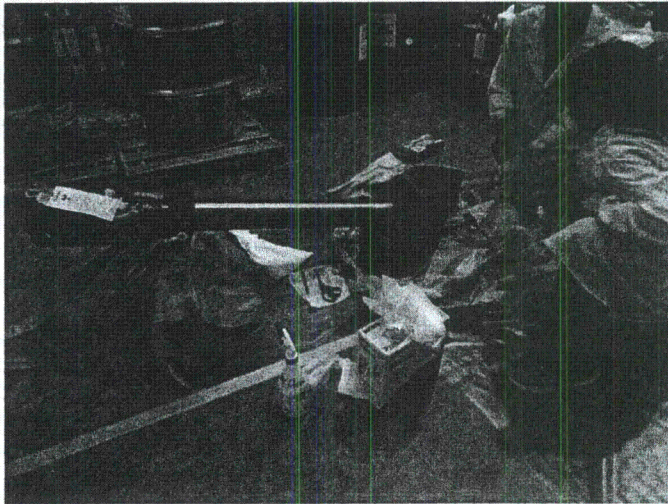
Figure 2.1 As-Received Condition of Nozzle 63.

When received at the Pacific Northwest National Laboratory (PNNL), the control rod drive mechanism (CRDM) Nozzle 63 from the North Anna Unit 2 reactor consisted of a flame cut section of the upper reactor pressure vessel (RPV) head and a full length Alloy 600 penetration tube, as shown in Figure 2.1. The CRDM was removed from its storage box and a radiologic survey performed. The flame cut edges of the CRDM were then painted with two coats (the first yellow, the second red) of a flexible air dried plastic coating from Plasti Dip® to reduce the risk of workers being cut while handling the CRDM (see Figure 2.2). An expandable 3-in. plug was inserted in the wetted-side of the penetration tube so the tube could be filled with water. In retrospect, it would have been better to cut the nozzle prior inserting the plug. This may have reduced some of the debris that first coated the ultrasonic scanner (see Section 5.2). With the plug inserted, the nozzle was wrapped in plastic (see Figure 2.3) and bagged to contain contamination during the nozzle cutting. The nozzle was then secured on a wheeled cart that was modified to allow the penetration tube to be kept vertical during the testing, as seen in Figure 2.4.

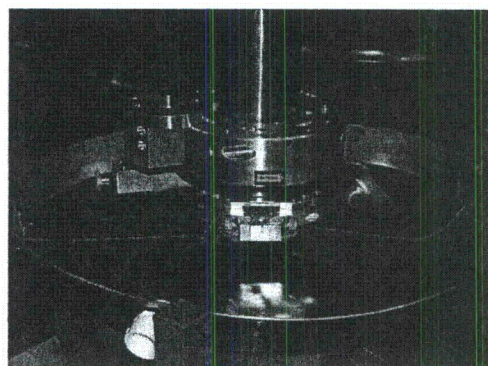
Figure 2.5 Nozzle 63 with Hydraulic Rotary Pipe Cutting Tool

In order to better fit in a glovebag for contamination control purposes and to facilitate connection of the scanner, approximately two feet of the penetration tube had to be removed. A catch pan was first fitted around the penetration tube below where the cut was to be made, approximately 12 in above the RPV steel. A hydraulic rotary pipe cutting tool was then fitted around the penetration tube as shown in Figure 2.5. The penetration tube and catch tray were wrapped in plastic to provide contamination control. The hydraulic cutting tool was connected and the first attempt at cutting the tube was made (see Figure 2.6). A "hard spot" was encountered within the nozzle and two cutting heads broke before the decision was made to attempt a new cut approximately 1 in above the previous cut attempt. Cutting proceeded without any other issues in this new location. The removed section of the penetration tube was placed in a 55 gallon drum for storage.

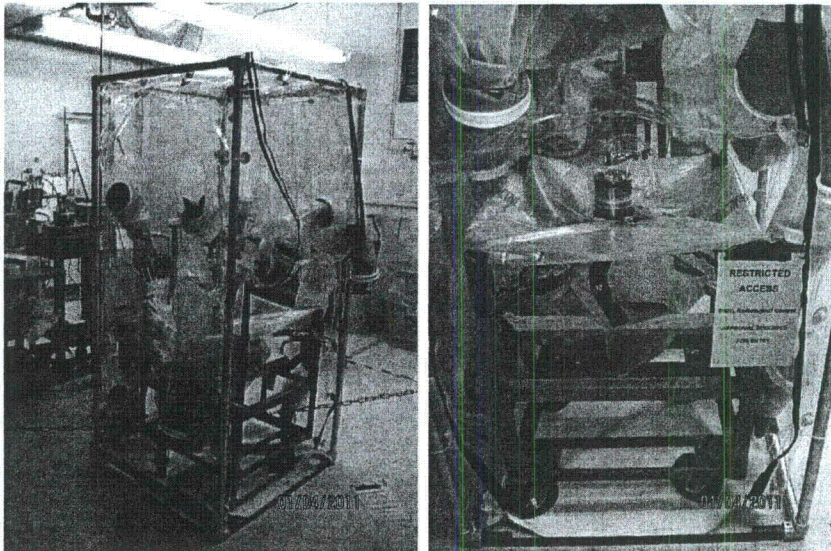
Figure 2.7 CRDM Installed in Containment Glovebag.

After cutting, the CRDM was completely wrapped in plastic to prevent the spread of contamination. The CRDM was then transported to RPL/33 where a containment glovebag had been assembled to house the nozzle. The cart with the nozzle was wheeled into the glovebag as shown in Figure 2.7. Once the nozzle was properly positioned, the two-axis scanner with attached ultrasonic phased array probe was lowered through an upper access port and centered onto the penetration tube. The scanner was secured to the penetration tube using three set screws. The main door and the upper access port were sealed and the control cables secured to the upper frame. Approximately 1.5 liters of distilled water was added to the penetration tube. The final configuration of the scanner in the glovebag is shown in Figure 2.8.

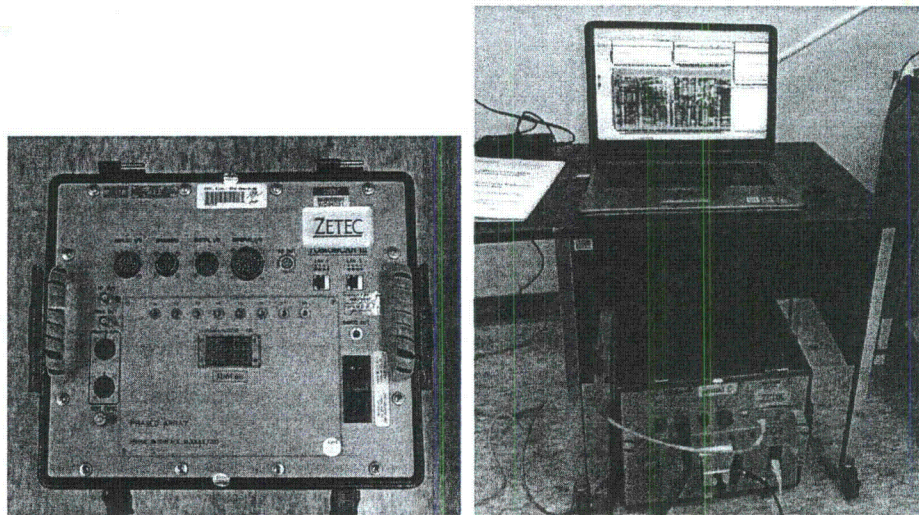
Figure 3.1 Data Acquisition System and Laboratory Workstation. Left: Tomoscan III phased array data acquisition system. Right: Laboratory workstation/laptop computer for both data acquisition and data analysis, with the Tomoscan III system below.

Ultrasonic data acquisition for Nozzle 63 was accomplished using the ZETEC Tomoscan III phased array system to control the PA probe employed in this study. This commercially available system was equipped to accommodate a maximum of 64 channels of data from PA probes and was operated with UltraVision 1.2R4 software. Its frequency pulsing electronics can drive probes in the 0.7–20 MHz range. The system is capable of accepting multiple axis positional information from external encoders to map ultrasonic data to spatial location on a specimen. The data acquisition system is shown in Figure 3.1.

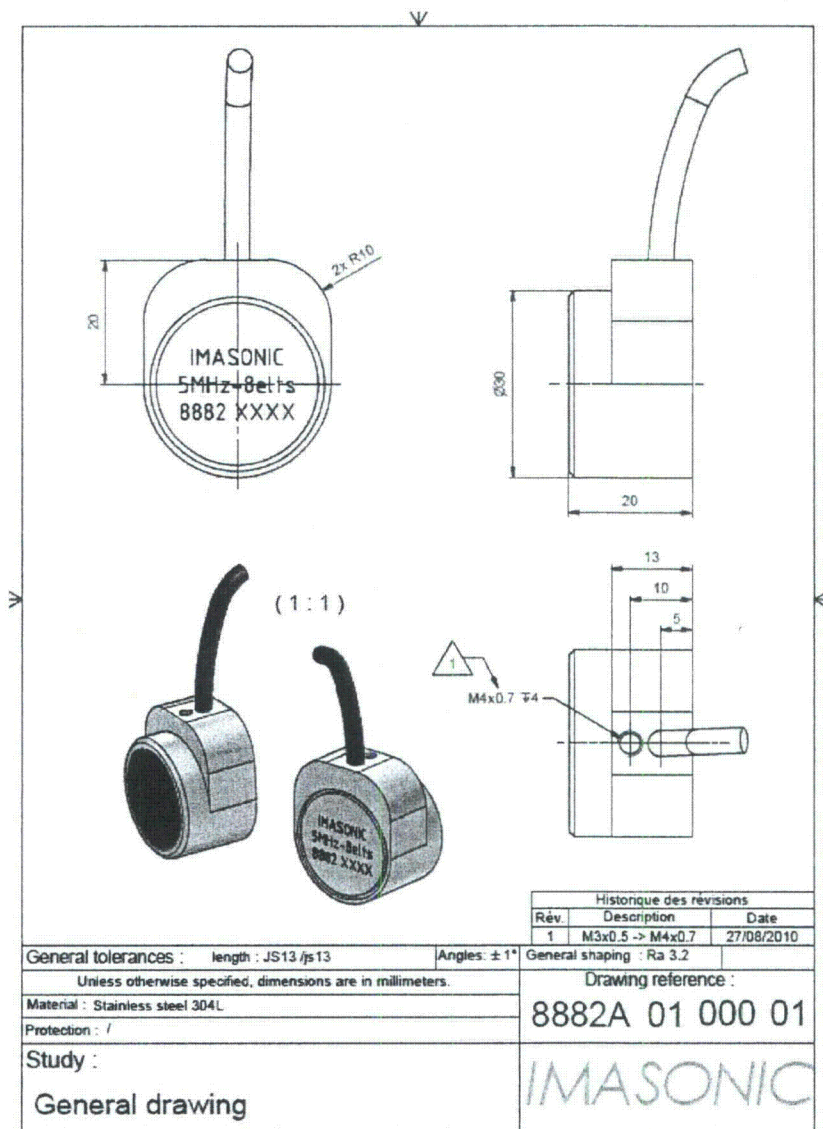
Figure 3.2 5.0-MHz Phased Array Probe

Nozzle 63 was examined with a pulse-echo (PE) longitudinal-wave immersion phased-array probe with a center frequency of 5 MHz, as shown in Figure 3.2. The PA probe was designed in a 1-D annular configuration using eight elements. The probe contained elements in a Fresnel radius pattern starting with a radius of 3 mm (0.12 in.) up to the final element radius of 9.72 mm (0.38 in.). Thus, the total aperture was 296.81 mm² (0.46 in.²). As characterized by the manufacturer, Imasonic, the probe exhibited an overall 71% bandwidth at -6 decibels (dB) with all eight elements and an overall central frequency of 5.4 MHz. This design was chosen for enhanced depth focusing capabilities. Its beam-forming capabilities showed a satisfactory insonification of the interference fit region of interest as well as the ability to propagate a coherent ultrasonic beam deep into the weld region. Figure 3.3 shows the probe attached to the scanning arm.

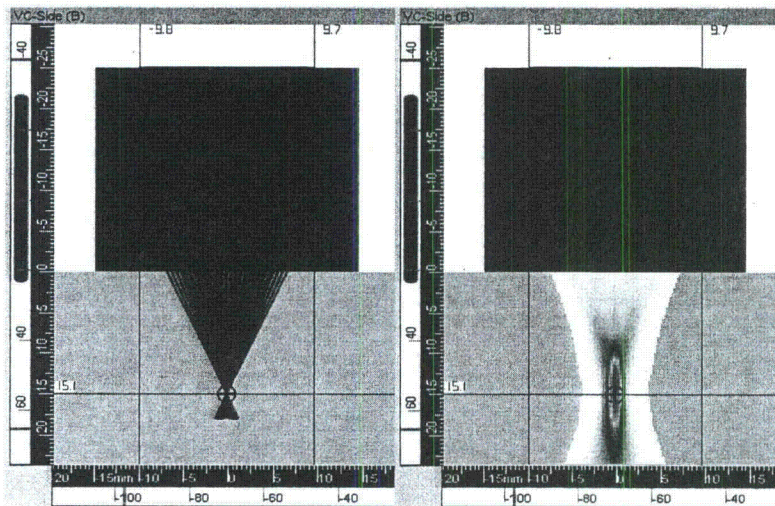
Figure 3.4 Law Formation and Sound Field Simulation for a Depth Focus of 15 mm

as the 'wedge' material. The red horizontal line at 15.1 mm (0.59 in.) represents the target focal region. The simulation showed a favorable sound field density at the desired focal depth.

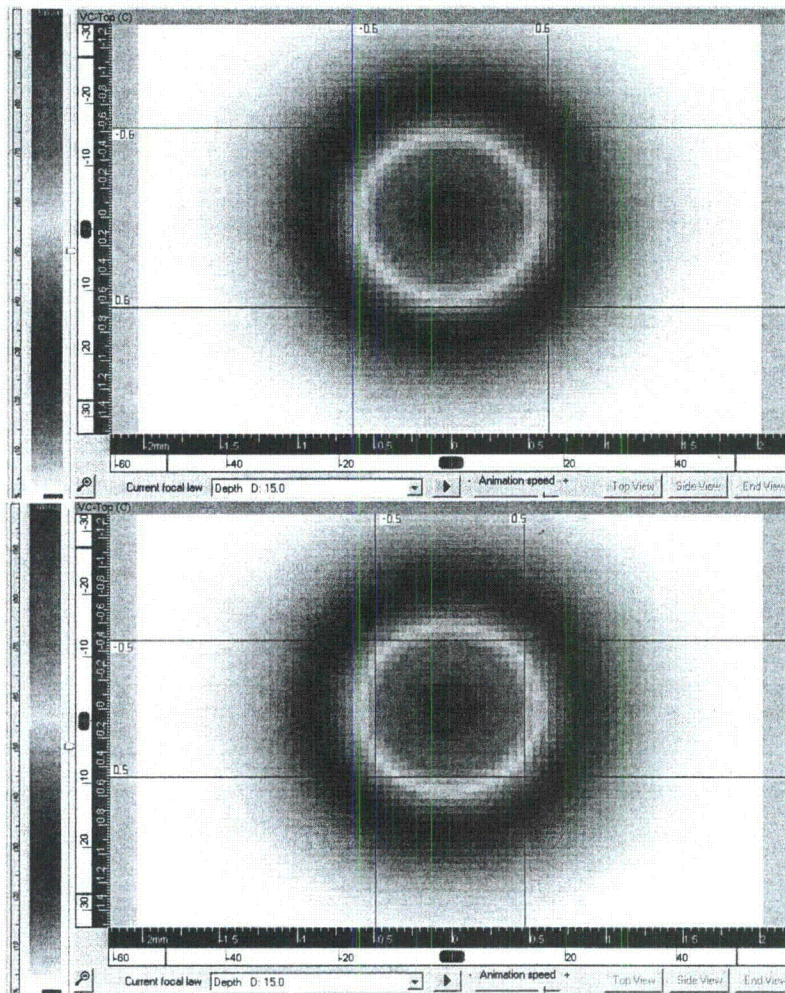
Figure 3.5 C-Scan View at a Depth Focus of 15 mm. Top: -6 dB spot size. Bottom: -3 dB spot size.

depth of 15 mm (0.59 in.) in Alloy 600 material were 1.2×1.2 mm (0.047×0.047 in.) and 1.0×1.0 mm (0.04×0.04 in.), respectively. Additional sound field simulations were modeled at 1 mm (tube inner diameter [ID]) and 30 mm (15 mm into the J-groove weld region). The -6 dB spot size for depth focuses of 1 and 30 mm were 0.6×0.6 mm (0.024×0.024 in.) and 2.0×2.0 mm (0.079×0.079 in.), respectively. The -3 dB spot sizes were 0.4×0.4 mm (0.016×0.016 in.) and 1.4×1.4 mm (0.055×0.055 in.), respectively.

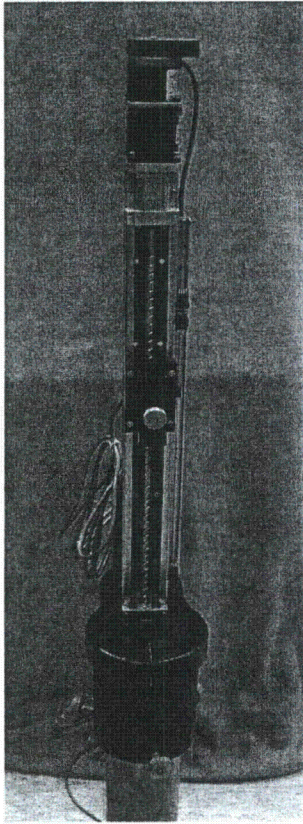
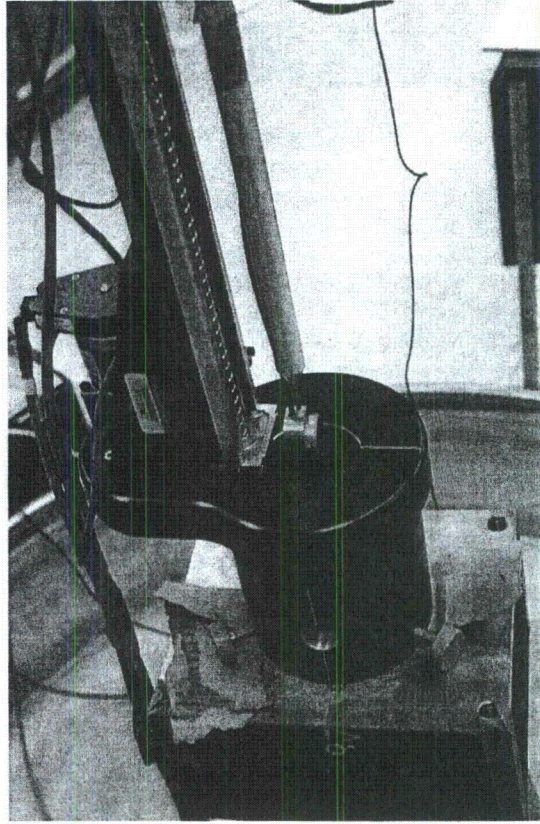
Figure 3.6 Scanner on Mockup Nozzle Specimen. Left: Scanner alone. Right: Scanner with PA probe attached sitting on the calibration mockup specimen.

The scanner was lowered onto the top of the nozzle specimen, centered, and secured by uniformly tightening the three set screws in the collar. Centering the scanner apparatus allowed the transducer arm to be positioned at the center of the nozzle tube so that a constant sound path was maintained during a circumferential scan sweep to reduce signal walk. The phased array probe was then affixed to the 762-mm (30-in.) scanner arm using an M4 threaded rod running directly into the transducer housing and attached to the vertical axis via a set screw, as shown in Figure 3.7. The transducer face was orientated such that the ultrasonic beam was propagating radially outward towards the annulus or weld region. Using a set screw to hold the scanner arm enabled manual positioning the probe in the vertical axis for increased versatility.

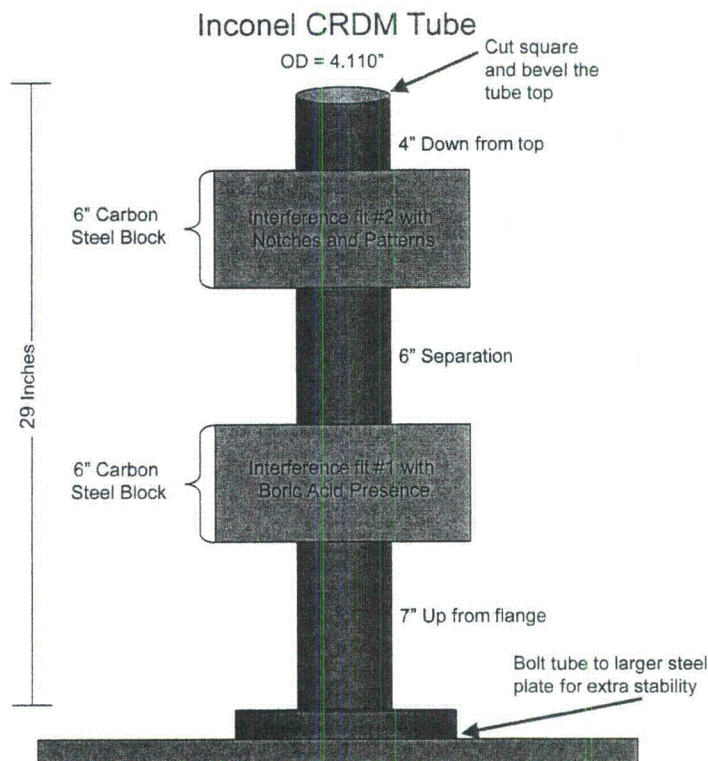
Figure 4.1 Assembled CRDM Interference Fit Mockup Specimen

The CRDM mockup was made from an Alloy 600 tube fitted with two 6-in.-thick carbon steel blocks. The mockup was designed to simulate the interference fit between the CRDM nozzle and the reactor vessel head (RVH) material in a pressurized water reactor (PWR), using similar materials and fabrication techniques. The mockup had two interference fit regions as shown in Figure 4.1. In the top interference fit, notches were made in the tube and carbon steel blocks with electric discharge machining (EDM) to simulate cracking, wastage, and degradation of the materials. In the bottom interference fit, crystalline boric acid was placed between the tube and the carbon steel blocks to simulate deposits left by primary water leakage. Due to safety concerns (tipping) regarding specimen weight and center of mass, the flange end of the tube was bolted to a larger plate for increased stability.

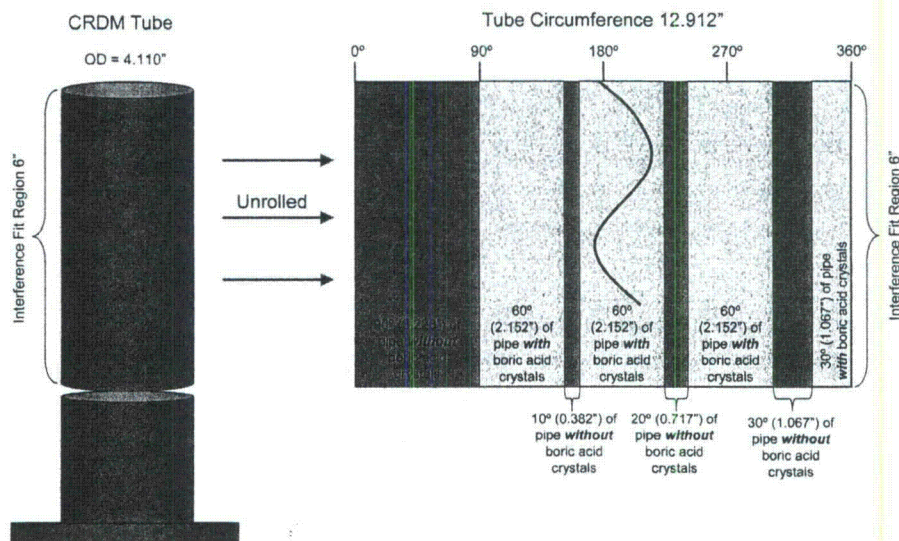
Figure 4.2 Boric Acid Pattern Conceptual Design

The lower interference fit on the CRDM nozzle mockup contained crystalline boric acid deposits in the region between the Alloy 600 tube and the carbon steel block. Boric acid deposits in the interference fit of an operating plant could indicate leakage of borated primary water through the J-groove seal weld. In-service-inspection data show that the presence of boric acid creates a unique ultrasonic transmission and reflection patterns in the fit regions (Cumblidge et al. 2009). The boric acid fit of the mockup was designed so that PNNL could evaluate and quantify this ultrasonic transmission and reflection phenomenon.

acid was unwanted, as shown in the left hand side of Figure 4.3. The boric acid was prepared for application by mixing a small amount of boric acid in solid form with a small amount of methanol. The two components were then sonicated into a paste with medium to high viscosity. The application of the acid involved spreading a thin and even coat of the paste with a compatible brush over the localized region on the OD of the tube between the masked-off sections. Upon evaporation of the methanol and solidification of the boric acid, the masking tape was removed. A snake-like pattern was scraped into one of the boric acid regions as indicated with the blue line in Figure 4.2 and the arrow in the right hand side of Figure 4.3.

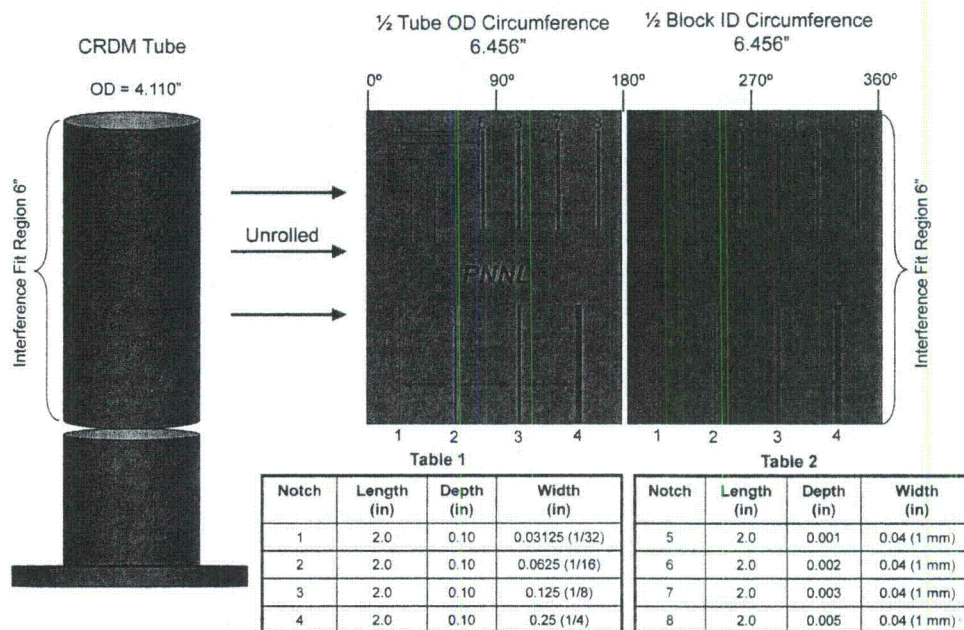
Figure 4.4 Interference Fit #2; Notch and Pattern Conceptual Design

The probe resolution in both the circumferential and axial directions was measured by acquiring data on a series of notches 2-mm wide \times 2-mm deep \times 25-mm long (0.079-in. \times 0.079-in. \times 1.0-in.) that were spaced 2, 3, and 5 mm (0.079, 0.12, and 0.20 in.) apart (approximately 2, 3, and 5 λ), respectively. One set of these notches was orientated circumferentially and the other was oriented axially, as represented by blue lines in Figure 4.4. To measure width detection sensitivity, axial notches labeled 1–4 in Figure 4.4 were placed equidistant from each other and had a constant depth, while the widths varied from 0.7938 to 6.35 mm (0.03125 to 0.25 in.). The third set of notches was used to assess depth sensitivity, with axially oriented notches placed equidistant from each other. These notches are labeled 5–8 in Figure 4.4 and had constant lengths and widths but varied in depth. Figure 4.5 shows additional detailed notch dimensions. Complete as-built dimensional details for all of the notches can be found in Appendix A.

The machined notches in the Alloy 600 tube of the CRDM nozzle mockup simulated potential cracks or degradation of the nozzle penetration. The notched area shown in Figures 4.4 and 4.5 was scanned over approximately a 0 to 170 degree range in the circumferential direction (horizontal axis) and 0 to 180 mm (7.1 in.) in the axial direction (vertical axis) with the data image shown in Figure 4.13. This top view, plan view, or C-scan image shows the resolution notches in the upper-left portion of the image. The variable depth and width notches are also seen as well as the letters "PNNL." The color scale is displayed on the left with lowest amplitudes at the bottom represented by white and the highest amplitude at the top of the color bar represented by red. In this pulse-echo data, the low amplitude signals (blue and green) indicate good transmission or low reflection of the ultrasonic energy at the interface of the tube to the carbon steel. Conversely, the high-amplitude signals (yellow and red) represent poor transmission or large reflection at the interface. A large reflected signal would be generated at a tube-to-air interface as would be seen above and below the interference fit region or in the presence of a notch with large enough dimensions.

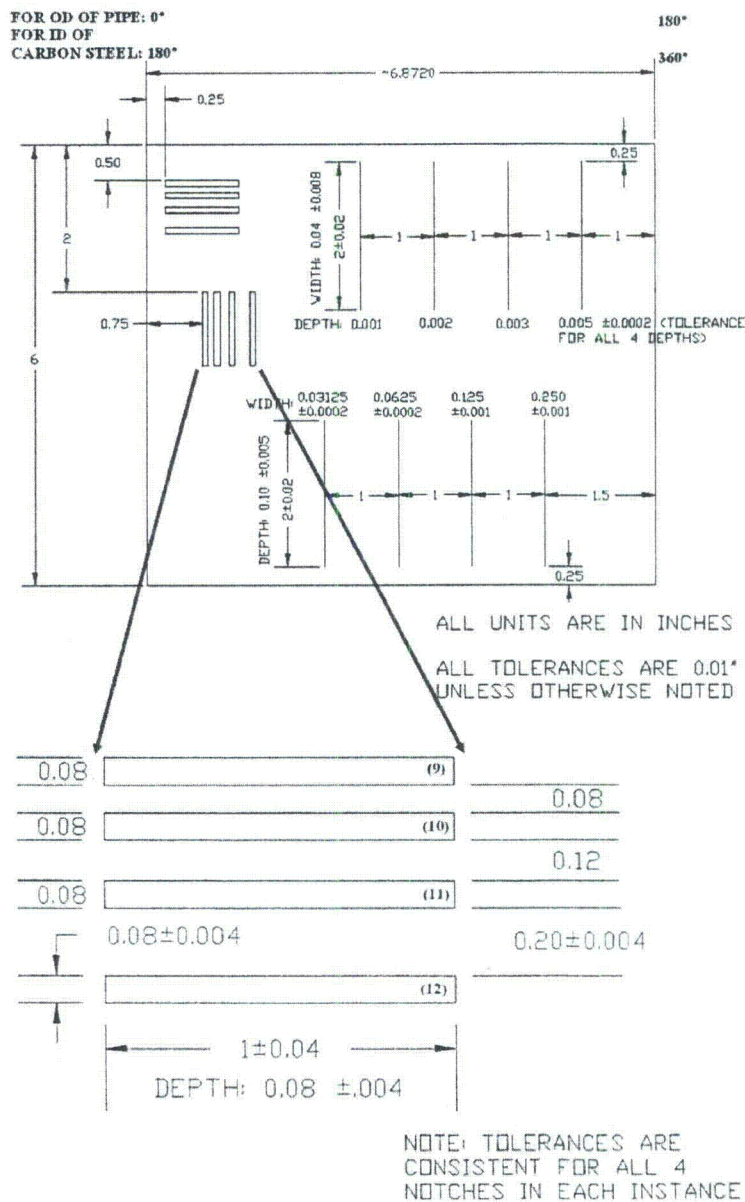
Figure 4.5 Notch Pattern in the CRDM Calibration Mockup Specimen, Upper Interference Fit. All units are inches. Above: General notch layout with detail. Below: Circumferentially orientated resolution notch detail.

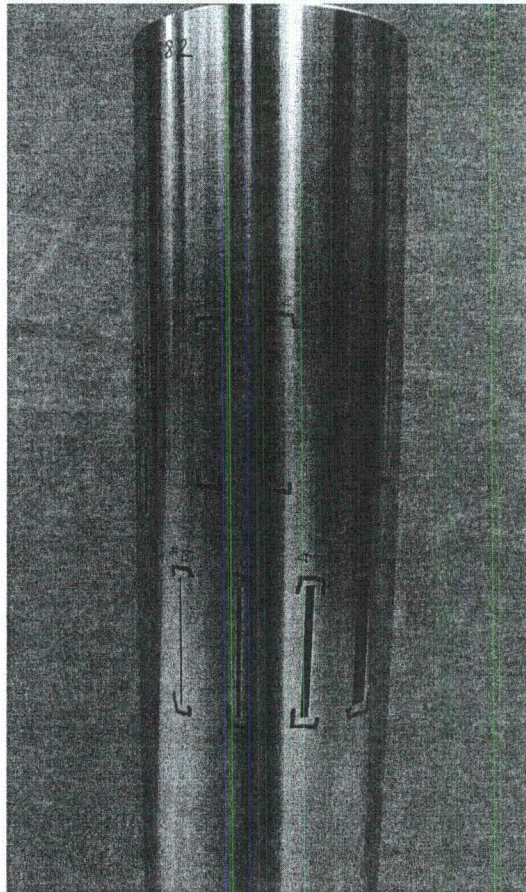
Figure 4.6 EDM Notches in Alloy 600 Tube

The three sets or groupings of notches did not overlap, but were separated so that ultrasonic observations could be made independently on the ability to resolve two closely spaced indications, as well as width and depth sensitivity. The acronym 'PNNL' was also notched on the OD of the tube to provide an indication of off-axis sensitivity. Figures 4.6 and 4.7 show the EDM notch patterns as cut into the Alloy 600 tube and carbon steel block.

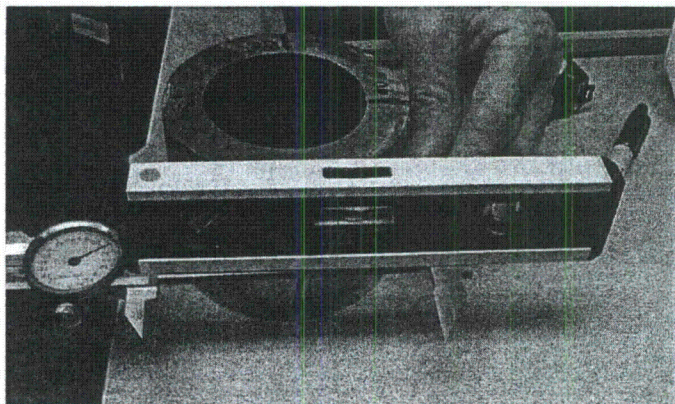
Figure 4.8 Diameter Measurements Acquired at Room Temperature Using a Caliper

Prior to assembly of the mockup, experimental verification of the calculated shrinkage was conducted on a section of Alloy 600 tubing cut from a tube similar to that which was used for the mockup. At room temperature, five outside diameter measurements were acquired at 0–180 and five at 90–270 degrees using a calibrated caliper, shown in Figure 4.8, at marked locations along the axial length of the specimen. Temperature measurements were obtained using a Raytek ST80XXUS infrared (IR) standoff thermometer. At room temperature the average diameter of the tube was 104.902 mm (4.130 in.). The tube section was then submerged in a

liquid nitrogen (LN) bath for approximately 2.5 minutes. The chilled tube section was promptly removed from the LN bath and the diameter of the tube was again measured at the same locations. The temperature of the tube upon removal from the LN bath was unattainable as it surpassed the low end capability of the IR thermometer (-32 to 760 degrees C [-25 to 1400 degrees F]). The theoretical temperature of LN is -195.95 degrees C (-320.71 degrees F). At cold temperatures, the average diameter of the tube was 104.699 mm (4.122 in.). The tube section was allowed to re-equilibrate to room temperature and additional diameter measurements were made. These showed that the average nozzle diameter returned to 104.902 mm (4.130 in.). A full set of diameter data can be viewed in Table 4.1, where data were acquired in descending order from position 5 to 1. Figure 4.9 shows the tube diameter at the three stages of this experiment as a function of axial position: room temperature initial (RT initial), after LN, and room temperature final (RT final). The results from this test indicated that the Alloy 600 tube material shrank an average of 0.203 mm (8 mils) in diameter when chilled with LN and then was restored to its original size after returning to room temperature. The CRDM calibration specimens were designed and machined for a 0.076 -mm (3-mils) diameter interference fit. Tube shrinkage of an additional 0.127 mm (5 mils) provided the necessary room for slipping the machined carbon steel blocks over the tube during mockup assembly. Moreover, it was equally important that the tube return to its original size (at room temperature) in order to create the tight interference fit. This successful preliminary test proved that both necessary requirements could be achieved.

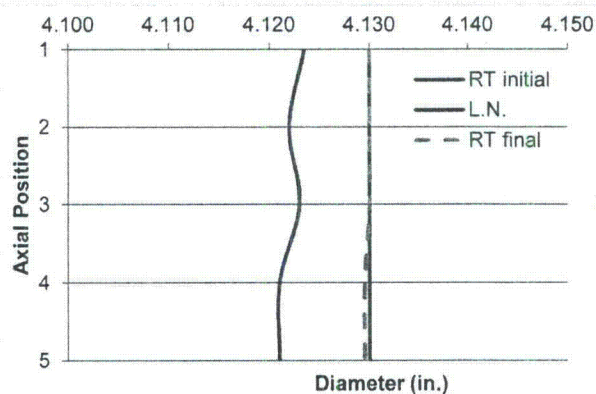
Figure 4.9 Tube Shrinkage Measurements

Temp (F)	Room Temp 73.9		Liquid Nitrogen Unknown		Return to Room Temp 73.9	
	0-180	90-270	0-180	90-270	0-180	90-270
	Diameter (in.)					
1	4.130	4.130	4.122	4.125	4.130	4.130
2	4.130	4.130	4.122	4.122	4.130	4.130
3	4.130	4.130	4.124	4.122	4.130	4.130
4	4.130	4.130	4.120	4.122	4.130	4.129
5	4.130	4.130	4.120	4.122	4.130	4.129
Average:	4.130		4.122		4.130

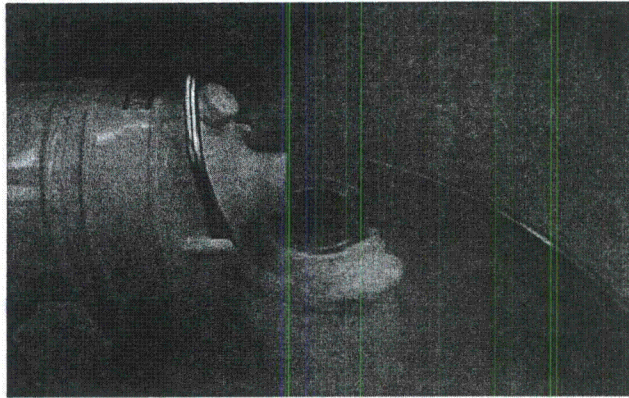
Figure 4.10 Filling Alloy 600 Tube with Liquid Nitrogen

To assemble the mockup, LN was used to shrink the 736.6-mm (29-in.) long Alloy 600 tube. As the tube rested vertically in a stainless steel secondary containment trough, LN was added in the tube to within 101.6 mm (4 in.) below the top, as shown in Figure 4.10. The LN was contained solely within the tube. A permanent end cap was seal welded at the flange end of the tube to prevent leakage of any LN. Towels were used to assist in insulating the tube to prevent unwanted heat transfer and/or ice formation on the OD of the tube. Once the tube cavity was full of LN, the OD of the tube was monitored until the maximum shrinkage level was achieved. As measured at the top of the tube, a diameter-shrinkage of 8 mils (0.20 mm) was achieved.

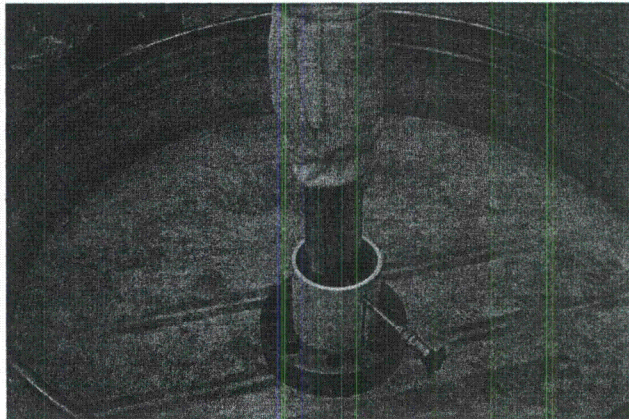
Figure 4.11 PVC Spacer Shown at Bottom of Specimen

The first fit to be made was the lower one with simulated boric acid deposits. Oversized polyvinyl chloride (PVC) piping was cut to length and fitted over the Alloy 600 tube and served as a hard stop for the carbon steel block to rest on while the specimen returned to room temperature, as seen in Figure 4.11. Next, the insulation towels were removed and the machined carbon steel block was hoisted over top of the tube and aligned accordingly. The block was lowered rapidly and slid down the Alloy 600 tube, but came to rest approximately 63.5 mm (2.5 in.) above the targeted resting place. Thus, the boric acid deposits were only under the bottom half of the carbon-steel block. Upon return to room temperature, the PVC piping was no longer needed and was removed.

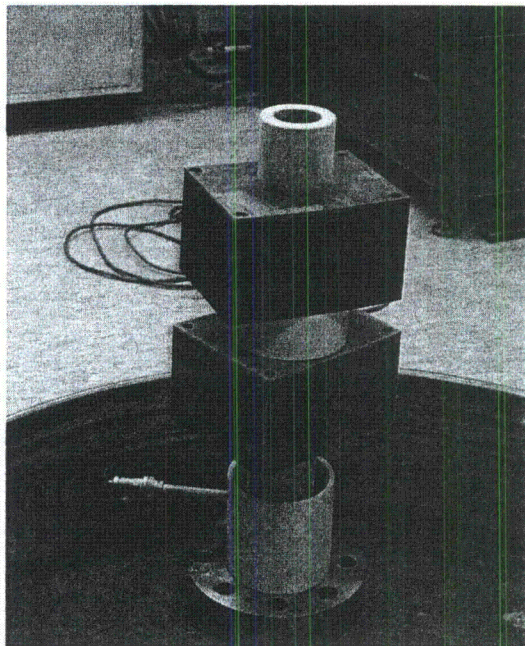
Figure 4.12 Assembled Calibration Specimen

The second interference fit with machined notches was created following a similar protocol. For this fit, it was critical to align the zero degree point of the carbon steel block with the zero degree point stamped on the Alloy 600 tube so as to not overlap the notch patterns created in the two materials. The assembly of this fit went according to plan using the PVC piping separator during assembly to maintain separation between the two fit regions. Figure 4.12 shows the completed and assembled calibration specimen.

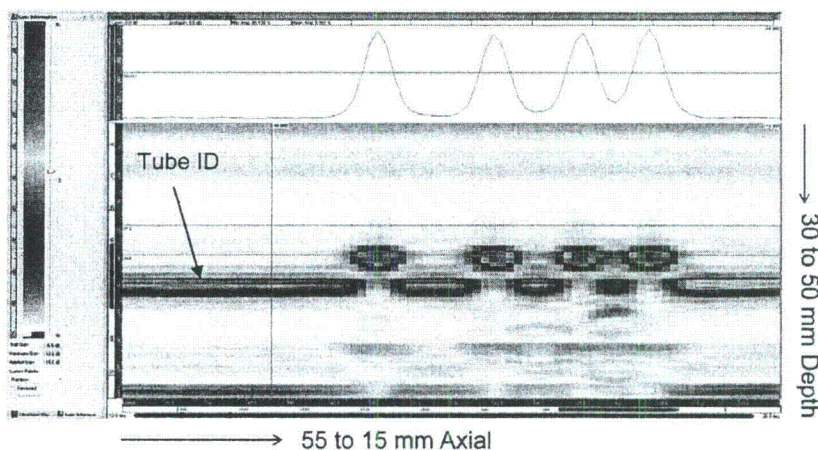
Figure 4.14 D-scan End View of the Axial Resolution Notches in the Inconel Tube

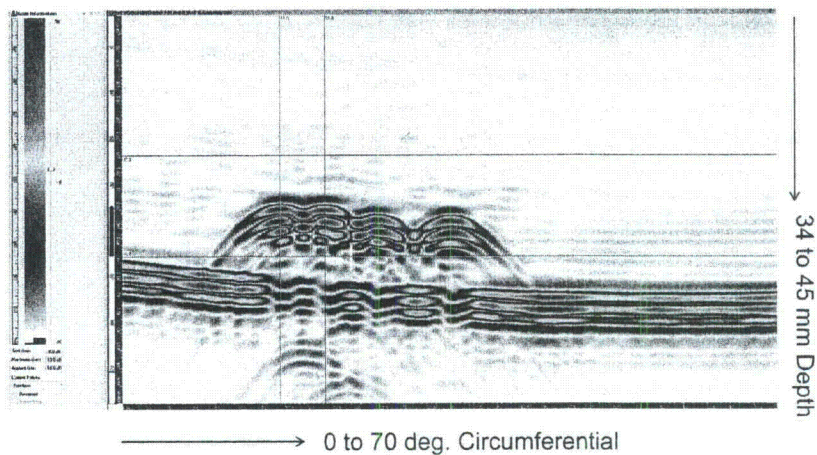
The gated circumferential resolution notch set is shown in Figure 4.15. This image was taken as viewed from the bottom edge in Figure 4.13. Notice that the closely spaced two notches on the left are overlapping but they are still resolvable. Peak-to-peak values gave measured notch separations of 4.36, 5.18, and 6.82 mm (0.17, 0.20, and 0.27 in.), respectively. The actual separations were 4.06, 5.08, and 7.11 mm (0.16, 0.20, and 0.28 in.), respectively. This is greater error than was observed for the axial direction. This test demonstrated a circumferential probe resolution of approximately 4.4 mm (0.17 in.).

Figure 4.15 B-scan Side View of the Circumferential Resolution Notches in the Inconel Tube

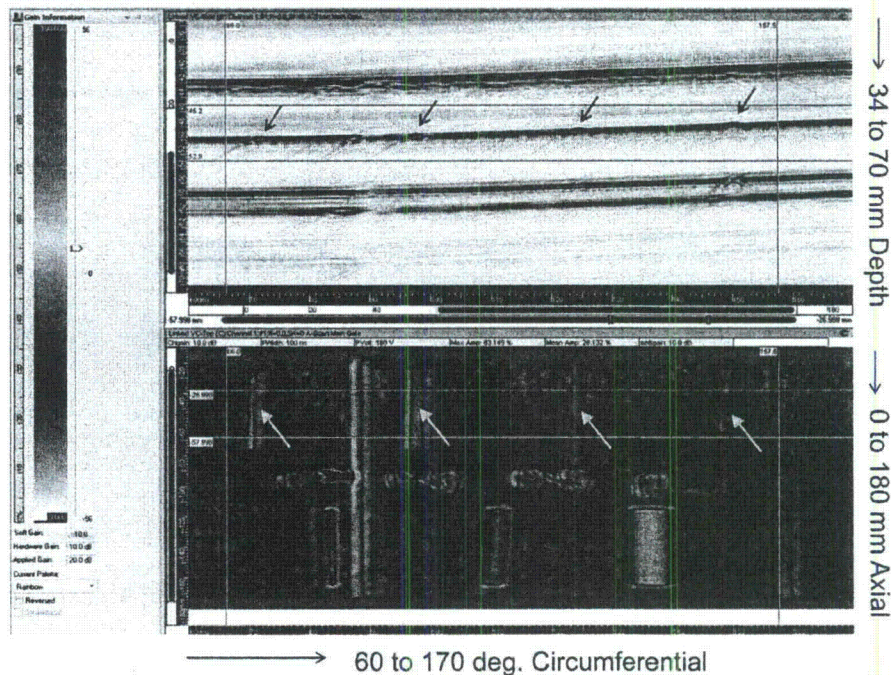
Figure 4.16 The Second Echo is Gated in the Side View Image in the Top of Figure with the Horizontal Lines. The corresponding C-scan top view is displayed in the bottom image. This second echo captures a disturbance in the back-wall echo showing some depth information, noted by the red arrows at top.

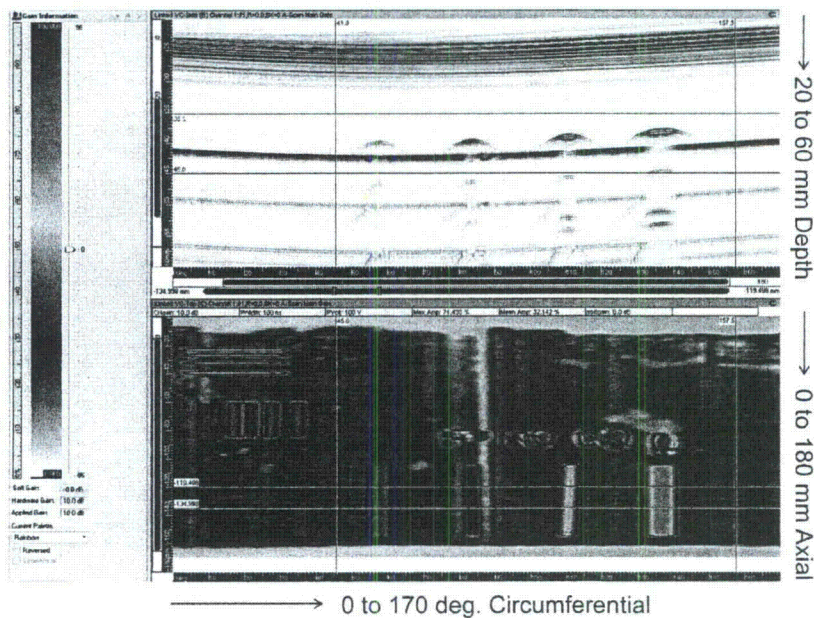
In summary, the system resolution for defects as represented by notches in the Alloy 600 tube was better than 4 mm (0.16 in.) in the axial direction and 4.4 mm (0.17 in.) or greater in the circumferential direction. The depth or range resolution notches, as small as 0.028 mm (0.0011 in.), were beyond the system limits for depth sizing but the notches were detected. Range resolution was estimated at 1 mm (0.039 in.). Notches as narrow as 0.80 mm (0.031 in.) in the circumferential direction were detected and sized but the limits were somewhat dependent on the machining marks and other anomalies in the materials and interference fit that also gave ultrasonic indications.

Figure 4.17 B-scan Side View on Top and C-scan Plan View on Bottom of the Width Varying Notches in the Inconel Tube

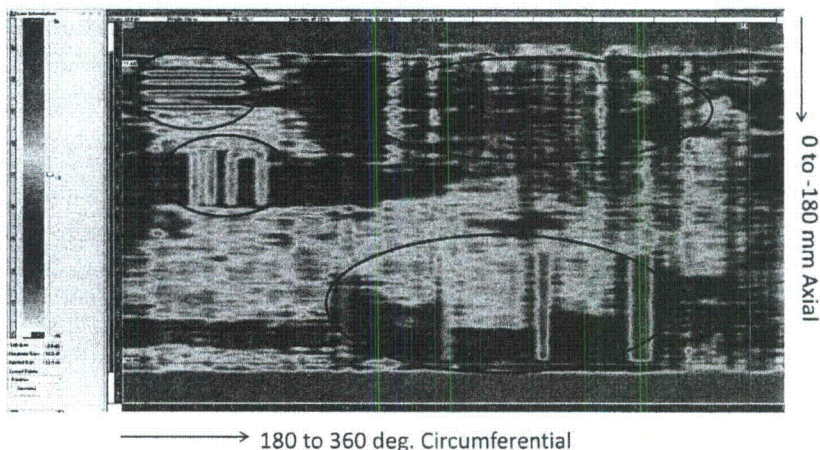
The 180–360 degree portion of the upper fit region in the CRDM mockup contained notches in the carbon steel block to simulate degradation or wastage of the RPV head material. These notches were on the far side of the interference fit relative to the location of the probe. Because the interference fit was not uniform, the notch responses were not as clear as those for notches in the tube, as evident in Figure 4.18.

Figure 4.18 C-scan Plan View of the Notches in the Carbon Steel from the First Ultrasonic Echo

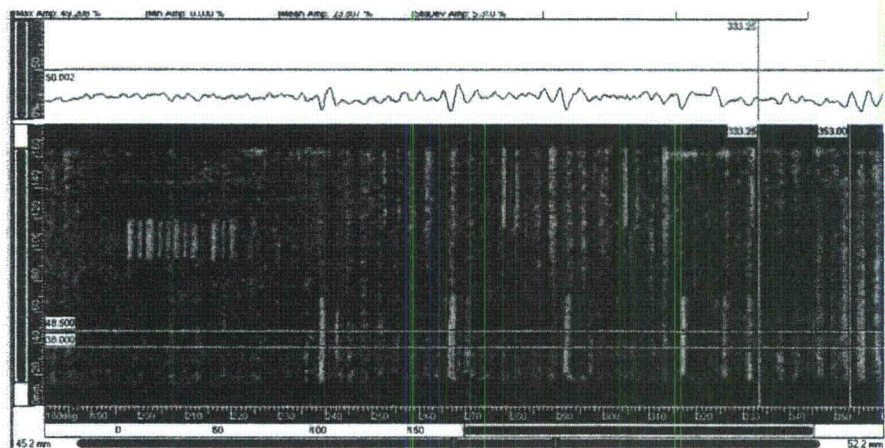
Figure 4.21 C-scan Plan View of the Width Notches in Carbon Steel, on the Bottom. This image was acquired from the second ultrasonic echo.

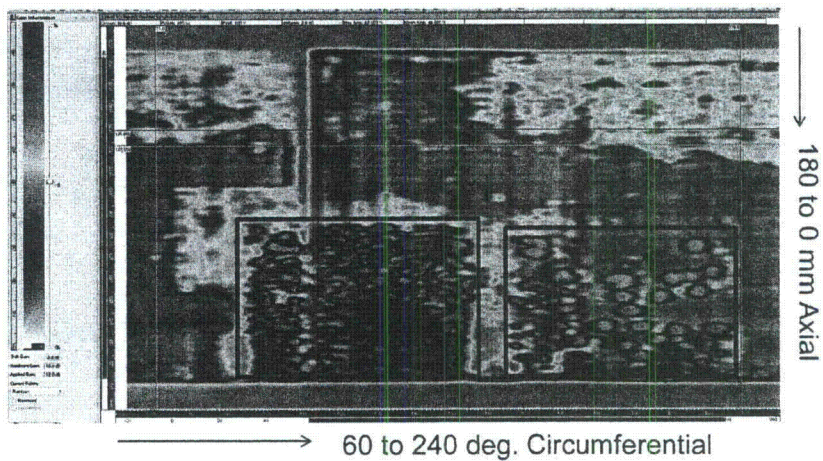
Figure 4.22 C-scan Plan View of the Boric Acid Deposits in the Lower Interference Fit Region. The horizontal axis represents the circumferential range of 60–240 degrees. This image is from the first ultrasonic echo.

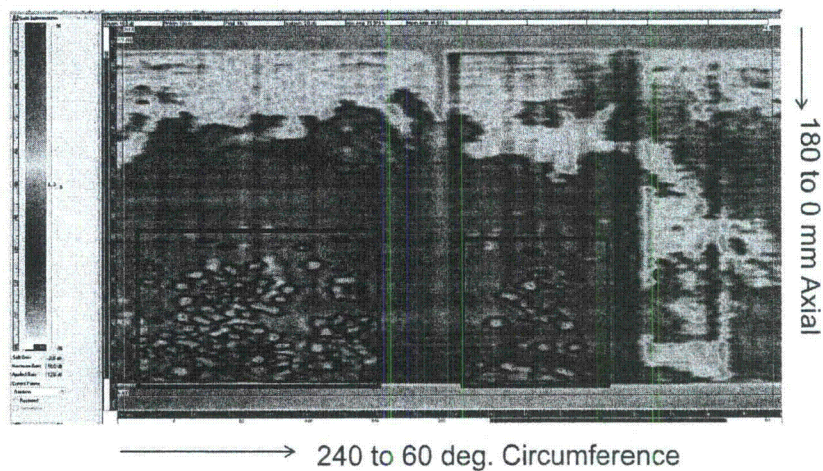
Figure 4.23 C-scan Plan View of the Boric Acid Deposits in the Lower Interference Fit Region. The horizontal axis represents the circumferential range of 240–60 degrees. This image is from the first ultrasonic echo.

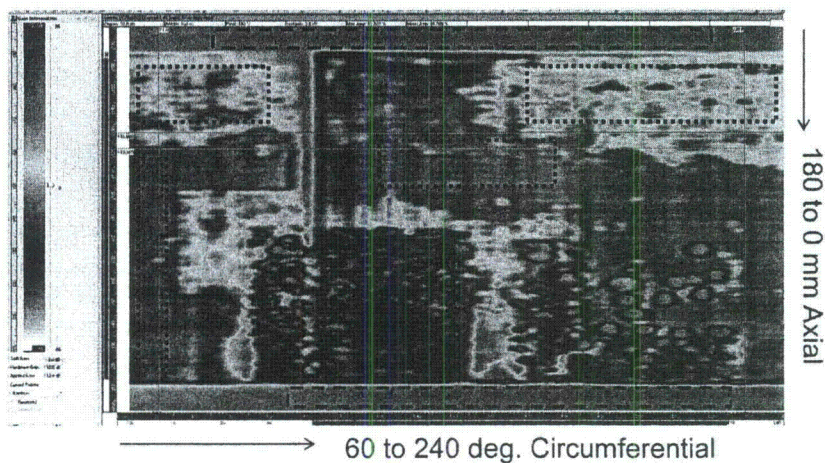
Figure 4.24 The Interference Fit Region Containing Boric Acid is Subdivided into Three Regions. The red box represents the presence of boric acid in the interference fit region, the black dashed boxes represent the tube region, and the black dotted boxes represent the interference fit region.

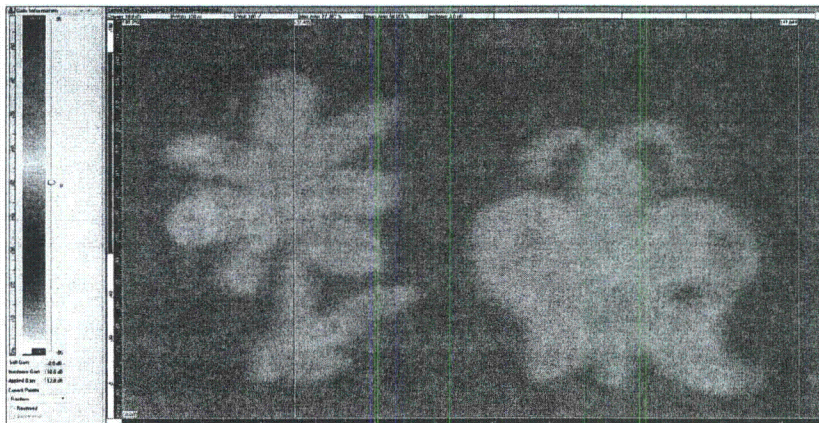
Figure 4.25 Putty on a Nozzle Outer Surface is Detected. The horizontal axis represents 250 mm (9.8 in.) and the vertical axis represents 90 mm (3.5 in.).

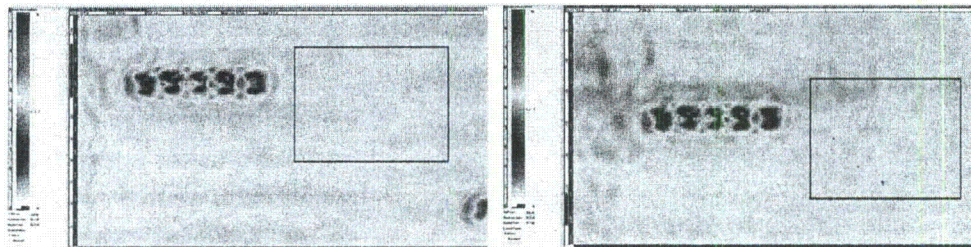
Figure 5.1 Calibration Data on the Blank Nozzle Piece Before (left) and After (right) Transport to RPL/33. The horizontal axis represents 150 degrees of circumference and the vertical axis represents 50 mm (1.97 in.) in the axial direction in each image.

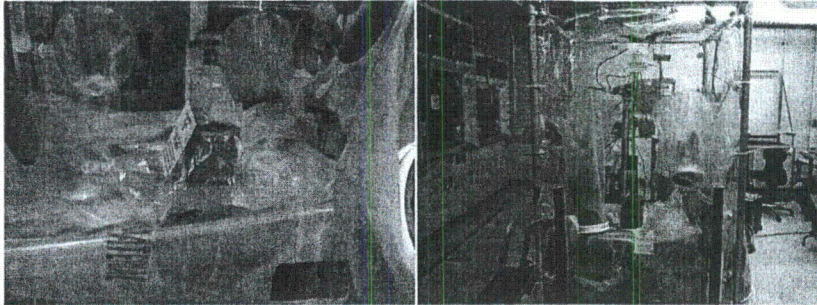
Figure 5.2 Dry Side of Nozzle 63 Prior to Scanner Mounting (left); Scanner Mounted on the Nozzle in the Glove Bag (right)

After equipment verification, the scanner was placed on Nozzle 63 in the glove bag as depicted in Figure 5.2 and diagrammed in Figure 5.3. The wetted side of the nozzle assembly was facing down. A plug was inserted in the wetted side of the nozzle several months earlier. At that time the nozzle was removed from storage and the length of nozzle extending above the reactor pressure vessel (RPV) head material (dry side) was shortened to give easier access to the interference fit region and for easier maneuvering of the nozzle/head assembly. Water was added several days prior to mounting the scanner on the nozzle. With the scanner in place, the glove bag was examined for any leakage points in the bag walls and glove ports. No leaks were

found and the glove bag was sealed. Any materials entering the glove bag from this point forward were passed through an access port in the bag wall.

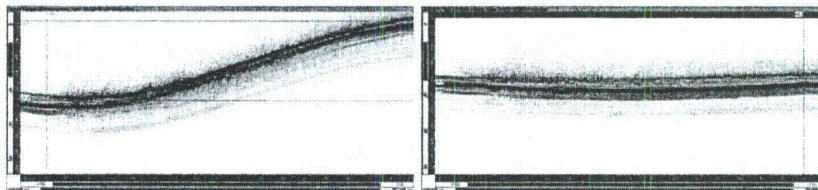
Figure 5.4 Alloy 600 Tube ID Response Before (left) and After (right) Centering the Scanner on the Nozzle. The horizontal axis represents approximately 180 degree and the vertical axis 20 mm (0.79 in.).

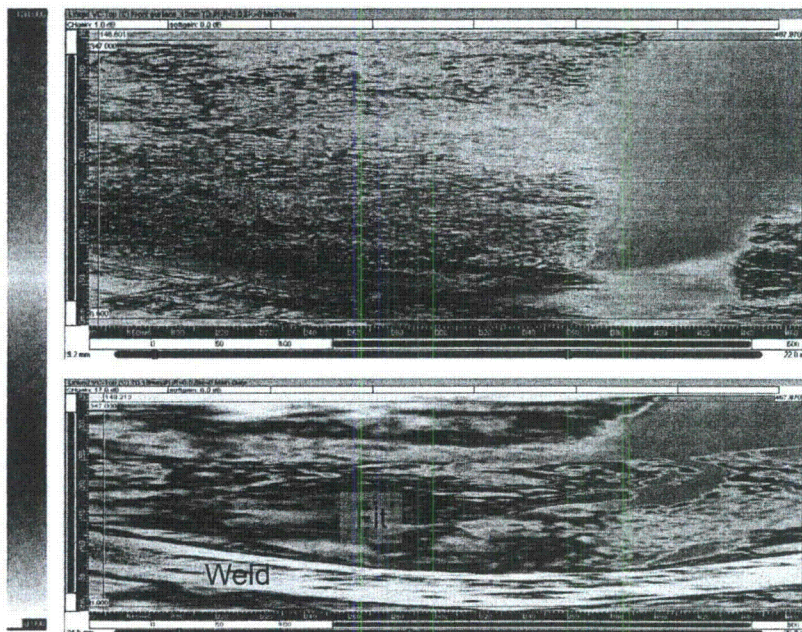
Figure 5.5 First PA Ultrasonic Data from Nozzle 63. The front surface or nozzle ID echo is on the top and the interference fit echo on the bottom. The horizontal axis represents the 86 to 274 degree area and the vertical axis represents 360 mm (14.17 in.). The color scale is represented on the far left.

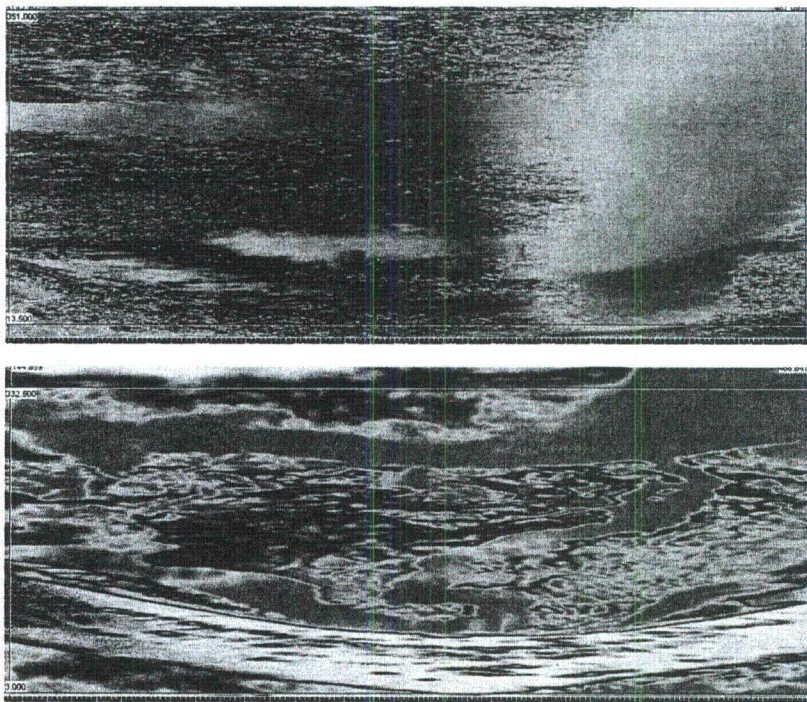
Figure 5.6 PA Ultrasonic Data from Nozzle 63 Acquired After Cleaning the Probe Face. The front surface or nozzle ID echo is on the top and the interference fit echo on the bottom. The horizontal axis represents the 86 to 274 degree area and the vertical axis represents 360 mm (14.17 in.).

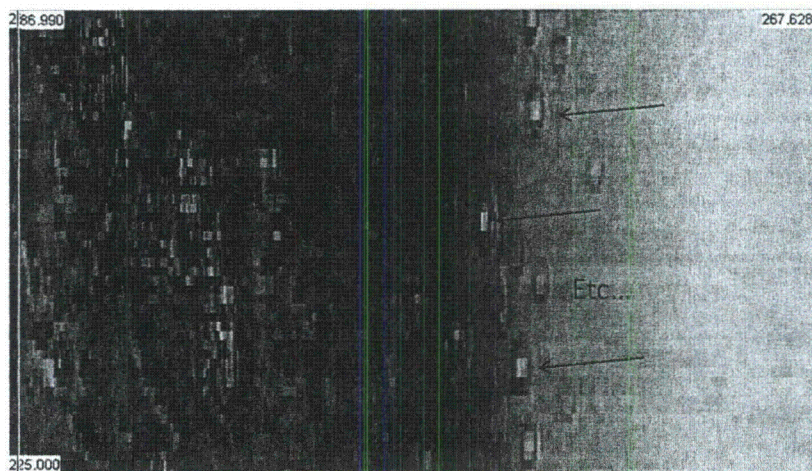
Figure 5.7 Bubbles are Detected on the ID of the Nozzle, some of which are Indicated by Arrows. The vertical axis represents 25 mm (0.98 in.) and the horizontal axis represents 190 degrees.
