**Ultrasonic Phased Array
Assessment of the Interference
Fit and Leak Path of the
North Anna Unit 2 Control Rod
Drive Mechanism Nozzle 63 with
Destructive Validation**

Prepared by
S. L. Crawford, A. D. Cinson, P. J. MacFarlan, B. D. Hanson,
R. A. Mathews

Pacific Northwest National Laboratory
P.O. Box 999
Richland, WA 99352

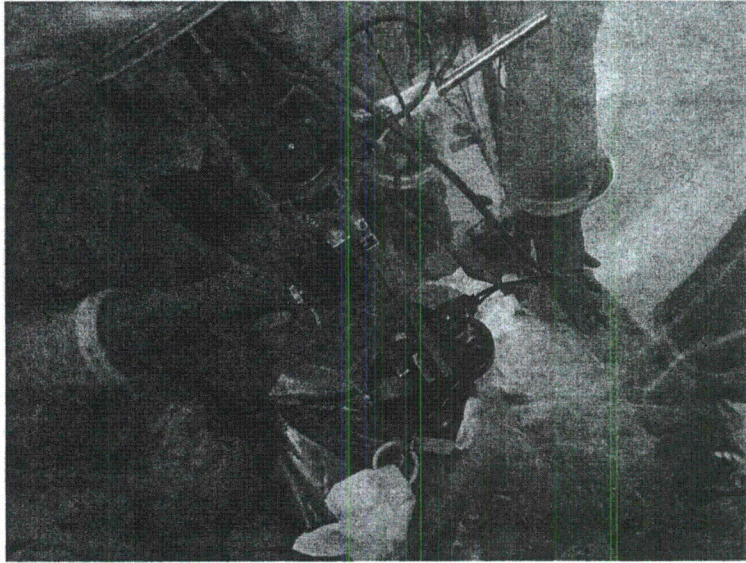
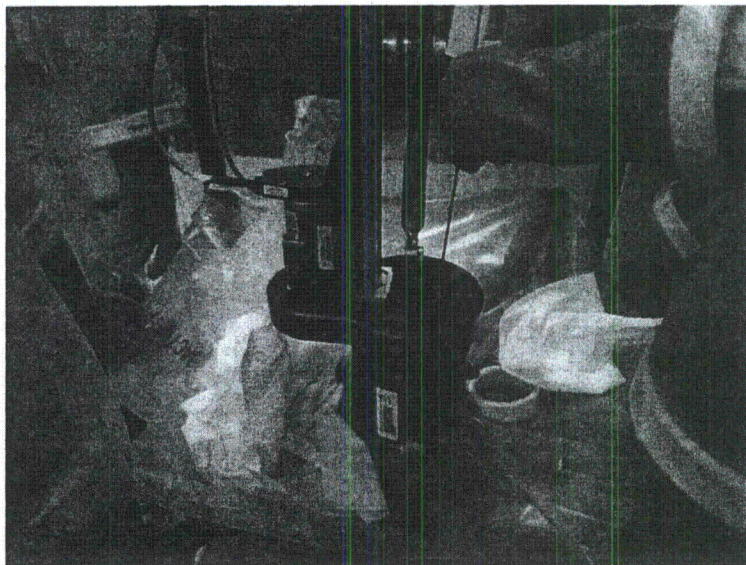
Figure 5.8 Brush Used to Remove Surface Bubbles (top); Brushing in Progress (bottom)

After this second scan attempt, it was decided to brush the tube ID surface to remove bubbles but to do it carefully to minimize or avoid introducing new bubbles. The top photo in Figure 5.8 shows the brush being inserted past the probe and into the nozzle. The bottom photo is another view of the manual brushing process. The data acquired after brushing are shown in Figure 5.9 with the front surface echo on top and the interference fit data on the bottom. Several days later the tube ID was brushed again and data acquired to show repeatability of the data and to attempt to remove any remaining bubbles. These results are depicted in Figure 5.10. As expected, the interference fit image (bottom image) showed nearly uniform amplitude response from the tube OD above the interference fit (orange region at top of image). More bubbles were removed during the second brushing as evidenced by the smoother front surface image on the top in Figure 5.10 as compared to Figure 5.9.

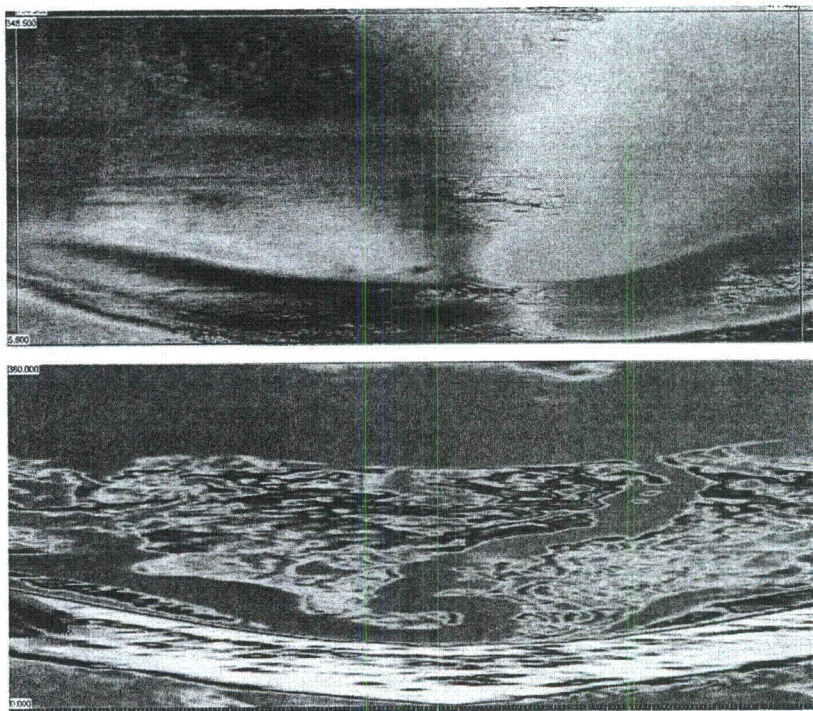
Figure 5.9 PA Ultrasonic Data from Nozzle 63 Acquired After First Brushing of the Nozzle ID. The front surface or nozzle ID echo is on the top and the interference fit echo on the bottom. The horizontal axis represents the 86 to 274 degree area and the vertical axis represents 360 mm (14.17 in.).

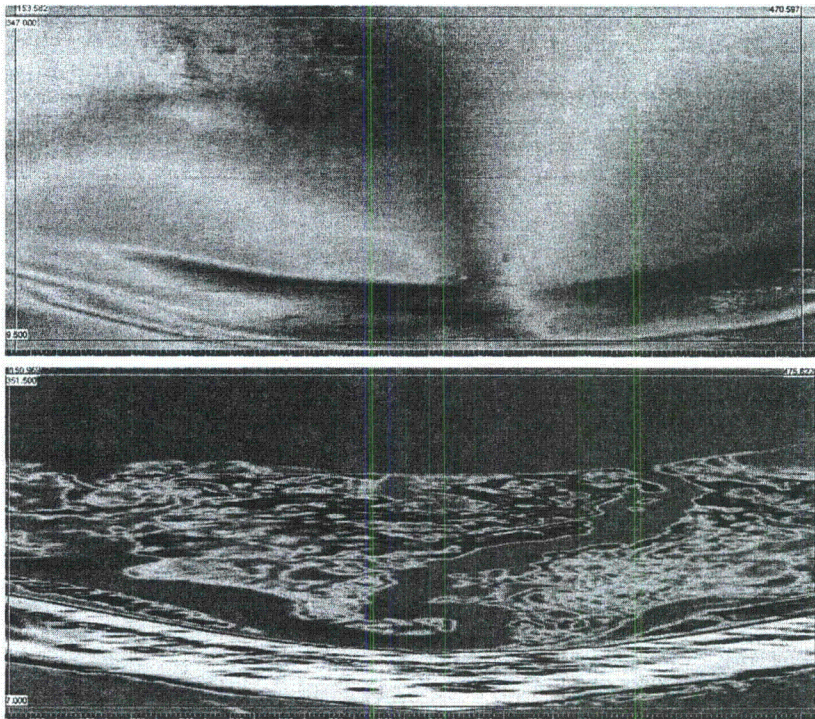
Figure 5.10 PA Ultrasonic Data from Nozzle 63 Acquired After Second Brushing of the Nozzle ID. The front surface or nozzle ID echo is on the top and the interference fit echo on the bottom. The horizontal axis represents the 86 to 274 degree area and the vertical axis represents 360 mm (14.17 in.).

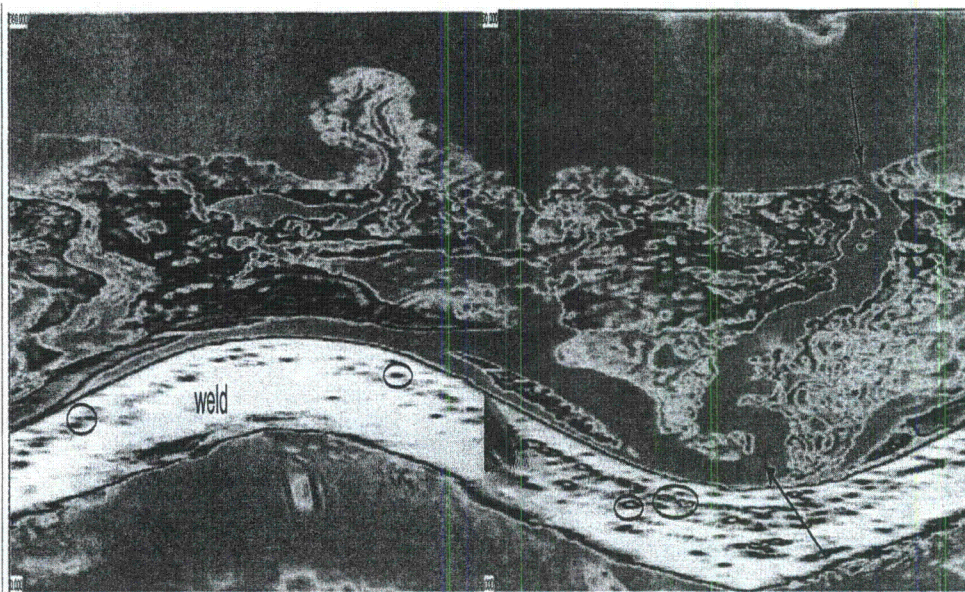
Figure 5.11 PA Ultrasonic Data from the Interference Fit in Nozzle 63 Acquired After the First Brushing of the Nozzle ID. The horizontal axis represents the full 360-degree area and the vertical axis represents 360 mm (14.17 in.).

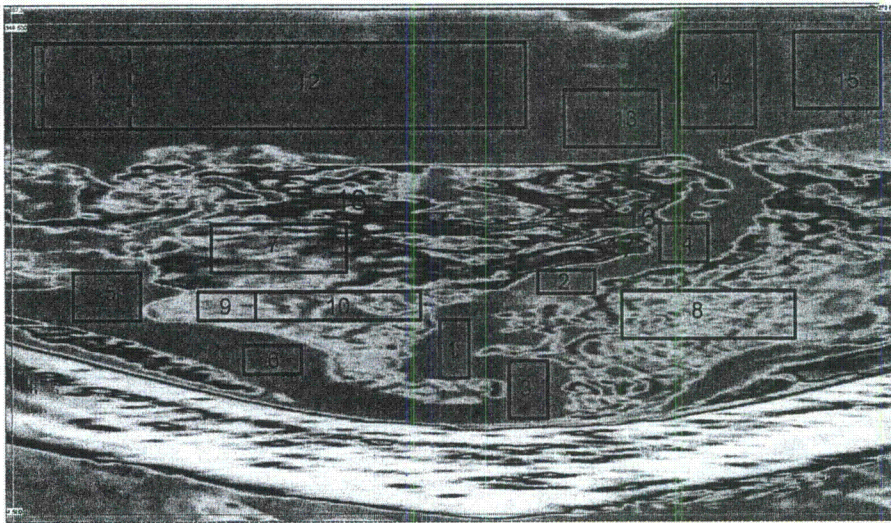
Figure 5.12 Interference Fit Data Image After First Brushing. The horizontal axis represents approximately 90 to 270 degrees. The vertical axis represents 360 mm (14.17 in.).

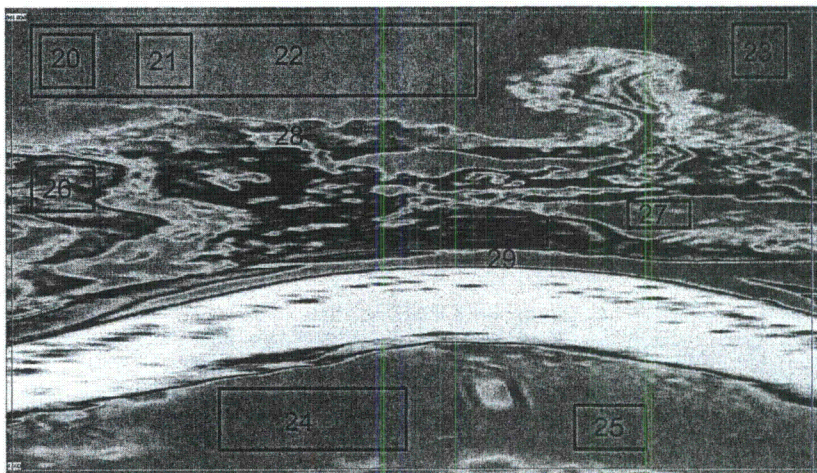
Figure 5.13 Interference Fit Data Image After First Brushing. The horizontal axis represents approximately -90 to $+90$ degrees. The vertical axis represents 360 mm (14.17 in.).

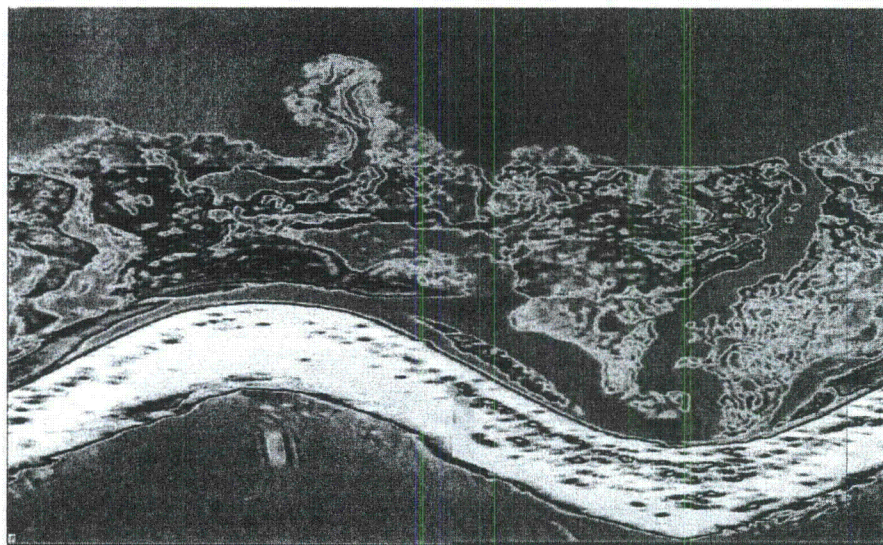
Figure 5.15 Nozzle 63 Interference Fit Data After Second Brushing. The horizontal axis represents -95 to 275 degrees. The vertical axis represents 360 mm (14.27 in.).
