# **Stress Corrosion Crack Growth Response of Alloy 152/52-Carbon Steel Dissimilar Metal Welds in PWR Primary Water**

***Mychailo Toloczko, Matt Olszta, Nicole  
Overman and Steve Bruemmer***

*Pacific Northwest National Laboratory*

*2013 ICG-EAC Meeting*

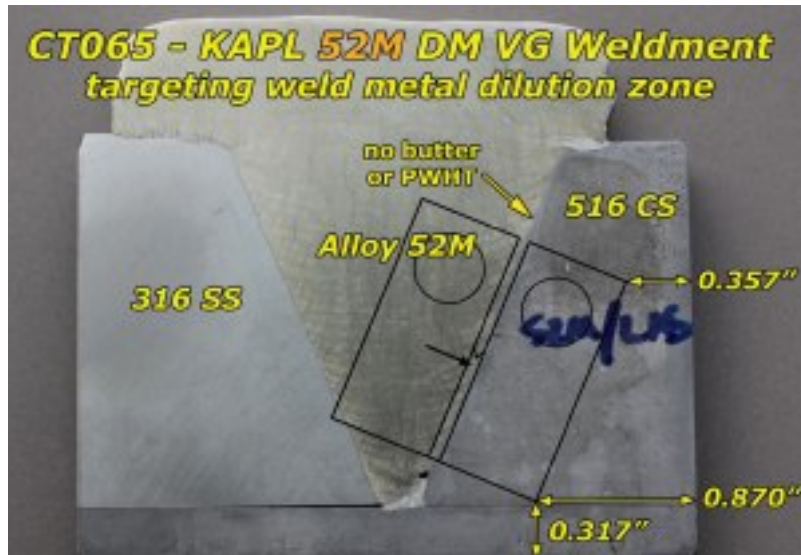
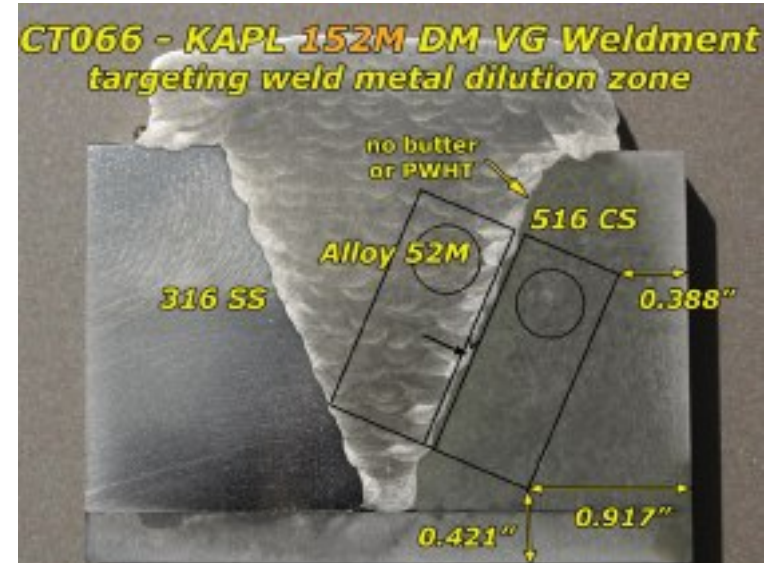
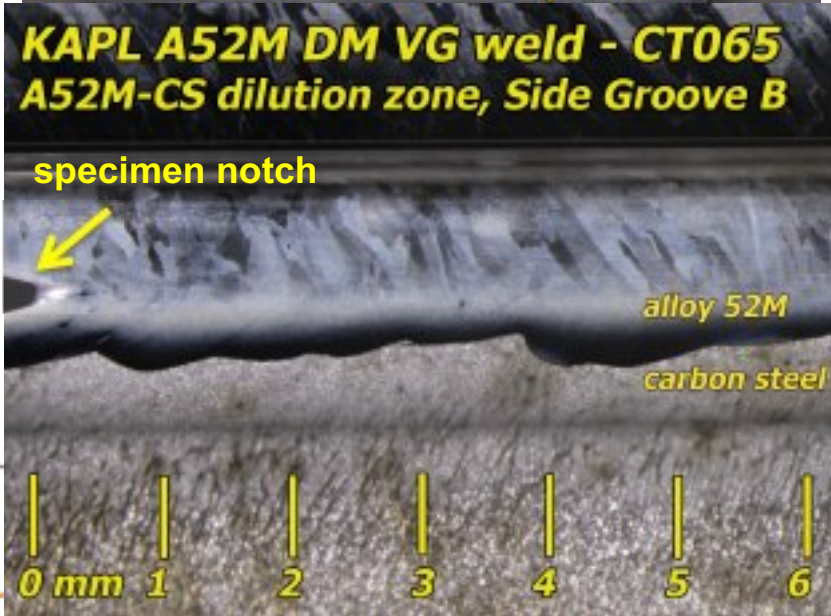
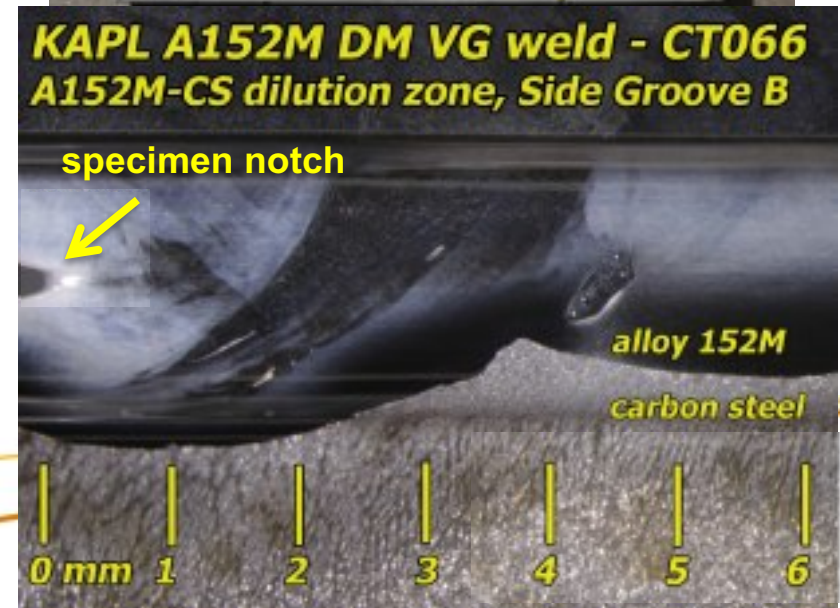
# KAPL 52M/CS (CT065) and 152M/CS (CT066) Dilution Zone Specimens

Goal was to measure weld dilution zone response. ~0.5-1 mm from fusion line.

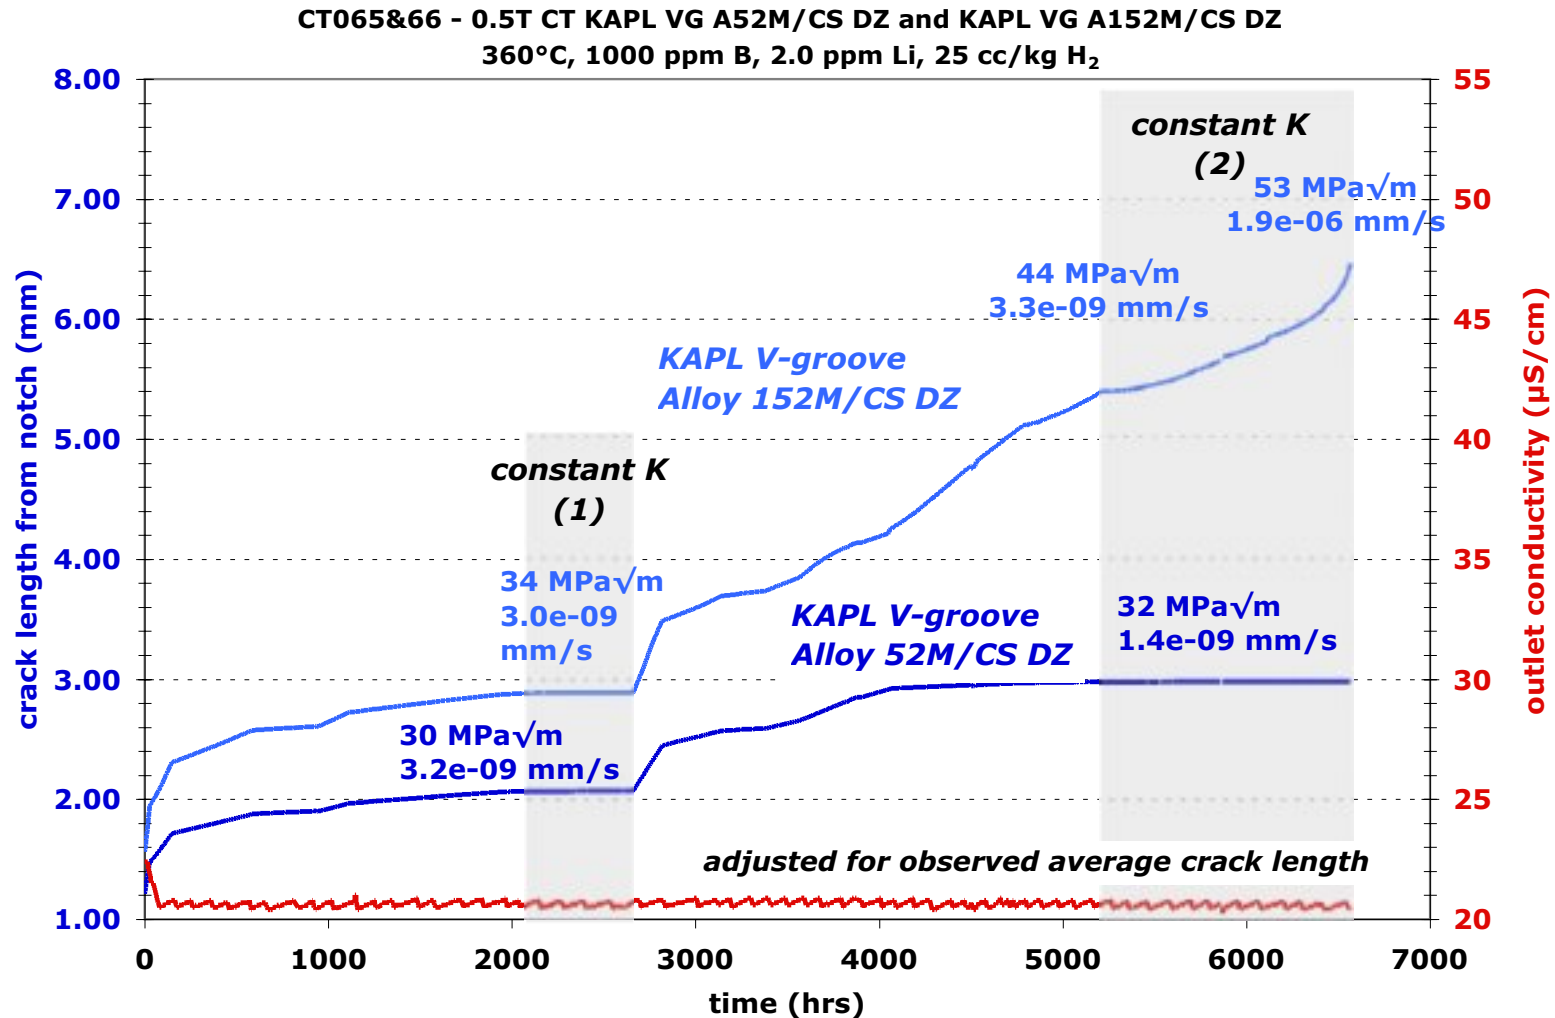
# Overview of Crack Growth Test for KAPL 152M/CS and 52M/CS Specimens

Constant  $K$  response measured twice for the dilution zone specimens with high SCC rates seen for the alloy 152M/CS specimen at high  $K$  levels.

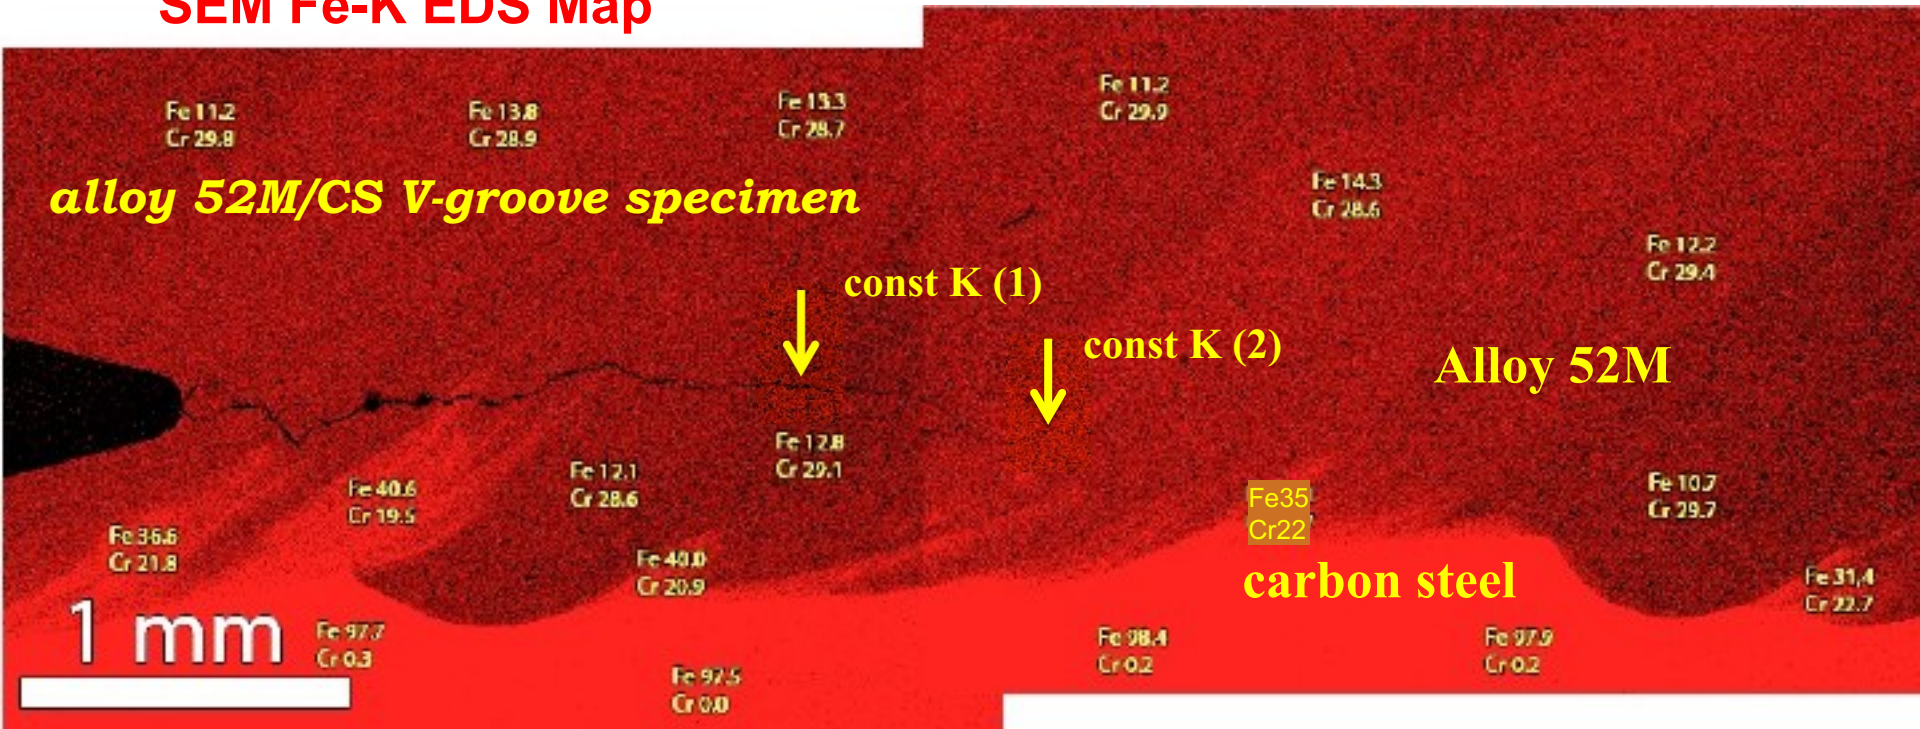
# KAPL Alloy 52M/CS Dilution Zone Specimen CT065: Cross-Section

- **First** and **second** constant  $K$  in 52M/CS take place in regions of little or no chromium dilution.

## SEM Fe-K EDS Map

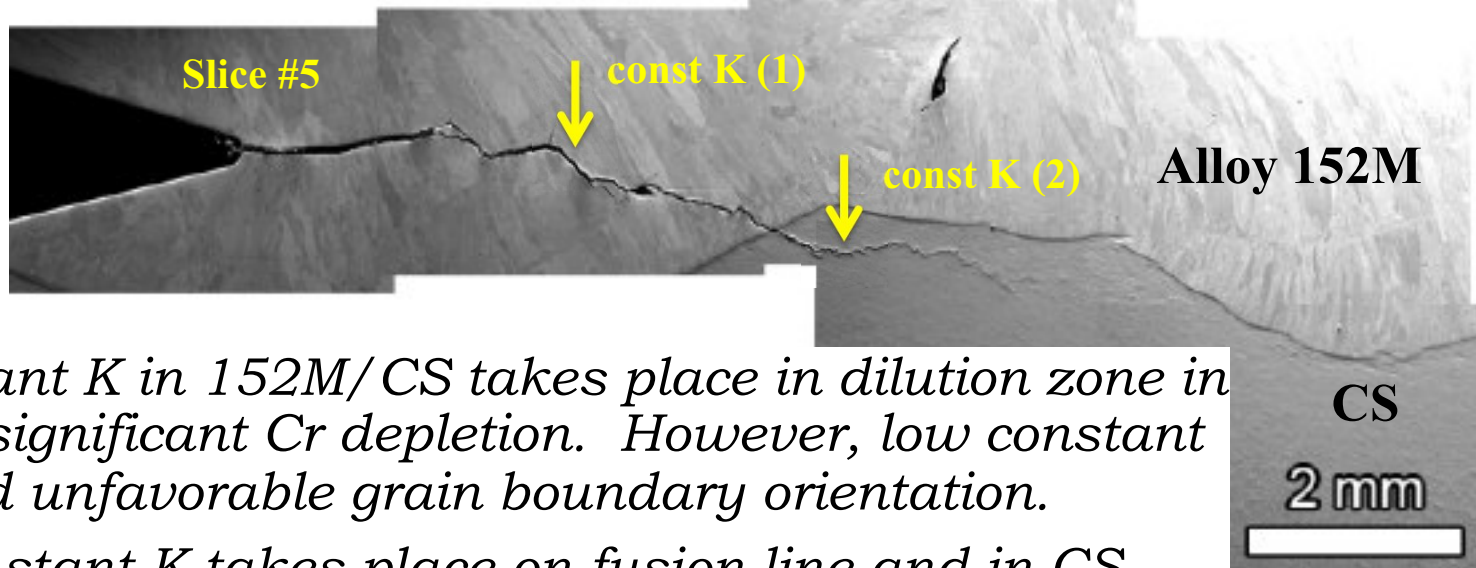
# KAPL Alloy 152M/CS Dilution Zone Specimen CT066: Cross-Section

SEM BSE  
Image

- ▶ **First** constant  $K$  in 152M/CS takes place in dilution zone in a region of significant Cr depletion. However, low constant  $K$  CGRs and unfavorable grain boundary orientation.
- ▶ **Second** constant  $K$  takes place on fusion line and in CS HAZ (depending on location in the specimen.)

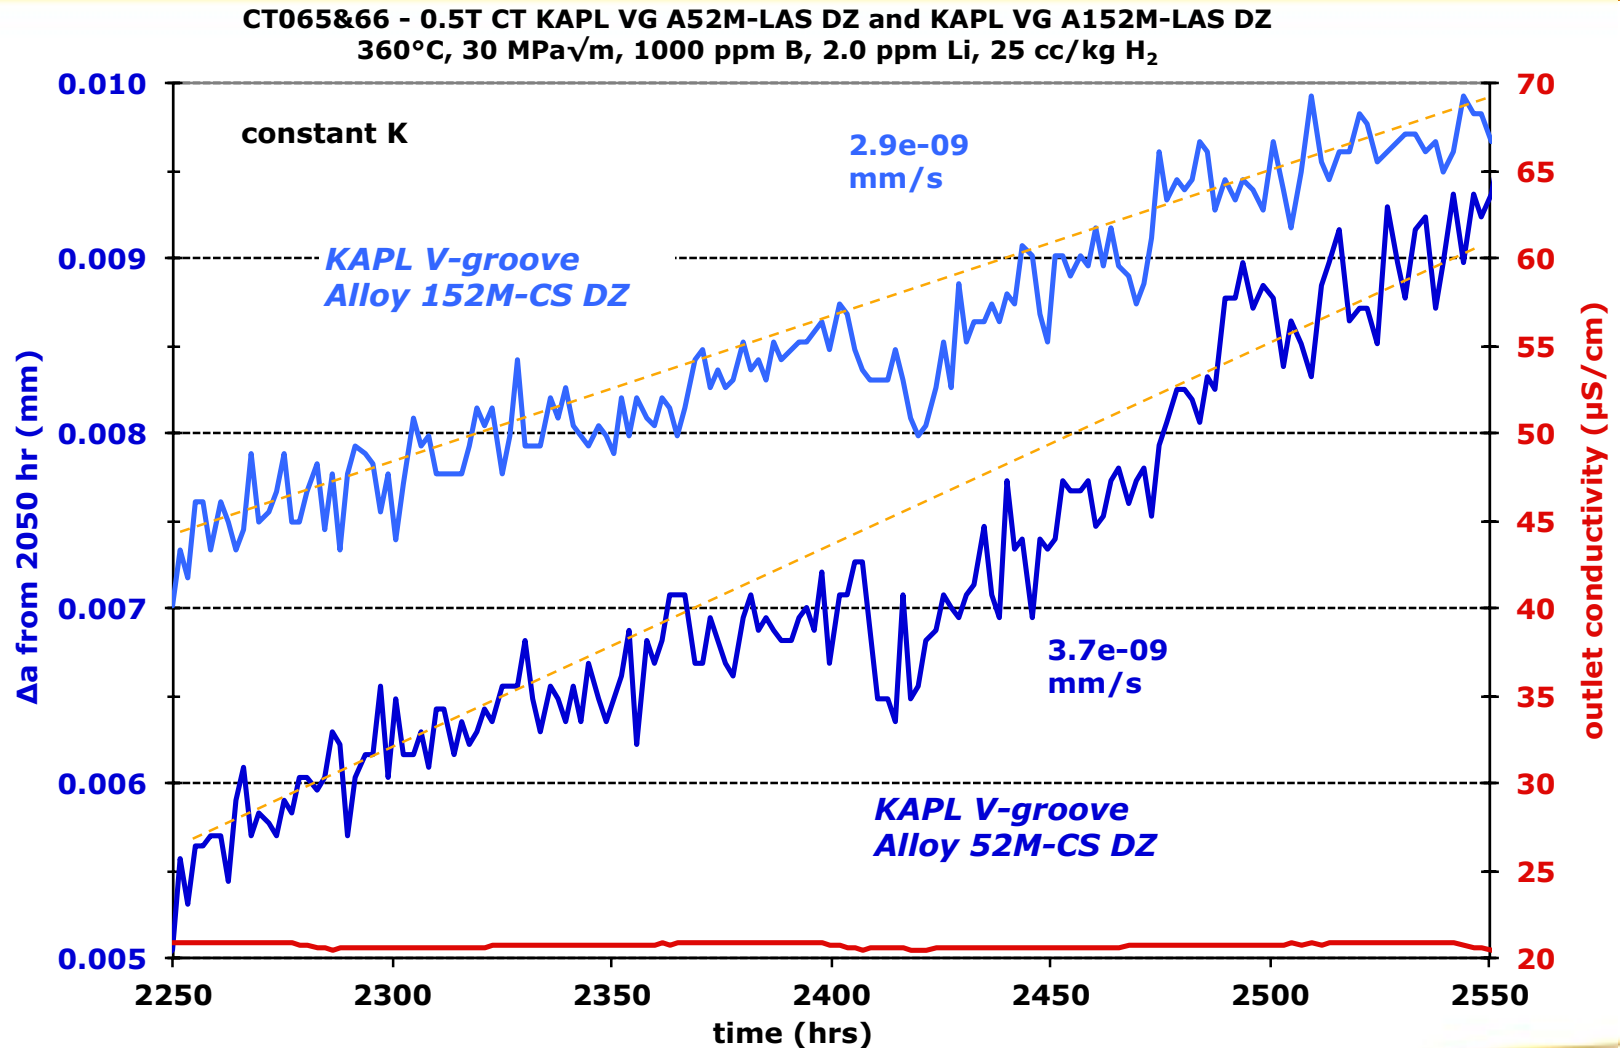
# First Constant K Evaluation of Alloy 52M/CS and 152M/CS Dilution Zone Test Specimens

52M/CS: Within weldment. Minor compositional change.

152M/CS: Within weldment. Significant Fe enrichment and Cr/Ni depletion.

For both specimens, weld GBs are strongly tilted relative to geometric crack path.

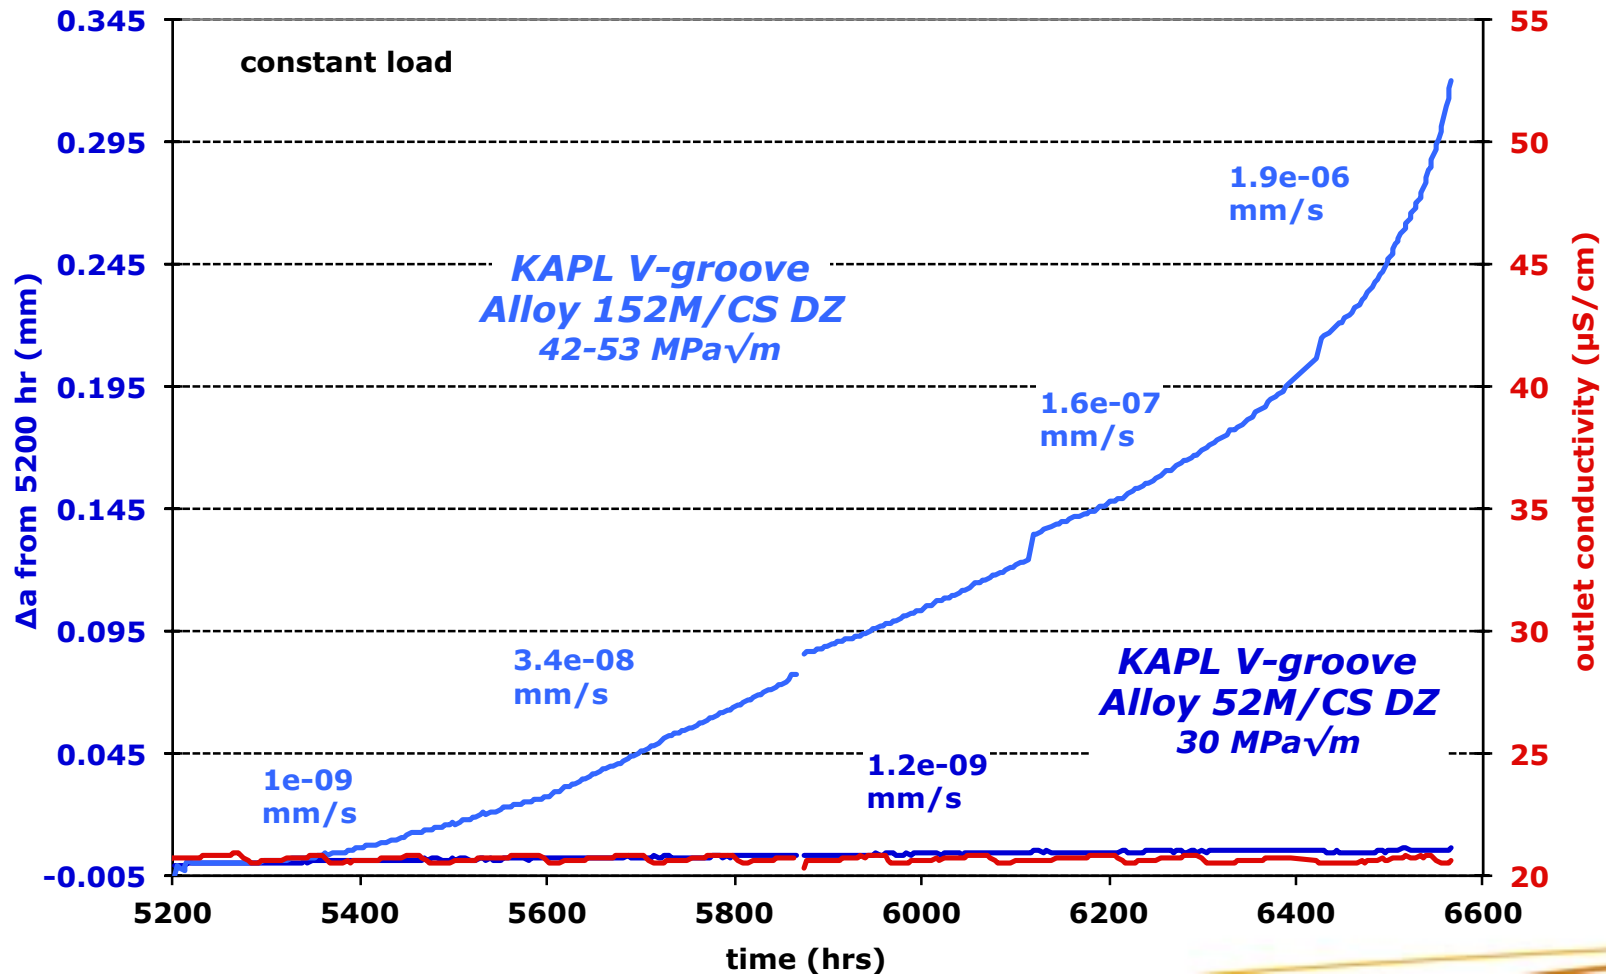
# Second Constant K Evaluation of Alloy 52M/CS and 152M/CS Dilution Zone Test Specimens

CT065&66 - 0.5T CT KAPL VG A52M/CS DZ and KAPL VG A152M/CS DZ  
360°C, 1000 ppm B, 2.0 ppm Li, 25 cc/kg H<sub>2</sub>

52M/CS: Crack is within the weld metal and at lower K, weld GBs tilted.  
152M/CS: Crack is either on fusion line or CS HAZ and at high K.

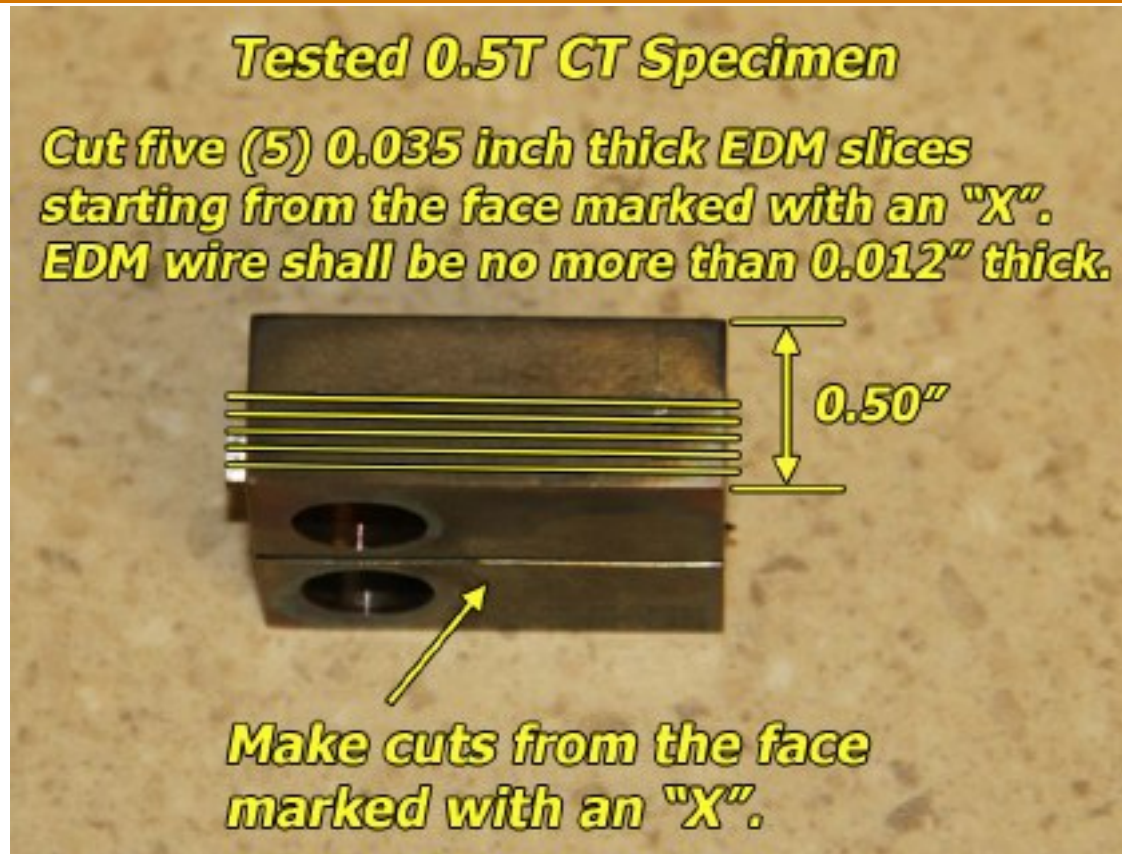
# KAPL Alloy 152M/CS Dilution Zone Specimen CT066: Cross-Sectioning

- *High crack growth rate observed in 152M/CS specimen.*
- *Section half of the width of specimen into 5 slices. Slice #1 is nearest to the sidegroove while slice #5 is at the center of the specimen.*

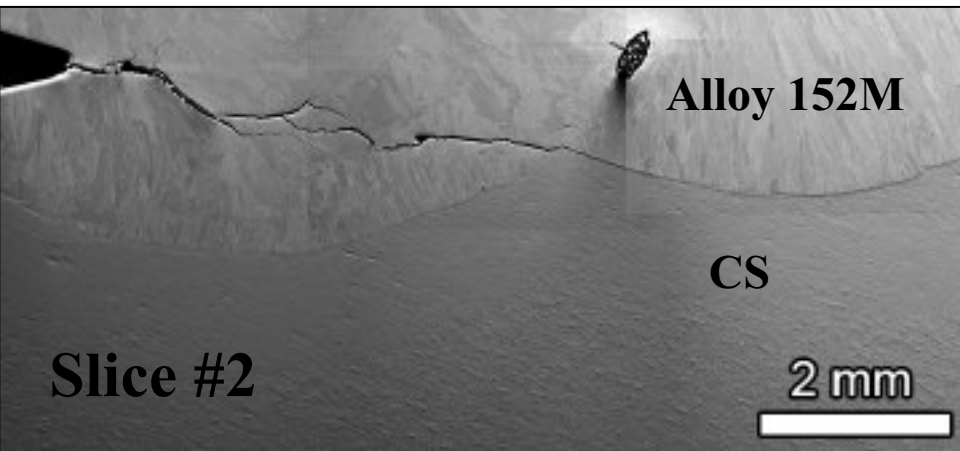
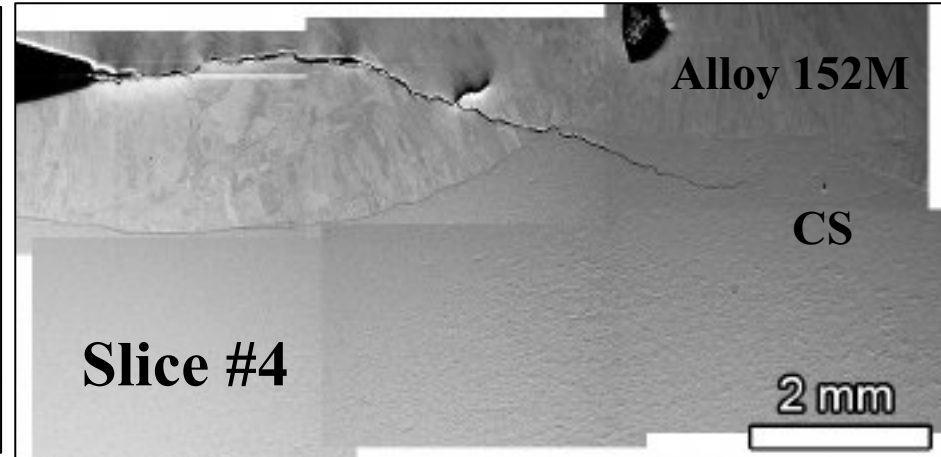
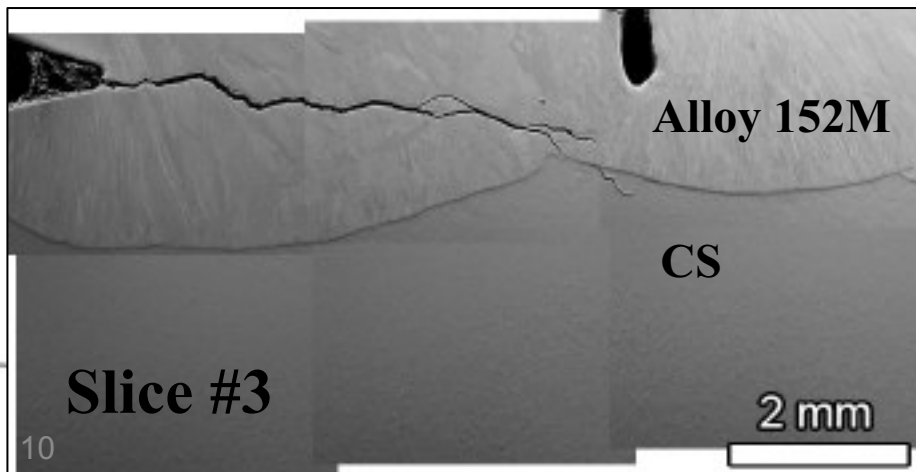
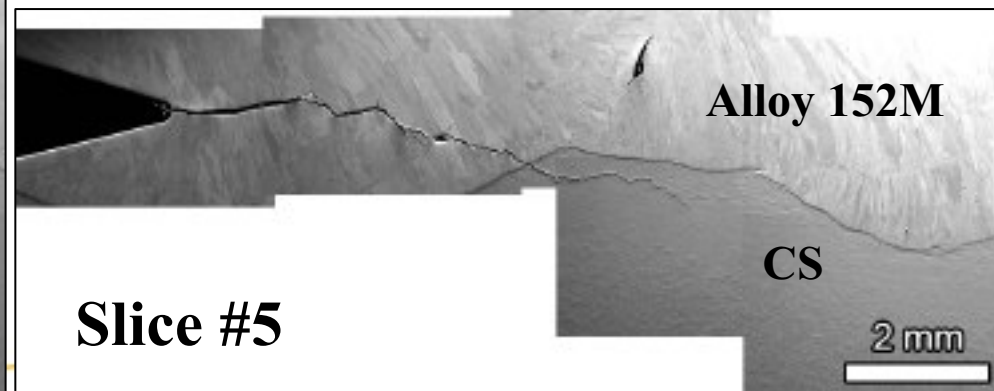
# KAPL Alloy 152M/CS Dilution Zone

- Slice #2 is nearest to sidegroove, and slice #5 is at the center of the specimen.
- Crack starts in alloy 152M weld and propagates toward and into the CS.

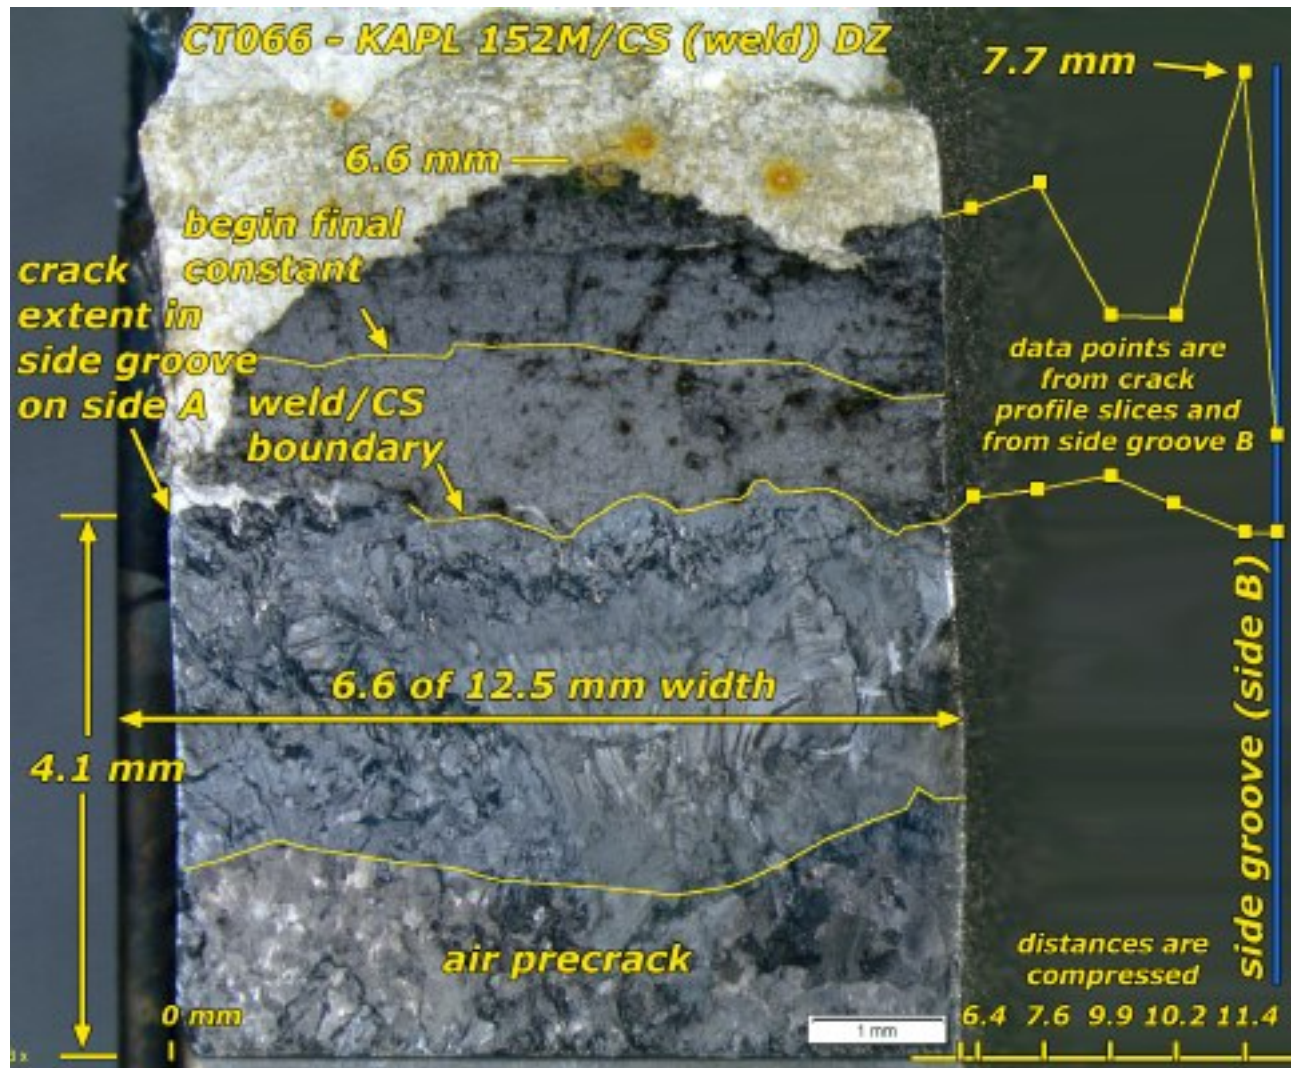
## CT066: Crack Growth Surface

*Extensive SCC growth in carbon steel during final constant load exposure at high K in CT066.*

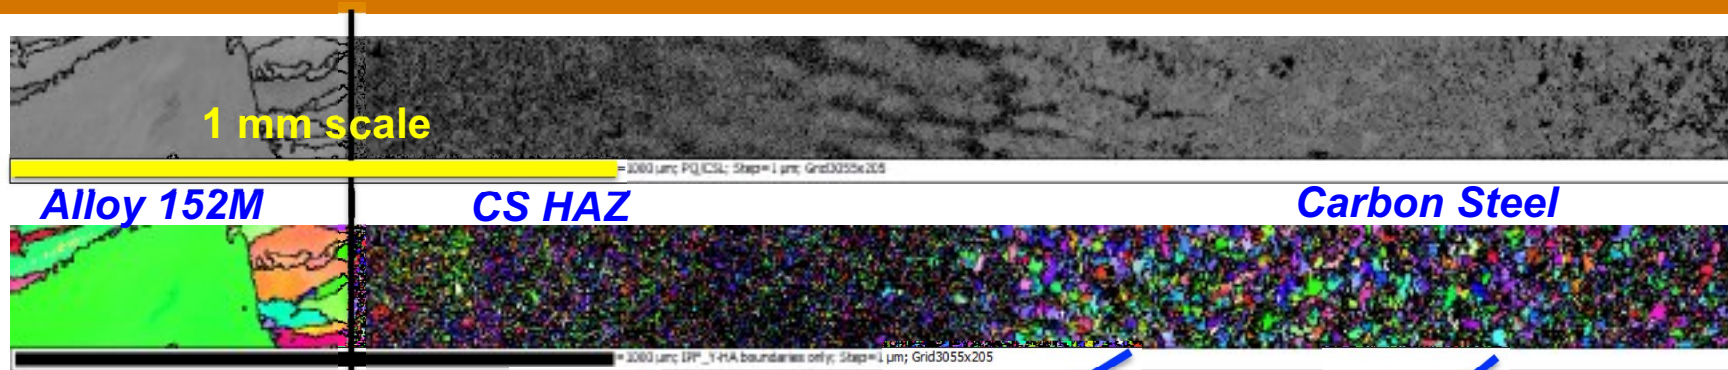
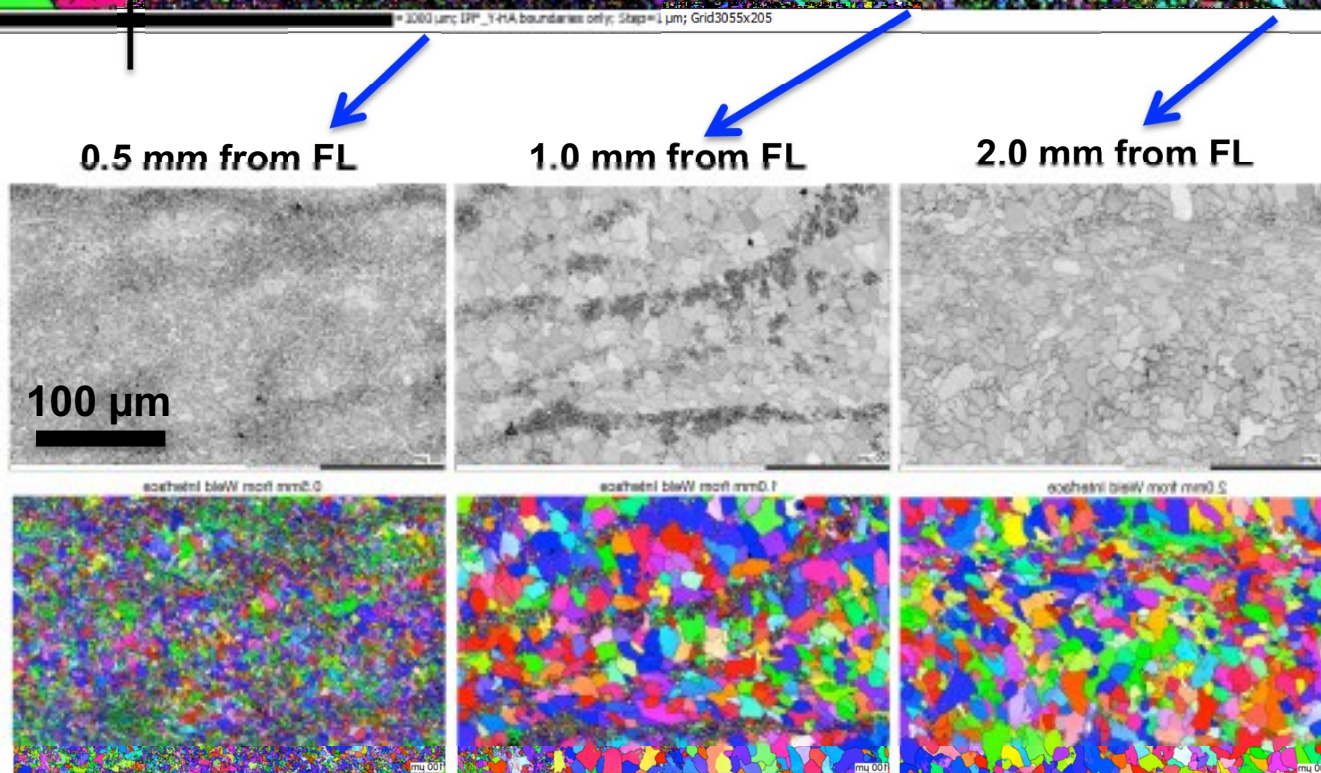
# KAPL Alloy 152M/CS Dilution Zone Specimen CT066: EBSD Cross-Section #5

*EBSD reveals extremely fine grained microstructure  
in CS HAZ within ~1 mm of weld fusion line*

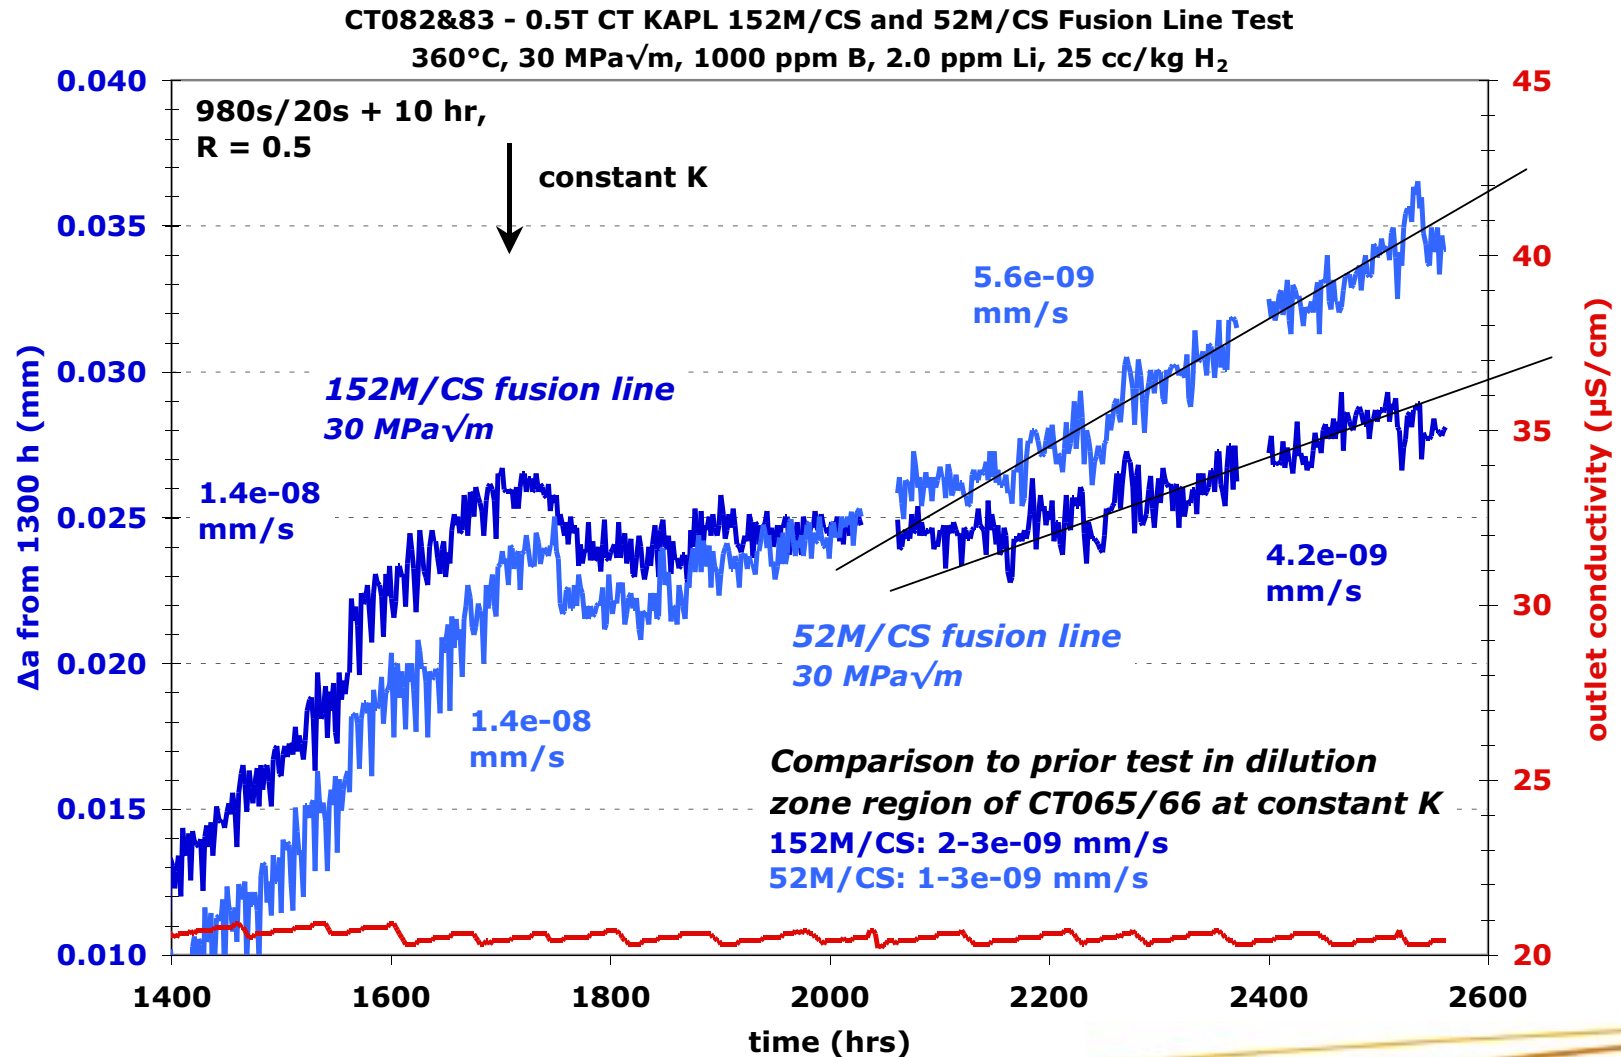
# Ongoing Results on Alloy 152M/CS and 52M/CS Fusion Line Test – $30 \text{ MPa}\sqrt{m}$

*Slightly higher CGRs than in dilution zone evaluation of previous test but lower than fusion line/HAZ response in previous test.  $K$  only  $30 \text{ MPa}\sqrt{m}$ .*

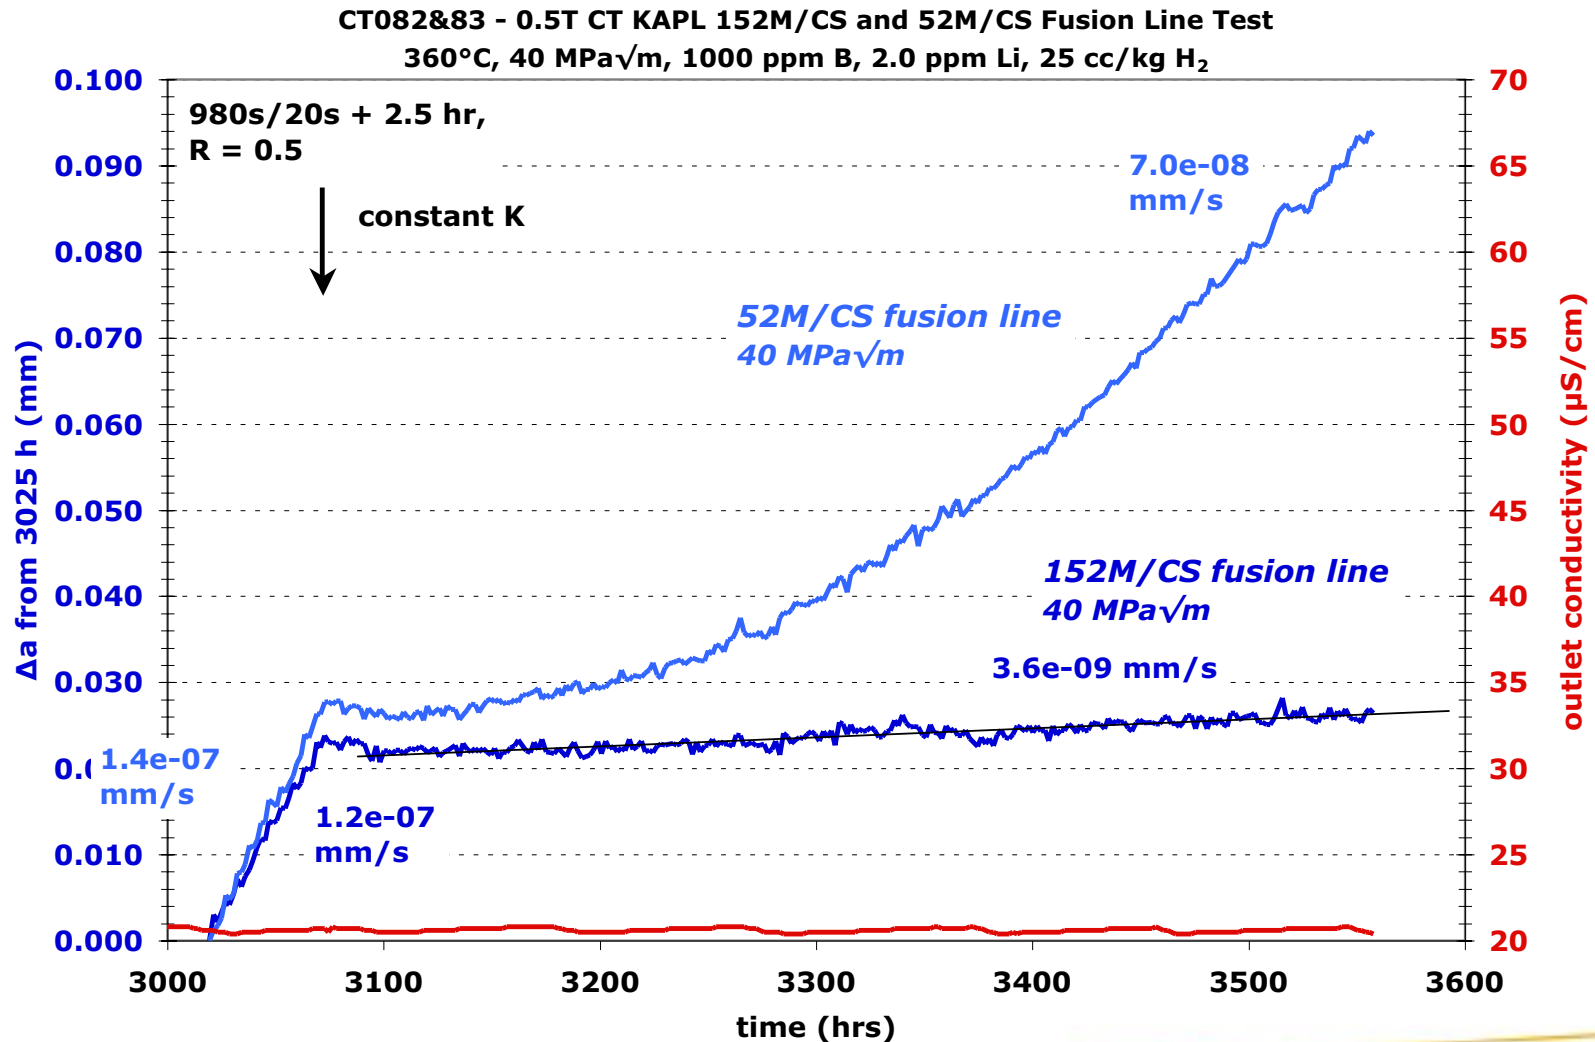
# Ongoing Results on Alloy 152M/CS and 52M/CS Fusion Line Test – $40 \text{ MPa}\sqrt{m}$

- 52M/CS fusion line CGR is 10x higher than at 30 MPa√m, and still increasing.
- 152M/CS specimen CGR is similar to 30 MPa√m. Crack in this specimen is further from the fusion line.
