**SPIE Smart Structures/NDE 2012**

# **Ultrasonic Phased Array Evaluation of Control Rod Drive Mechanism (CRDM) Nozzle Interference Fit and Weld Region NDE Results and Destructive Analysis**

**Pacific Northwest National Laboratory, Richland, WA**

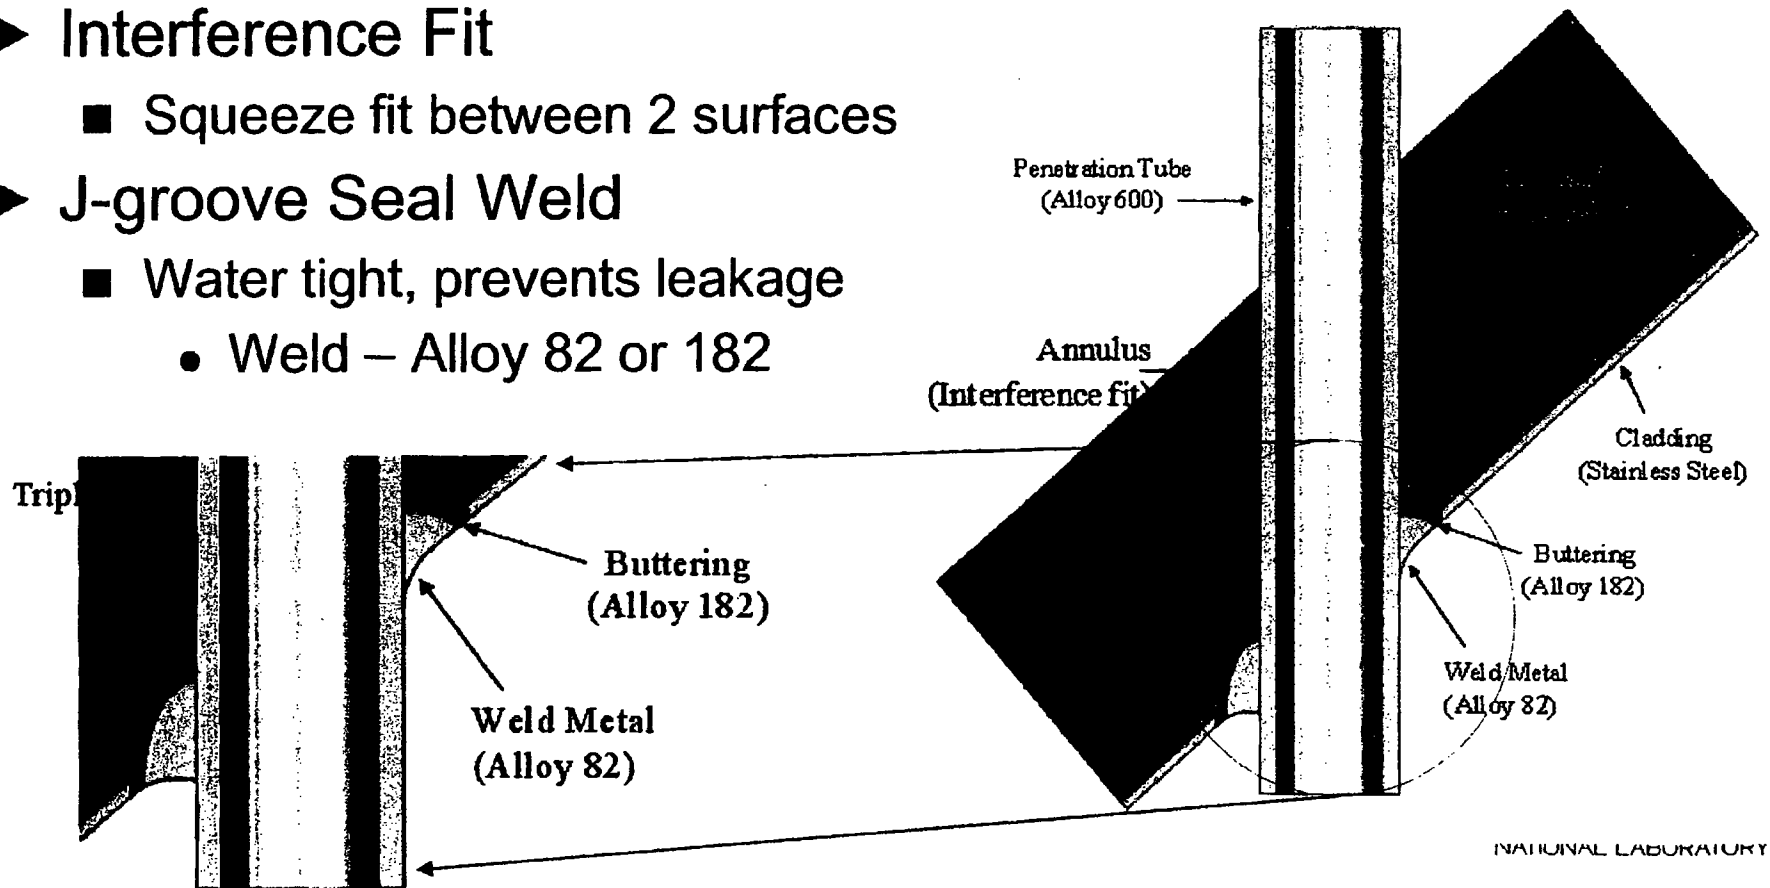
# CRDM Nozzle/Fit/Weld Design

- ▶ Vessel Head Penetration (VHP) nozzle
  - Nickel-based alloy, Alloy 600 (Inconel) tube
  - Low Alloy Steel Reactor Vessel Head (RVH)
  - Interference fit and J-groove weld hold nozzle in place
- ▶ Interference Fit
  - Squeeze fit between 2 surfaces
- ▶ J-groove Seal Weld
  - Water tight, prevents leakage
    - Weld – Alloy 82 or 182

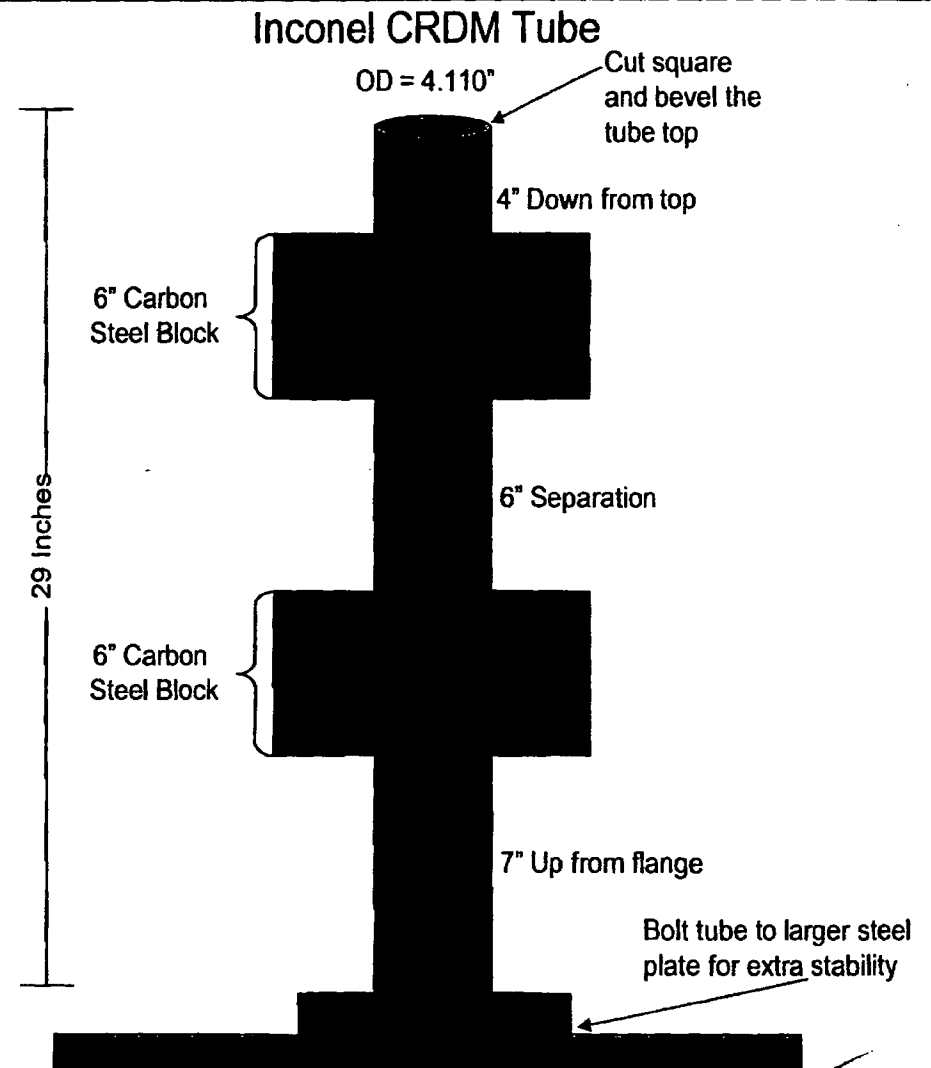
# Mock-up Calibration Specimen Design

- ▶ **Goal: Mimic actual field interference fits**
  - Inconel tubing and RVH material
  - Used similar assembly procedures
    - 3 mil fit
- ▶ **Components:**
  - Inconel tube (OD = 4.110")
  - Two 6" thick carbon steel blocks
    - Machined holes (D = 4.107")
- ▶ **Created 2 fit regions**
  - Boric acid presence
  - Precision EDM notch presence
- ▶ **Designed for specific signal responses**
  - Inspection resolution
  - Leak path characteristics

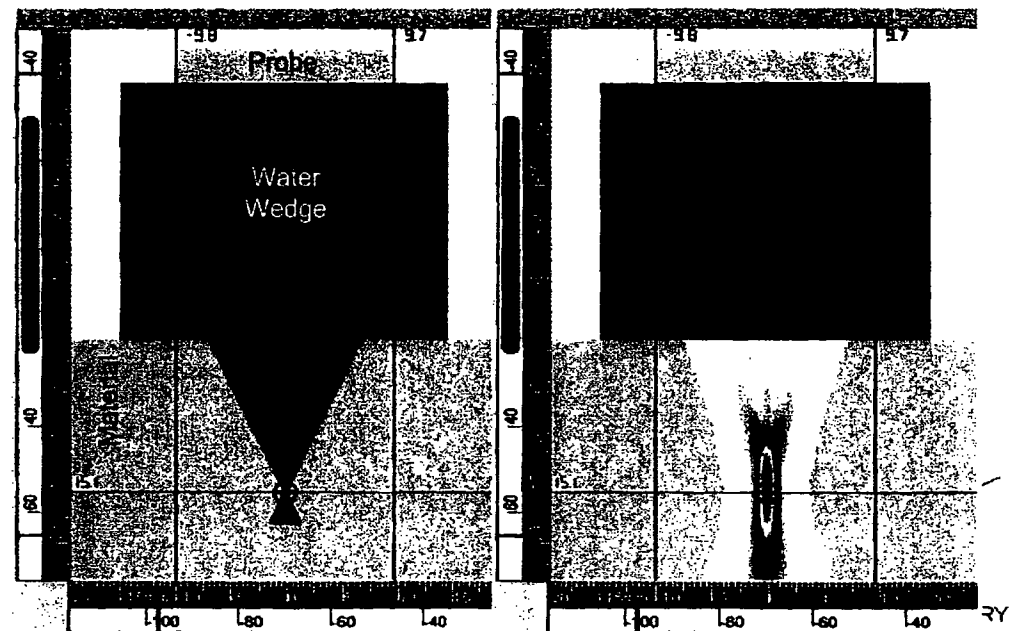
# Ultrasonic Phased Array Probe

- ▶ Custom pulse-echo (PE) immersion phased array probe
  - Center frequency – 5 MHz
  - 1-D annular Fresnel configuration
  - 8 elements
  - Element radii from 3 to 9.72 mm
    - 296.81 mm<sup>2</sup> total aperture
- ▶ Designed for variable depth focusing capabilities

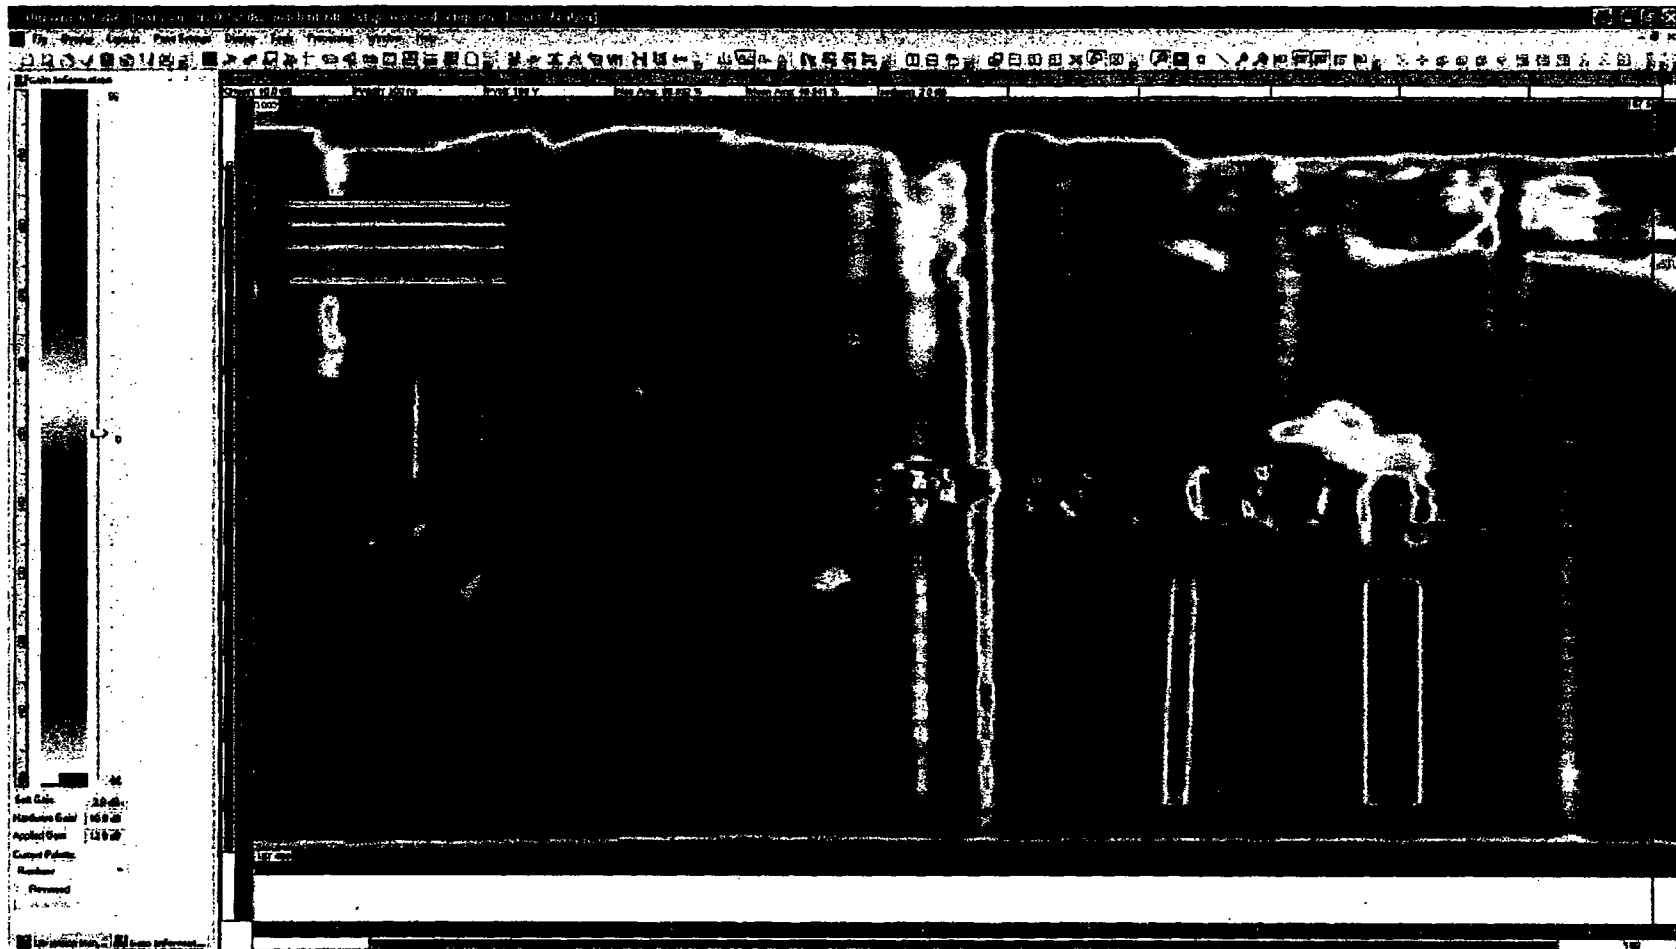
# Ultrasonic Data: Mock-up Notches

0 to 170 deg. Circumference

► C-Scan view: Calibration notches in the Inconel tube

- ▶ All EDM notches were detected
  - Difficult to depth size the 'depth variation notches'
  - Both resolution sets (axial and circumferential) were detected and clearly distinguishable in both Inconel and carbon steel
  - Width variation notches sized within 1 mm
- ▶ Boric Acid presence was easily detected with ultrasound
  - Acid presence created regions of low ultrasonic reflection at the interference fit zone
  - Served as a couplant medium for ultrasonic energy

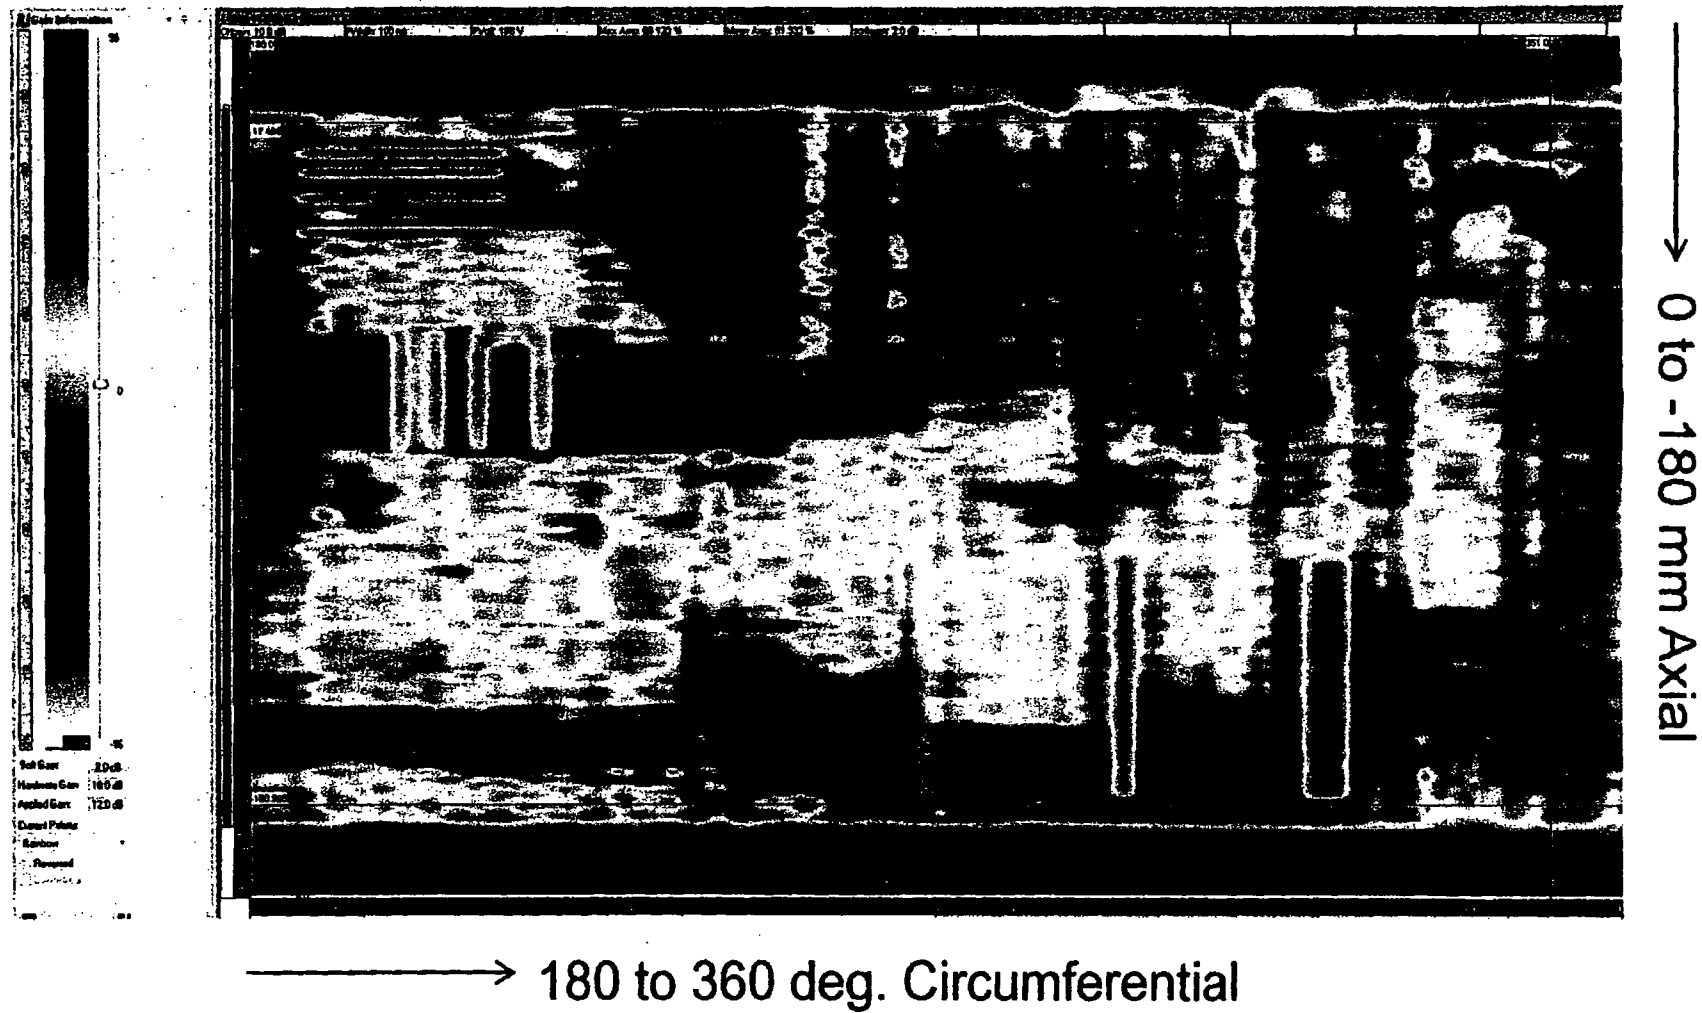
# Ultrasonic Data: Mock-up Notches

► C-Scan view: Calibration notches in the carbon block

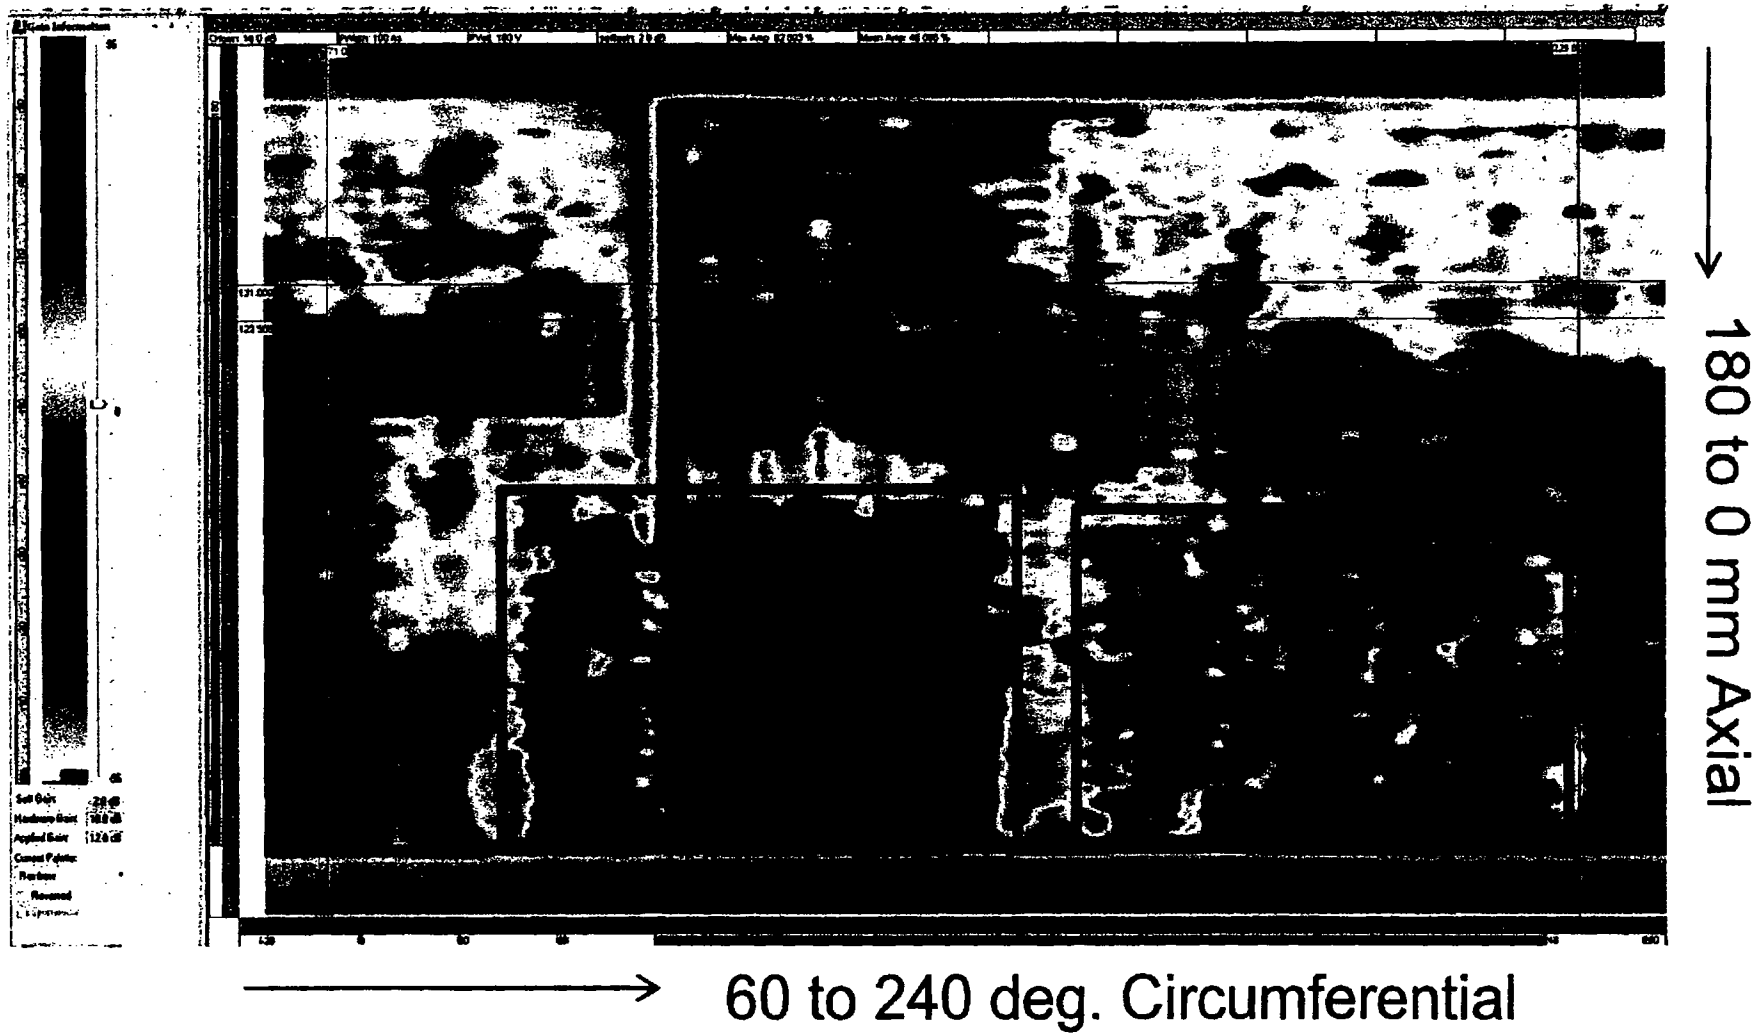
# Ultrasonic Data: Mock-up Boric Acid

► C-Scan view: Boric acid presence in fit region

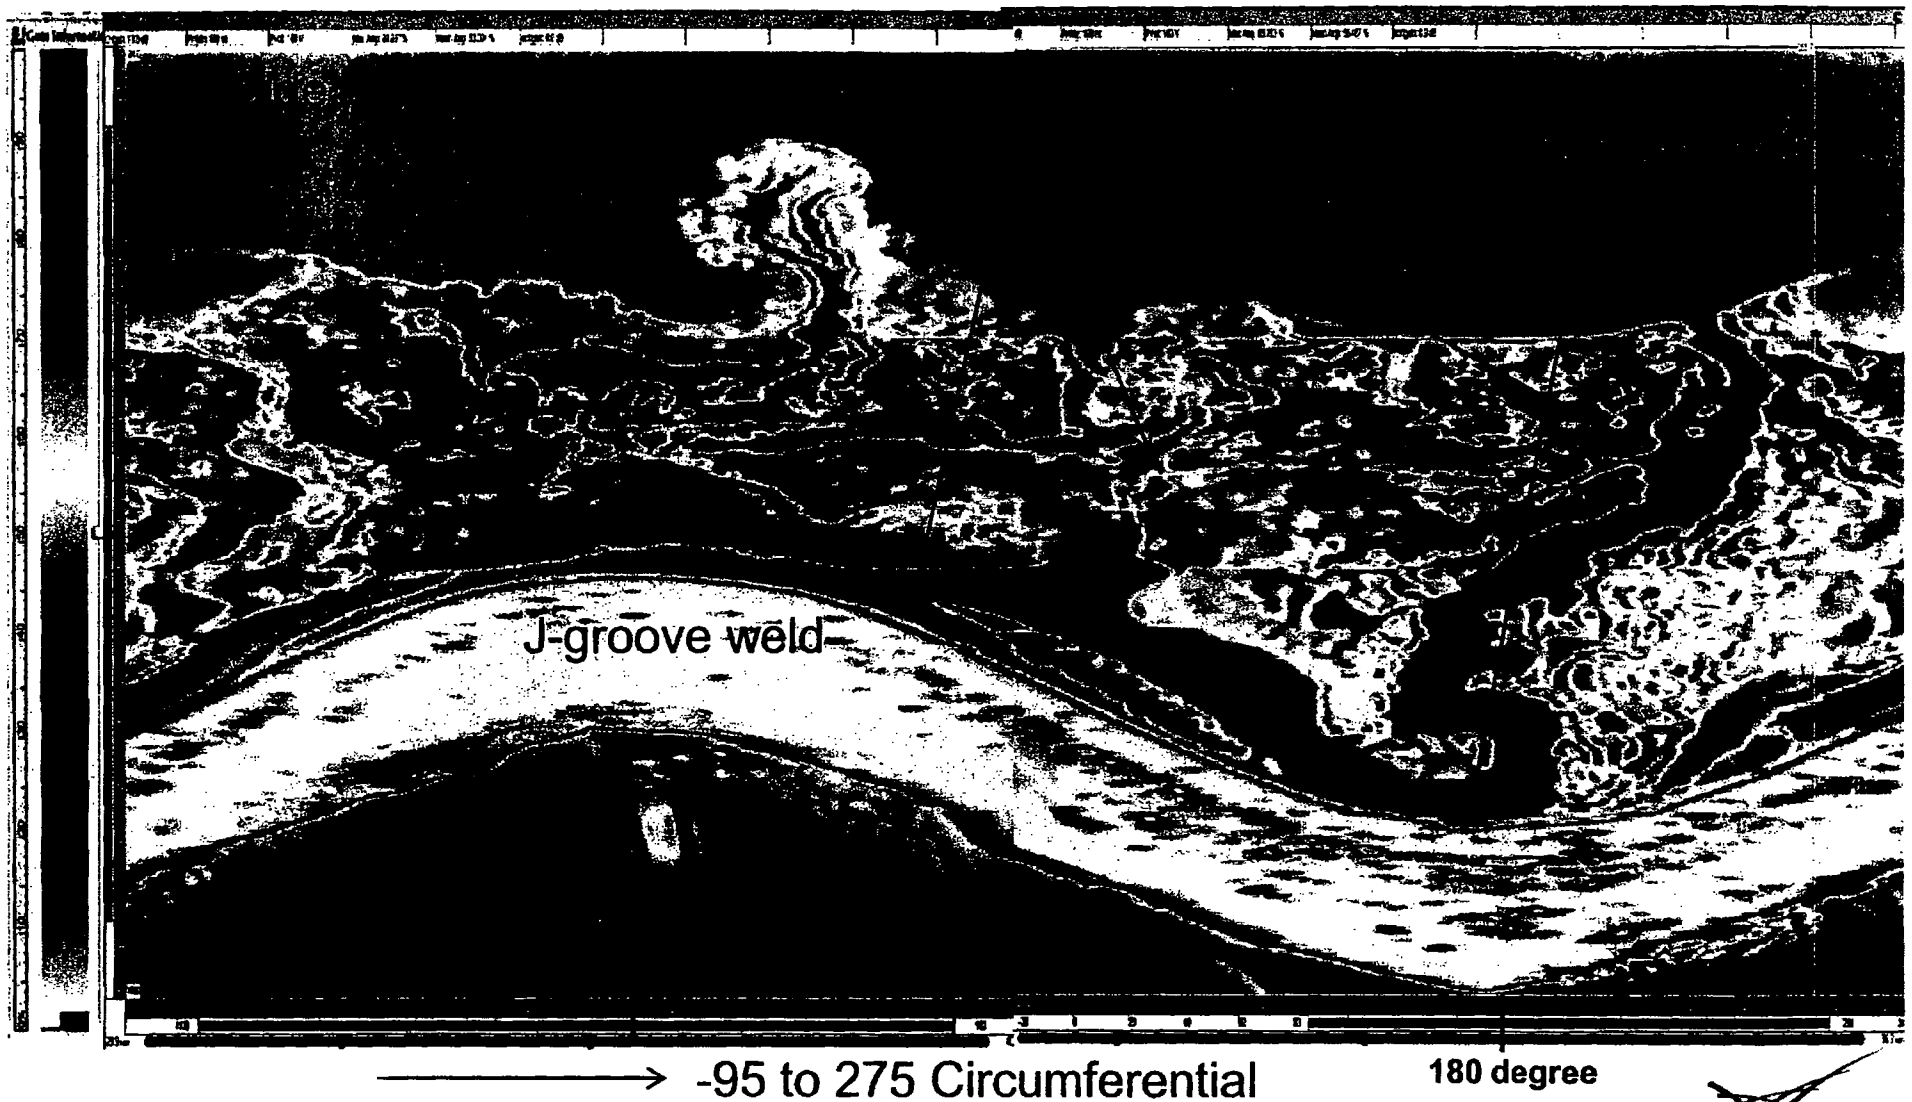
# Ultrasonic Data: Nozzle 63

19 ► C-Scan view: Full weld and fit region

- ▶ Mock-up Specimen
  - All calibration notches were detected
    - Most notches sized favorably with true state
    - Shallow notch detection showed sensitivity of UT method
  - Boric acid regions were detected
    - Greater ultrasonic transmission in boric acid regions
- ▶ A leak path was identified in Nozzle 63
  - A strong reflection pattern extended from the weld region through the interference fit
  - Corresponded to the previous industry assessment
  - Surrounding regions showed enhanced ultrasonic transmission
    - Indicative of boric acid trapped in the fit region
- ▶ The Leak path in Nozzle 63 was confirmed via destructive analysis

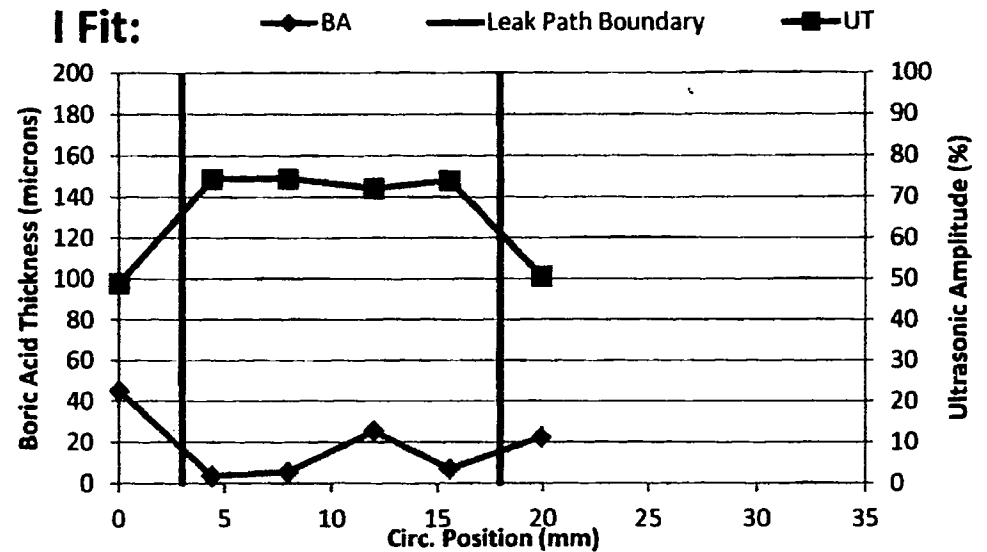
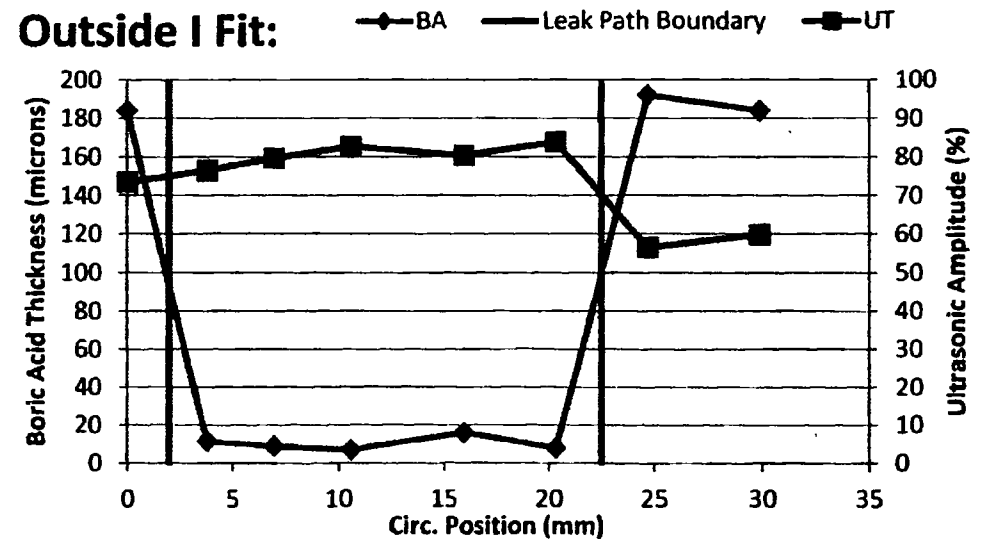
# Boric Acid/Corrosion Product Assessment (Leak Path Region)

- ▶ Eddy current point probe
  - Accurate to 2.5 microns
  - Measure boric acid/ corrosion product layer thickness
- ▶ Inverse relationship with ultrasonic response

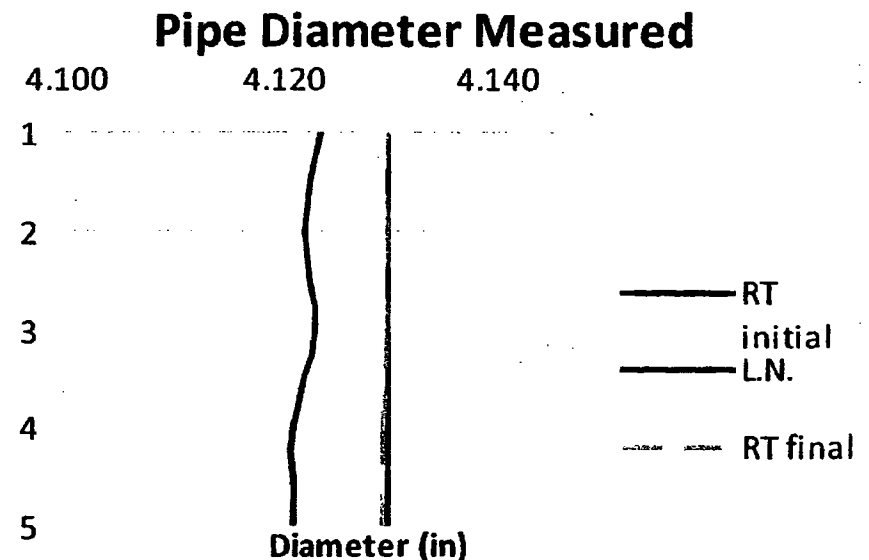
# Mock-up Assembly: Inconel Shrinkage

- ▶ Test Inconel tube achievable shrinkage
  - Theory predicts 9 mils
- ▶ Use representative Inconel tube section
  - Measure initial room temperature (RT) diameter (5 axial locations)
- ▶ Cool tube in liquid nitrogen (LN) (77.2° K)
  - Measure diameter at cryogenic temperature
- ▶ Natural equilibration to room temperature
  - Important that tube diameter returns to initial state

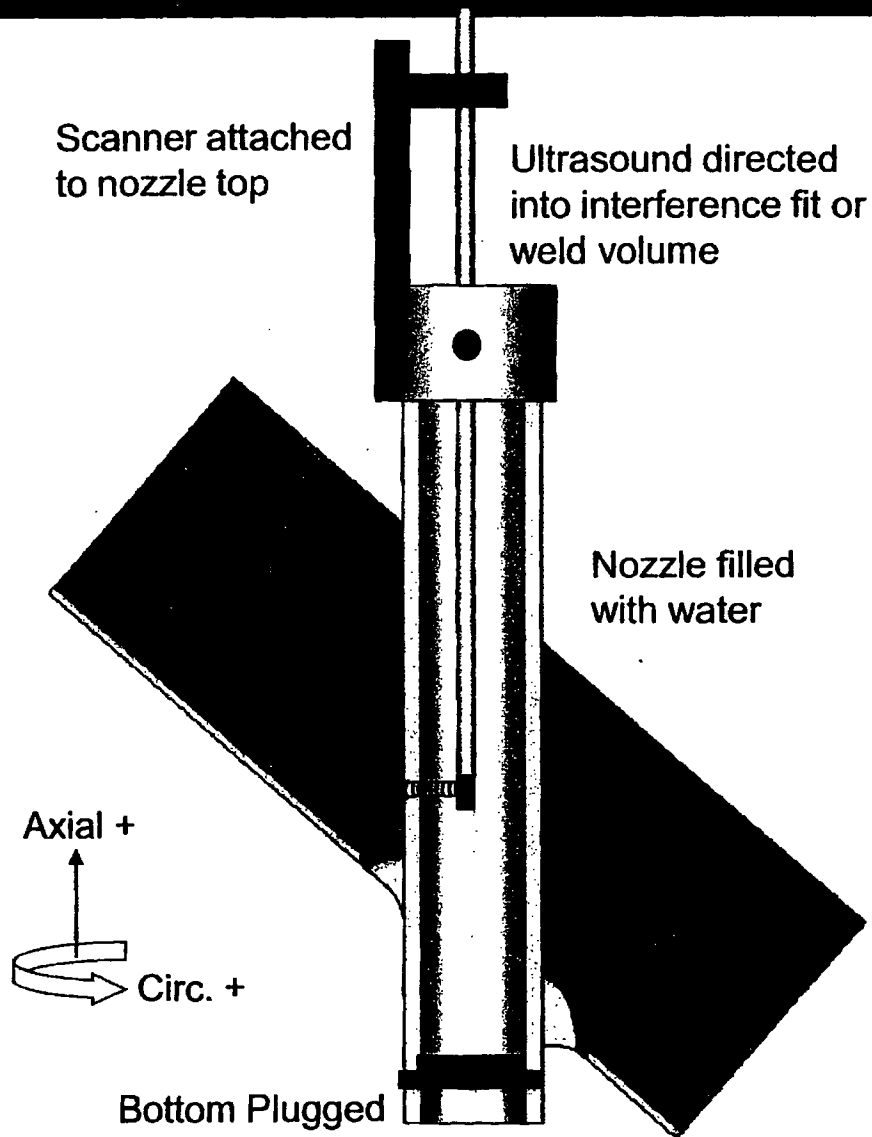
# Ultrasonic Data Acquisition

- ▶ Multiple depth focal laws implemented
  - Tube ID
  - Tube OD/interference fit region
- ▶ Raster scan protocol
  - 'Scan' in circumferential direction
  - 'Index' in axial direction
- ▶ Resolution
  - $0.5^\circ$  in scan by 0.5 mm in index
- ▶ Positional information relayed via shaft encoders
