Turkey Point Units 6 & 7
COL Application
Part 3 — Environmental Report

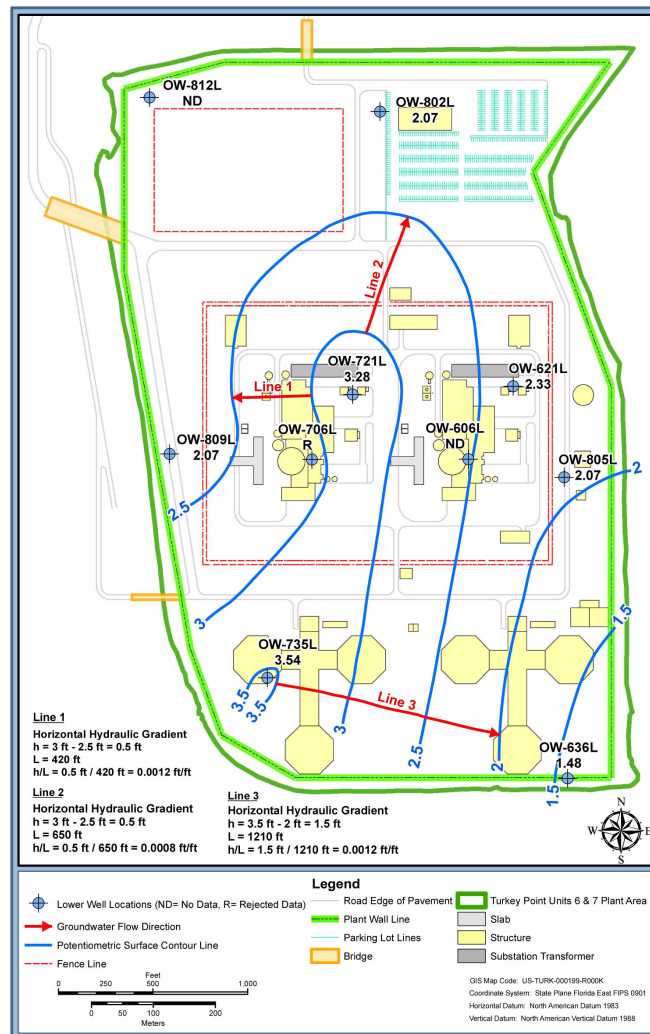
Figure 2.3-33 Biscayne Aquifer Potentiometric Surface Map, Lower Monitoring Interval, October 5, 2008 (Sheet 1 of 2) High Tide

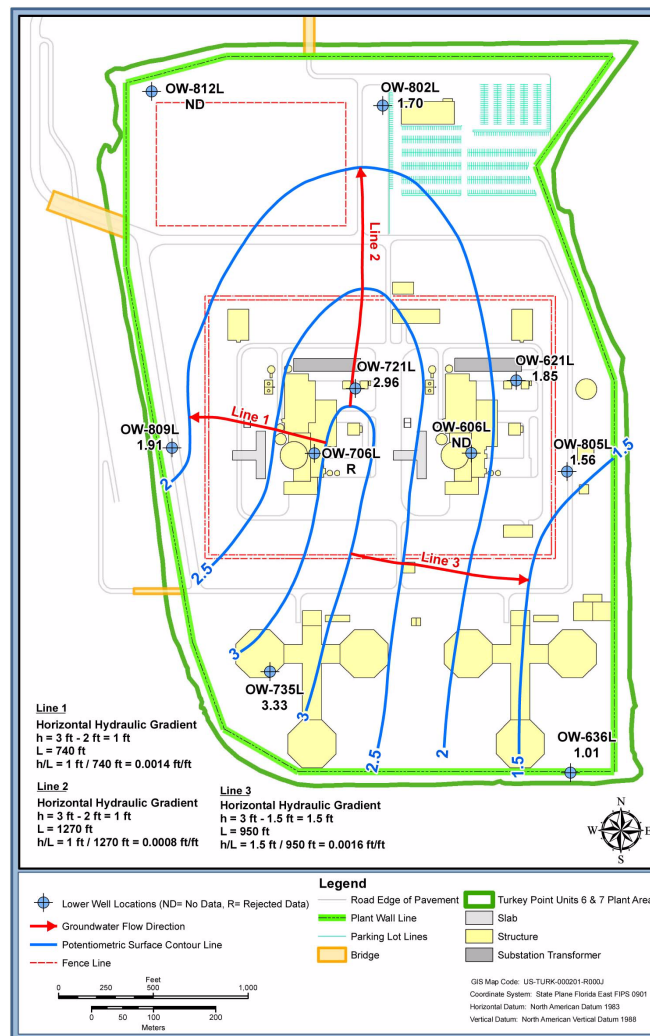
Figure 2.3-33 Biscayne Aquifer Potentiometric Surface Map, Lower Monitoring Interval, October 5, 2008 (Sheet 2 of 2) Low Tide

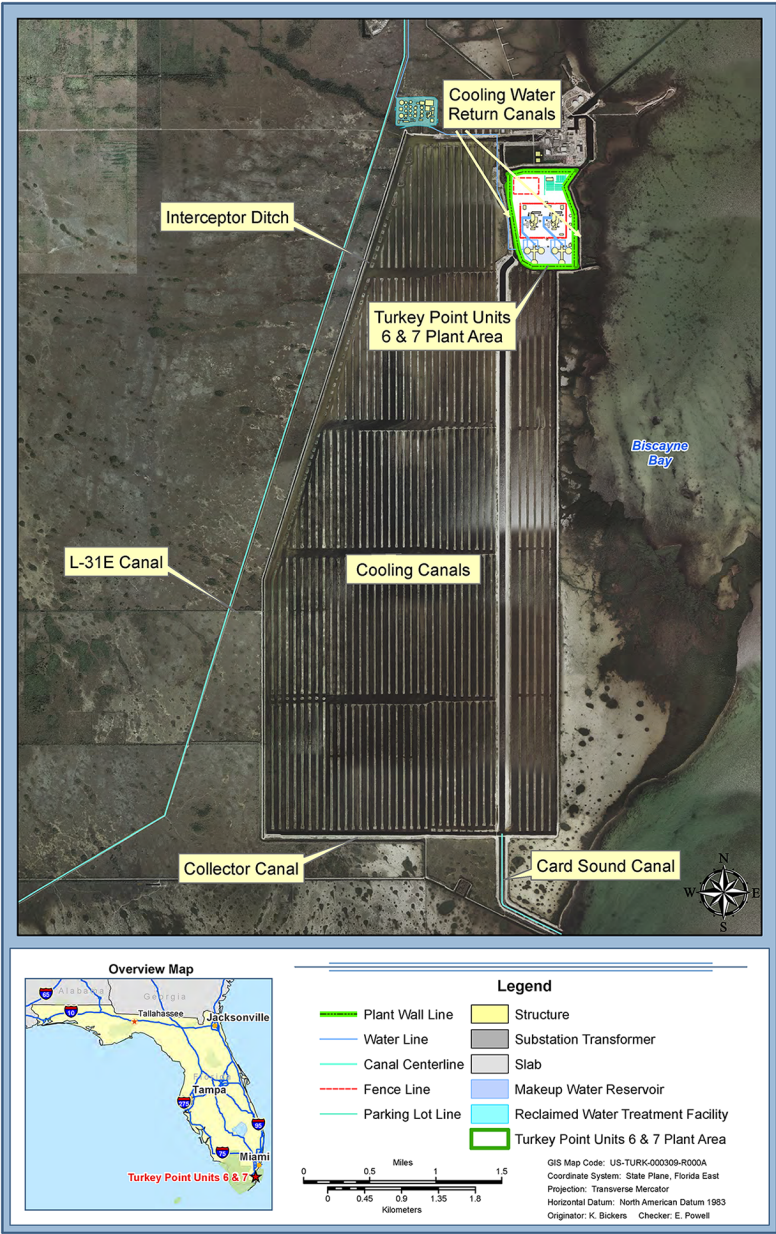
Figure 2.3-61 Industrial Wastewater Facility

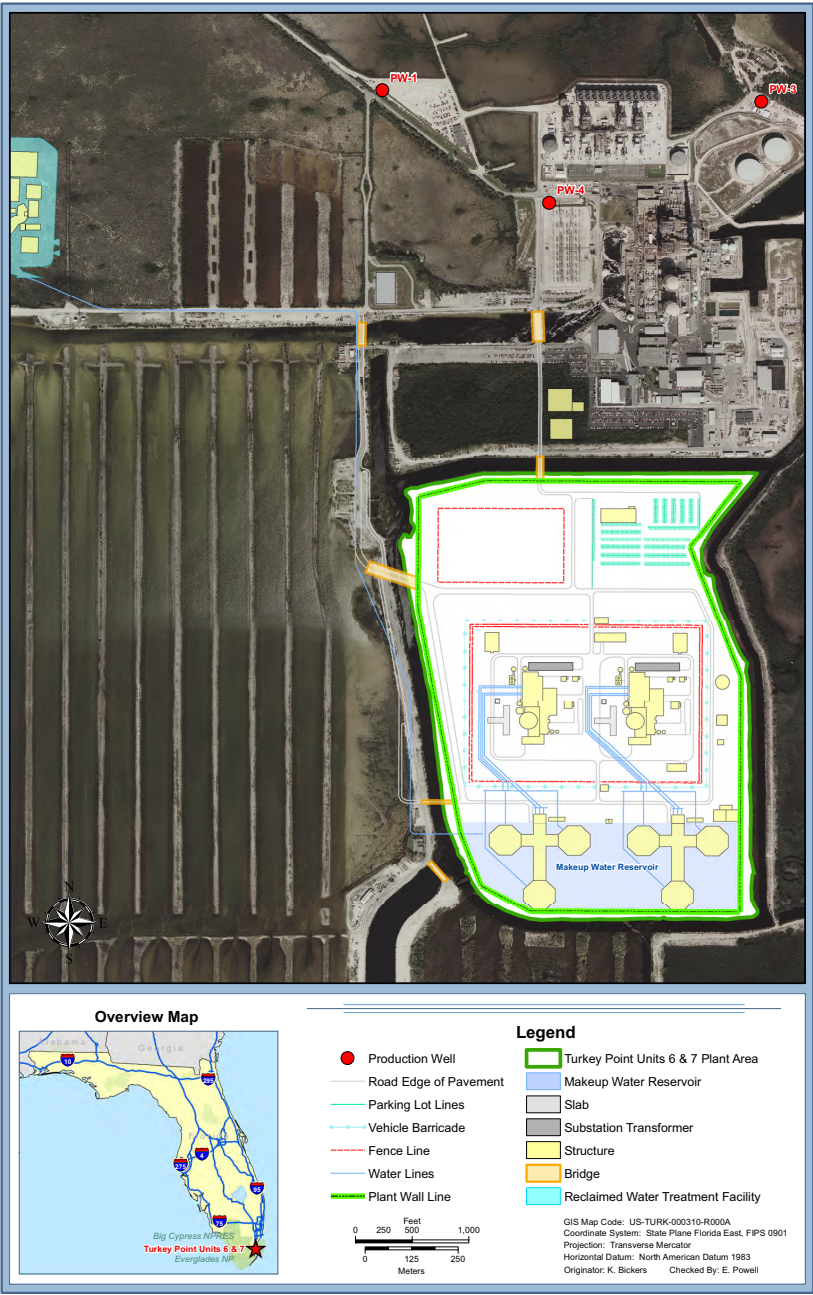
Figure 2.3-62 Upper Floridan Production Wells for Units 1, 2, 5

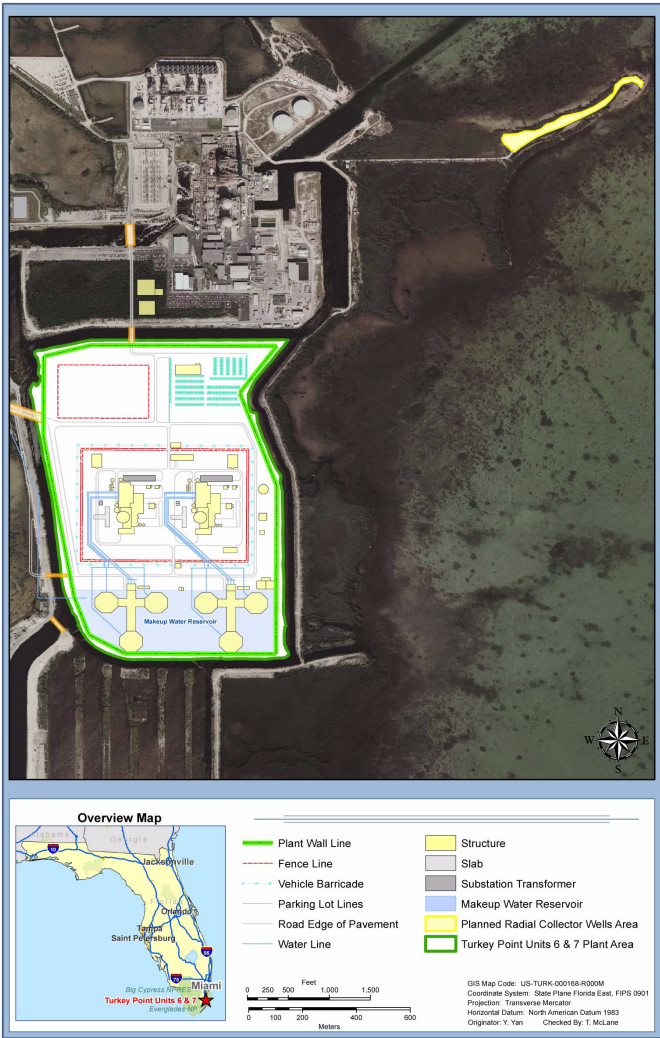
Figure 2.3-64 Radial Collector Well Area
