8.4 Summary of Test Schedule

40 NORTH AVE, BURLINGTON, MA 01803		DESCRIPTIVE DRAWING	
TITLE 650L SOURCE CHANGER TEST UNITS			
SIZE A	DWG. NO. R-TP80		REV D
SCALE: NONE		SHEET 1 OF 2

Test Plan 187 Model 880 Pipeliner, ISO 3999:2004(E) / ANSI N432 (1980), Endurance Test

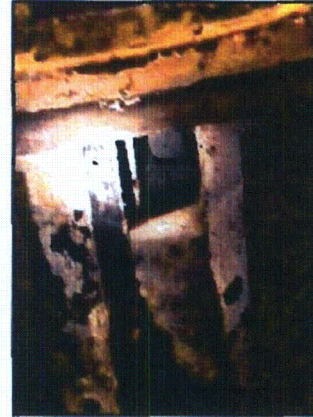
**TP80(B) Detail of
Cracked Shell**

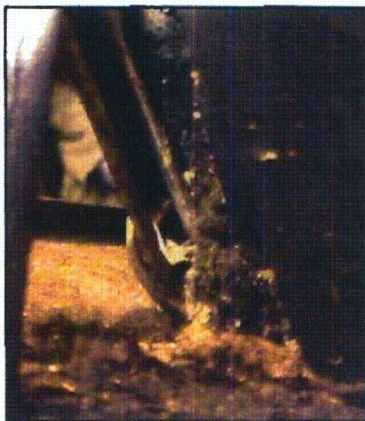
**TP80(B) Detail of
Uranium Oxide Residue**

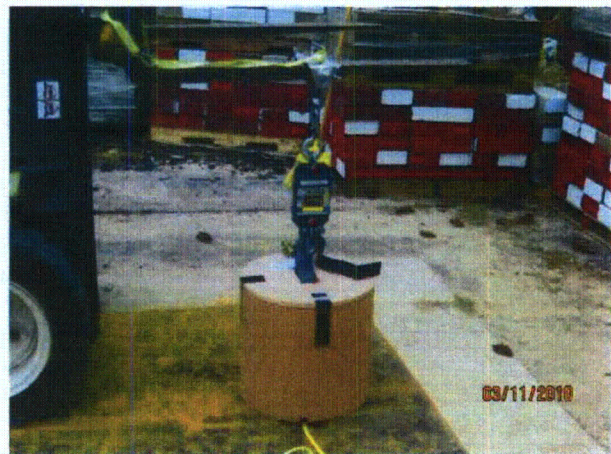
3 Test setup
