SUBJECT: NRC OBSERVATIONAL SITE VISIT AT THE CANONSBURG,  
PENNSYLVANIA, DISPOSAL SITE

Report No.: WM-00042/13-002

Facility: Canonsburg, Pennsylvania, Disposal Site

## **NRC TRIP REPORT**

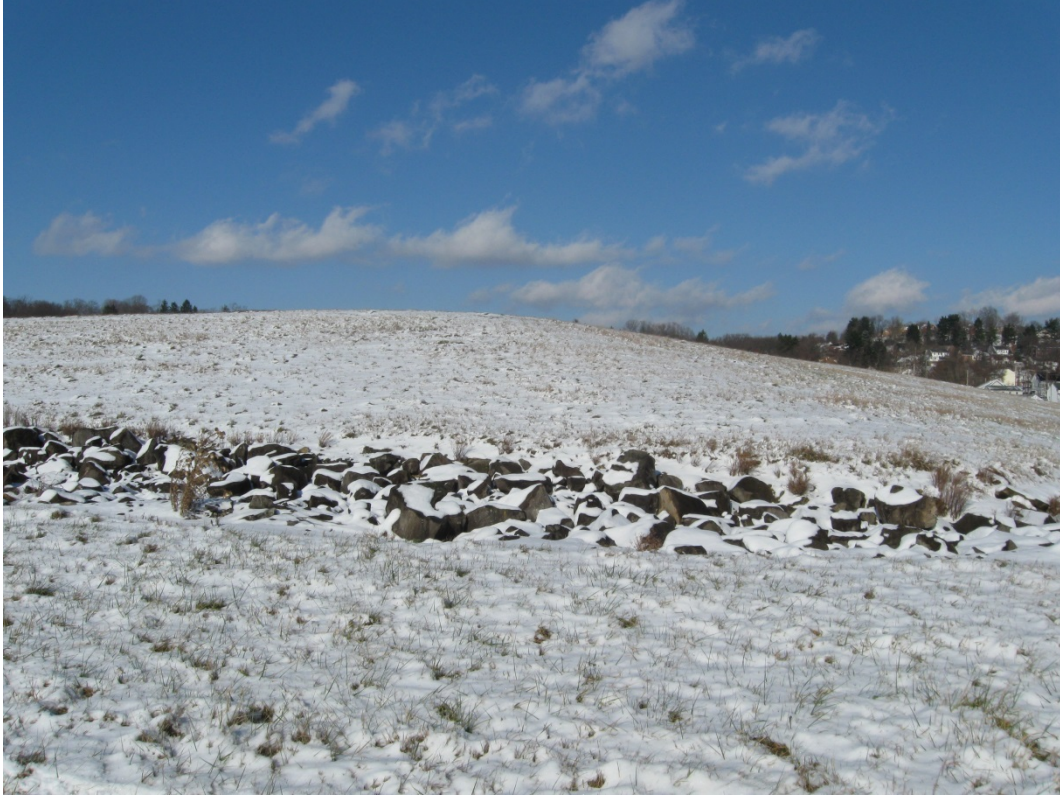
The DOE inspectors checked the disposal cell for evidence of erosion, settlement, slumping, displacement, and any other feature that would require maintenance or repair. The rock surfaces armoring the diversion ditch and the banks of the creek were found to be in good condition. The DOE contractors noted occasional animal burrows that did not appear to significantly affect cell performance.

Fig. 1: Canonsburg site – Disposal cell and riprap-armored diversion ditch (looking northwest)

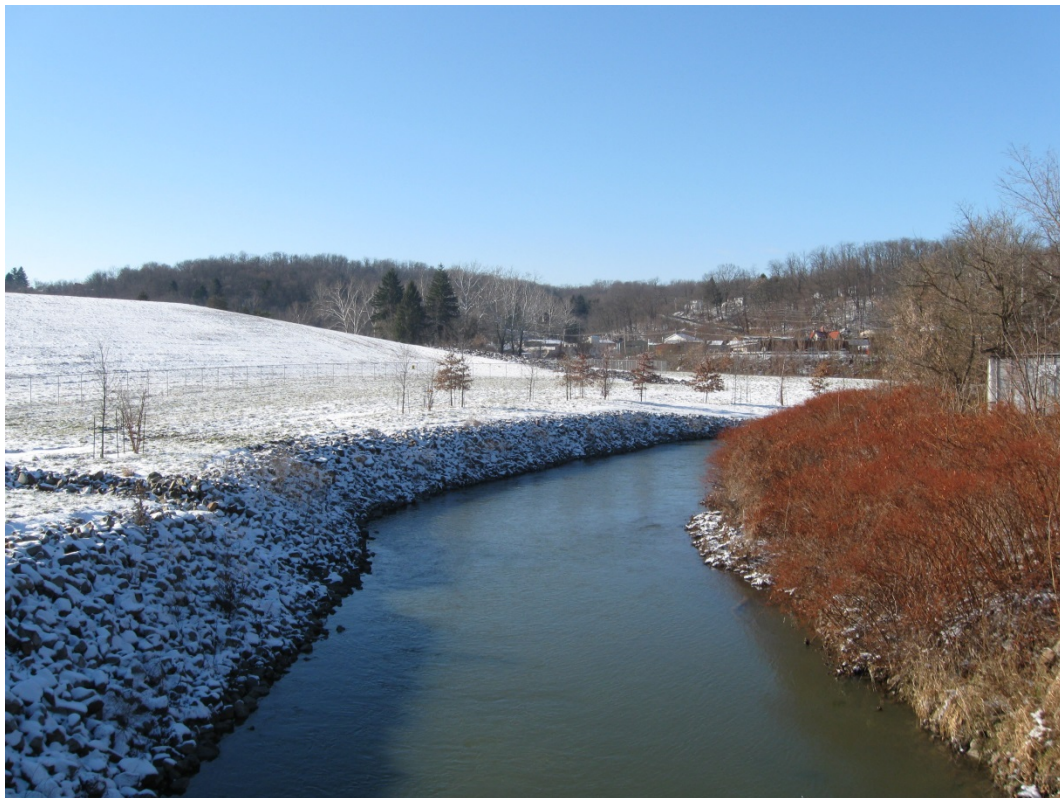
Fig. 2: Canonsburg site - Riprap stabilization between site boundary fence and Chartiers Creek (looking west)
