**Test Report of Vibration Testing of Inserts  
carried in Safkeg-HS 3977A**

**TR 2014/01/01**  
**Issue A**  
Page 1 of 22

Project No: Y09/10/04

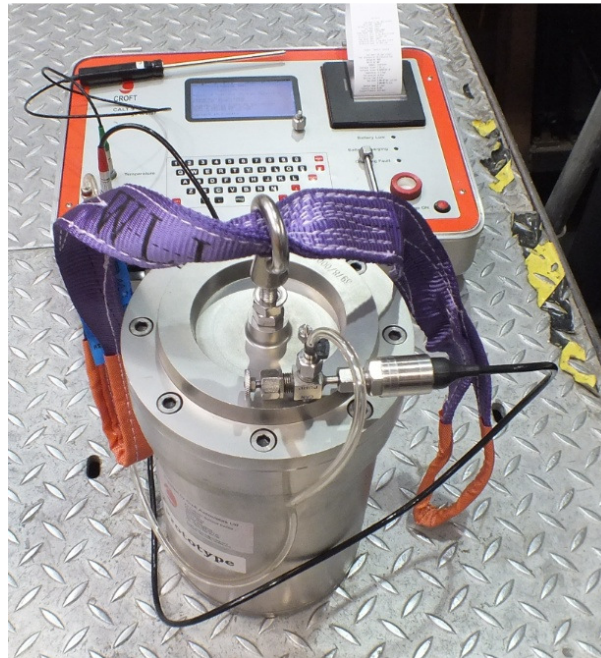
Photograph 4, Containment vessel being leakage tested after a vibration test using a CALT.

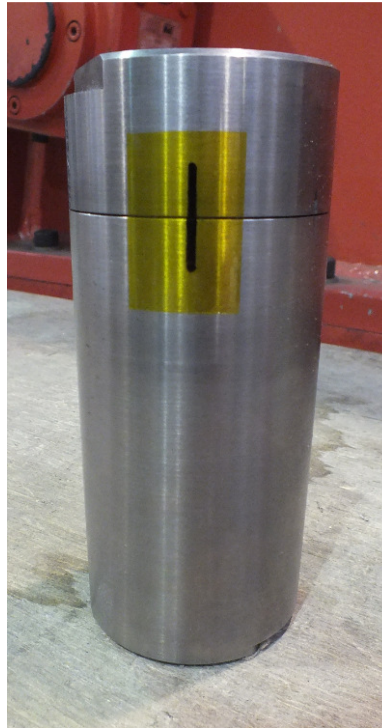
Photograph 5, Insert lid and body remained aligned after vibration test

- 9.5. Visual check to verify that the insert lid remained aligned with the insert body after the vibration test.

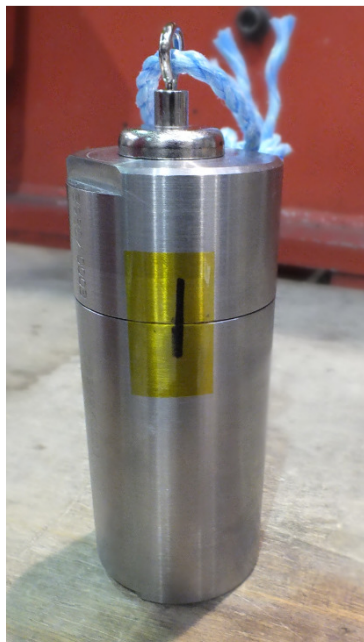
Photograph 6, Insert lid and body remained aligned after vibration test

- 10.3. Visual check to verify that the insert lid remained aligned with the insert body after the vibration test.

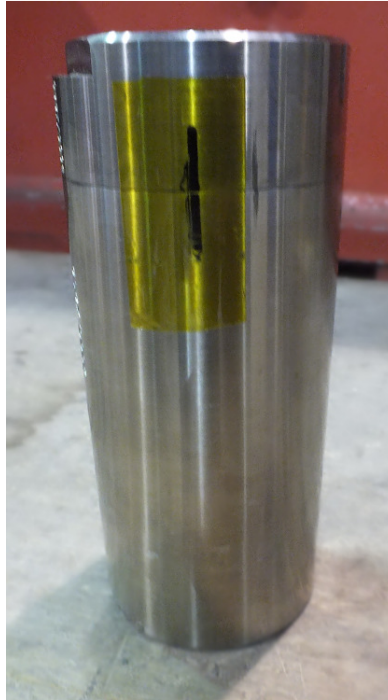
Photograph 7, Insert lid and body remain aligned after vibration test

- 11.5. Visual check to verify that the insert lid remained aligned with the insert body after the vibration test.
