# MRP RI-ITG Program Results and Status

NRC Meeting

October 23, 2003

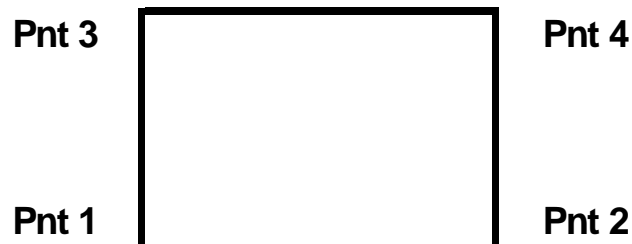
Core Side Surface			Middle of Plate			Back Side Surface		
Point	Phi	dpa	Point	Phi	dpa	Point	Phi	dpa
1	2.9E+21	4.2	1	2.5E+21	3.7	1	2.2E+21	3.2
2	1.6E+22	23.2	2	1.5E+22	22.2	2	1.5E+22	21.4
3	2.9E+21	4.2	3	2.5E+21	3.7	3	2.2E+21	3.2
4	1.6E+22	23.2	4	1.5E+22	22.2	4	1.5E+22	21.4

Looking at Sample from Core Side of Sample
