Stress-Corrosion Cracking of Insulated Austenitic Stainless Steel*

By A. W. DANA, JR.

The phenomenon of stress-corrosion cracking which may occur when austenitic stainless steels are exposed to moist thermal insulating materials is believed to result from the action of water-soluble chlorides leached from the insulations. Chemical analyses showed that water-soluble chlorides are present in 85 per cent magnesia, calcium silicate, and glass fiber insulating materials, with little difference in chloride level between them. Simulated service tests indicated that 85 per cent magnesia insulation had the greatest tendency to produce cracking at 100 C. After 200 days of exposure, no statistically significant difference in cracking tendency was present between calcium silicate and glass fiber insulations.

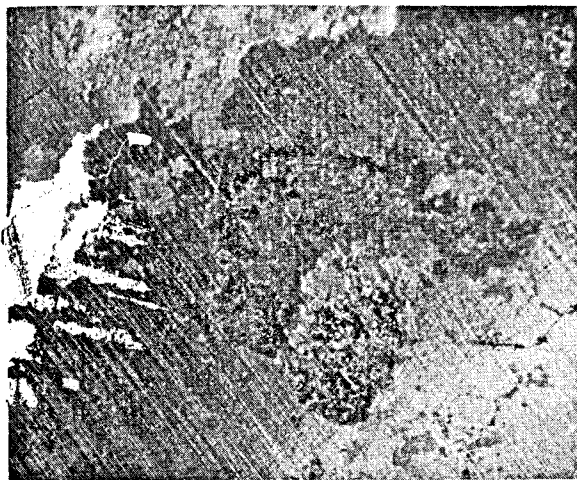
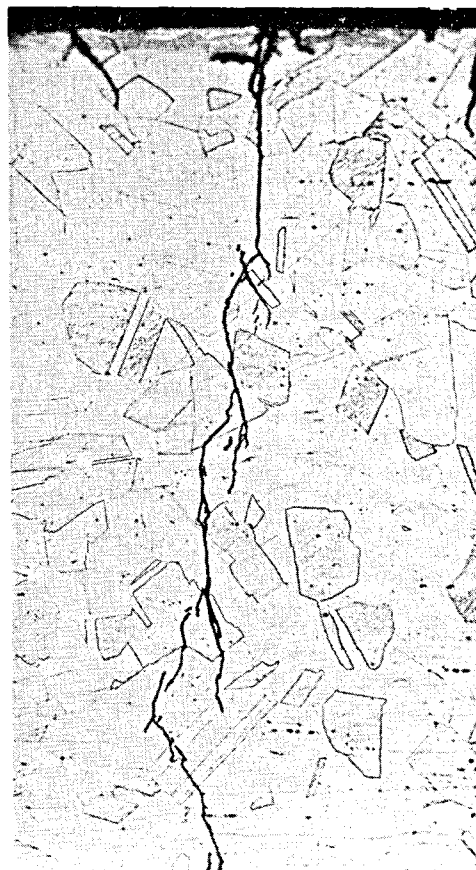
(a) Surface cracking. Note pitting associated with cracking ($\times 6$).

(b) Aqua regia etch. Cross-section of specimen. Note small surface cracks ($\times 250$).

Fig. 7.—Stress-corrosion cracking of type 304 stainless steel specimen exposed to glass fiber insulation at 100 C.

The stress-corrosion cracks noted on the surface of the specimens were usually very fine (Figs. 5(a), 6(a), and 7(a)) and often associated with black corroded areas and pitting attack. The cracks are branched and can occur at many sites. On propagating through the cross-section of the specimens (Figs. 5(b), 6(b), and 7(b)), the cracks take a "lightning-like" pattern that is transgranular.

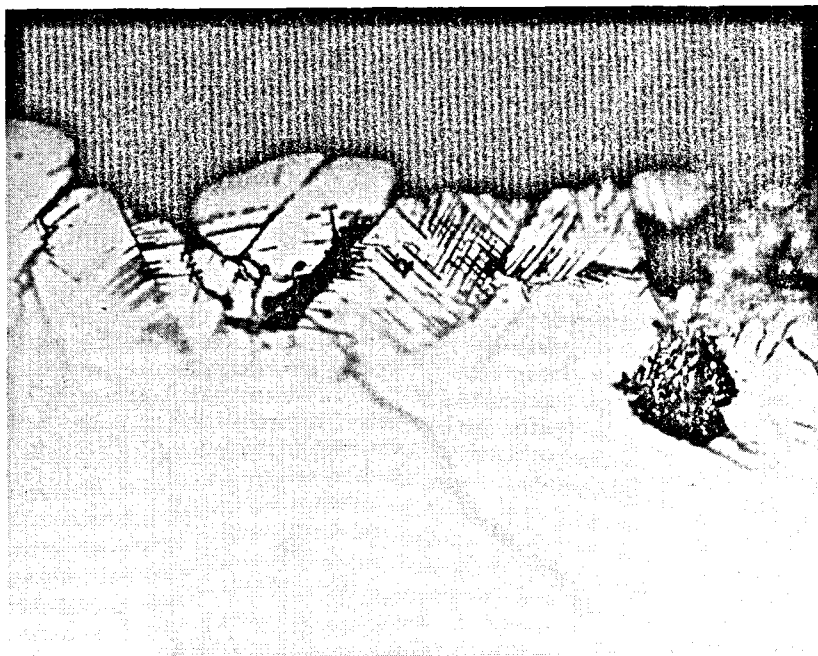
Fig. 8.—Surface of specimen exposed to 85 per cent magnesia insulation. Note main crack starting from corroded deformation lines. Unetched ($\times 1000$).

Examination of the surface layers of the specimens after polishing showed that the main cracks often started from areas where preferential corrosion attack had occurred (Fig. 8). These areas of preferential corrosion attack appeared to be slip lines or deformation bands formed in the distorted surface layer of the specimens. After the corrosion had proceeded sufficiently far, a pit-like depression formed from which larger cracks propagated. These data may provide a clue to the mechanism of crack initiation. The relation of the observed preferential corrosion attack
