Seismic Walkdown Checklist (SWC)

Equipment ID No.: 1Q-DC

Equipment Description: 125/250VDC DIST PANEL FOR EDG 1B

Project: TMI SWEL

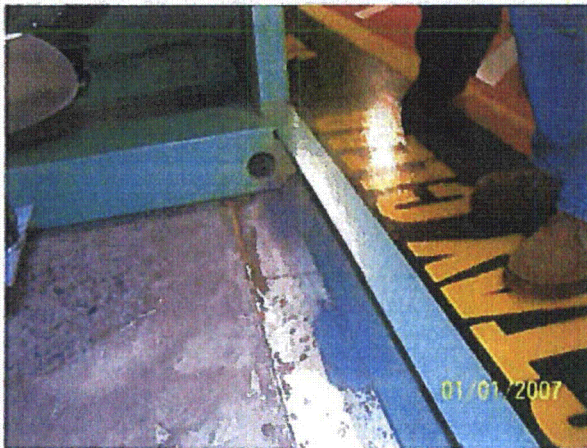
100_3390

- ① Seismic Qualification performed under SA-T1-1S-480V-ES Rev.1 for SQ09.
- ② Transformer anchored under FCR-C-100727
- ③ Missing / Loose Bolt at base of cabinet. Not an operability issue. This is tracked under IR 1401212
