ASSESSING THE IMPACTS OF HURRICANE SANDY ON COASTAL HABITATS

Prime Hook National Wildlife Refuge Before and After Sandy

By: The American Littoral Society
For: The National Fish and Wildlife Foundation
December 17, 2012

American Littoral Society Final Report

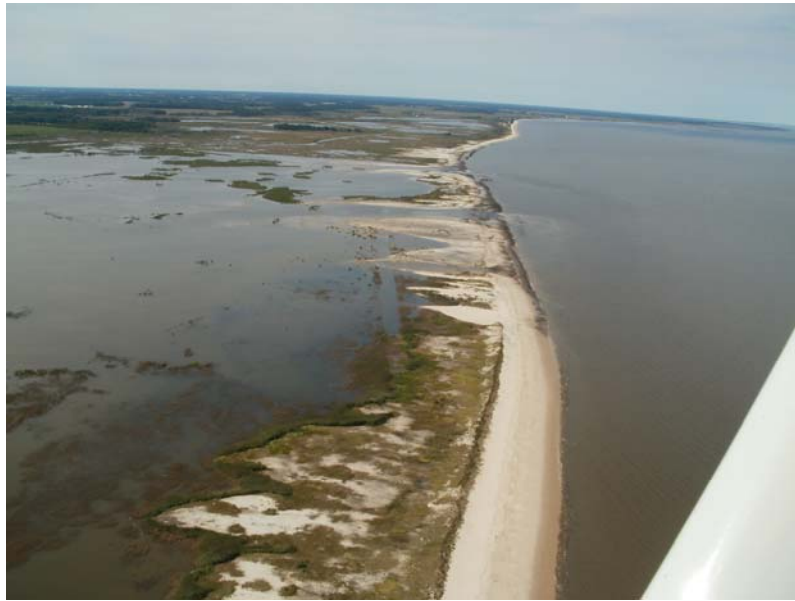
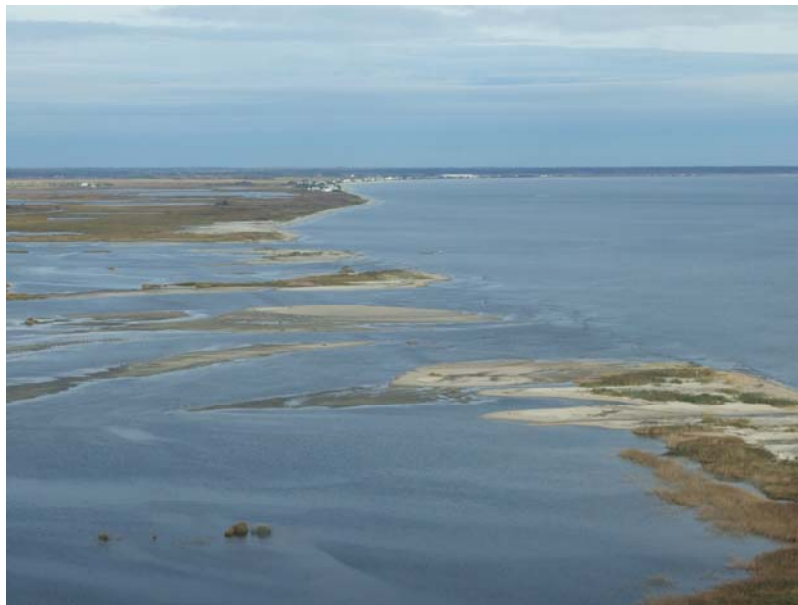
While several areas in Delaware fared well during the storm, such as the Cedar Swamp Wildlife Area and Bombay Hook National Wildlife Refuge, others were hit hard. At Prime Hook National Wildlife Refuge, breaches to dunes that separate the barrier island from its 4,200 acre freshwater marsh caused significant saltwater inundation. Although there are some freshwater and brackish portions remaining, most of the marsh has been converted to saltwater. The dune breaches are an ongoing problem that began with a storm event in 2008 and continued to worsen over the years, with Sandy wielding a major blow. In its current state, the marsh will not be able to sustain the species of ducks and other waterfowl that depend on the freshwater marsh, and the number of waterfowl that visit the site has dropped significantly over the past several years. The circumstances at Prime Hook are changing rapidly as a result of increased storm surges and sea level rise, and its resource managers are concerned that, without a more permanent and feasible solution, the freshwater marsh is not sustainable.

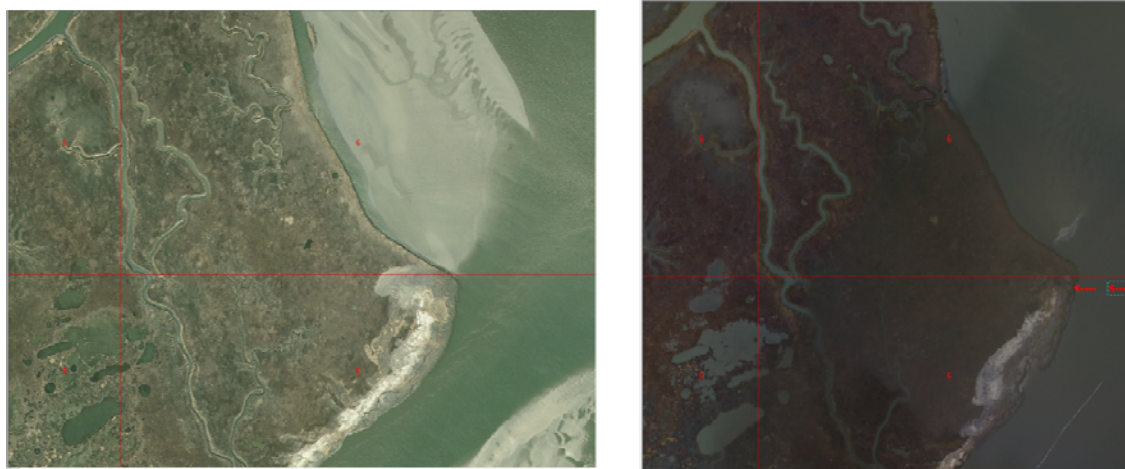
Figure 2. Example of Pre- vs. Post-Imagery for the Brigantine section of Forsythe NWR, NJ showing High Impact with active overwash of sand onto the salt marsh and several hundred feet of landward migration of the marsh edge.

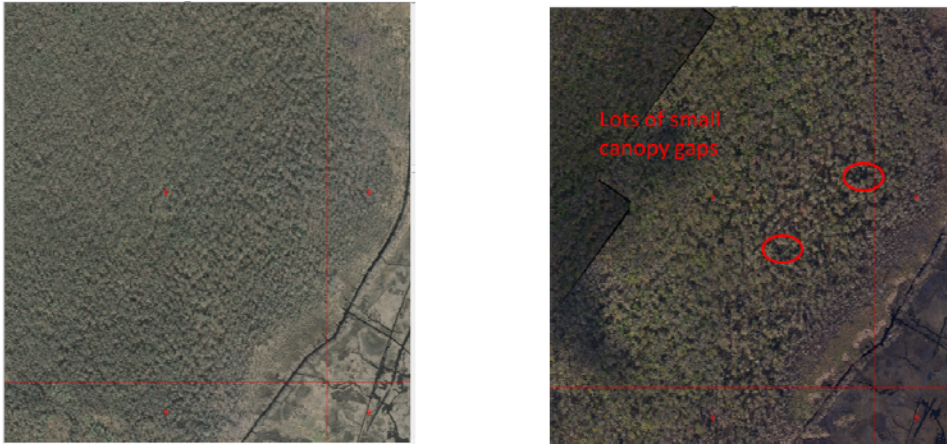
Figure 3. Example of Pre- vs. Post-Imagery for the Brigantine section of Forsythe NWR, NJ showing Moderate Impact to maritime forest areas with numerous small canopy gaps.
