**Palo Verde Unit 3
Bottom-Mounted Instrument (BMI)
Relief Request 52
Pre-submittal Meeting**

April 2, 2014

Unit 3 Reactor Vessel BMI Nozzle #3

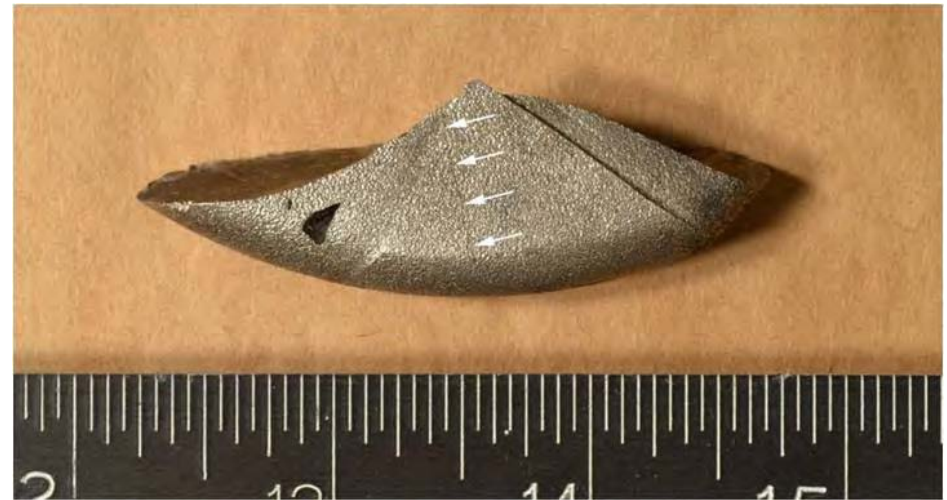
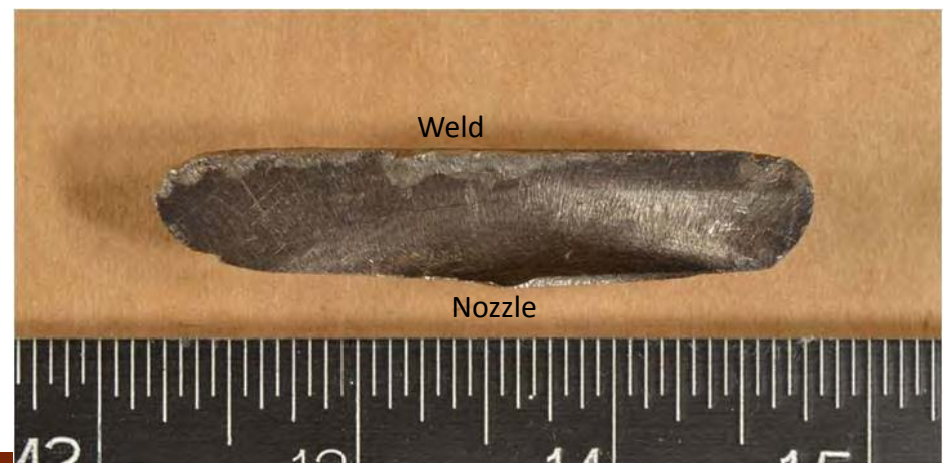
Sectioning (Piece B)

- How did cracking begin?
- Propagation mechanism(s) of the observed cracks?
- Nature, extent, and role of the weld inclusion zone?
- Assembled Industry Team
 - EPRI, Westinghouse, AREVA, Industry Peers
- Metallurgical Analysis
 - Visual inspections
 - X-ray radiography
 - High Resolution Replication
 - Scanning Electron Microscopy (SEM)
 - Energy Dispersive Spectroscopy (EDS)
 - Metallography

- Two crack types identified
 - Single weld solidification crack - in top of void
 - All other observed cracks are characteristic of PWSCC
- All cracks were found to be associated with the void
- Wetted-surface-connected crack not found in boat sample
- No detrimental residual chemicals

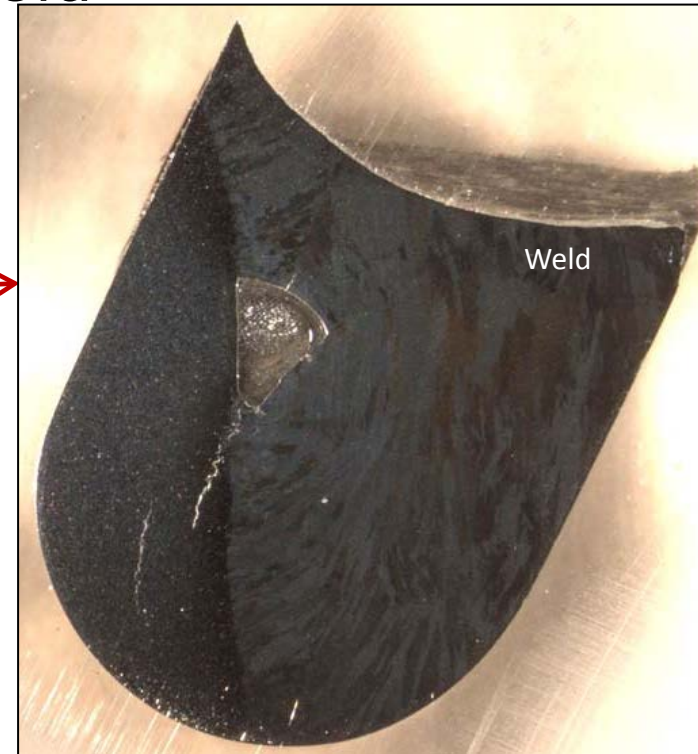
Boat Sample – Investigate Void

Piece B

As-polished

Cut #2

10% oxalic etch
