## Post test examinations on LOCA tested rods

Studsvik Report

2013-12-11

### Summary

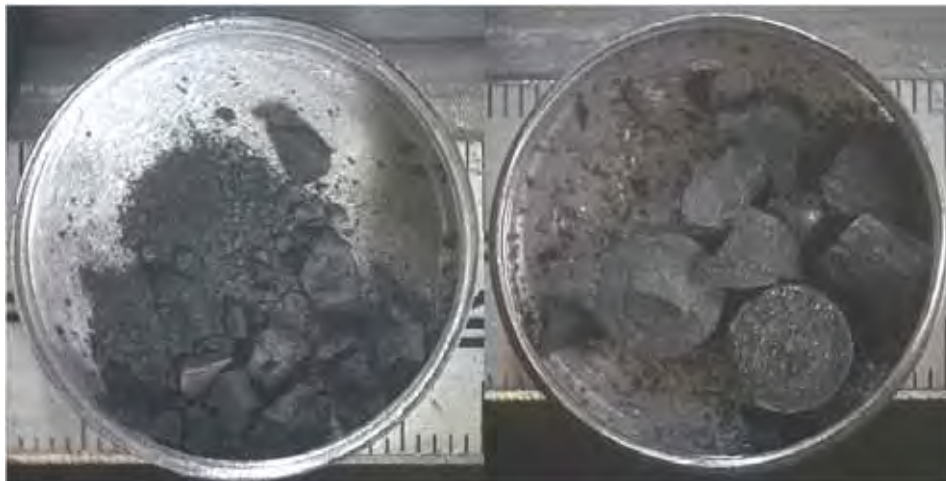
**Figure 1**

Figure 1 shows examples of the additional loose fuel from the second sieving, test 192 top (left) and test 196 bottom (right).

Example of additional loose fuel from, test 192 top (left), test 196 bottom (right). The scale in the background is in millimetres.

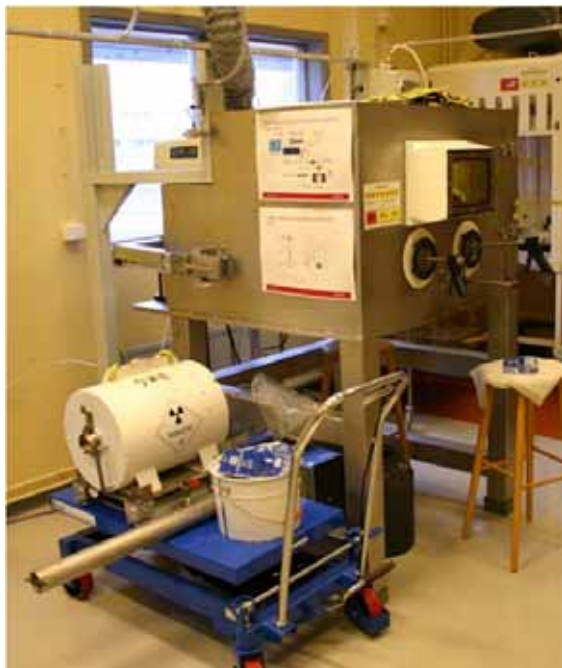
**Figure 29**

The ablation equipment consists of a New-Wave UP-213 Nd:YAG laser mounted on a motorized X-Y-Z stage in connection to an ablation chamber that is housed in a hot cell (Figure 29). The transport gas (typically He or Ar) from the ablation cell is injected into a Perkin Elmer Elan 6100 DRC II ICP-MS, installed in a glove box. The ablating laser operates at a wavelength of 213 nm with a pulse length of  $<4$  ns. The ablated spot size can be varied between  $\sim 5$ -160  $\mu\text{m}$  with an ablation frequency between 1-20 Hz. The equipment can be used for spot analysis (drilling) or for line scans (typical traversing speed 10-70  $\mu\text{m/s}$ ). The ablation chamber is cylindrical (30 mm diameter). Depending on the sample geometry samples of up to 30 mm in length can be accommodated.

The laser ablation hot cell and the sample transfer cask.
