Investigation Report on the Integrity of Thermally-Embrittled Cast Stainless Steel Pipe

JNES-SS Report

April 2006

Safety Standard Division, Japan Nuclear Energy
Safety Organization

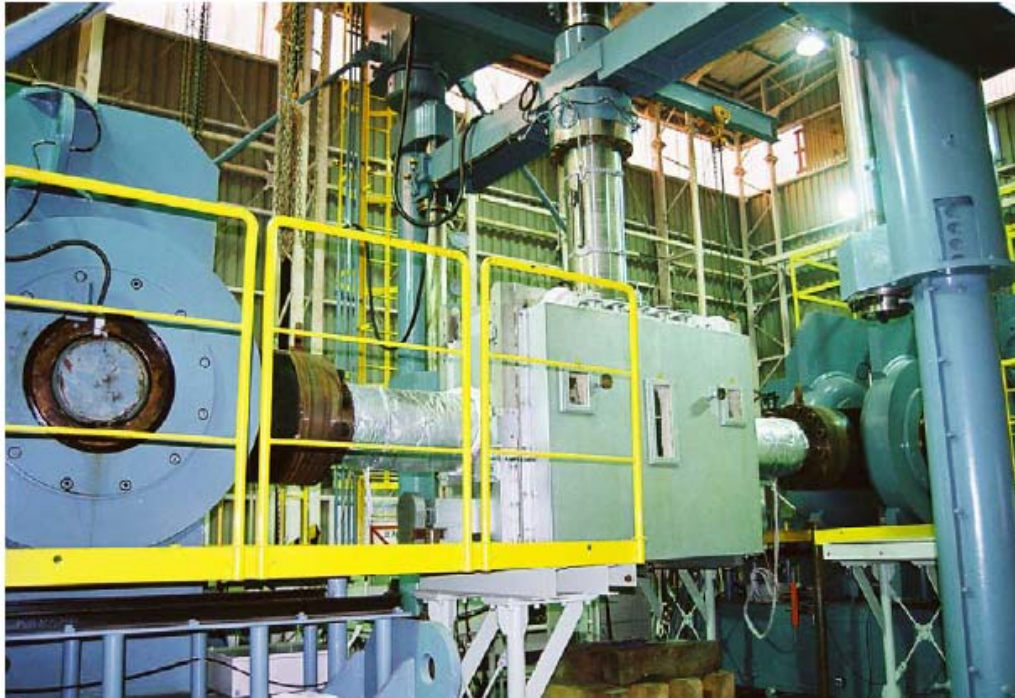
1. With regards to the center cross-section C—C, the test specimen [missing text]
2. The fulcrum [missing text] by the testing device support pin.
3. The overall weight of the test specimen was approx. 62.2 kN

Figure 1.3.2-3 Schematic of Large-Sized Pipe Test Specimen

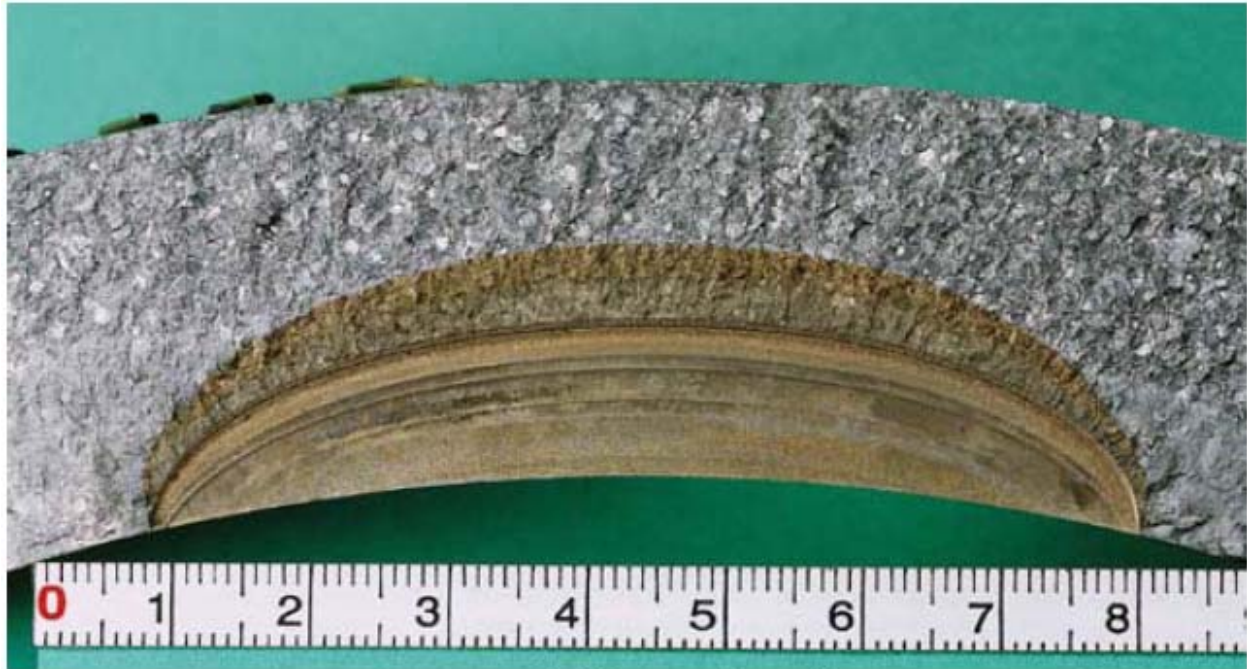
Figure 2.2-7 Fracture Surface Photograph of Test Specimen L2

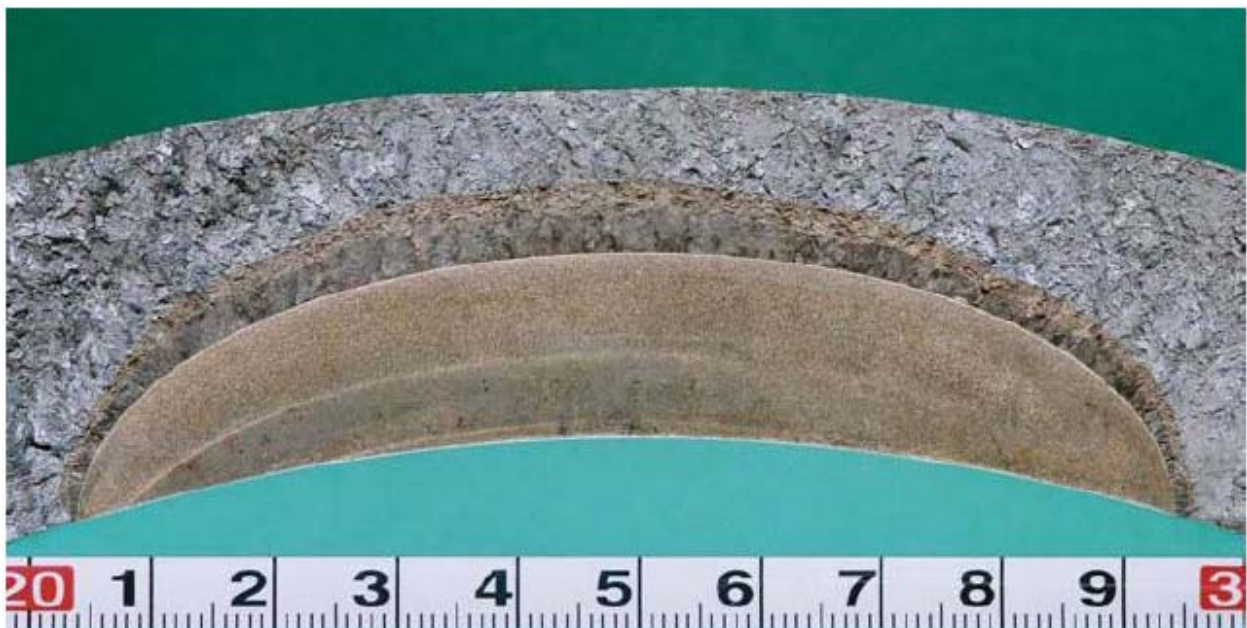
Figure 2.2-9 Fracture Surface of Test Piece L3

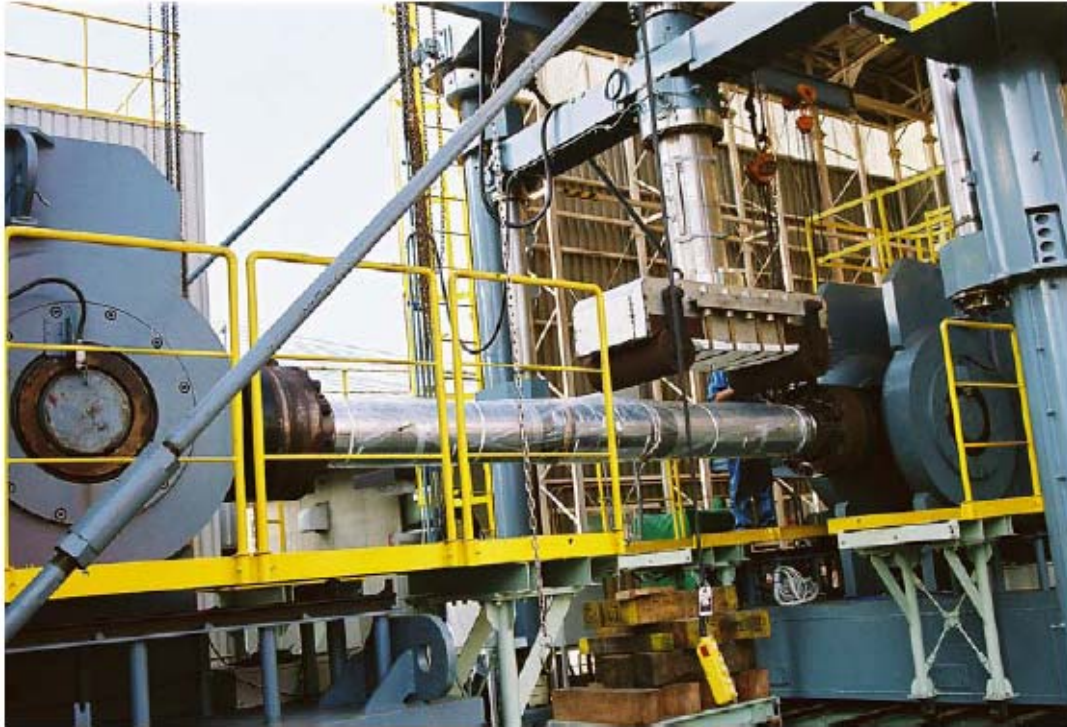
Installation of Large-Sized Pipe Test Specimen into Testing Device

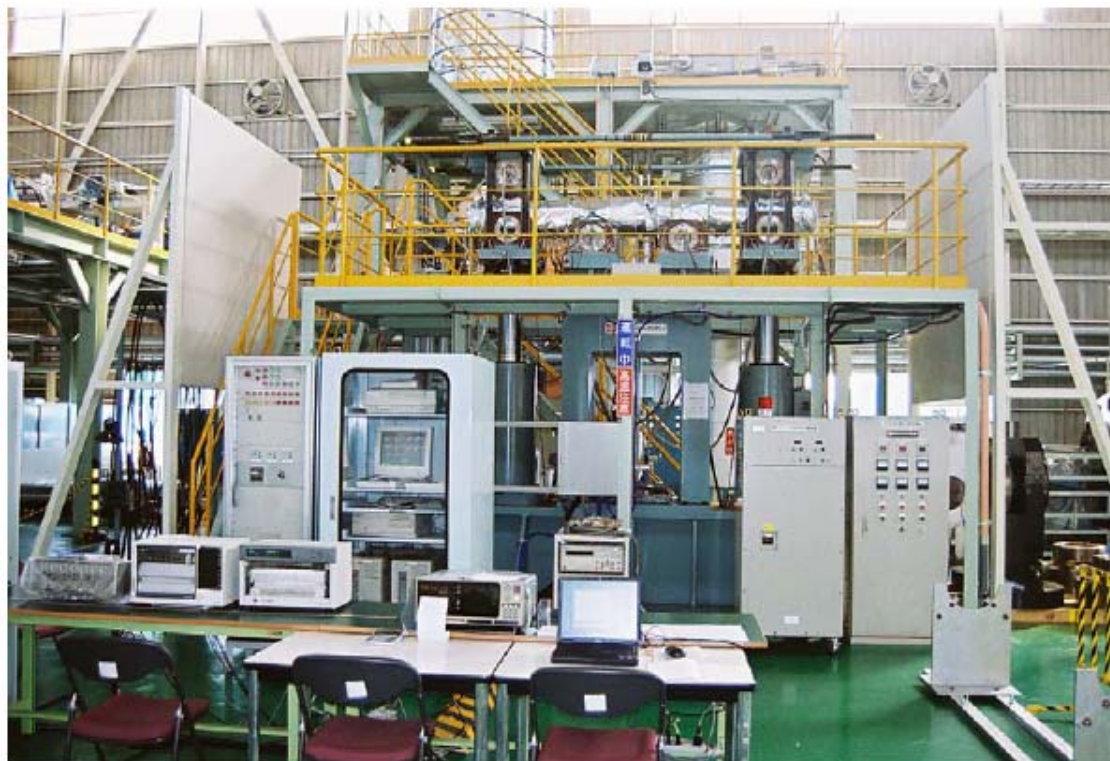
Testing of Medium-Sized Pipe Test Specimen (Internal Heater Applying Heat)

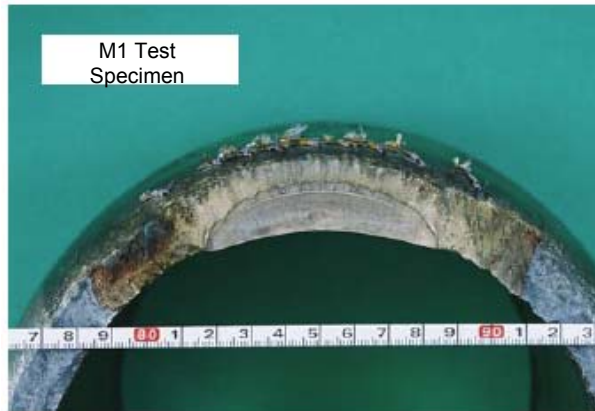
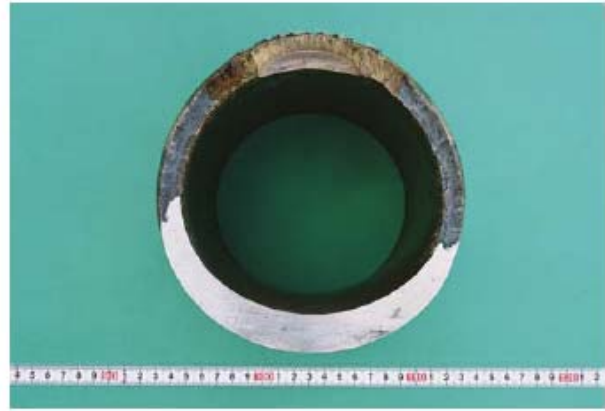
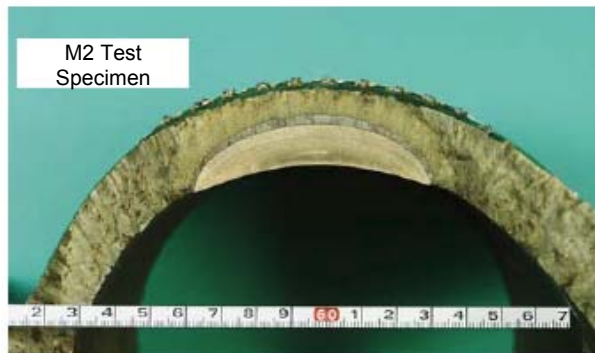
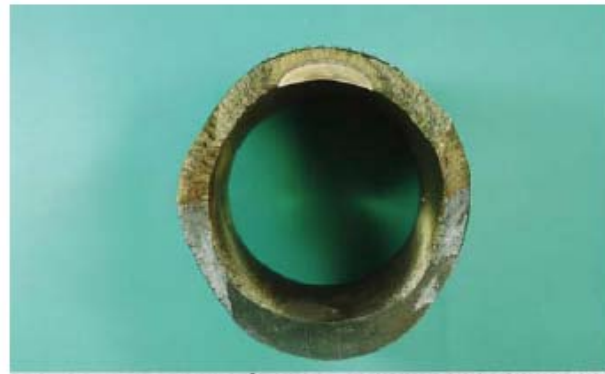
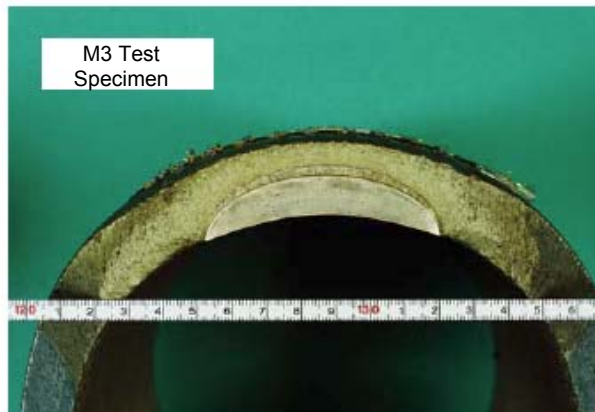
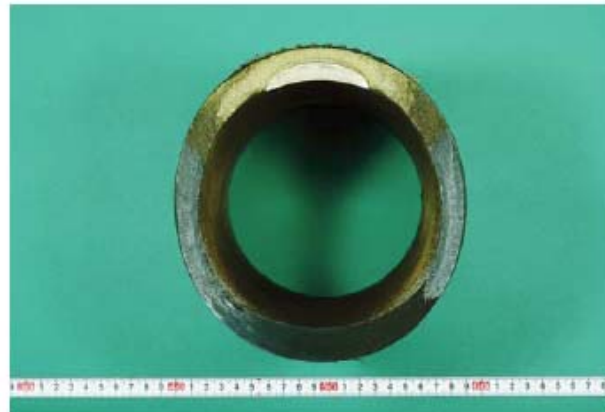
Post-Test Crack States for Medium-Sized Pipe Test Specimen
