APPENDIX A

PREVIOUS WORK

APPENDIX A1
BORING AND TEST PIT LOGS
REMOVAL SITE EVALUATION
MWH, 2007A

Northeast Church Rock Mine, NM

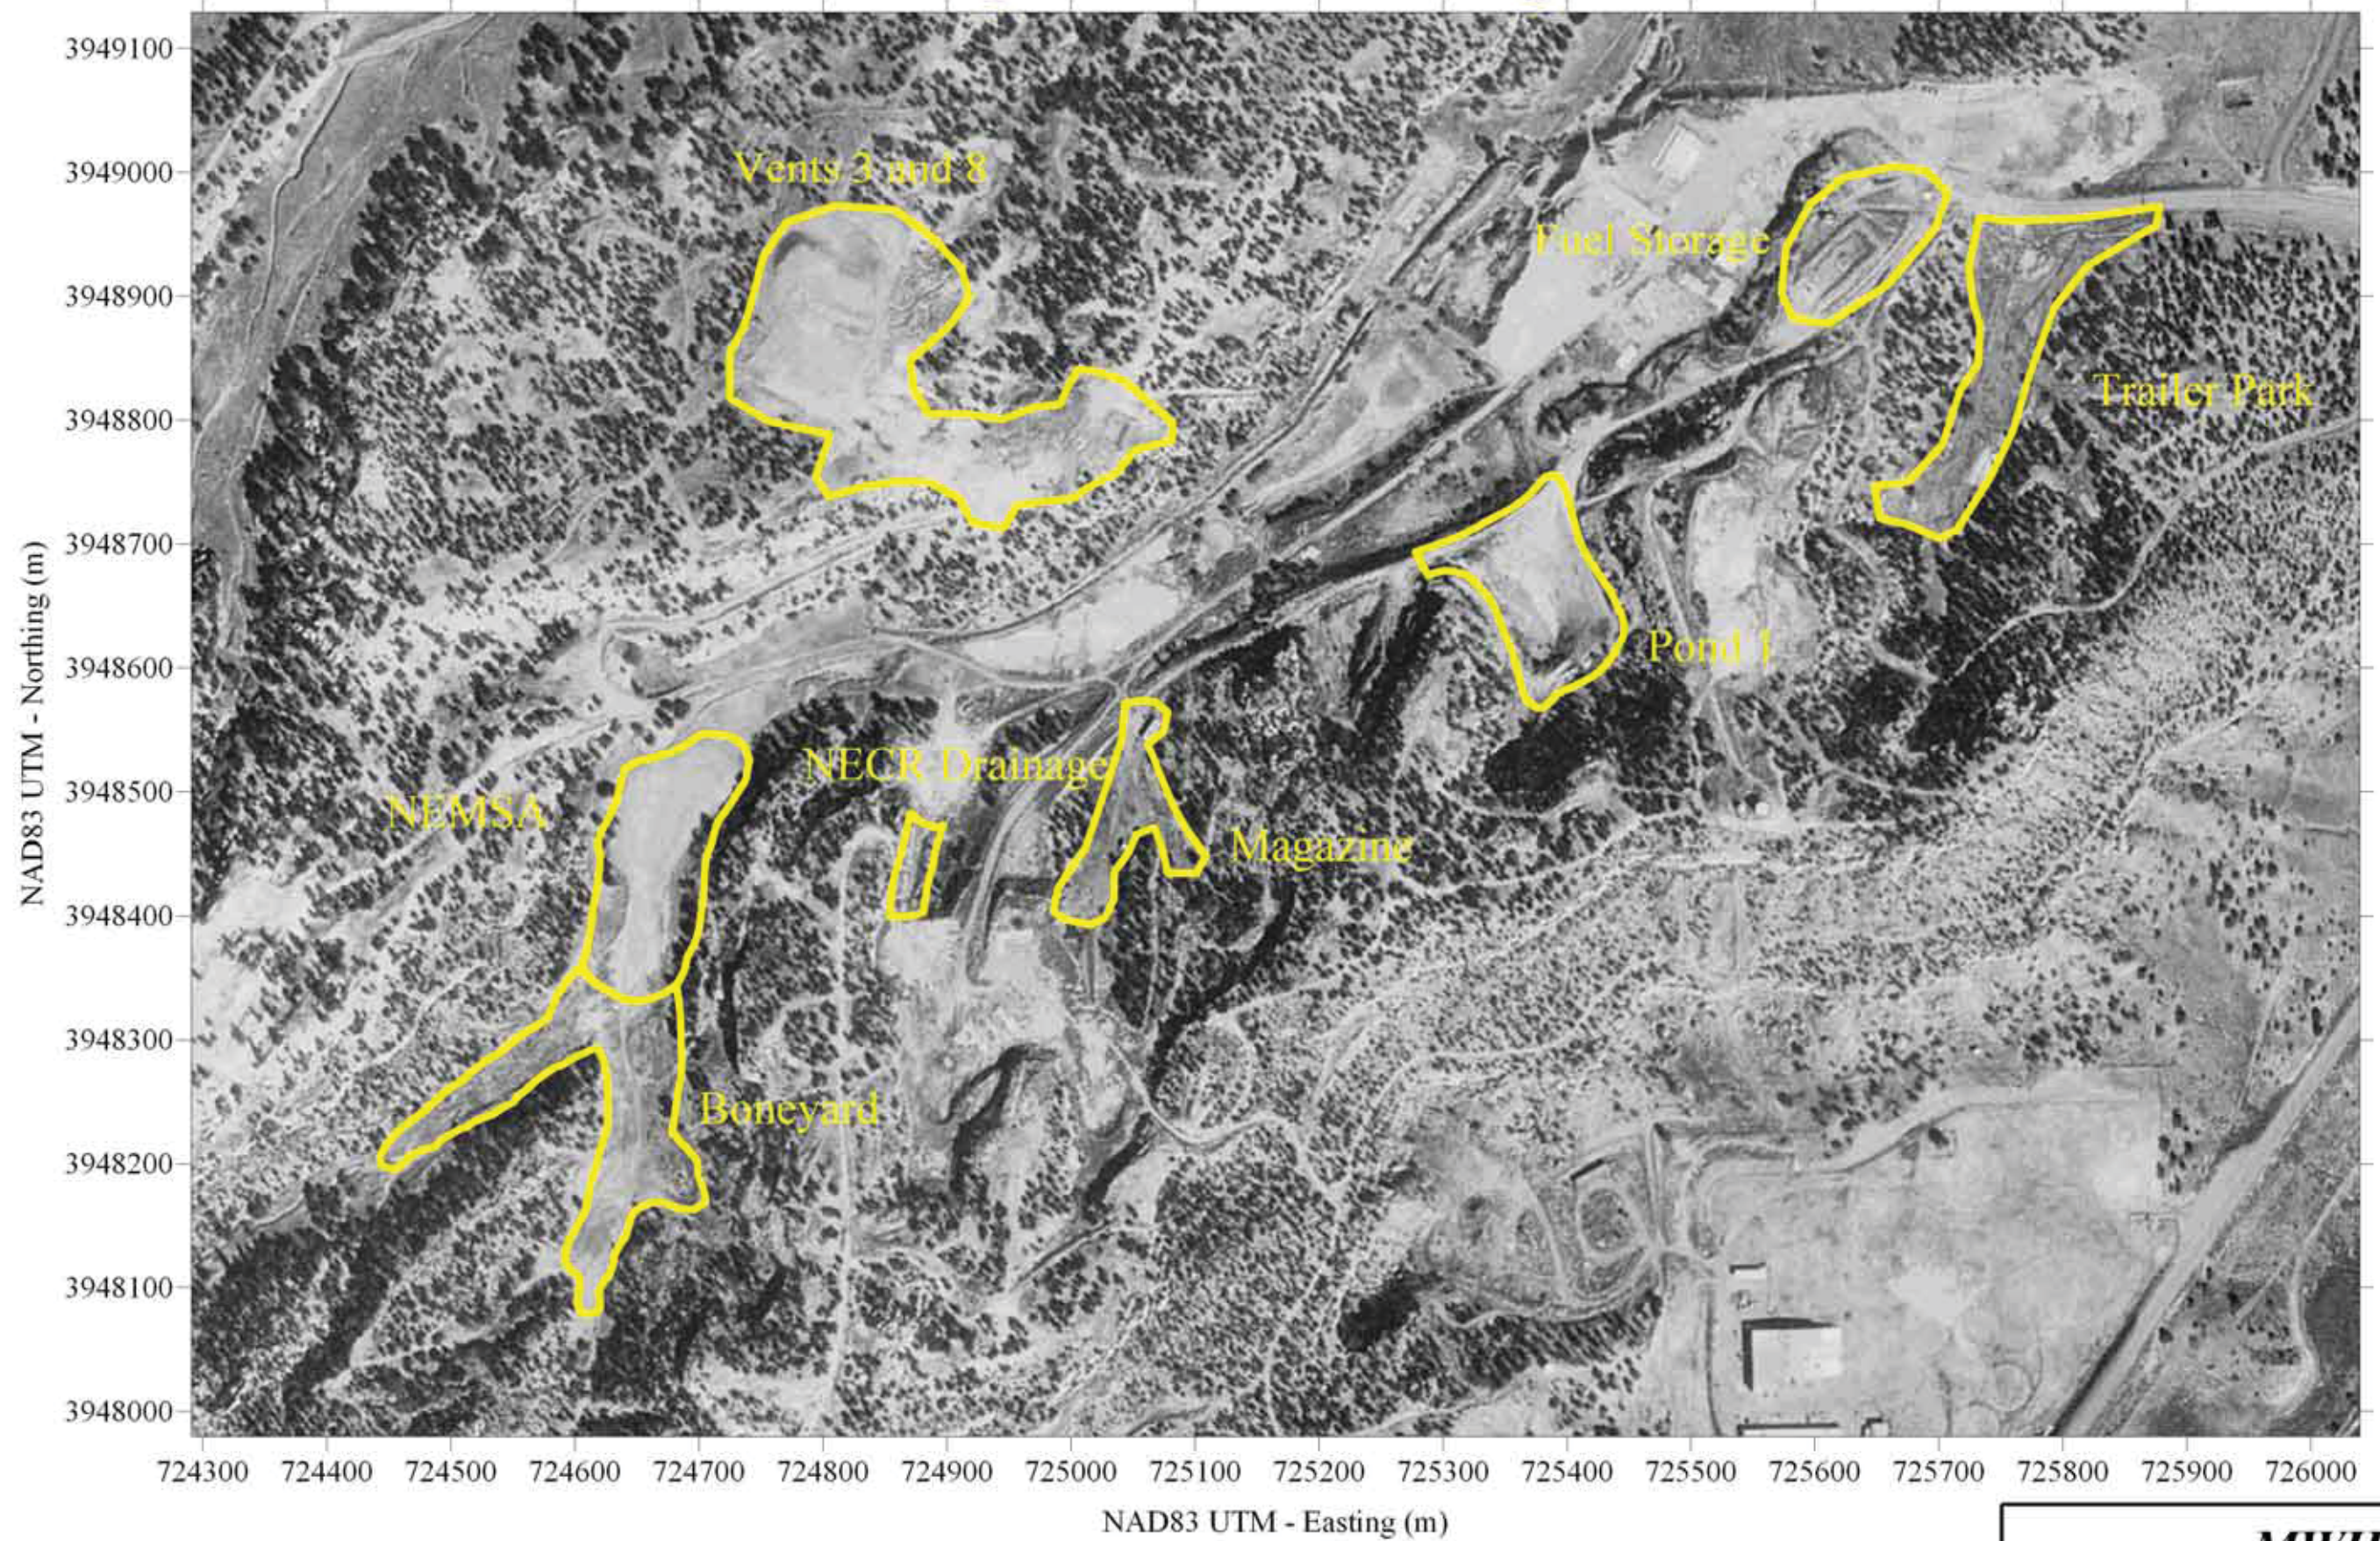
Figure 1 - Base Map

The geophysical survey was conducted within seven survey areas at the Site, as listed below and shown on Figure 1 of Attachment 1, which contains the *Geophysical Survey Report* (HGI, 2007) prepared by the geophysical contractor.

The survey areas are located within the town of Church Rock, New Mexico. The survey areas are interspersed, but are generally located within a 1 mile radius of each other. The survey areas have been decommissioned and no current mining takes place today, only remediation efforts. Refer to Figure 1 for a general base map of the site locations.
