ADDENDUM 3.4-A
WETLANDS DELINEATION

JURISDICTIONAL WETLANDS DELINEATION FOR THE PROPOSED ROSS ISR PROJECT, OSHOTO, WYOMING

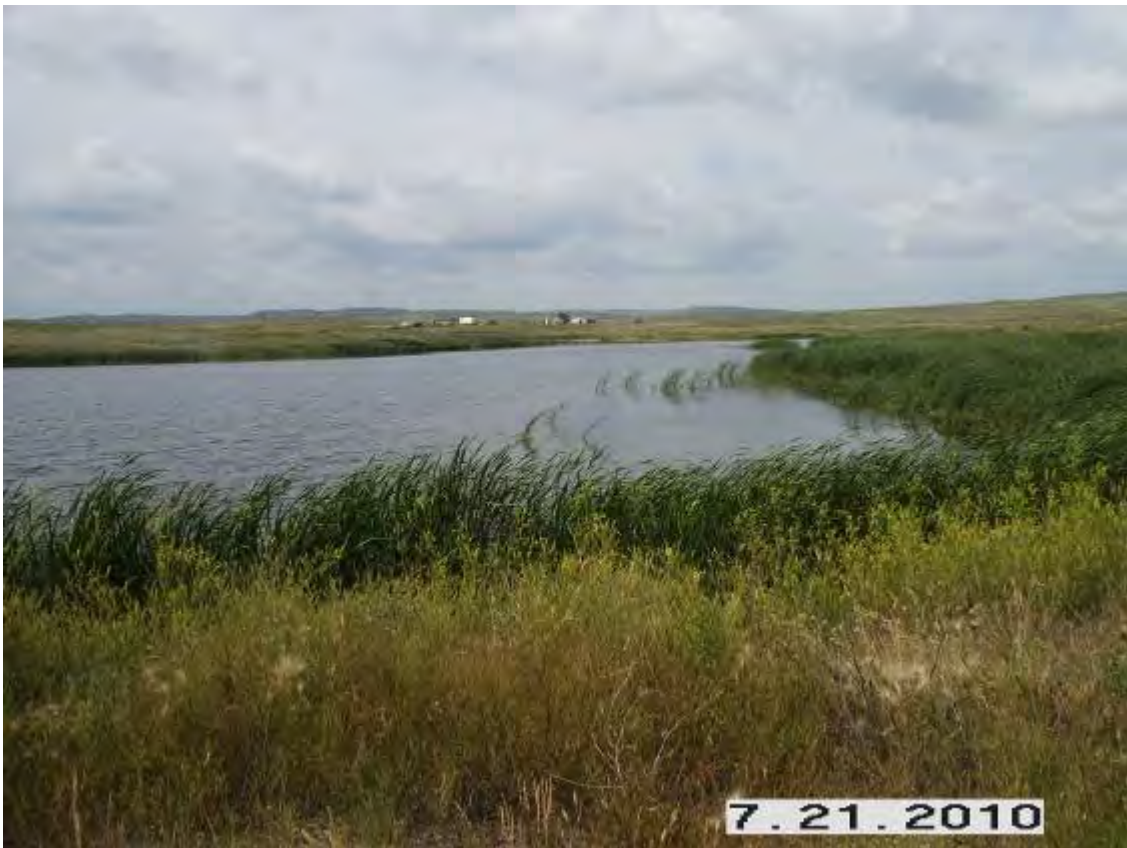
Photo 04. A2 (Lower Portion) Site R5

Site R5 is located at latitude 44.5815° and longitude -104.9503° (Exhibit 1). This site is associated with the main body of the Oshoto Reservoir and is within a Water/Gullied Land soil map unit. *Typha latifolia* and *Scirpus maritimus* dominate the area. *Carex praegracilis*, *C. nebrascensis*, *Eleocharis palustris*, *Potamogeton richardsonii*, *Rumex maritimus*, and *T. angustifolia* were also noted in the area but not within the vegetation

plot. Positive indicators of hydrophytic vegetation, hydric soil, and wetland hydrology were present at the sample point. This area meets all three diagnostic environmental characteristics of a wetland as defined by the COE (COE 2008) and it appears to be a wetland (Appendix A, Sample Point R5 and Appendix B, Photo 04).

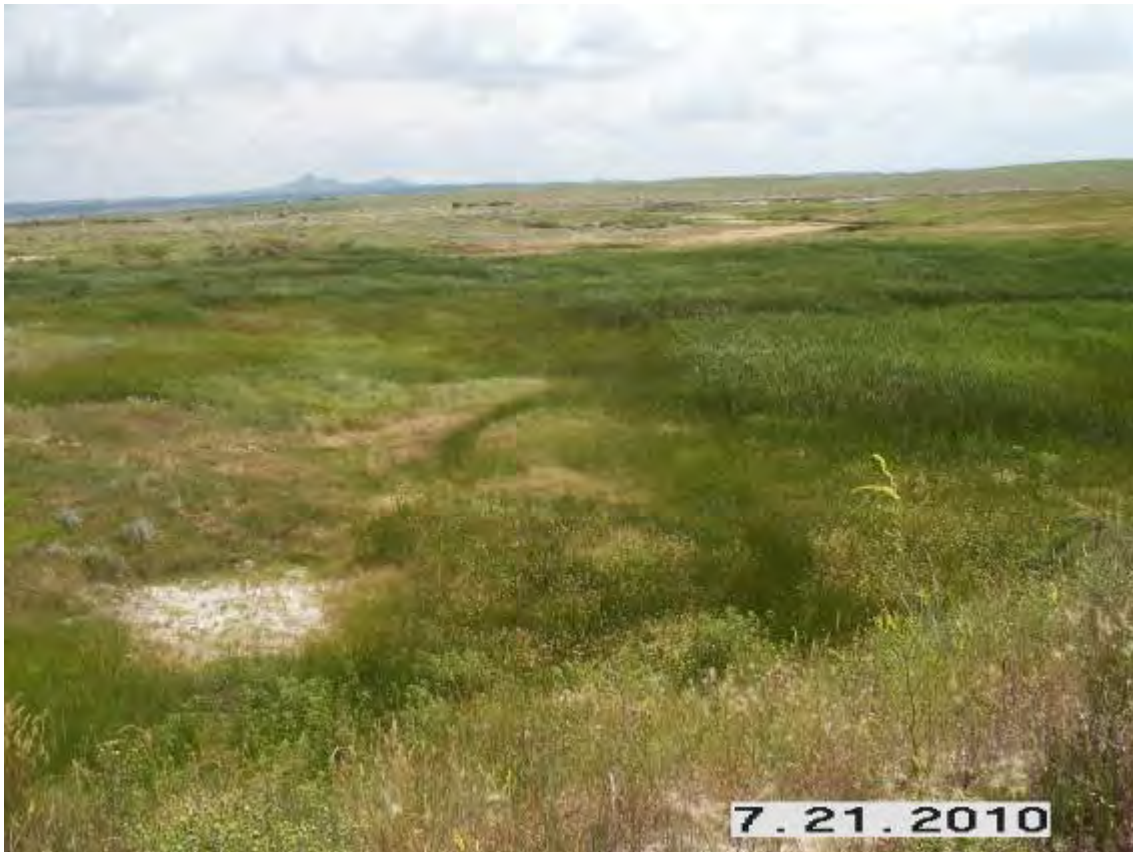
Photo 07. A4 (Upper Portion) Site R6

Site R6 is located at latitude 44.5811° and longitude -104.9495° (Exhibit 1). This site is directly below the Oshoto Reservoir and likely receives seepage from the reservoir and also is receiving some water from a groundwater source and is within a Gullied Land soil map unit. *Typha latifolia*, *T. angustifolia*, and *Carex lanuginosa* dominate the area. Positive indicators of hydrophytic vegetation, hydric soil, and wetland hydrology are associated with the area. This area meets all three diagnostic environmental characteristics of a wetland as defined by the COE (COE 2008) and it appears to be a wetland (Appendix A, Sample Point R6 and Appendix B, Photo 07).

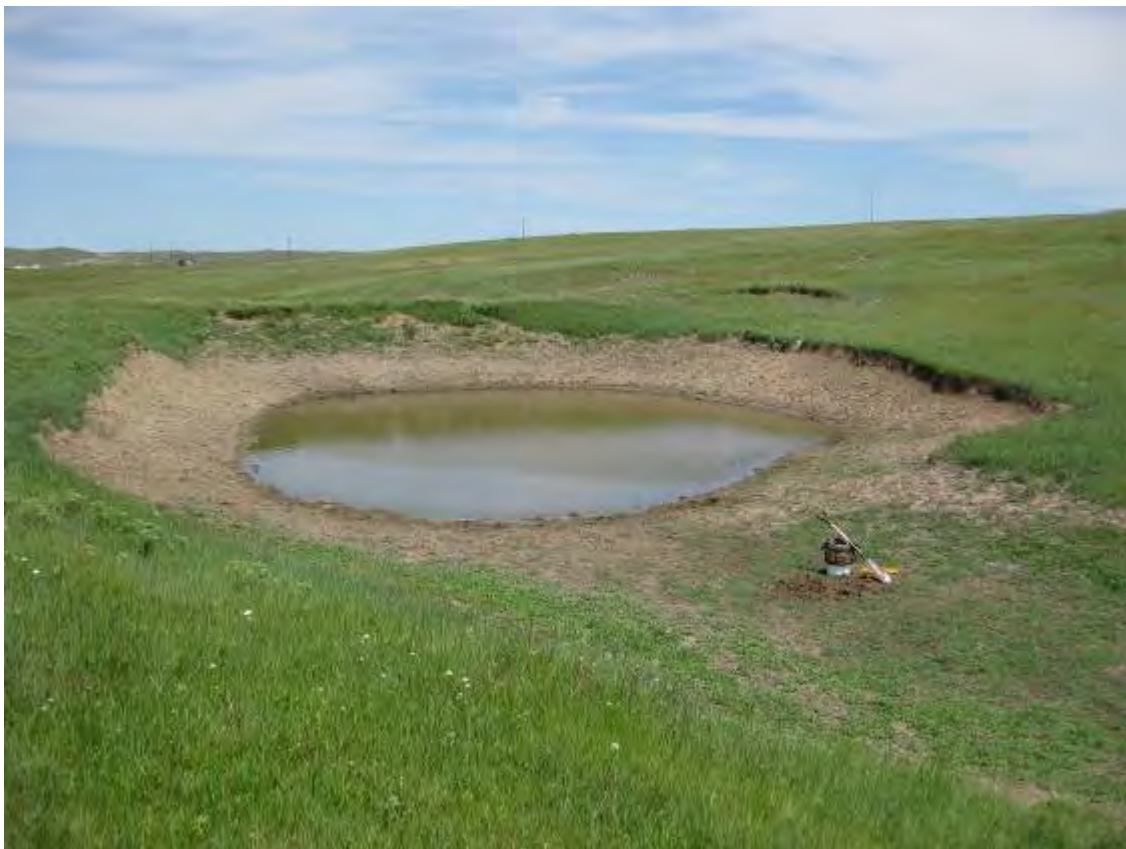
Photo 12. B2 (Site R1)

Site R1 is located at latitude 44.5640° and longitude -104.9522° (Exhibit 1). This site is associated with a small man made stock pond located on an ephemeraally-flowing tributary to the Little Missouri drainage and is within a Fort Collins Loam (6-10% Slope) soil map unit. It appears to be typical of an impoundment situation in that it has a relatively large amount of bare ground (approximately 98 percent) associated with the site. *Equisetum variegatum* dominates the vegetation within the area. Positive indicators of hydrophytic vegetation, hydric soil, and wetland hydrology are associated with the area. This area meets all three diagnostic environmental characteristics of a wetland as defined by the COE (COE 2008) and it appears to be a wetland (Appendix A, Sample Point R1 and Appendix B, Photo 12).

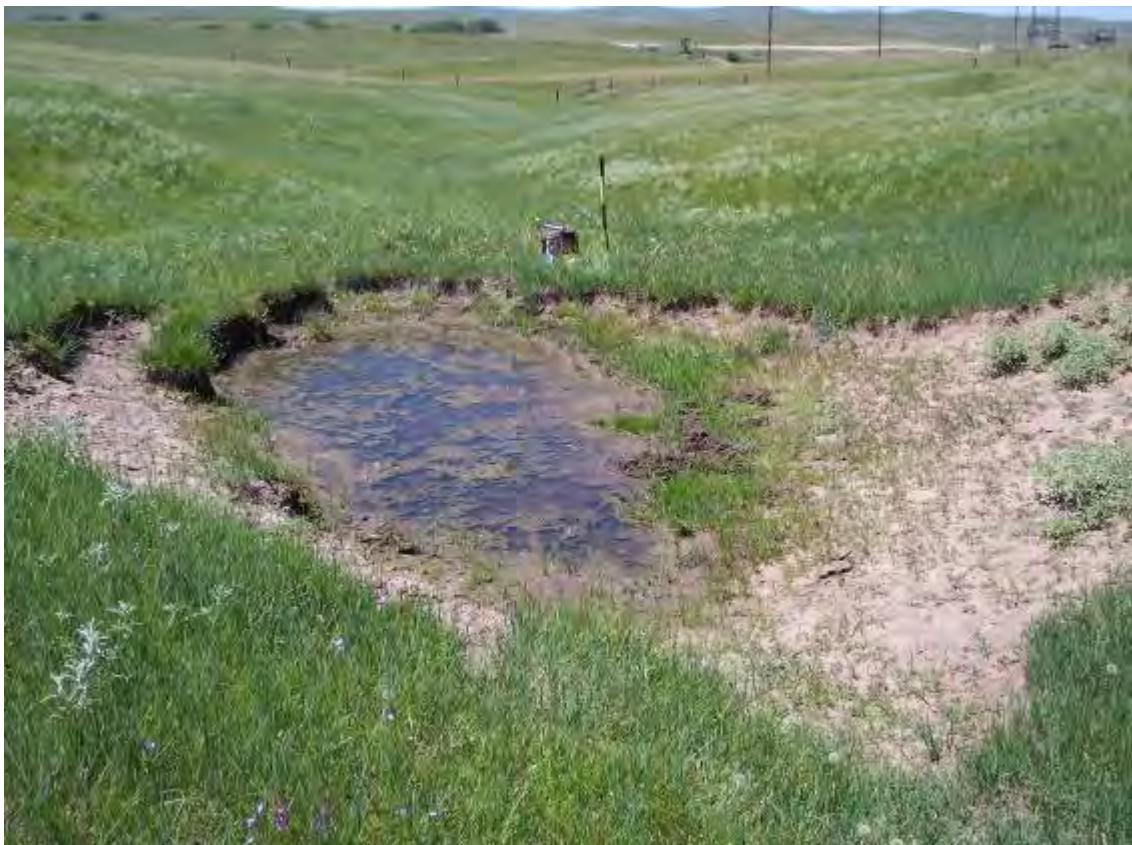
Photo 16. B6 (Site R2)

Site R2 is located at latitude 44.5674° and longitude -104.9520° (Exhibit 1). This site is within a small depression located on an ephemeraally-flowing tributary to the Little Missouri drainage and is within a Fort Collins Loam (6-10% Slope) soil map unit. The

dominant vegetative types include *Marsilea vestita* and *Equisteum Variegatum*. Positive indicators of hydrophytic vegetation, hydric soil, and wetland hydrology are associated with the area. The site may be receiving water from a groundwater source (seep), which helps maintain saturated conditions longer than the site location (higher on the drainage) would indicate. This area meets all three diagnostic environmental characteristics of a wetland as defined by the COE (COE 2008) and it appears to be a wetland (Appendix A, Sample Point R2 and Appendix B, Photo 16).

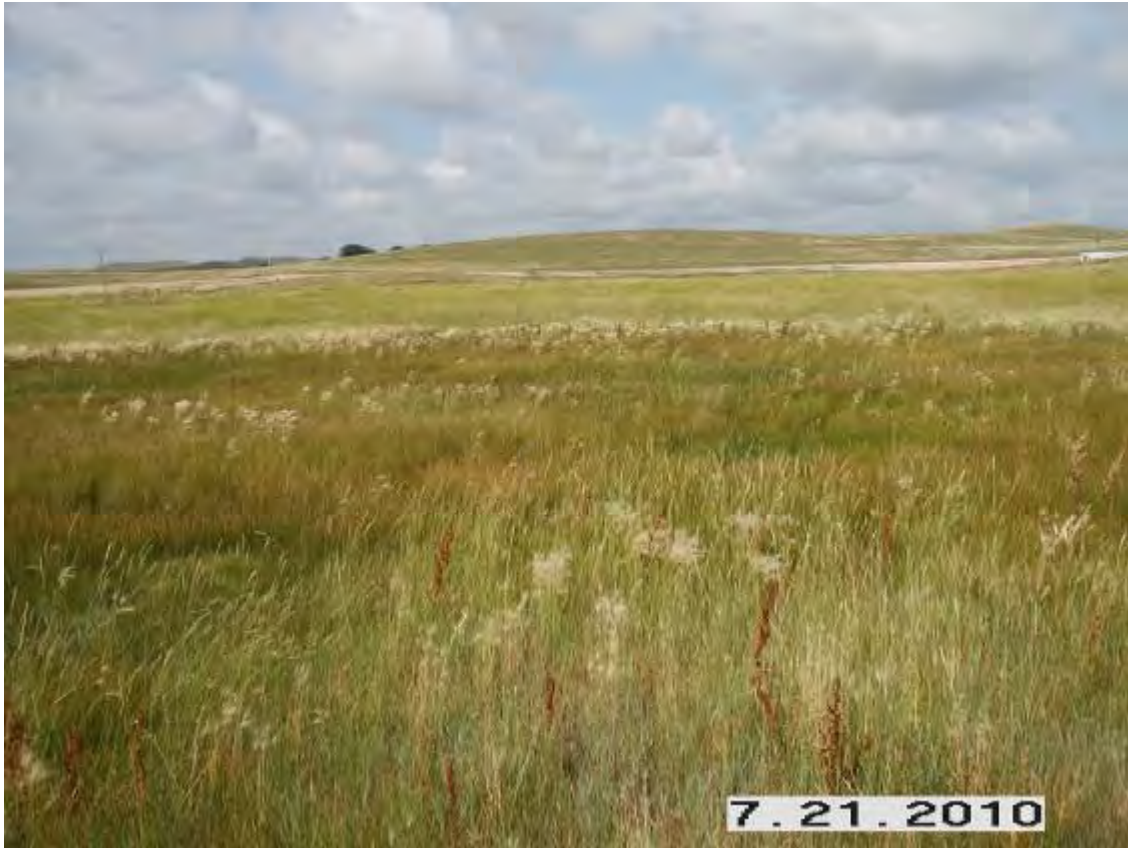
Photo 23. D2 (Site R3)

Site R3 is located at latitude 44.5716° and longitude -104.9601° facility (Exhibit 1). This site is located on an ephemerally-flowing tributary within is an excavated depression that is associated with a decommissioned uranium processing facility and is within an Absted-Bone Complex (0-3% Slope) soil map unit. *Eleocharis palustris* dominates the area. Positive indicators of hydrophytic vegetation, hydric soil, and wetland hydrology are associated with the area. This area meets all three diagnostic environmental characteristics of a wetland as defined by the COE (COE 2008) and it appears to be a wetland (Appendix A, Sample Point R3 and Appendix B, Photo 23).

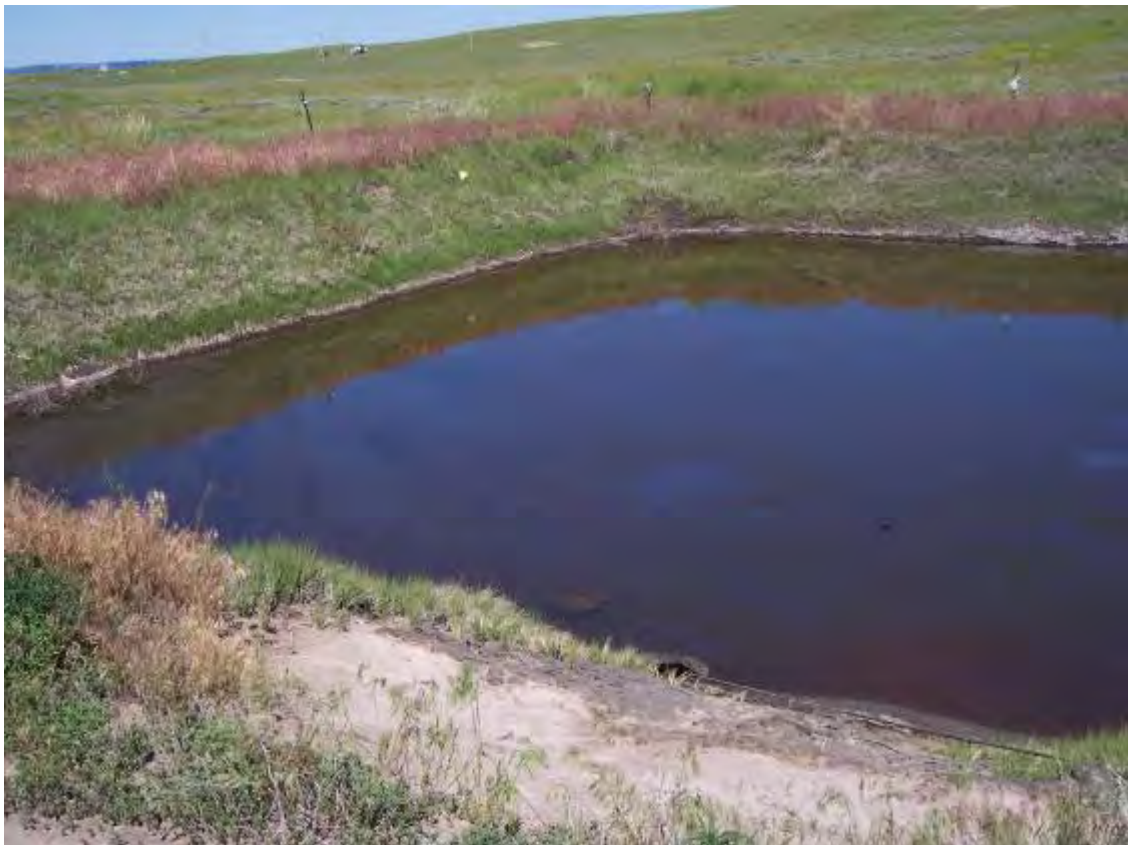
Photo 24. E1 (Site R8)

Site R8 is located at latitude 44.5723° and longitude -104.9601° (Exhibit 1). This site is associated with a man made oil well production pit and is within an Absted-Bone Complex (0-3% Slope) soil map unit. *Agropyron smithii* and *Hordeum jubatum* dominate the area. Although positive indicators of wetland hydrology are associated with the area, it does not meet all three diagnostic environmental characteristics of a wetland as defined by the COE (COE 2008). It does not appear to be a wetland (Appendix A, Sample Point R8 and Appendix B, Photo 24).

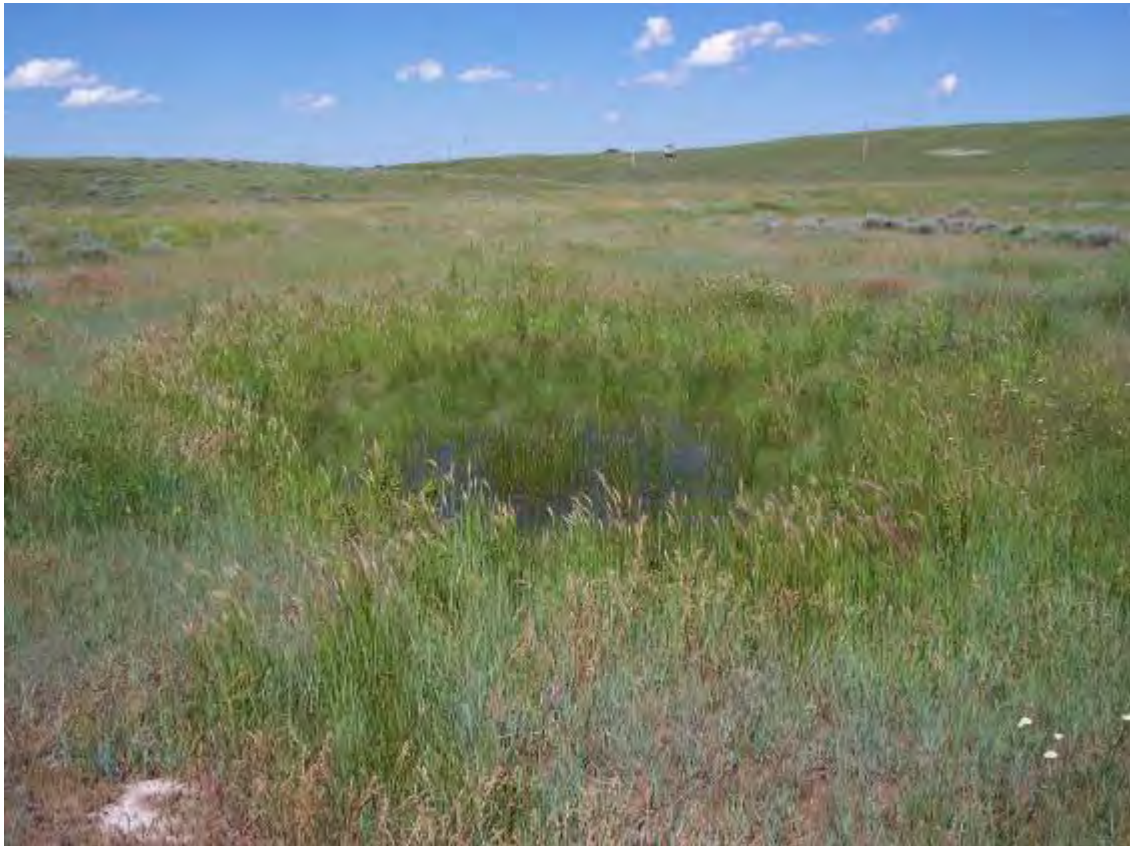
Photo 25. F1 (Site R4)

Site R4 is located at latitude 44.5734° and longitude -104.9599°. This site is within a small depression located on an ephemerally-flowing tributary to the Little Missouri drainage and is within an Absted-Bone Complex (0-3% Slope) soil map unit. *Eleocharis palustris* and *Hordeum jubatum* dominate the area. Positive indicators of hydrophytic vegetation, hydric soil, and wetland hydrology were present at the sample point. The site may be receiving water from a groundwater source. This area meets all three diagnostic environmental characteristics of a wetland as defined by the COE (COE 2008) and it appears to be a wetland (Appendix A, Sample Point R4 and Appendix B, Photo 25).

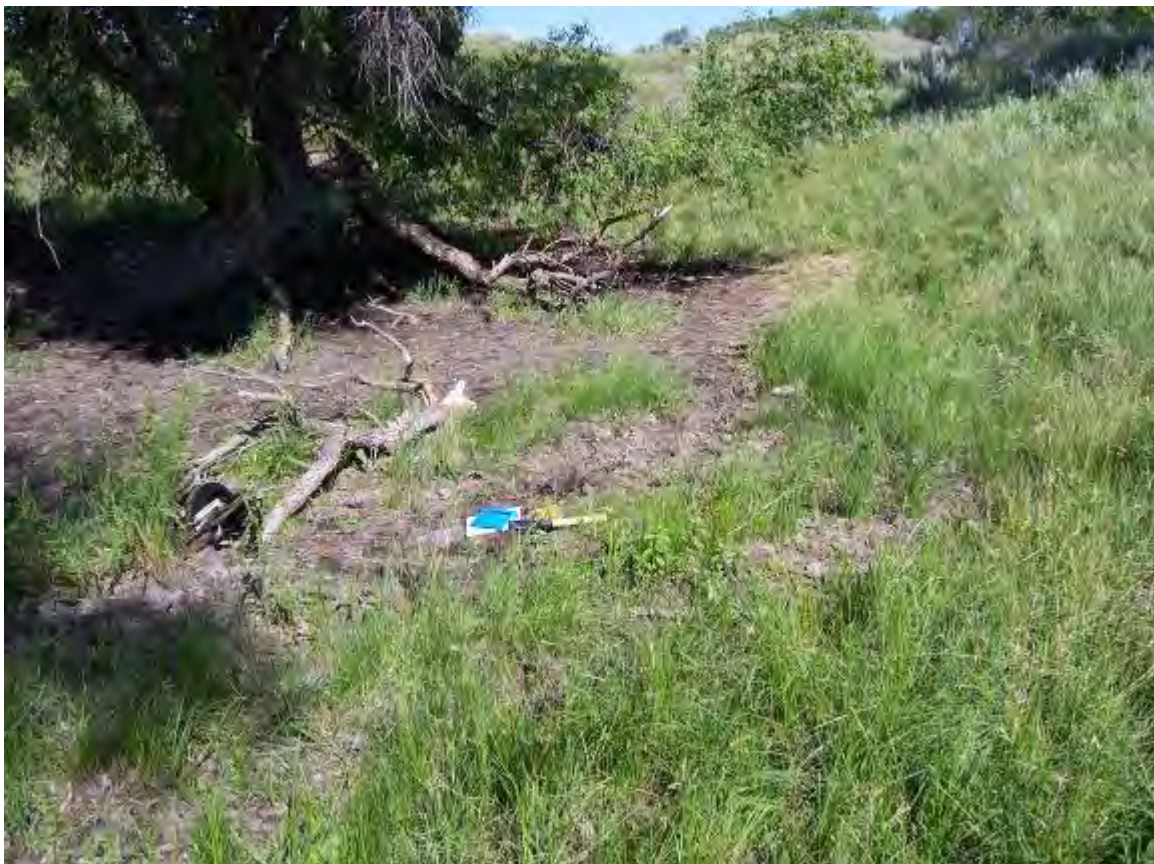
Photo 39. G2 Lower Portion (Site R7)

Site R7 is located at latitude 44.5675° and longitude -104.9640° (Exhibit 1). This site is within a depression above a road fill that has restricted flow down the drainage and is within a Bidman-Bone Loams (2-6% Slope) soil map unit. *Sporobolus airoides* and *Hordeum jubatum* dominate the area. *Carex praegracilis*, *C. nebrascensis*, *Sagittaria cuneata*, *Potamogeton nodosus*, and *Phleym pretense* were also noted in the area but not within the vegetation plot. Positive indicators of hydrophytic vegetation, hydric soil, and wetland hydrology are associated with the area. This area meets all three diagnostic environmental characteristics of a wetland as defined by the COE (COE 2008) and it appears to be a wetland (Appendix A, Sample Point R7 and Appendix B, Photo 39).

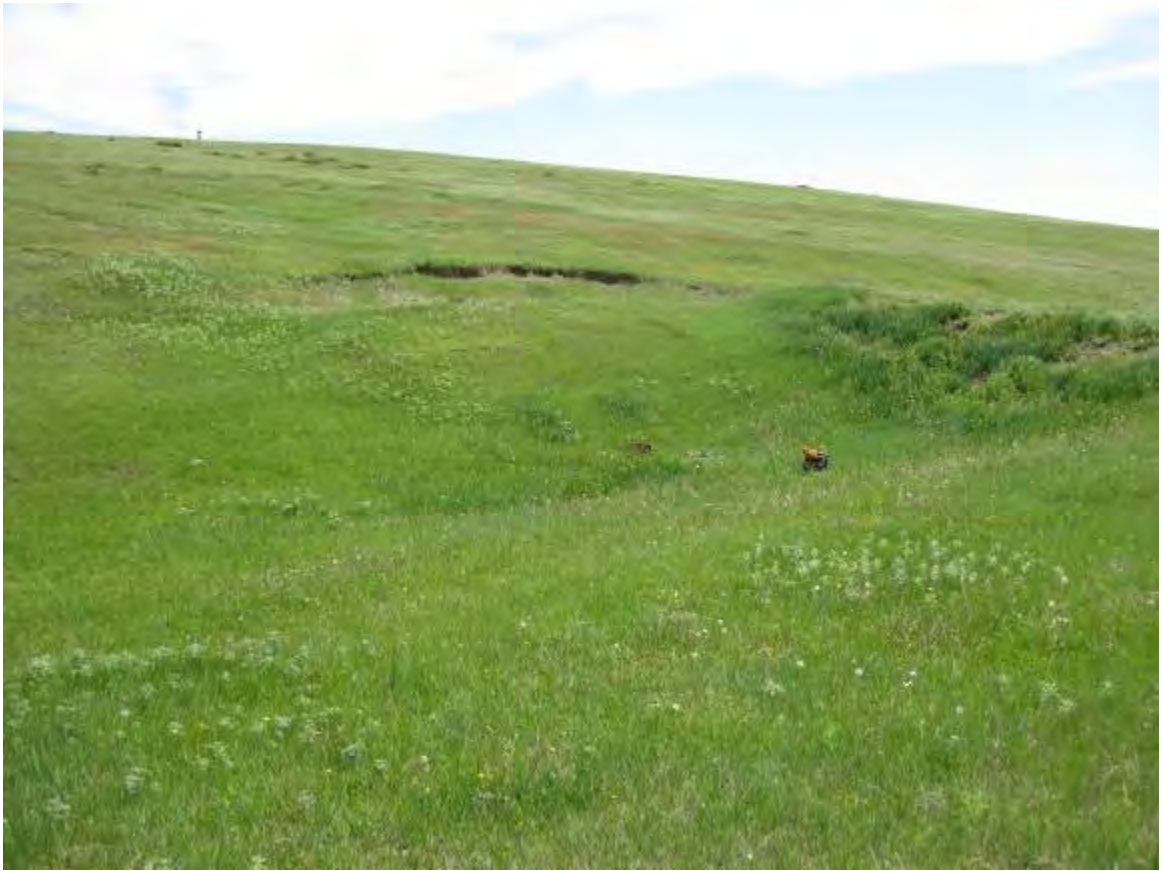
Photo 64. Site R9

Site R9 is located at latitude 44.5642° and longitude -104.9522° (Exhibit 1). This site is directly below a small stock pond (Site r1) and is within a Fort Collins Loam (6-10% Slope) soil map unit. *Agropyron smithii* and *Poa pratensis* dominate the area. Positive indicators of hydrophytic vegetation, hydric soil, or wetland hydrology are not associated with the area. This area does not meet any of the three diagnostic environmental characteristics of a wetland as defined by the COE (COE 2008) and it does not appear to be a wetland (Appendix A, Sample Point R9 and Appendix B, Photo 64). This site was evaluated since it represented an area that had the potential to be a wetland (possibly receiving seepage from the stock pond) but did not exhibit classic wetland characteristics.
