AEAT - 2568

Testing of BNFL DN3516 Type A(F) Container

N A H Palmer
J E Gillard

November 1997

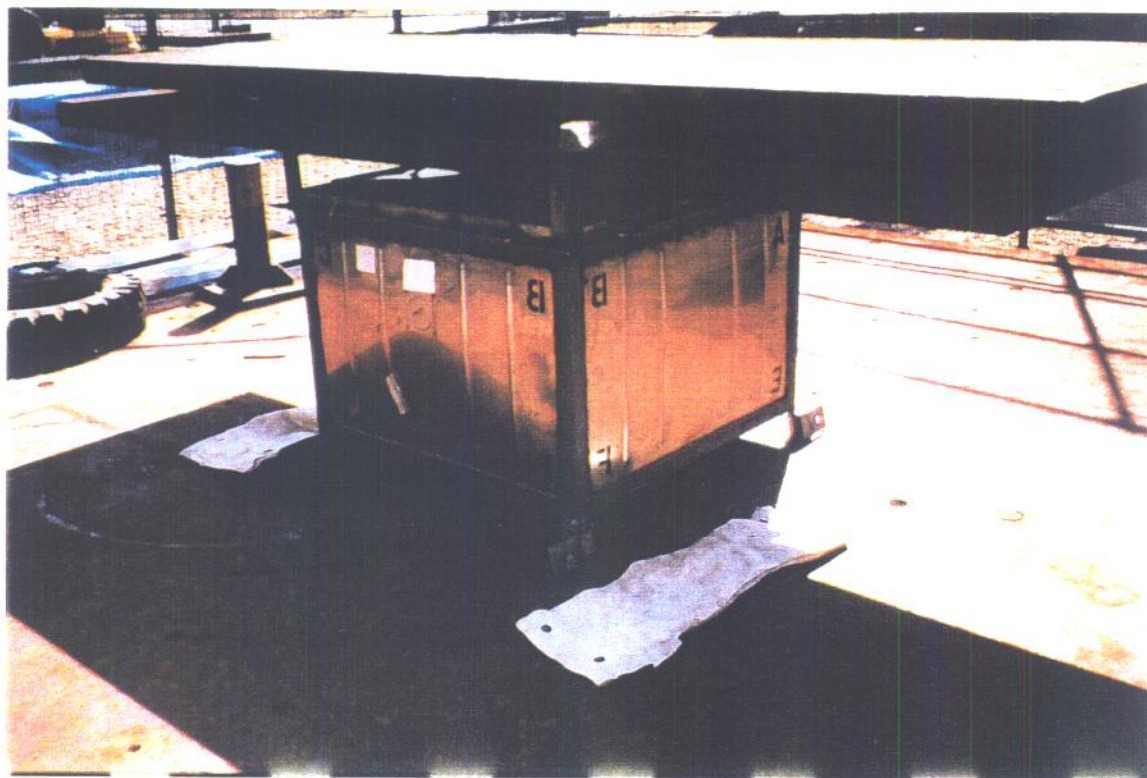
Figure 1 - Stacking Test

No damage or permanent distortion was visible when the 4.2 tonne load was removed, therefore the package had passed the stacking test.

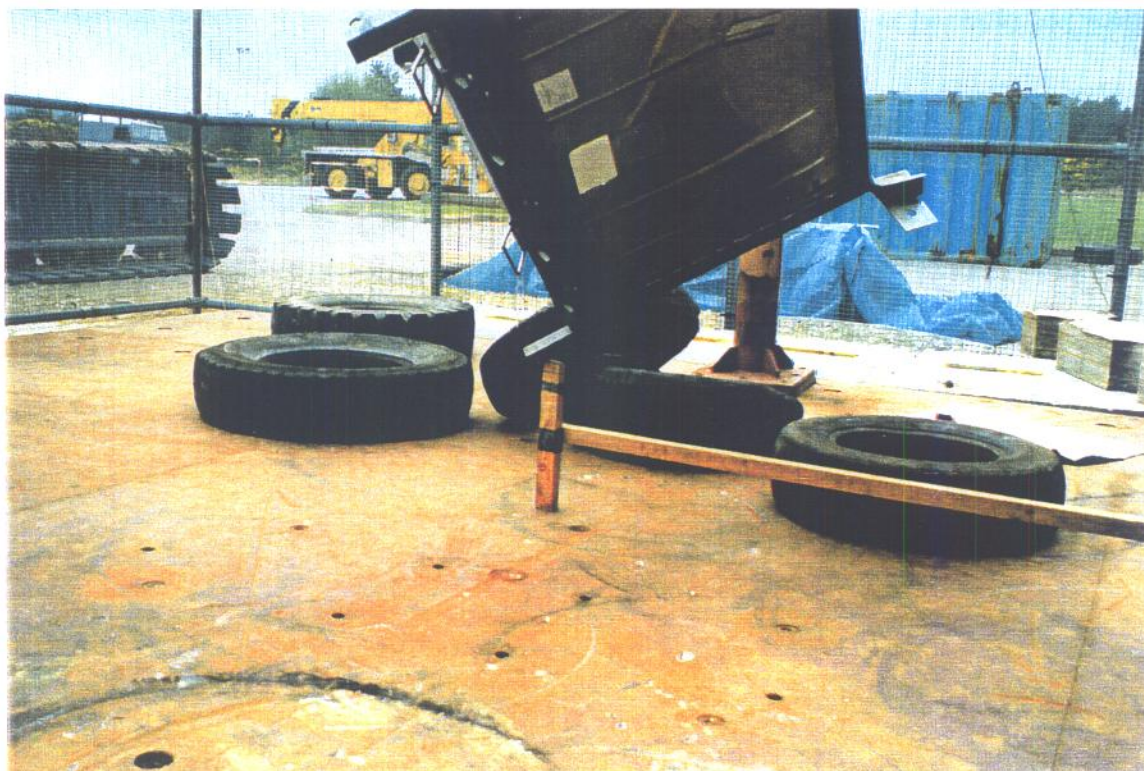
Figure 2 - Slings Arrangement for 0.3 m Corner Drops

Four 0.3 m drop tests were carried out onto each of the lid corners. To prevent slap-down to the package tyres were placed to absorb the secondary impact, the arrangement can be seen in figures 2 and 3. The drops were carried out in sequence on corners A to D. To achieve the correct angle of drop the package was suspended from the diagonally opposite base, e.g. to impact on corner A the package was slung from base G. Photographs of all the tests were taken but are not included in the report, each test was recorded on video and measurements taken of the resulting damage.

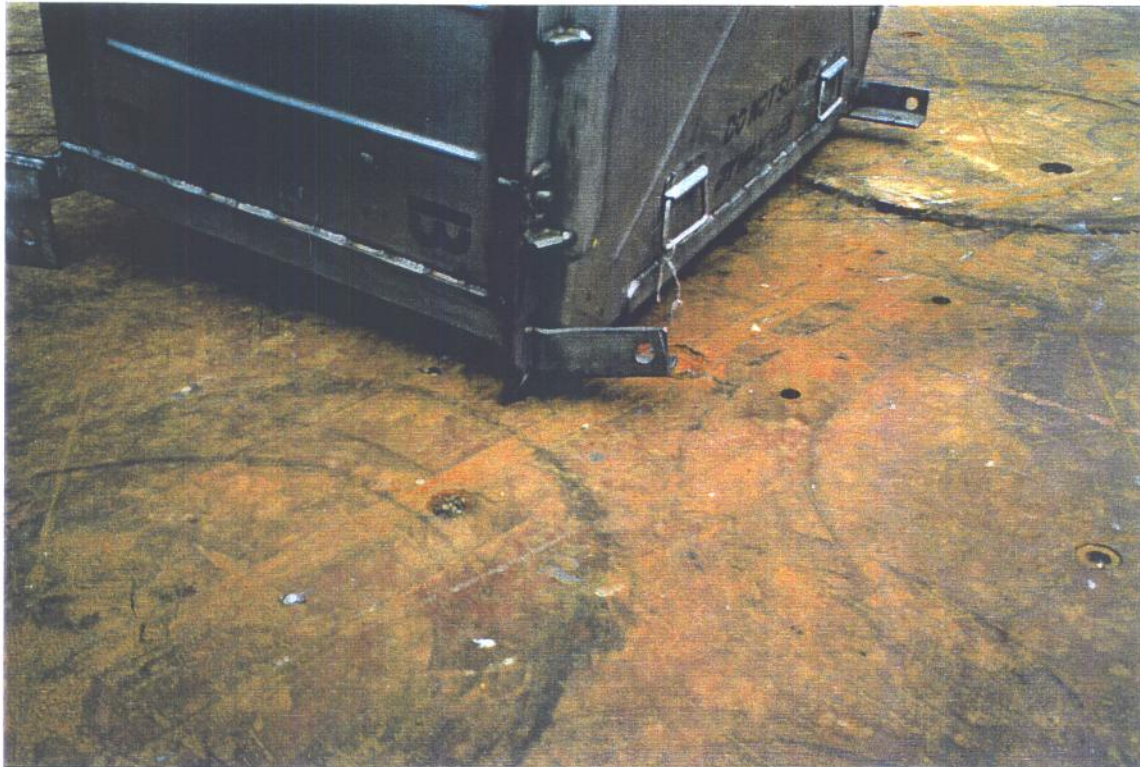
Figure 4 -Typical Damage to Package Following 0.3 m Corner Drop

Impact damage to the corner upright angle and flange was similar for all drops. The flanges were bent over a length of about 30 mm and the angle by about 40 mm, there was no visual evidence of weld damage or damage to the lid. Figure 4 shows typical resulting damage to a flange and upright angle. Details of damage to corners A,B,C,D are shown in figures 6,7,8,9 respectively.

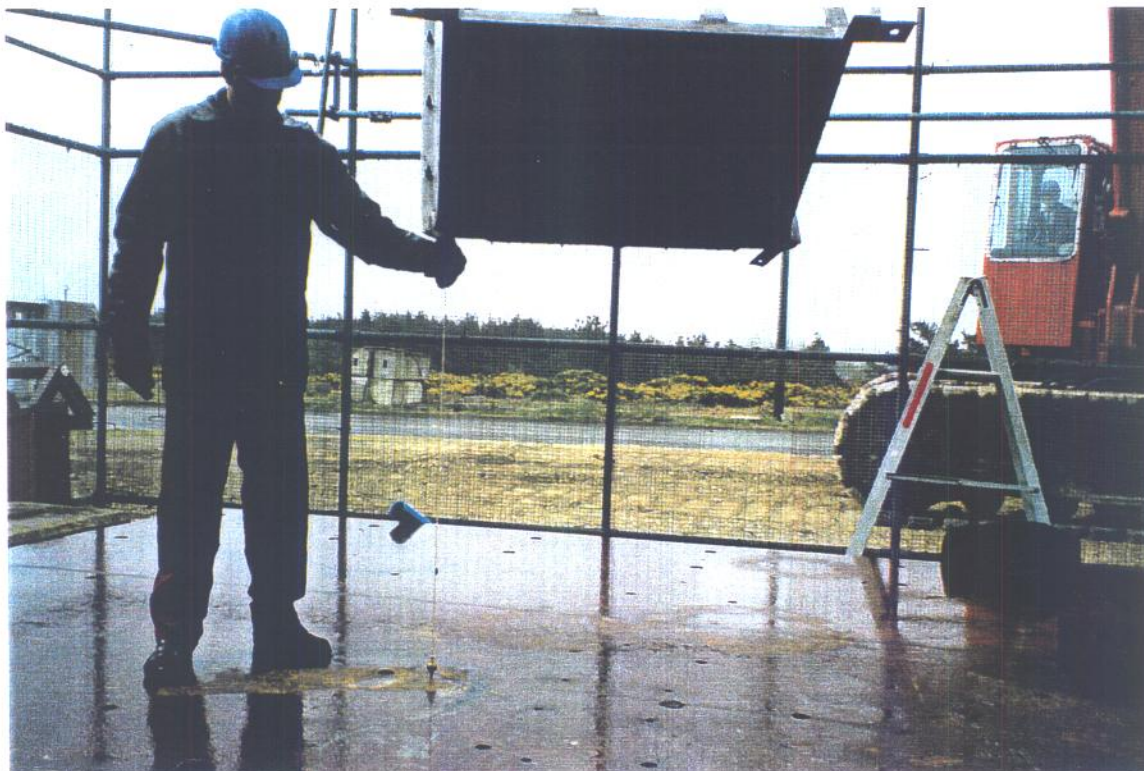
Figure 5 - Package Suspended for 1.2m Drop Test

A 1.2 m drop was carried out onto edge A-B as per the specification. Figure 5 shows the package suspended prior to release, the drop height was determined by attaching a pre-measured plumb line to the bottom of edge A-B. The drop test was recorded on video and the resulting damage recorded photographically and measurements taken of the resulting damage.

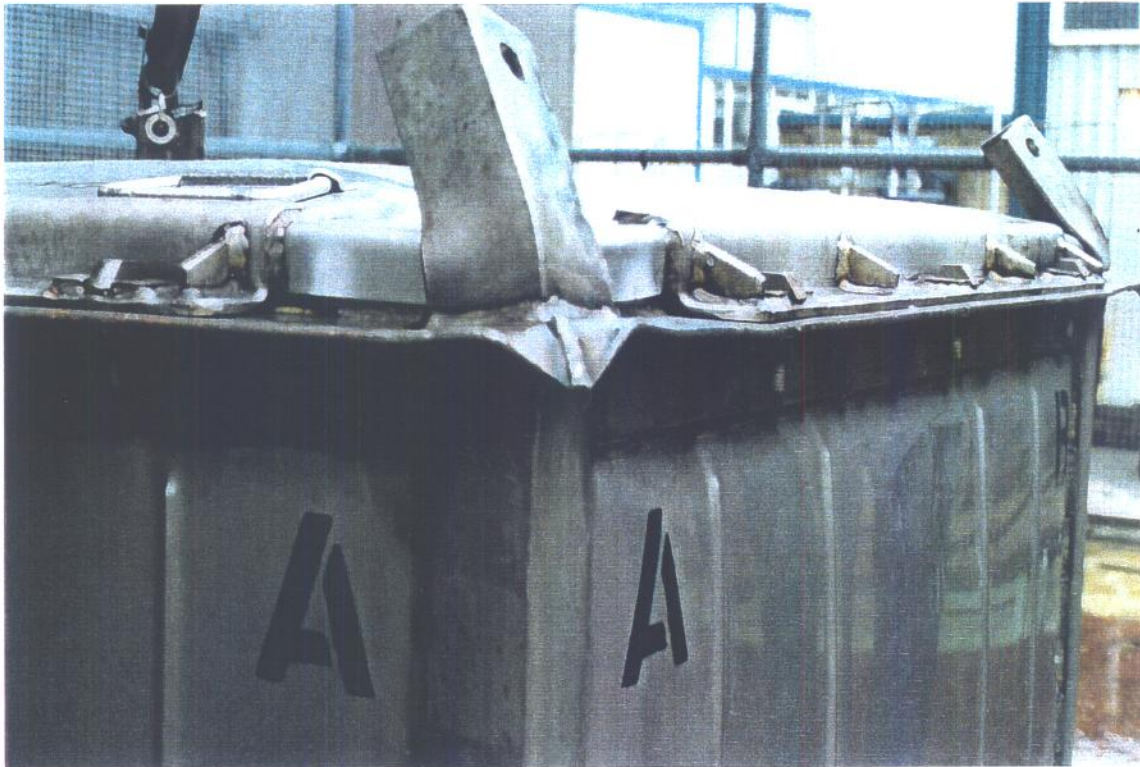
Figure 11 - View of Damage after 1.2m Drop From Corner A

Figures 11,12,13 and 14 show the resulting damage. Most of the impact was absorbed by the corners A and B which resulted in further distortion of the angles and flanges at corners. The lid had also buckled at the corners and some distortion had occurred to the lid along the edge AB. The package internal had shifted resulting in the face ABEF bowing.

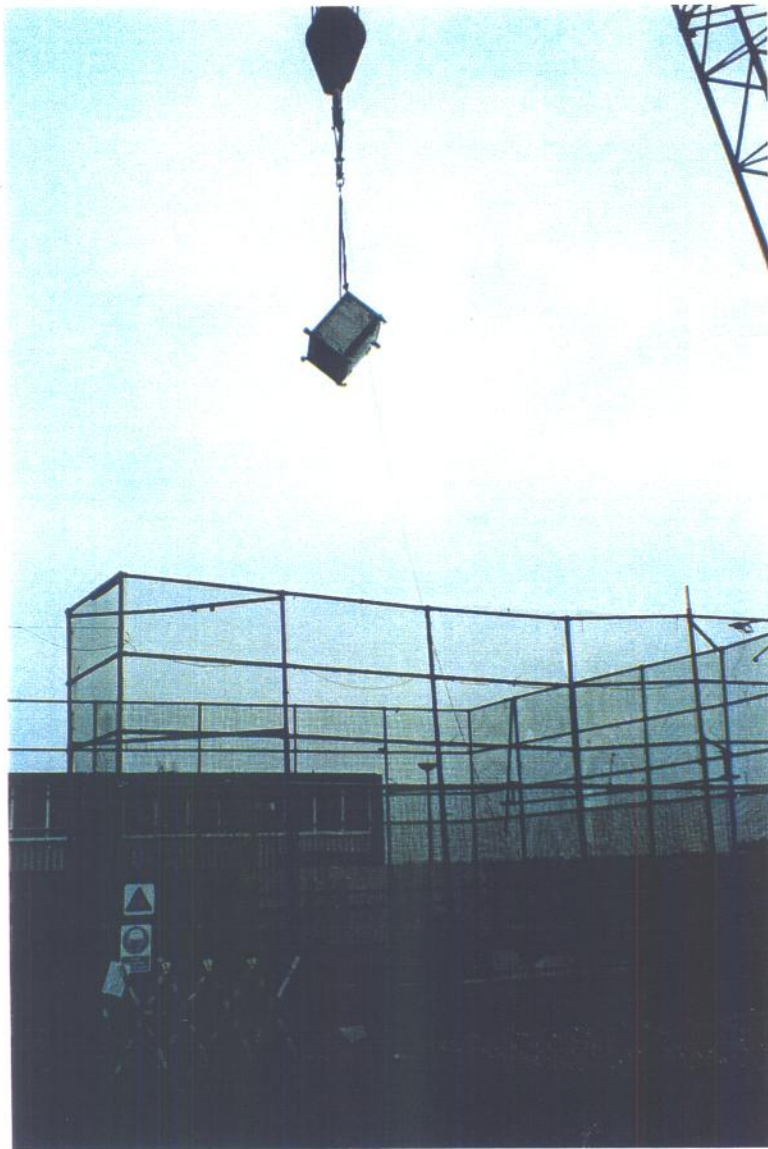
Figure 15 - Package Suspended Prior to Lifting to 9.0m Edge Drop

The orientation of the package was the same as for the 1.2 m drop as instructed by the DETR Inspector. Figure 15 shows the package suspended prior to release, the drop height was determined by a plumb line attached to edge AB. The drop test was recorded on video, however, the recording was lost when the punch test was accidentally taped over the 9 m drop. Photographs of the resulting damage were taken and measurements taken.

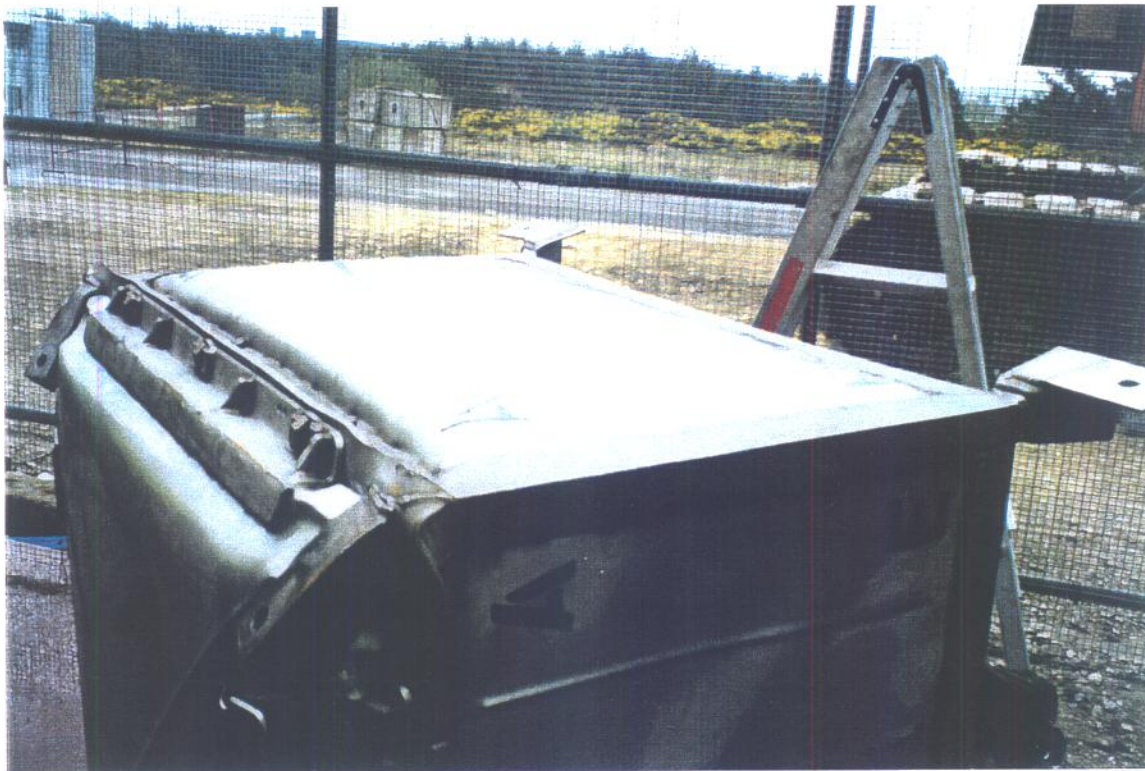
Figure 16 - Package Following 9.0m Drop onto Edge A-B Viewed from A-E

Figures 16 to 20 show the damage to the package following the 9 m drop onto edge AB. Considerable distortion occurred at the corners resulting in failure of the weld between the angles and the flange and further buckling of the lid (see figures 18 and 19). The impact also caused the sides BCFG and ADEH to buckle (see figures 16 and 17). Movement of the package internals had resulted in further bowing of face ABEF and the package lid had also bowed considerably (see figure 17). The impact also damaged the lid bolts on edge AB all of which had cracked. Some distortion was noted to the edge CD which had bent at the centre towards AB.

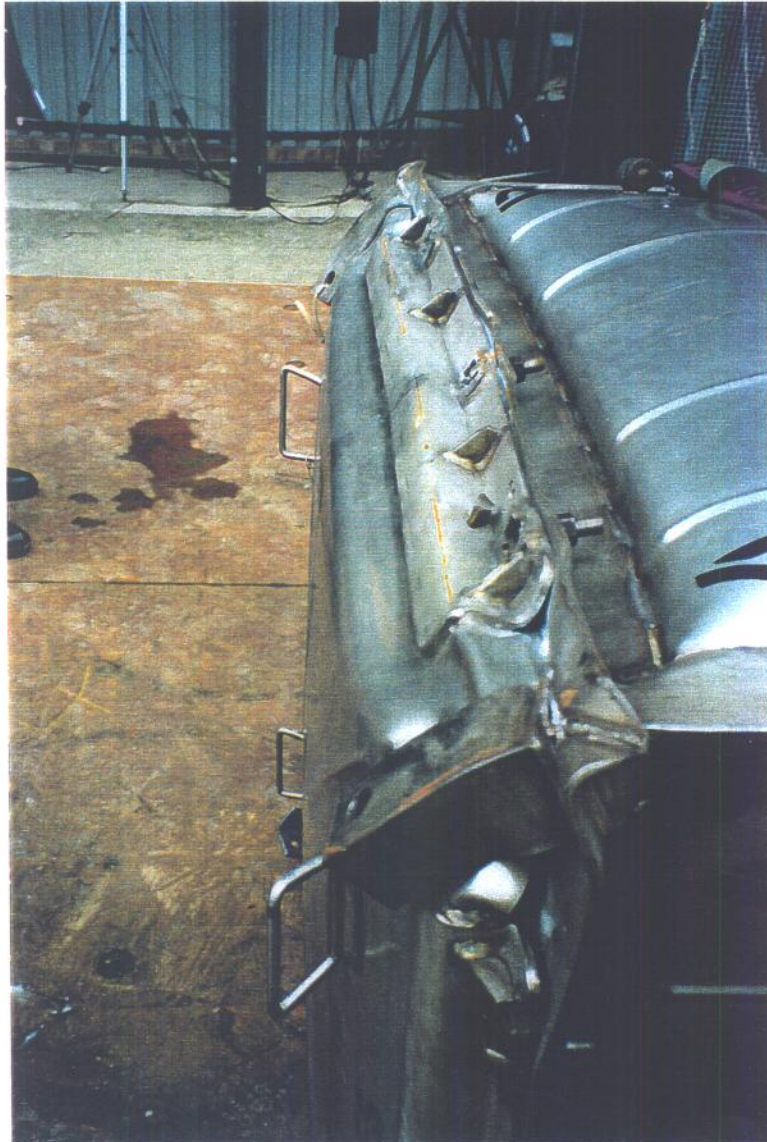
Figure 22 - Damage to Edge A-B Following 1.0m Punch Test

The damage resulting from the punch test was generally localised to edge AB. Figures 22 to 24 show the resulting damage. The punch caused some distortion to the lid flange along edge AB (see figure 22),

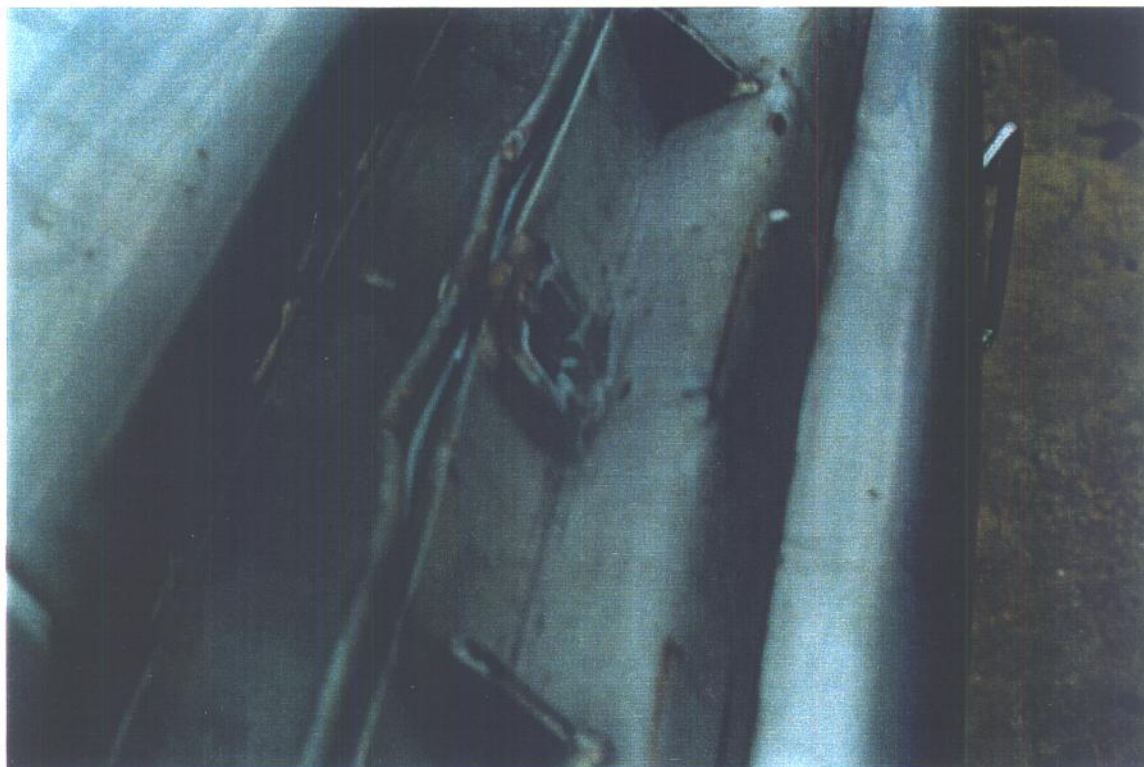
Figure 23 - Close Up of Centre Bolt Following 1m Punch Test

punched the centre bolt almost through the hole (see figure 23) and caused the bolts at corners A and B to fail (see figure 24).

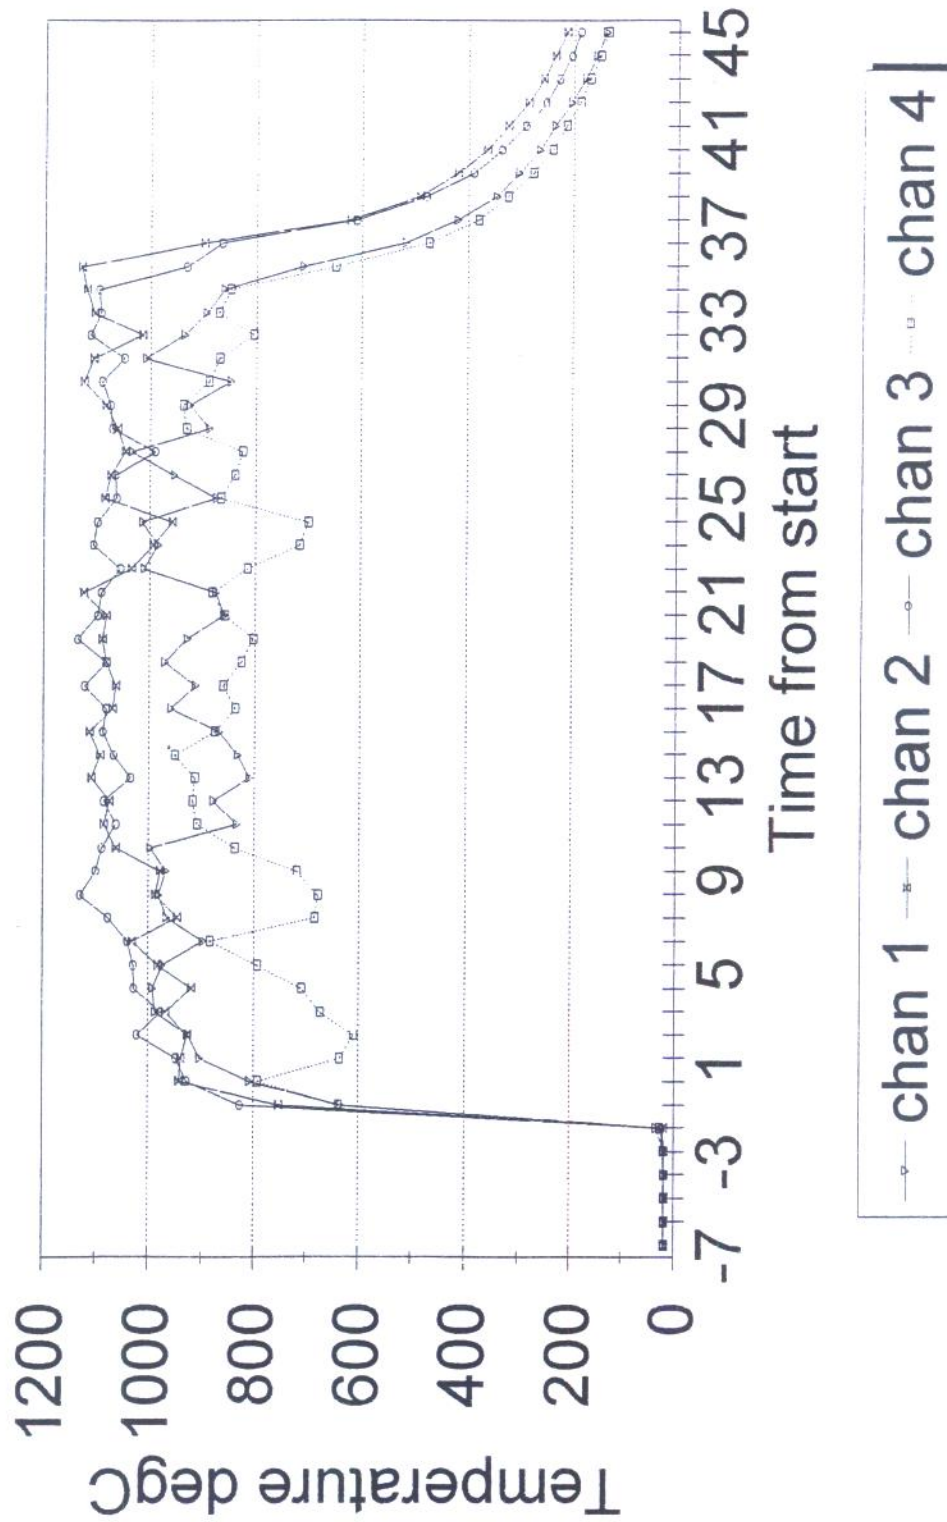
Figure 32 - Plots of Package Ambient Temperature During Fire Test

The temperature-time plot for the pool fire is shown in figure 32.

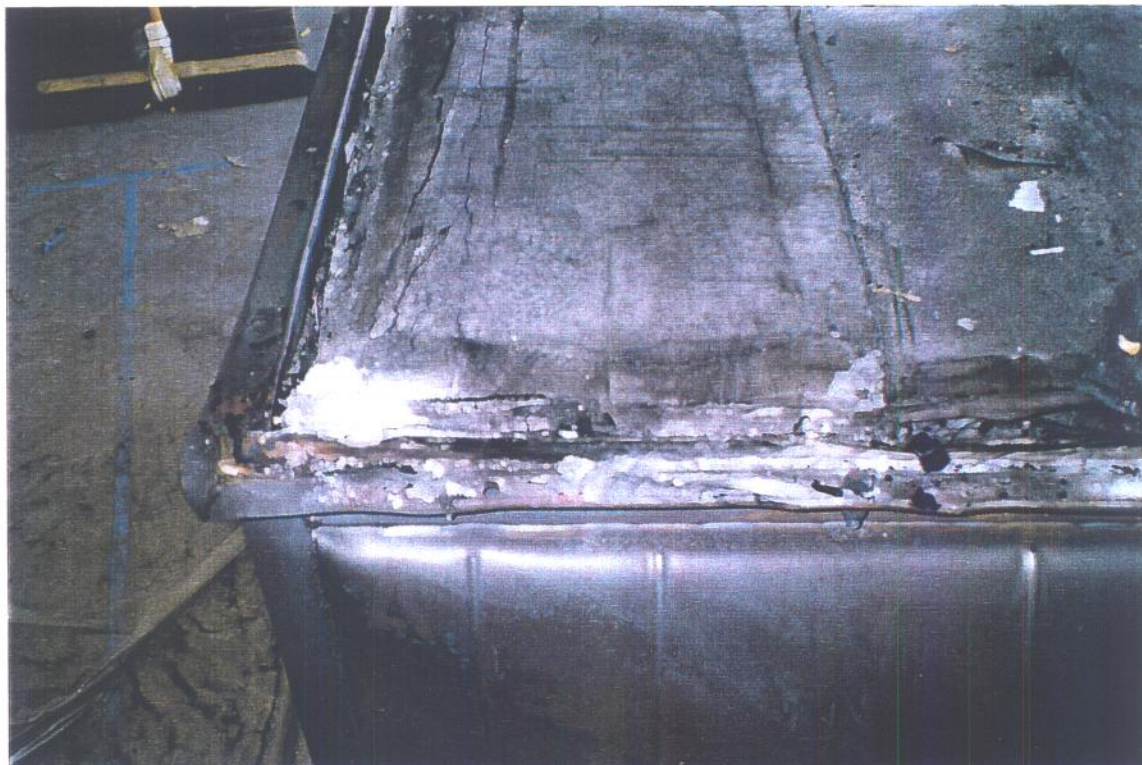
Figure 34 - Damage to Edge of Insulating Panel

There was some fragmentation of the edges of the Newtherm insulation material. (See figures 34 and 35.) The extent of severe heating of the package was evidenced by the discoloration seen in figure 36. The inner lid was removed and inspected. There was some sooting on the edge of the underside of the lid but no discoloration of the Plastazote pads or of the pail lids. (See figures 37 and 38.) The temperatures indicated by darkening of the sensitive areas of the labels were noted. The maximum internal temperatures are shown in figure 39. The pails were removed from the container and the lids opened. There was no discoloration or derangement of the powder contained in polythene bags. When the bags were removed from the pails there was some evidence of condensation of water vapour on the inside of the walls (Figures 40 and 41).
