# Open-Phase Validation Test

NRC Public Meeting June 4, 2014

Mark Bowman  
TVA

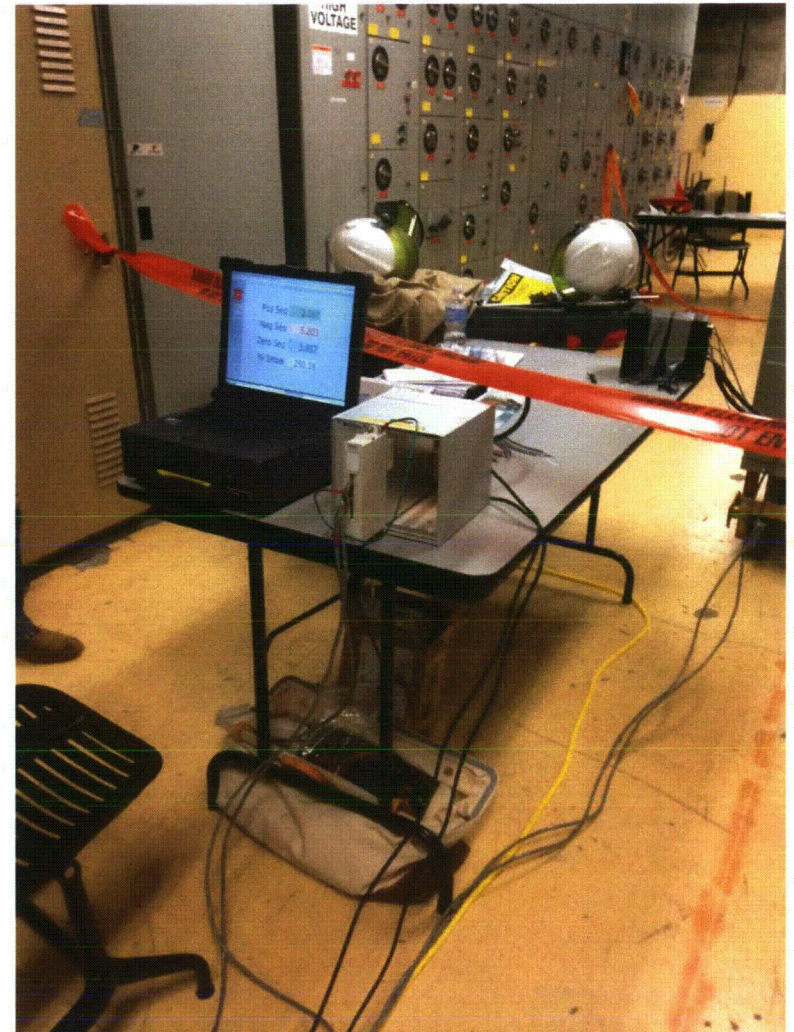
- High-speed recorders were installed to capture voltage and current waveforms for all plant buses and the switchyard
- TVA-developed system was used for real-time monitoring of in-plant voltage balance throughout the test

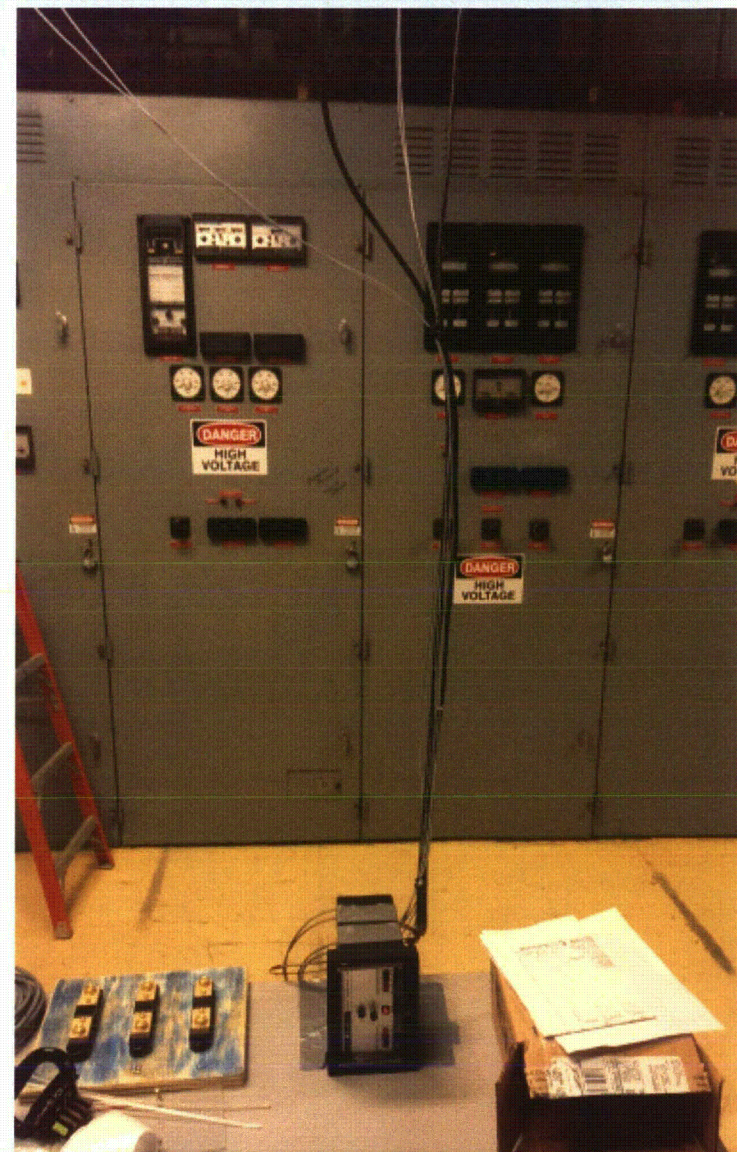
- A voltage balance protective relay was installed to protect plant loads in case of unexpected results
- Provided opportunity to study relay's behavior during normal plant operation (transformer inrush, motor starting, bus transfers, etc.)

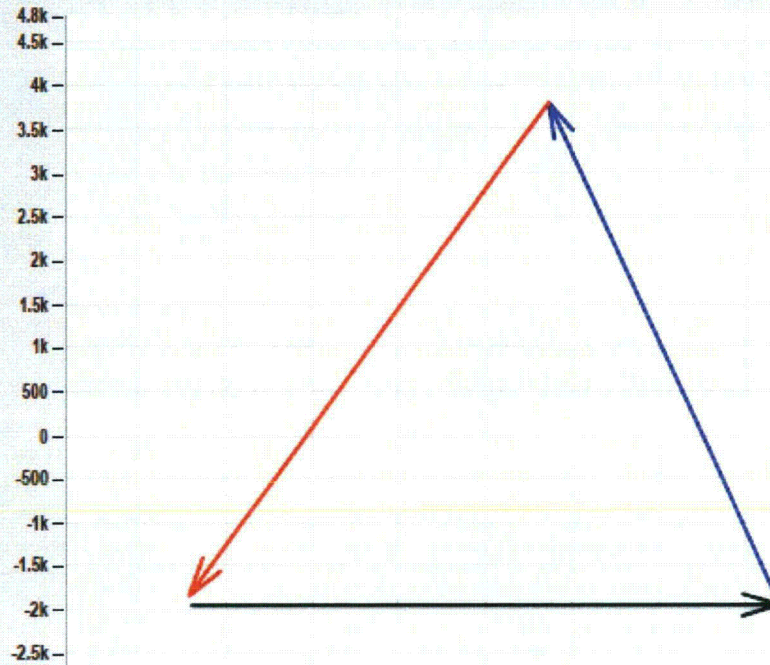
## Phasor Diagram

Magnitude	Angle
6.776k	0

Magnitude	Angle
7.011k	-126.37

Magnitude	Angle
6.338k	114.7

Magnitude	Angle
6.7k	-3.89

Magnitude	Angle
428.8	76.31

Magnitude	Angle
38.95	104.77

Unbalance  
6.4 %

During high peak loading conditions (~80%), in-plant voltages became more unbalanced (> 6%), as predicted

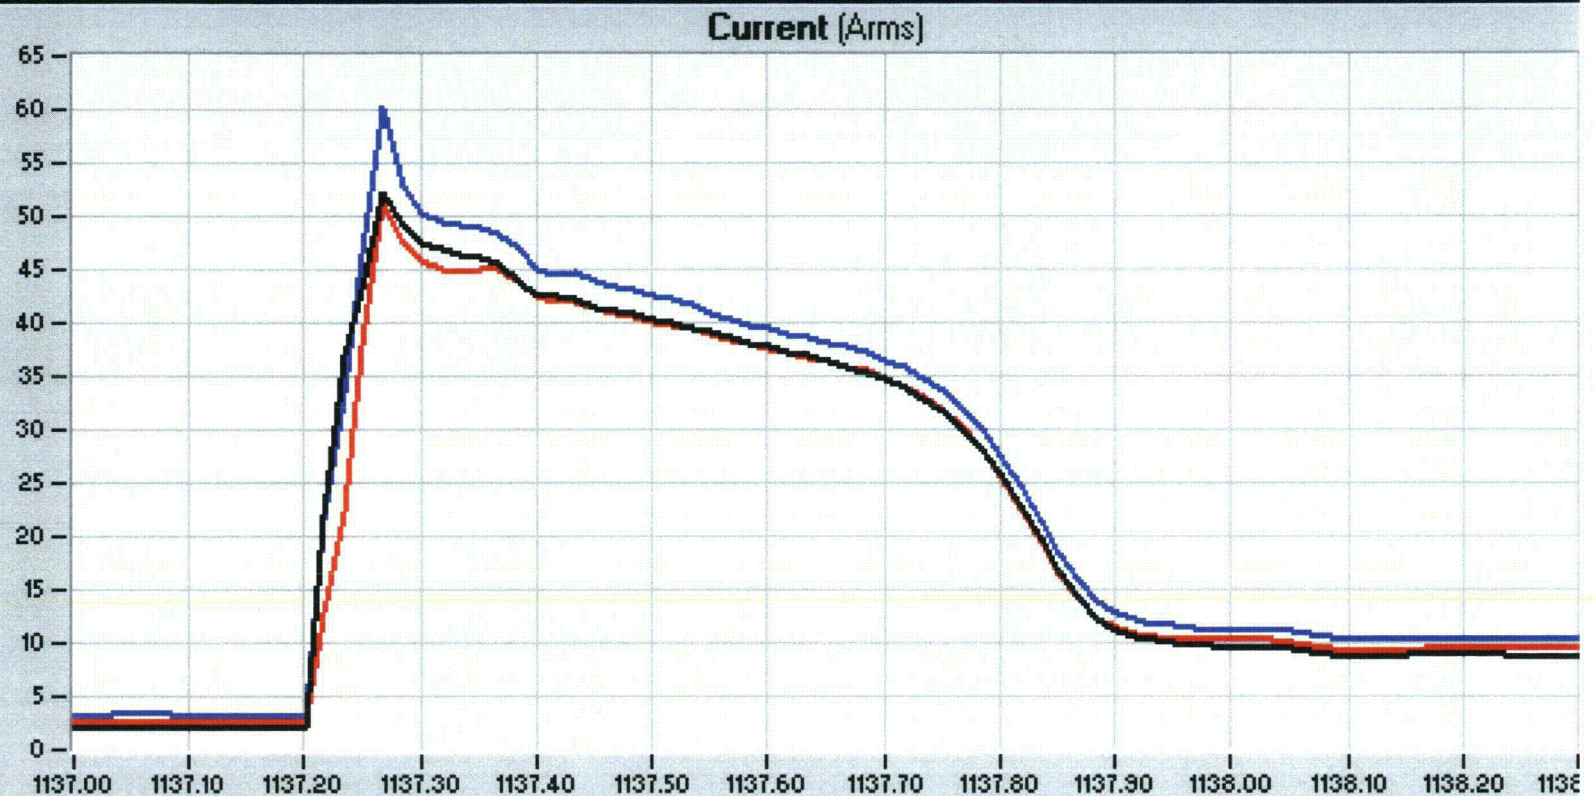
- Motors started within normal timeframes, as predicted
