ROOT CAUSE ANALYSIS REPORT

**September 9, 2014 Incident Investigation
Pressurized Drum of Yellowcake at the Honeywell
Uranium Refinery**

**October 27, 2014
Revised February 24, 2015**

123-81956 Rev. 1

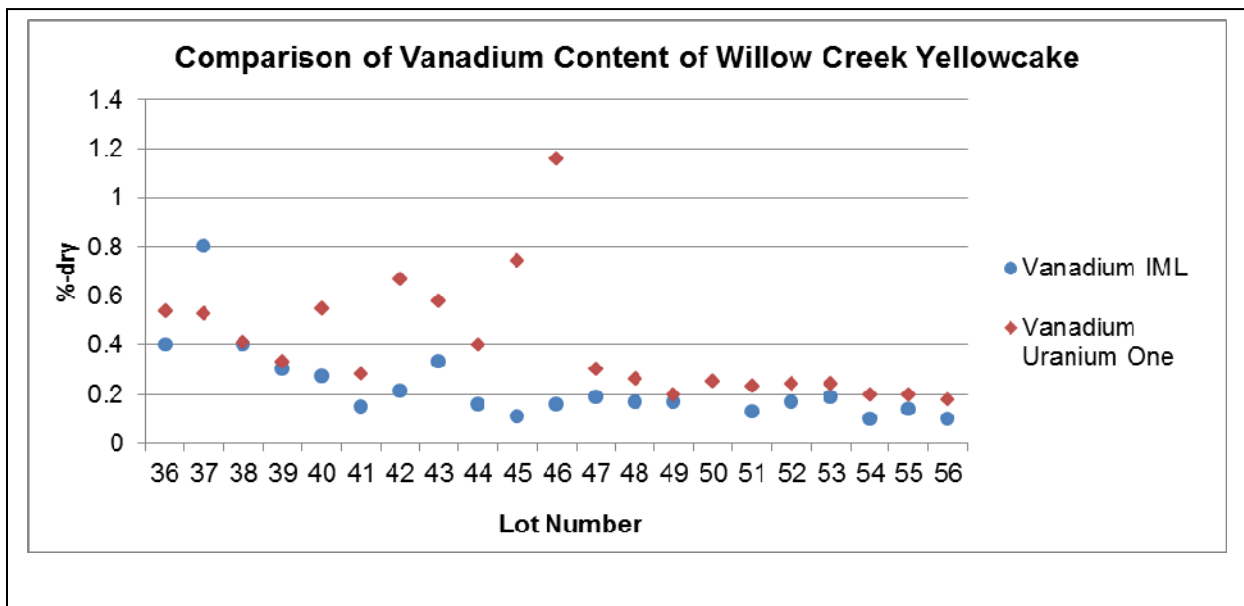
Figure 2: Vanadium Content of Willow Creek Yellowcake

IML = InterMountain Laboratory; an independent 3rd party laboratory

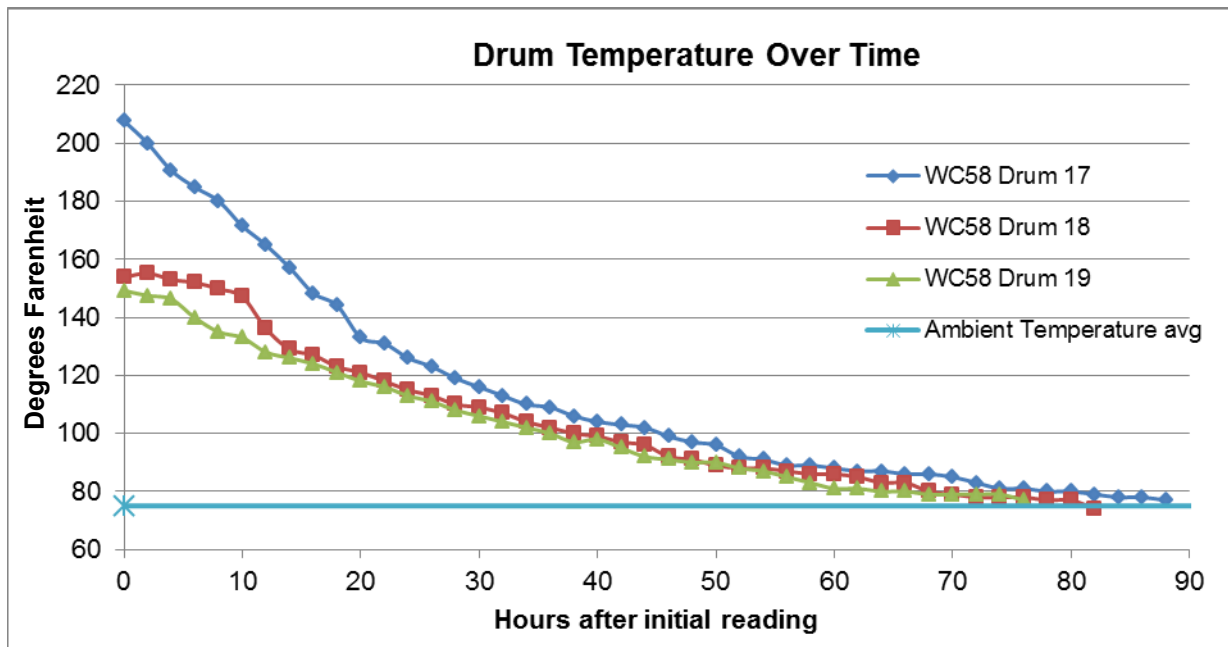
Figure 7: Drumming Temperature over Time

Temperature profiles were taken of the yellowcake inside drums as they were allowed to vent. The profiles were created by placing stationary temperature probes into 3 yellowcake drums (WC58 Drum 17, WC58 Drum 18, and WC58 Drum 19) and recording measurements every 2 hours over a monitoring period of at least 76 hours as is shown by Figure 7. It was noted that the temperatures inside the drum appeared to be highly dependent on the location of the probe within the drum. Due to the insulating properties of the yellowcake, a thermal gradient was observed inside the drums such that temperature was a function of depth and closeness to the outside edges of the container.

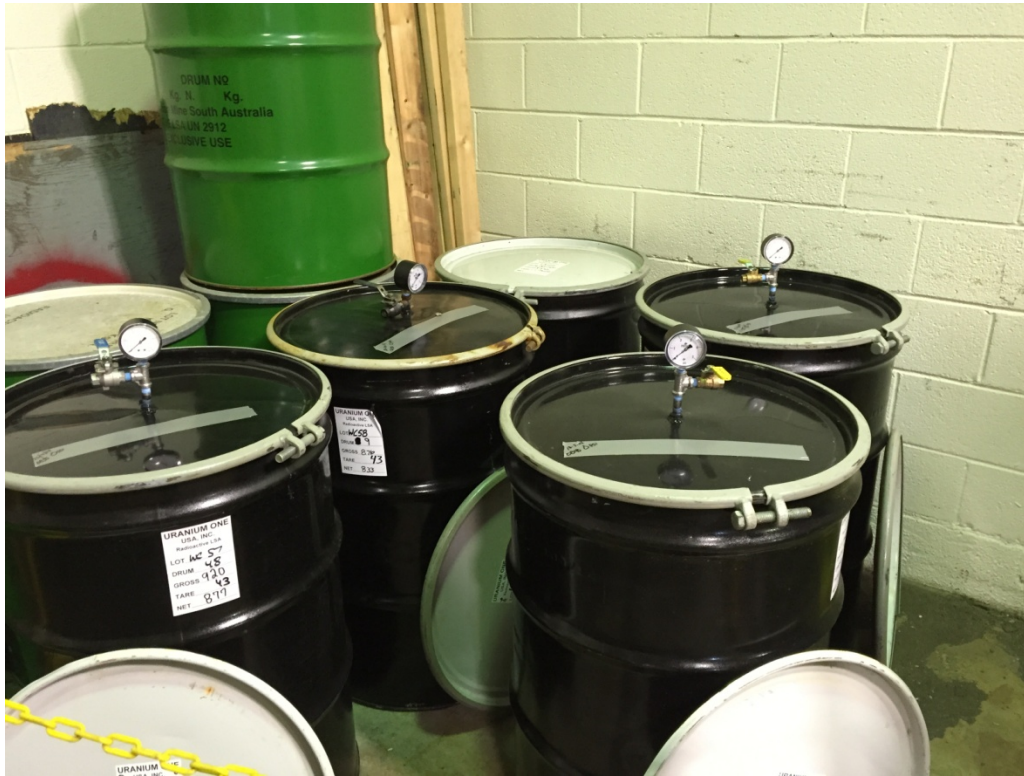
**Figure 10: Picture of Selected Drums for Pressurization Test**

Pressurization tests were performed on dried product drums to verify that no pressure was building up in the production runs. As shown in Figure 10, four drums were monitored, (WC57 Drum 9, WC57 Drum 10, WC57 Drum 49, and WC57 Drum 48). Drums WC57 Drum 9 and WC57 Drum 10 were allowed to vent for 24 hours and then were sealed with a pressure test lid. The lid was equipped with a zero to five pound-per-square-inch (psi) gauge and a bleed-off valve. The temperature at the time of sealing the drums was approximately 100°F (38°C). Two additional drums WC57 Drum 47 and WC57 Drum 48 that had already been sealed and were in storage were re-opened and pressure lids were installed. The temperature of the product when pressure lids were installed was 80°F (27°C). Each of the drums was monitored for at least eight days and no pressurization was observed. Additionally, a pressure test was performed on a drum that was vented using the old procedure of placing the lid loosely on the drum. To represent a possible worst case scenario a lid with a pressure gauge was placed directly on the drum and the closure ring was loosely placed on the drum as it was allowed to vent for 24 hours. The pressure gauge was then monitored for 24 hours with no observable pressure build-up.

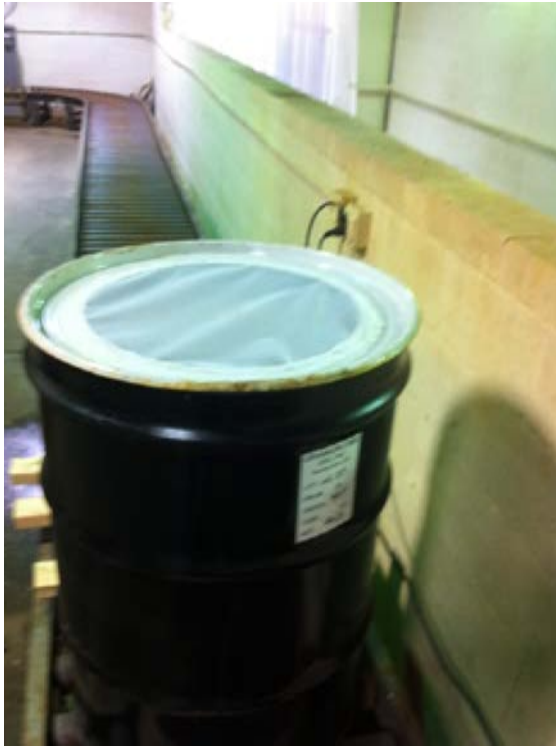
Figure 11: Picture of Screened Lid

Measurements using a four-gas meter indicated that the screens allow for proper ventilation of any gas residuals in the drum. The meter was used with the measurement tube placed inside a drum underneath the screened lids. These measurements were performed on four drums and all drums had oxygen levels at or close to background (within 0.1 percent) indicating that any uranyl peroxide decomposition reaction that could take place is either not occurring, or occurring to a very small degree. Using the mesh screened lids allows for more complete ventilation and cooling of the packaged yellowcake.

1. Improved Packaged Drum Venting and Cooling Procedures. The Irigaray site has instituted a revised cooling and venting procedure that involves the use of a temporary lid with a mesh opening to allow any build-up of gases to escape prior to drum closure. Longer cooling and venting times have been instituted to insure that the drummed yellowcake has stabilized prior to shipment.

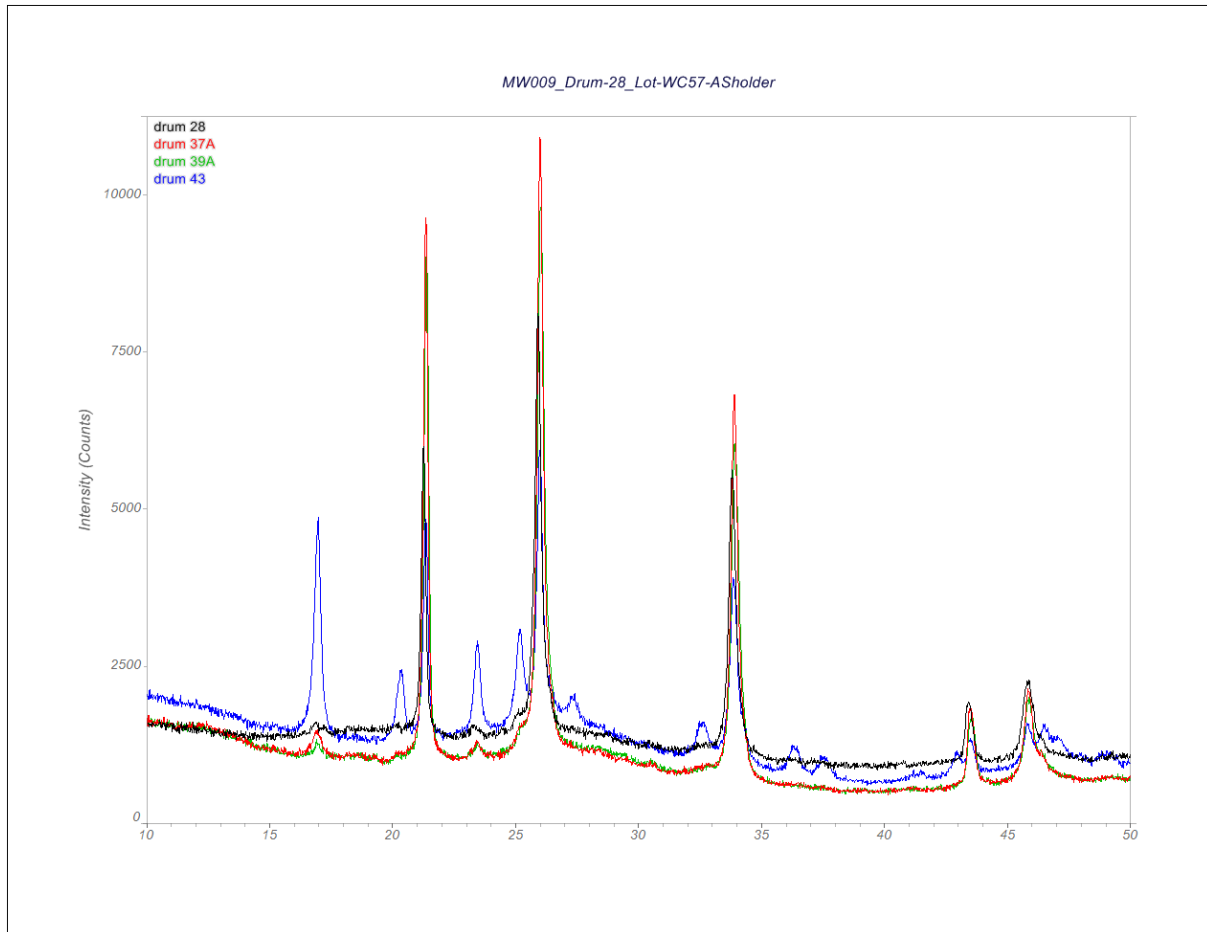
Figure 12: Evans Analytical Yellowcake XRD Analysis Comparison

Various samples of yellowcake dried in the Irigaray dryer at approximately 1,200°F (704°C) were sent to Evans Analytical Group, a laboratory specializing in the analysis of solid materials using XRD and to Dr. Peter Burns, Director, Energy Frontier Research Center *Materials Science of Actinides* at Notre Dame University. Dr. Burns is a well-respected uranium researcher who has conducted significant work in the behavior of uranium oxides and peroxides.

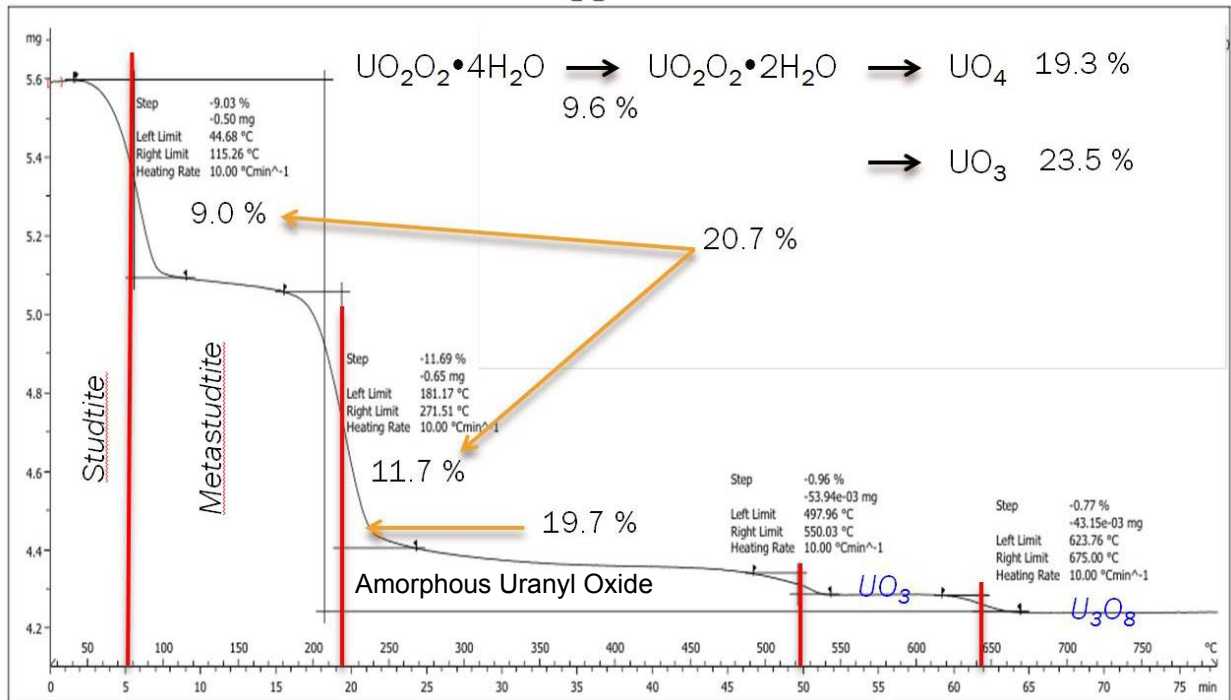
Figure 14: Uranyl Peroxide Thermogravimetric Analysis

The decomposition of metastudtite in the temperature range of 230°C – 520°C is shown on X-ray diffraction patterns as peak broadening and overall reduction of the quality of the diffraction character. As such, mixtures of various oxide states of uranyl peroxide can be said to be poorly crystalline, although they do have a definite structure and composition within a defined range. The point at which one decides to call a poorly crystalline material “amorphous” is arbitrary in a case such as this. However, it is notable that one does not need to invoke the existence of an unknown phase, amorphous or otherwise, to explain the diffraction, spectroscopic, and thermogravimetric data collected by Burns (Ref 7, 2014).

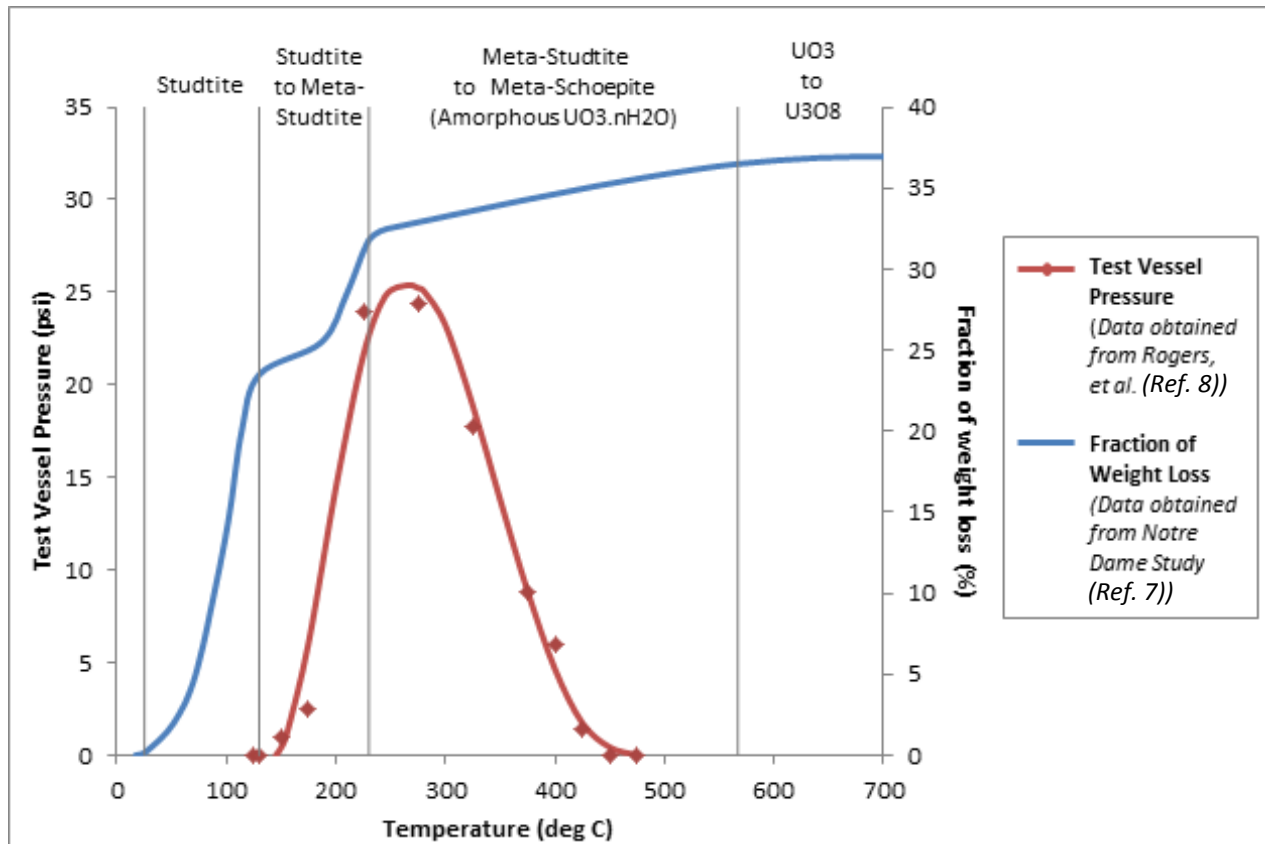
Figure 15: Reaction of Amorphous Uranyl Oxide with Water

This relationship of water with amorphous uranyl oxide is an indication that water should not be allowed to come into contact with the dried product if the dried yellowcake still contains some amount of amorphous uranyl oxide.

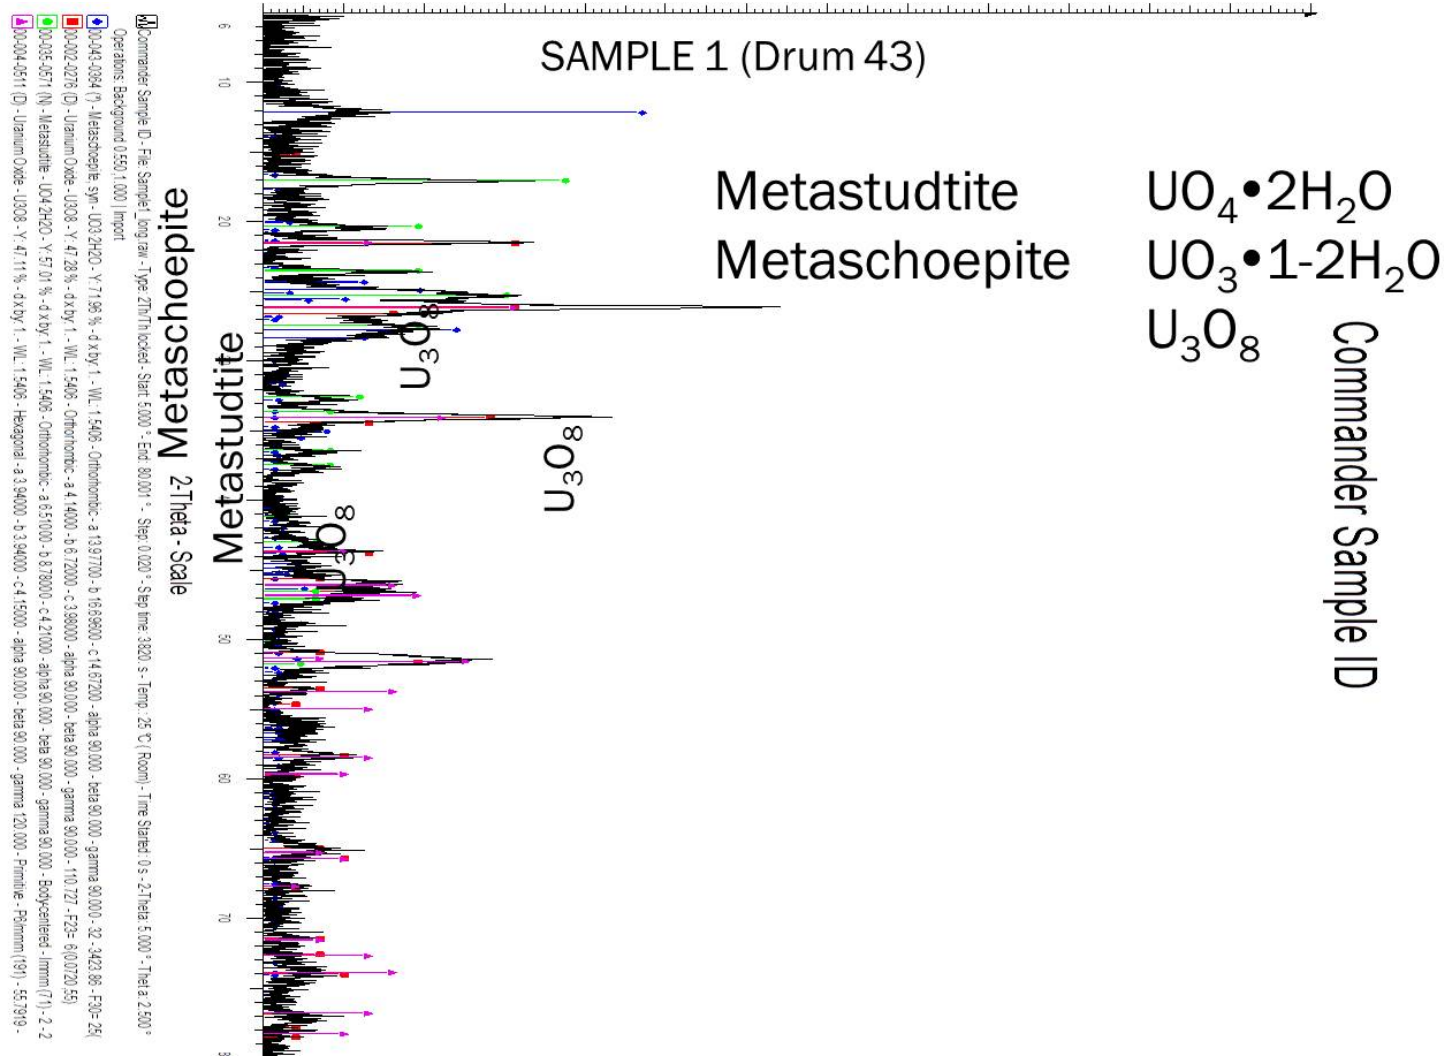
Sample 1 represents the XRD spectra from a sample taken from WC51 Drum 43 which is the drum that was found to be pressurized. This shows the highest percentage of metastudtite and amorphous uranyl oxide found in all of the samples tested. The metaschoepite ($UO_3 \cdot 1-2 H_2O$) is also a significant contributor to the composition of the matrix.

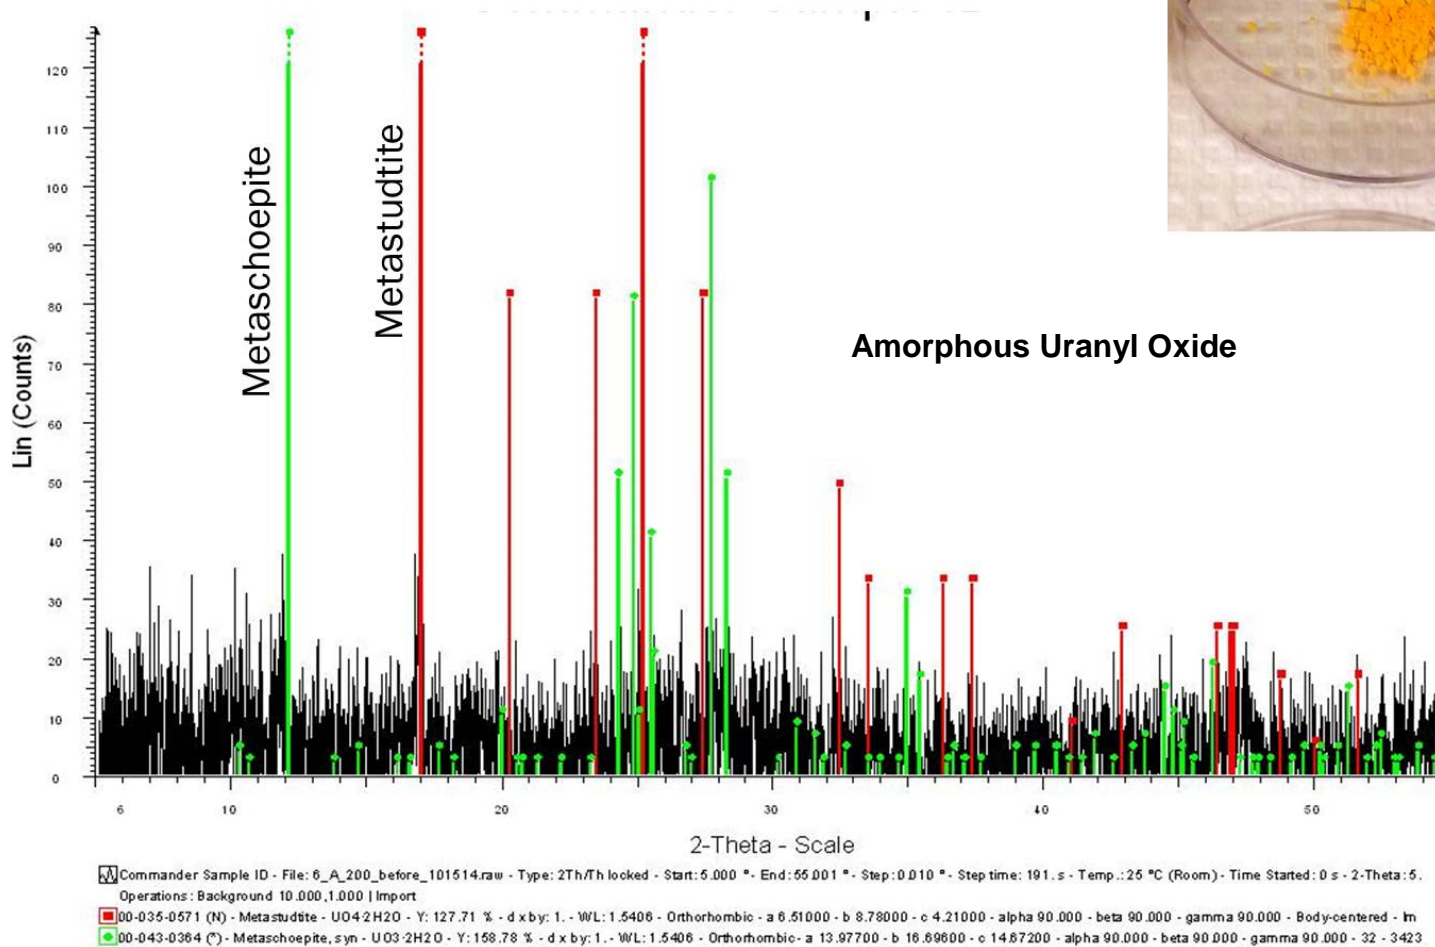
XRD Spectra of metastudtite heated to 200° which shows the amorphous nature of the uranyl oxide that is formed.
