Unit 3 Reactor Coolant Pump 2A Pressure Instrument Nozzle

PVNGS Regulatory Affairs
April 9, 2015

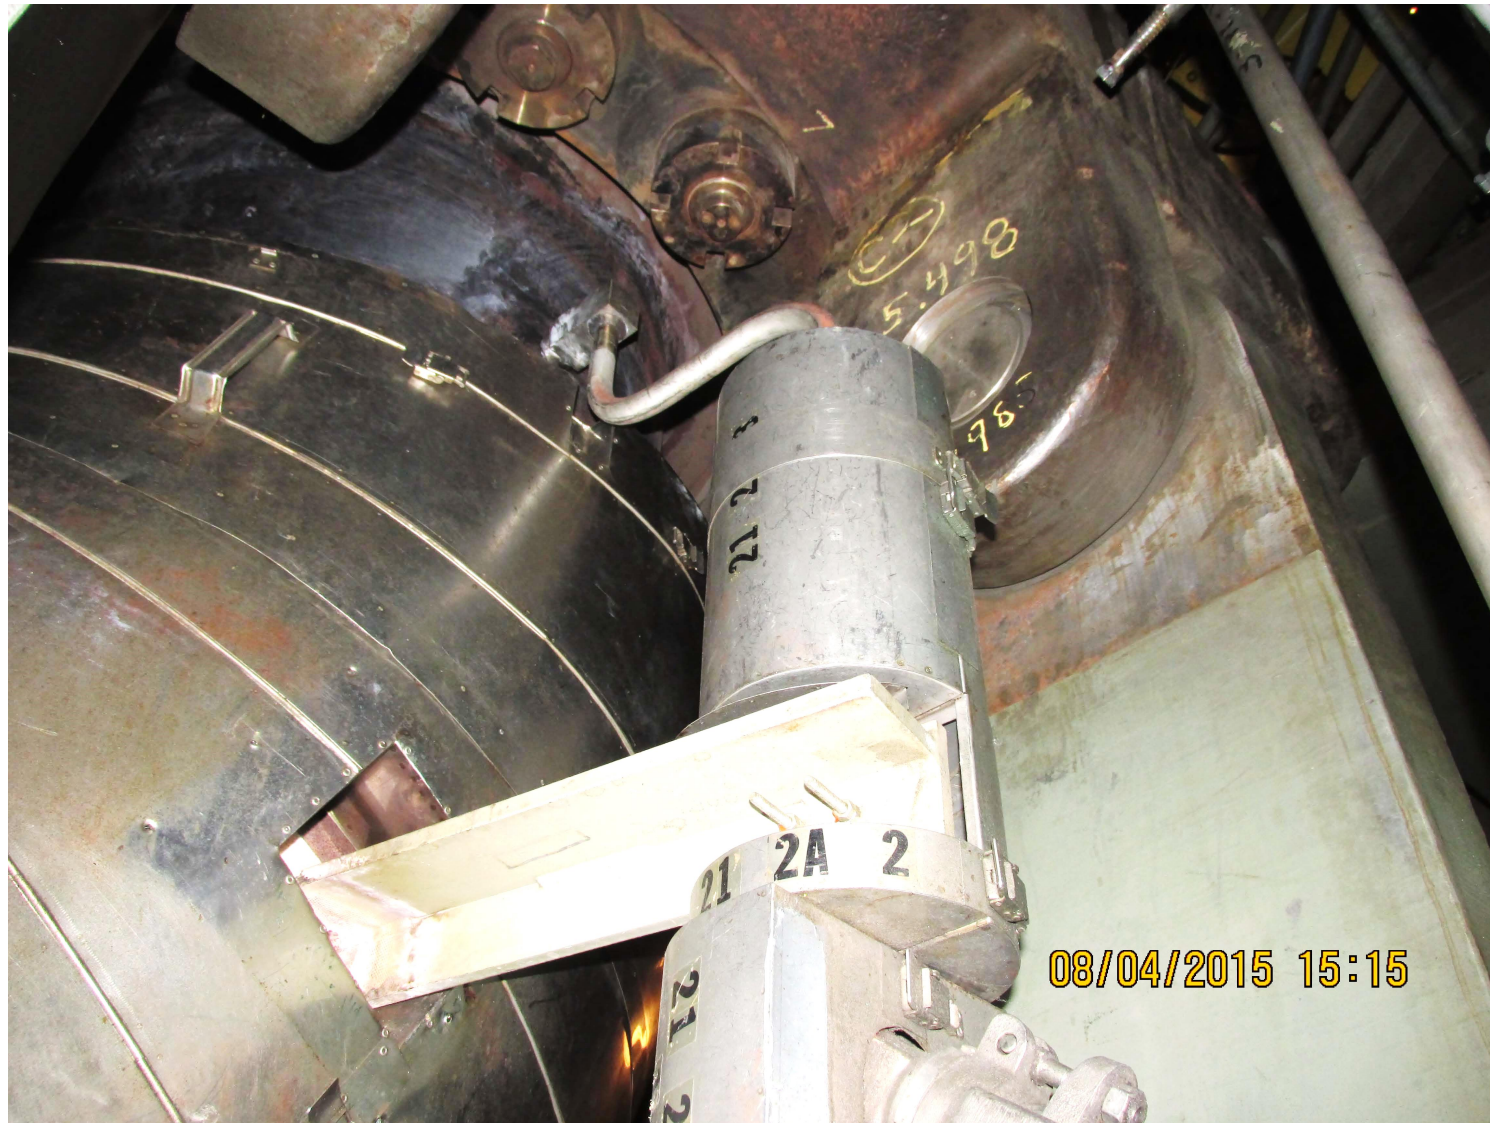
As-Found Leakage Indication (after insulation removal)

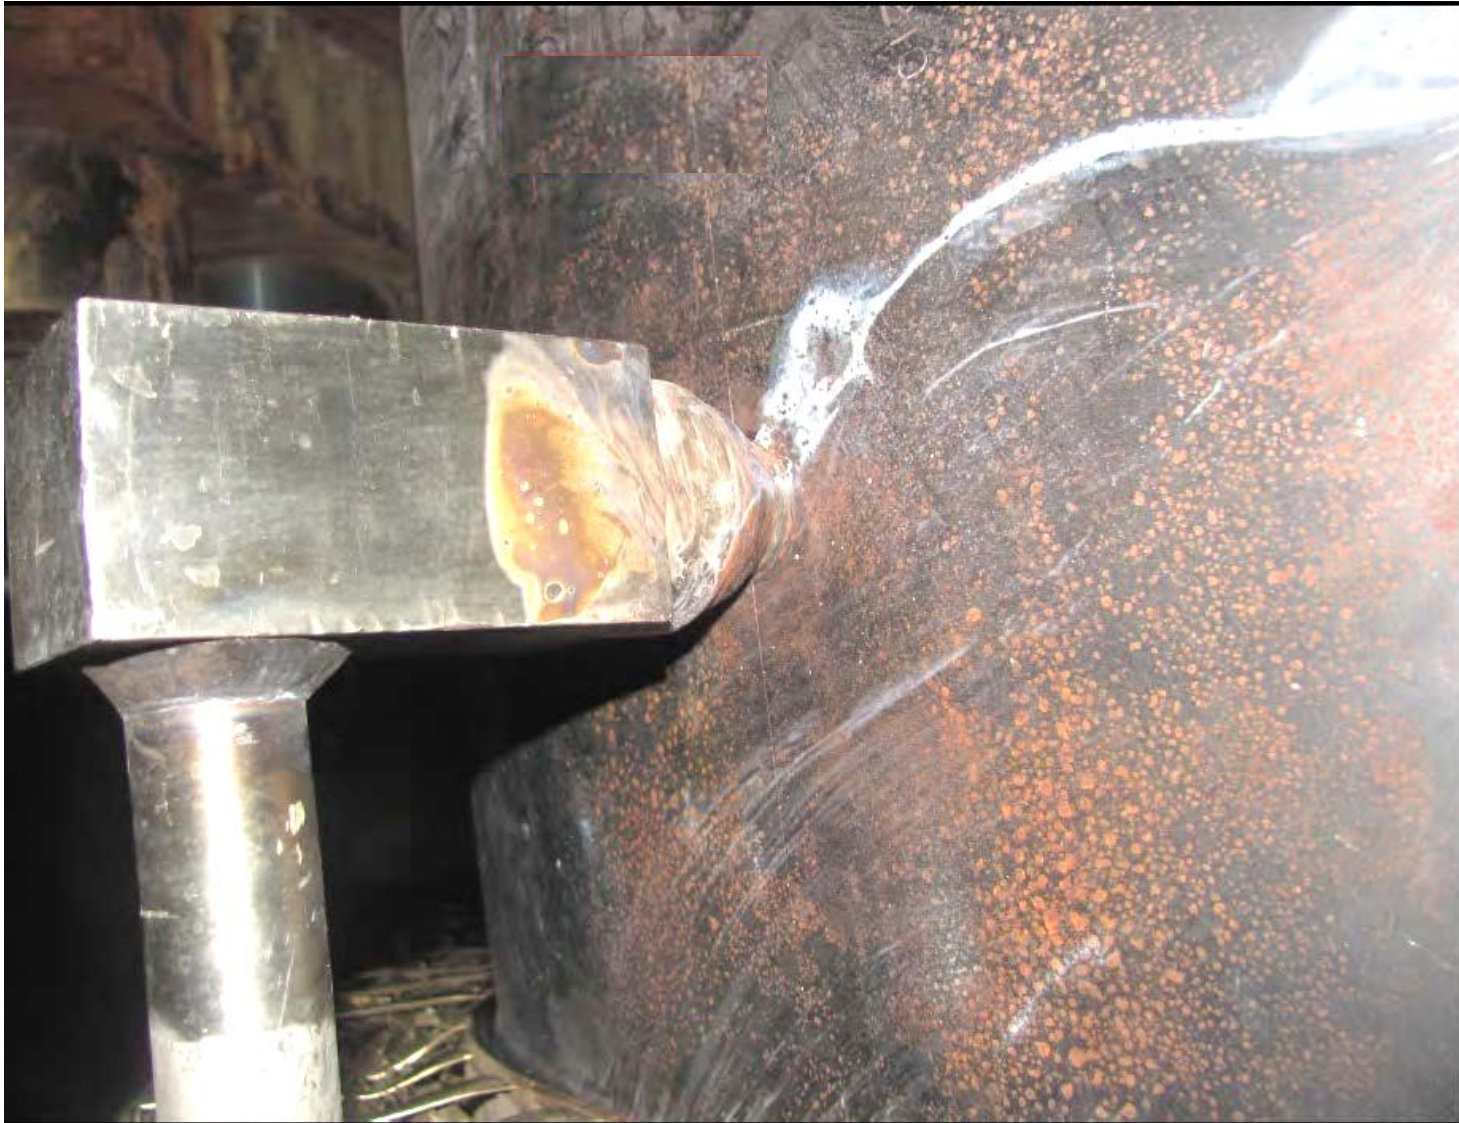
3R17 (2013) As-Found – No Indications
