TABLE OF CONTENTS

The Traveller series packages are limited to use for transporting unirradiated, low enriched uranium, nuclear reactor core assemblies. There is no packaging design feature for heat removal because the contents does not contain heat generating radioactive material. The use of polyethylene as a moderator requires controlled heat-up during accident conditions, to prevent loss of hydrogen within the moderator.

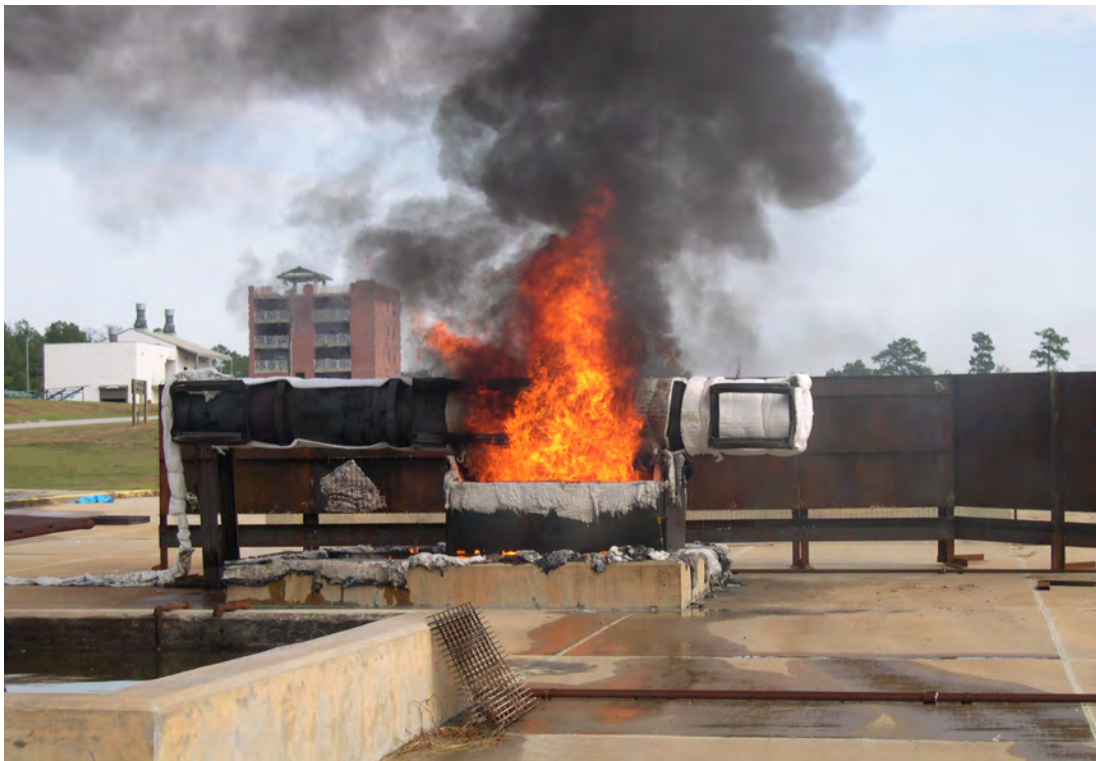
The first burn was of the control section. During the 30 minute burn, internal temperatures rose within the test section throughout the test due to the gap deliberately left in the seam between Outerpack base and lid. Peak internal temperatures over 500°C were observed, Figure 3-3.

Figure 3-3 Seam Burn Test

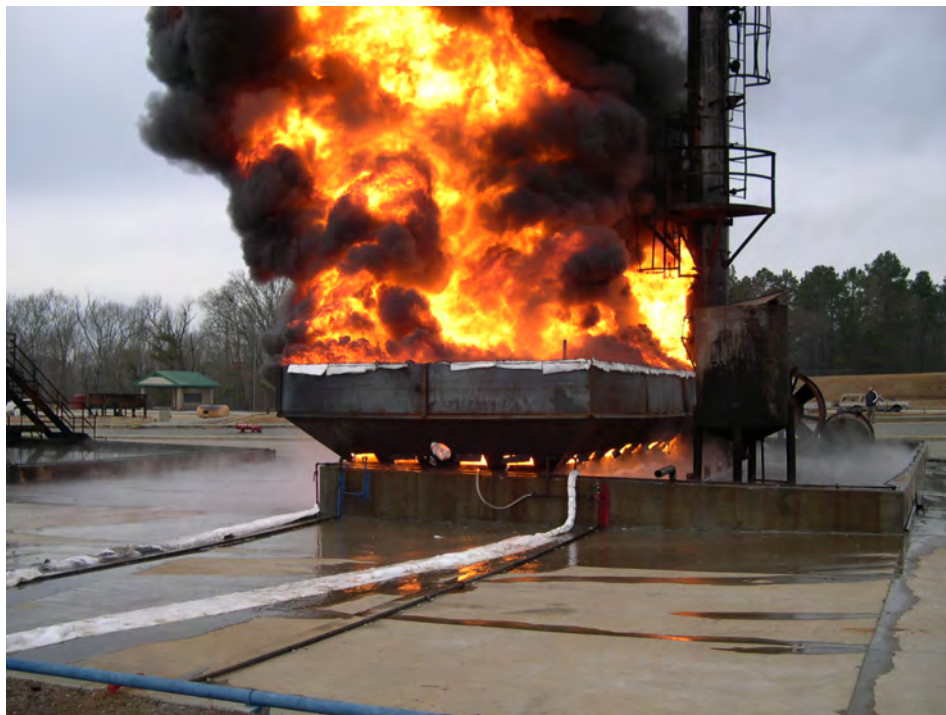
test unit was mounted over the small weir built for the seam burn tests and burned for 40 minutes, Figure 3-4. Because the ambient temperature dropped below freezing during the night, initial temperatures inside the package started the test at approximately 0°C. Temperatures within the impact limiter pillow climbed to between 70 and 95°C depending on location during and after the burn test. Temperatures within the Outerpack interior cavity varied from 50 to 320°C. The only temperature measurements above 200°C were at locations near the outside skin of the Outerpack and well away from the moderator or impact limiter pillow.

Figure 3-4 December 15, Impact Limiter Burn Test

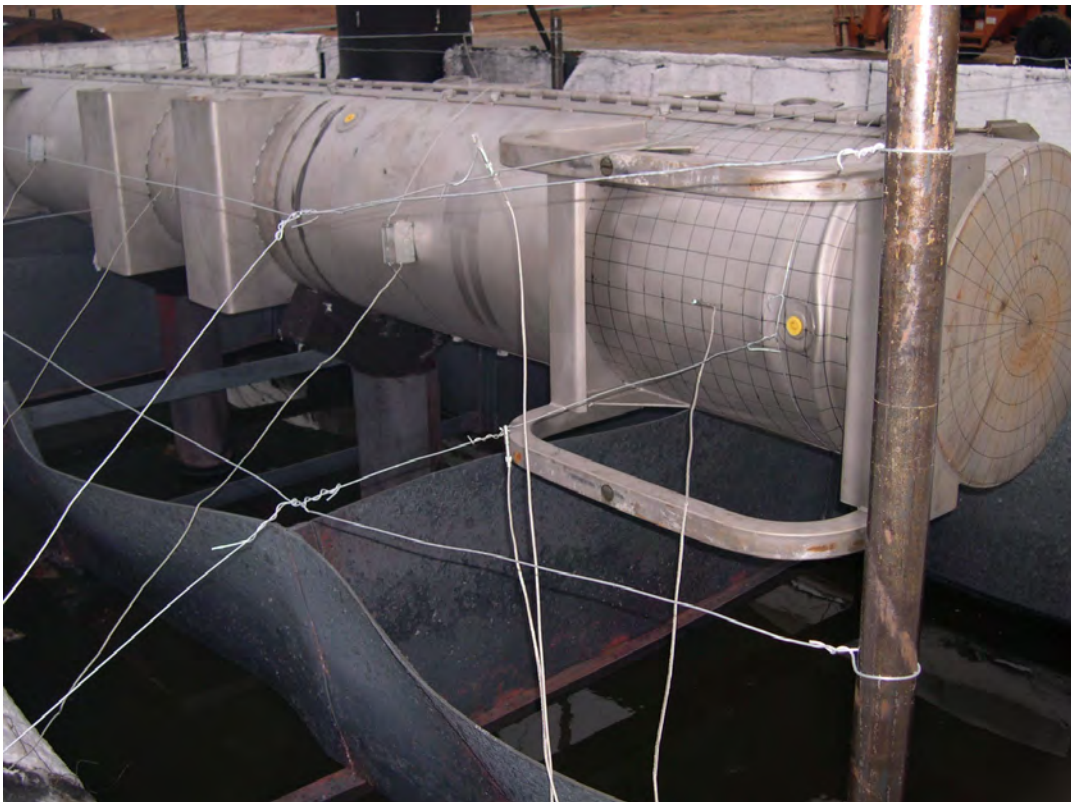
Twenty-two, inconel sheathed type-K thermocouples were used to measure flame temperature immediately around the Traveller and the Outerpack outer skin as shown in Figure 3-7. Before and during the pool fire, temperature measurements were made at 16 locations using type K thermocouples located. During the test temperatures were measured at six locations on the package skin, at twelve locations inside the pool fire, at four locations using directional flame thermometers (DFTs) facing away from the package, and from outside the fire using two optical thermometers.

Figure 3-5 Pool Fire Test Facility

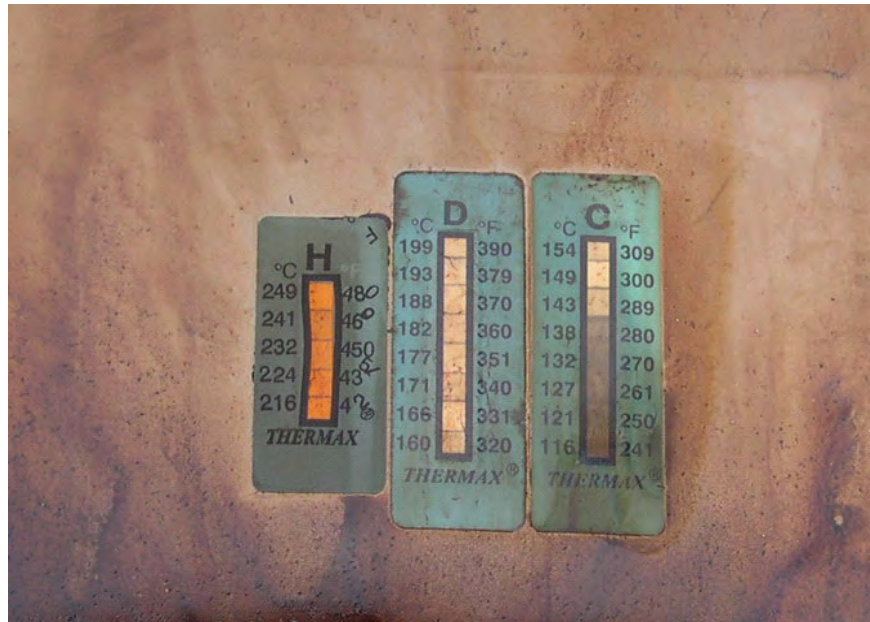
Temperatures were measured on the CTU Outerpack outer skin using six type K thermocouples, attached by screws. These thermocouples were located as shown in Figure 3-7 above. The 30 minute average temperature measured by these thermocouples was 904°C (1659°F). Temperatures inside the CTU Outerpack were measured using 13 sets of non-reversible temperature strips. One set on the inner stainless steel skin covering the Outerpack lid moderator was unreadable. All of the remaining temperature strips on the Outerpack lid recorded temperatures of 177°C (351°F) or below. Temperatures on the inside surface of the top and bottom impact limiters were 116 (241°F) and 149°C (300°F) respectively. Temperatures inside the Clamshell were below 104°C (219°F). An example of the temperature strip sets attached to the Outerpack lid moderator cover sheets is shown in Figure 3-8.

Figure 3-8 Temperature Strip Condition After CTU Burn Test

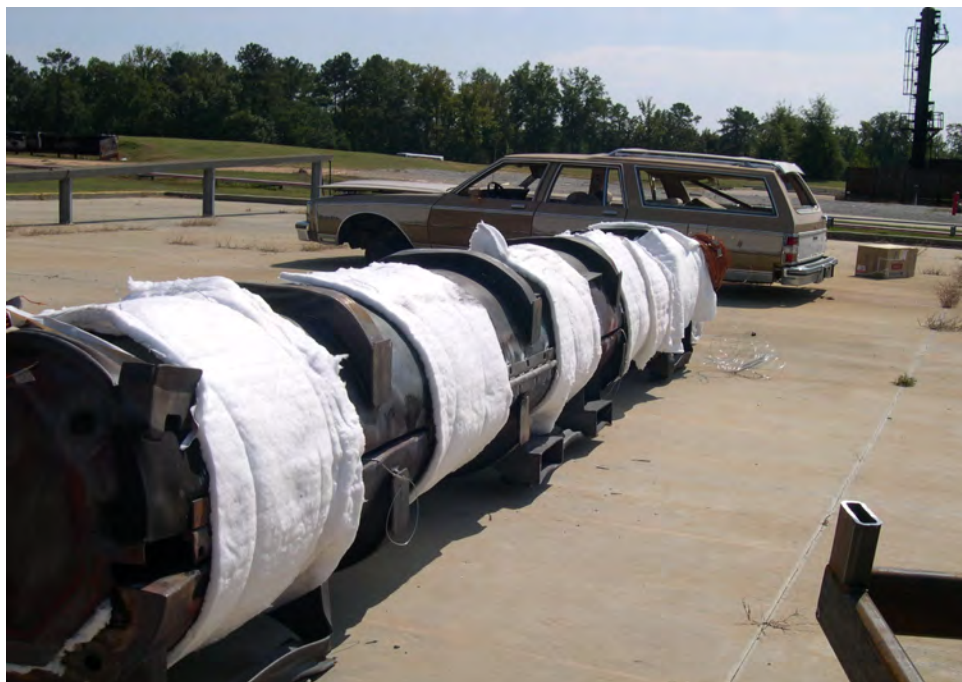
Figure 3-11 Package Exterior Wrapped with Ceramic Fiber Insulation

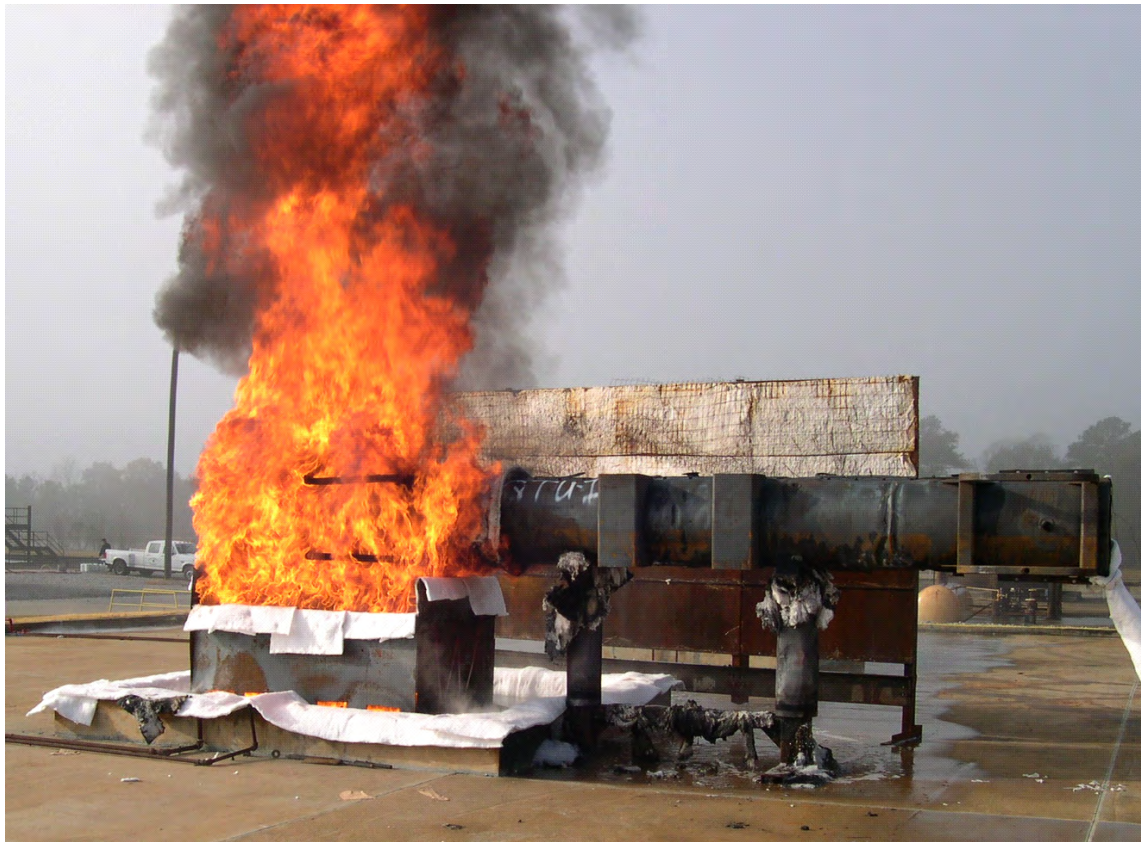
The test unit was mounted over the small weir built for the seam burn tests and burned for 40 minutes, Figure 3-19. Because the ambient temperature dropped below freezing during the night, initial temperatures inside the package started the test at approximately 0°C. Temperatures within the impact limiter pillow climbed to between 70 and 95°C depending on location during and after the burn test, Figure 3-20. Temperatures within the Outerpack interior cavity varied from 50 to 320°C, Figure 3-21.

Figure 3-19 December 15, Impact Limiter Burn Test

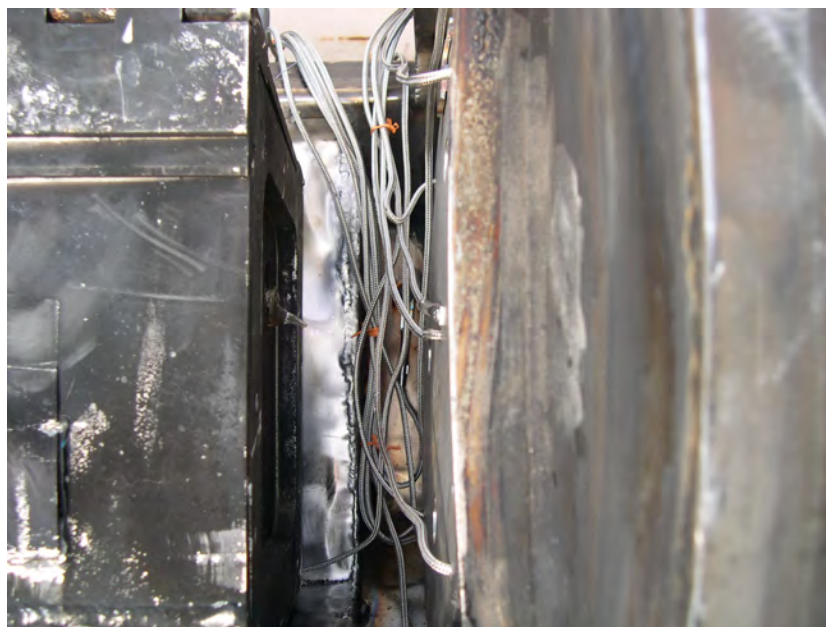
During this test, external temperatures were measured with two optical thermometers. Readings were taken every five minutes, Figure 3-22. After the test was completed, the Outerpack was opened. Other than a thin layer of soot lining the inside surfaces, there was no noticeable change in the Outerpack or Clamshell, Figure 3-23.

Figure 3-23 Outerpack Internals after December 15 Burn Test

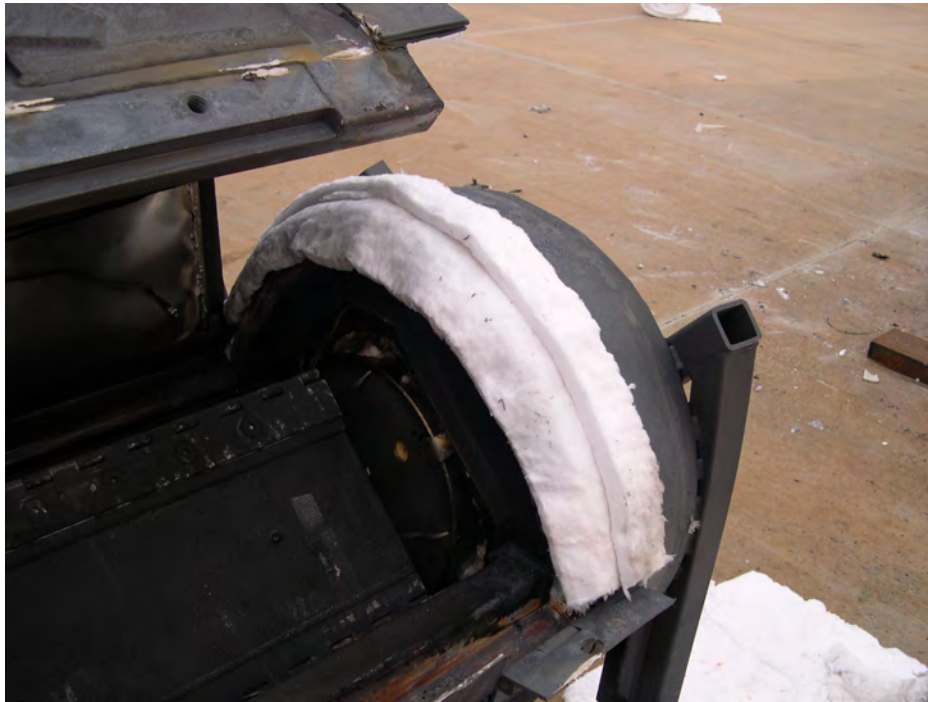
The relatively high temperature observed at the Outerpack top seam led to questions of heat transfer. Was hot gas entering past the lip on the Outerpack door, or was the temperatures the result of heat conduction through the metal of the impact limiter bulkhead. The impact limiter burn test was therefore repeated but with Kaowool insulation stuffed into the Outerpack upper seam to prevent hot gasses from entering the package from that location, Figure 3-24. This burn lasted for 30 minutes, Figure 3-25. This test was performed in the late afternoon, so the initial temperatures inside the package were higher than the previous day. Temperatures within the Outerpack interior cavity varied from 80 to 340°C, Figure 3-26. Temperatures within the impact limiter pillow climbed to between 70 and 95°C depending on location during and after the burn test, Figure 3-27. The Outerpack top seam temperature rose to the same levels with insulation stuffed into the seam, demonstrating that the primary heat transport mechanism in this region is conduction.

Figure 3-24 Kaowool Layers on Outerpack Bottom Impact Limiter

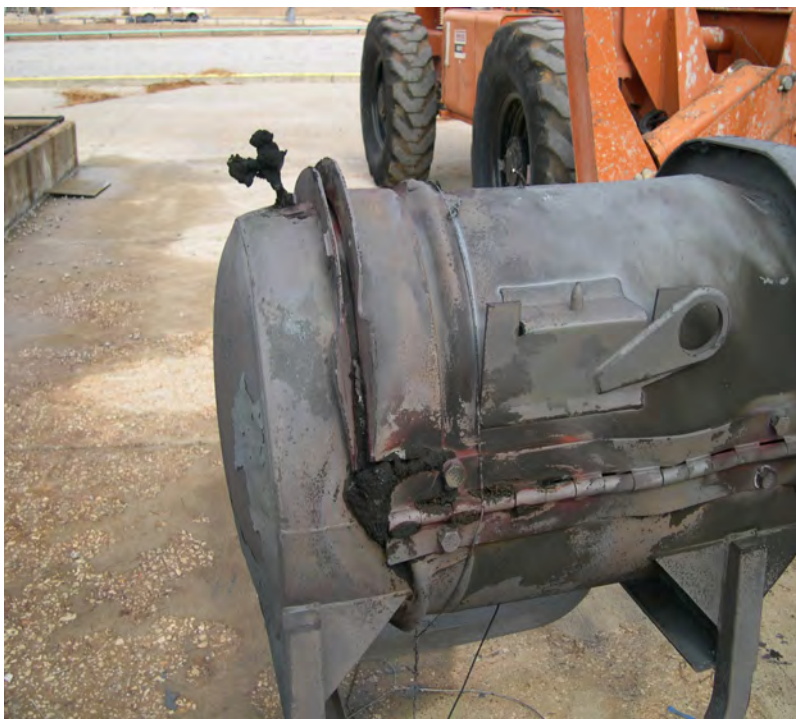
After the pool fire was extinguished, the package was removed from the pool and allowed to cool. Small amounts of smoke were observed to be coming from the package seams. The package was opened and the interior was examined. Significant amounts of polyurethane intumescence residue were observed along the Outerpac seam, Figure 3-30, and brown tar from the polyurethane was observed inside the package, Figure 3-31. Internal temperature strips recorded peak temperatures under 150°C throughout the package with one possible exception. Approximately 2 m (6 ft) from the bottom of the package, one set of temperature strips was unreadable due to heating and urethane deposits. An examination of the fuel assembly and the moderator blocks showed no significant heat damage.

Figure 3-30 Polyurethane Char in Outerpack Seam After Burn Test

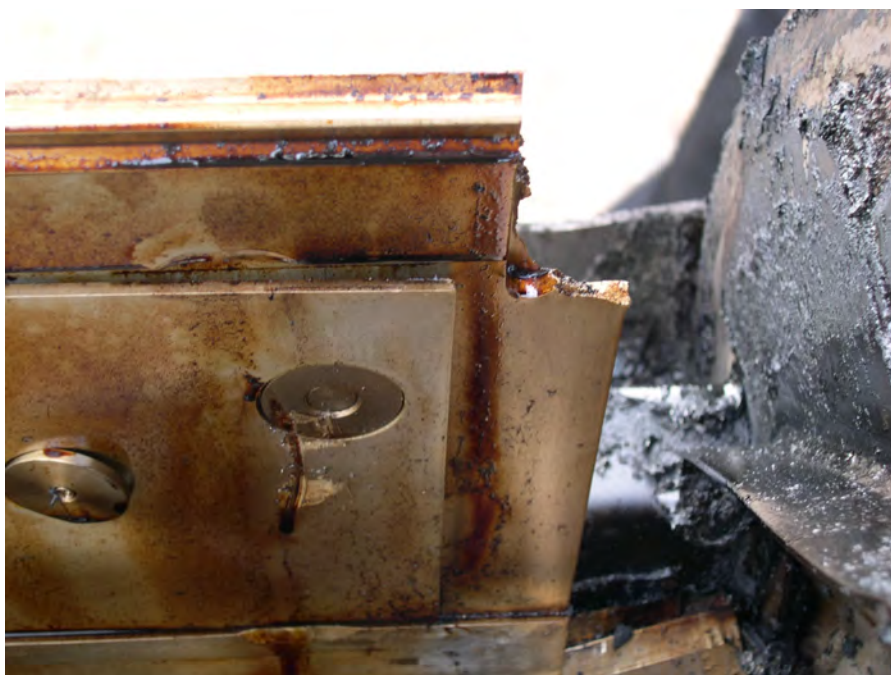
Figure 3-31 Brown Polyurethane Residue Inside Outerpack After Burn Test

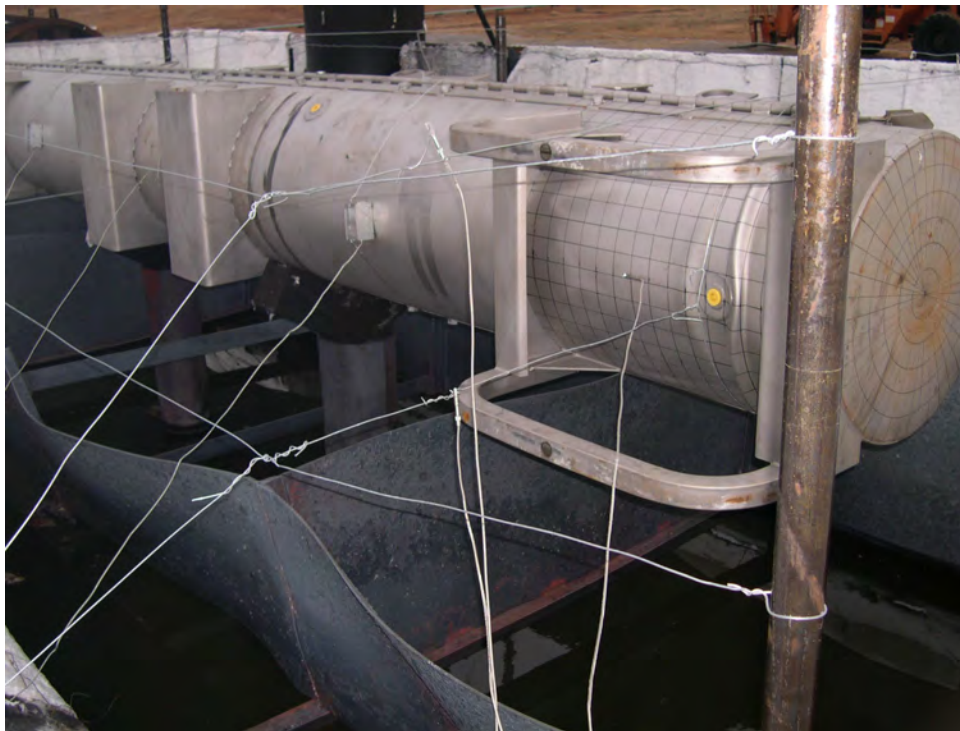
Figure 3-32 Test Stand for Fire Test

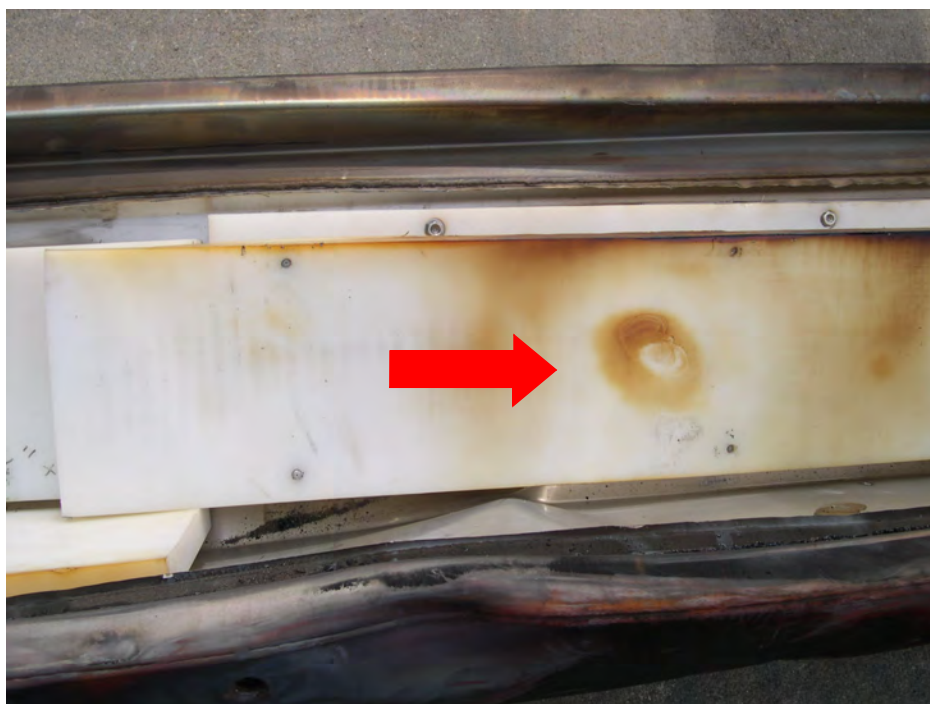
Figure 3-44 Localized Melt Spot in Lid Moderator Block

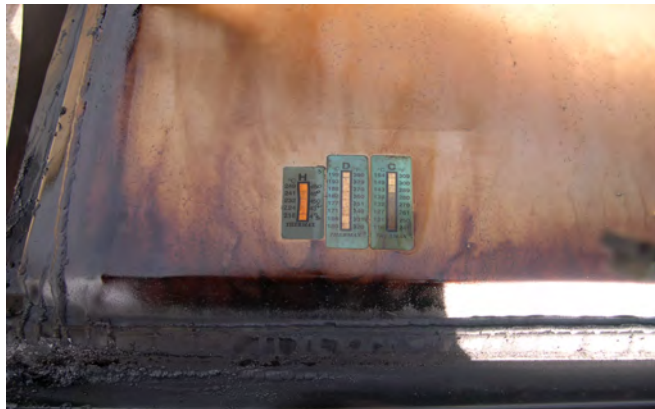
Twelve sets of non-reversible temperature strips were attached to the CTU. Two were placed on the inside faces of the impact limiters (one at each end), six were placed on the stainless steel covering the moderator in the Outerpack lid, and five were attached to the inside doors of the Clamshell. Except for one set that was unreadable after the test, the peak indicated temperature was 177°C. Locations of the temperature strip sets are shown in Figure 3-45. Readings on one of the Outerpack lid temperature strip sets is shown in Figure 3-46.

Figure 3-46 Temperature Strip Set After Fire Test
