Re: St. Lucie Units 1 and 2
Docket Nos. 50-335 and 50-389
2014 Annual Environmental Operating Report

FLORIDA POWER & LIGHT COMPANY

ST. LUCIE PLANT

ANNUAL ENVIRONMENTAL

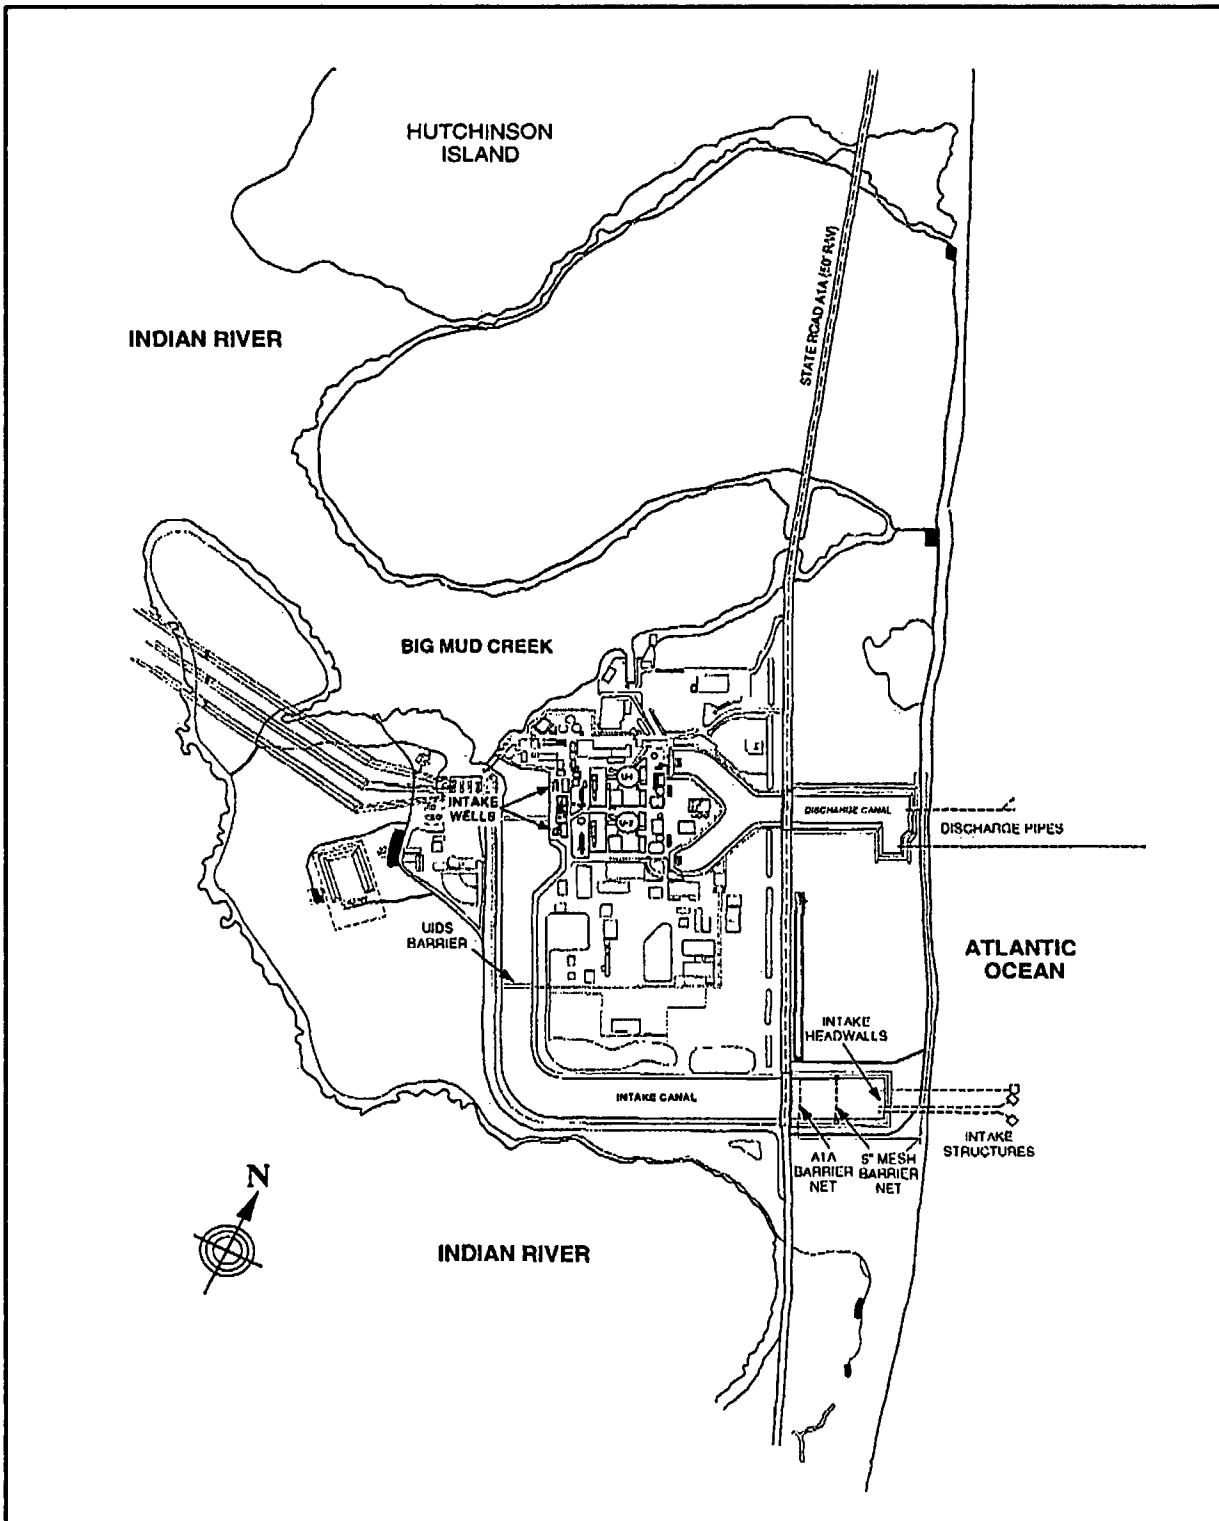
Figure 2. St. Lucie Plant cooling water intake and discharge system.

Florida Power & Light Company (FPL) - St. Lucie Plant is located on a 457-hectare site on South Hutchinson Island on Florida's east coast (Figures 1 and 2). South Hutchinson Island is a barrier island that extends 36 km between inlets and attains its maximum width of 2 km at the plant site. The plant is approximately midway between Ft. Pierce and St. Lucie Inlets and is bounded on the east by the Atlantic Ocean and on the west by the Indian River Lagoon. Elevations approach five meters atop dunes bordering the beach and decrease to sea level in the mangrove swamps that are common on the western side. The Atlantic shoreline of South Hutchinson Island is composed of sand and shell hash with intermittent rocky promontories protruding through the beach face along the southern end of the island. Submerged coquinoïd rock formations parallel much of the island off the ocean beaches. The ocean bottom immediately offshore from the plant site consists primarily of sand and shell sediments. The Gulf Stream (Florida Current), which flows parallel to the continental shelf margin, begins to diverge from the coastline at West Palm Beach. At South Hutchinson Island, the current is approximately 33 km offshore. Oceanic waters associated with the western boundary of the current periodically meander over the inner shelf, especially during summer months.

The St. Lucie Power Plant consists of two 1,000 MWe nuclear-fueled electric generating units that use nearshore ocean waters for the plant's once-through condenser cooling system. Unit 1 was placed on-line in March 1976 and Unit 2 in April 1983. Water for this system enters through three submerged intake structures located 365 m offshore (Figure 2). The intake structures are equipped with a velocity cap to minimize entrainment of marine life. Water passes through these structures and into submerged pipes (two 3.7 m and one 4.9 m in diameter) running under the beach. It then passes into a 1,500 m long intake canal, which transports it to the plant. After passing through the plant, the heated water is discharged into a 670 m long canal that leads to two buried discharge pipelines. These pass underneath the dunes and along the ocean floor to the submerged discharge, the first of which is 730 m north of the intake and extends approximately 365 m offshore. The second pipeline is located just to the south of the first and is nearly twice as long.

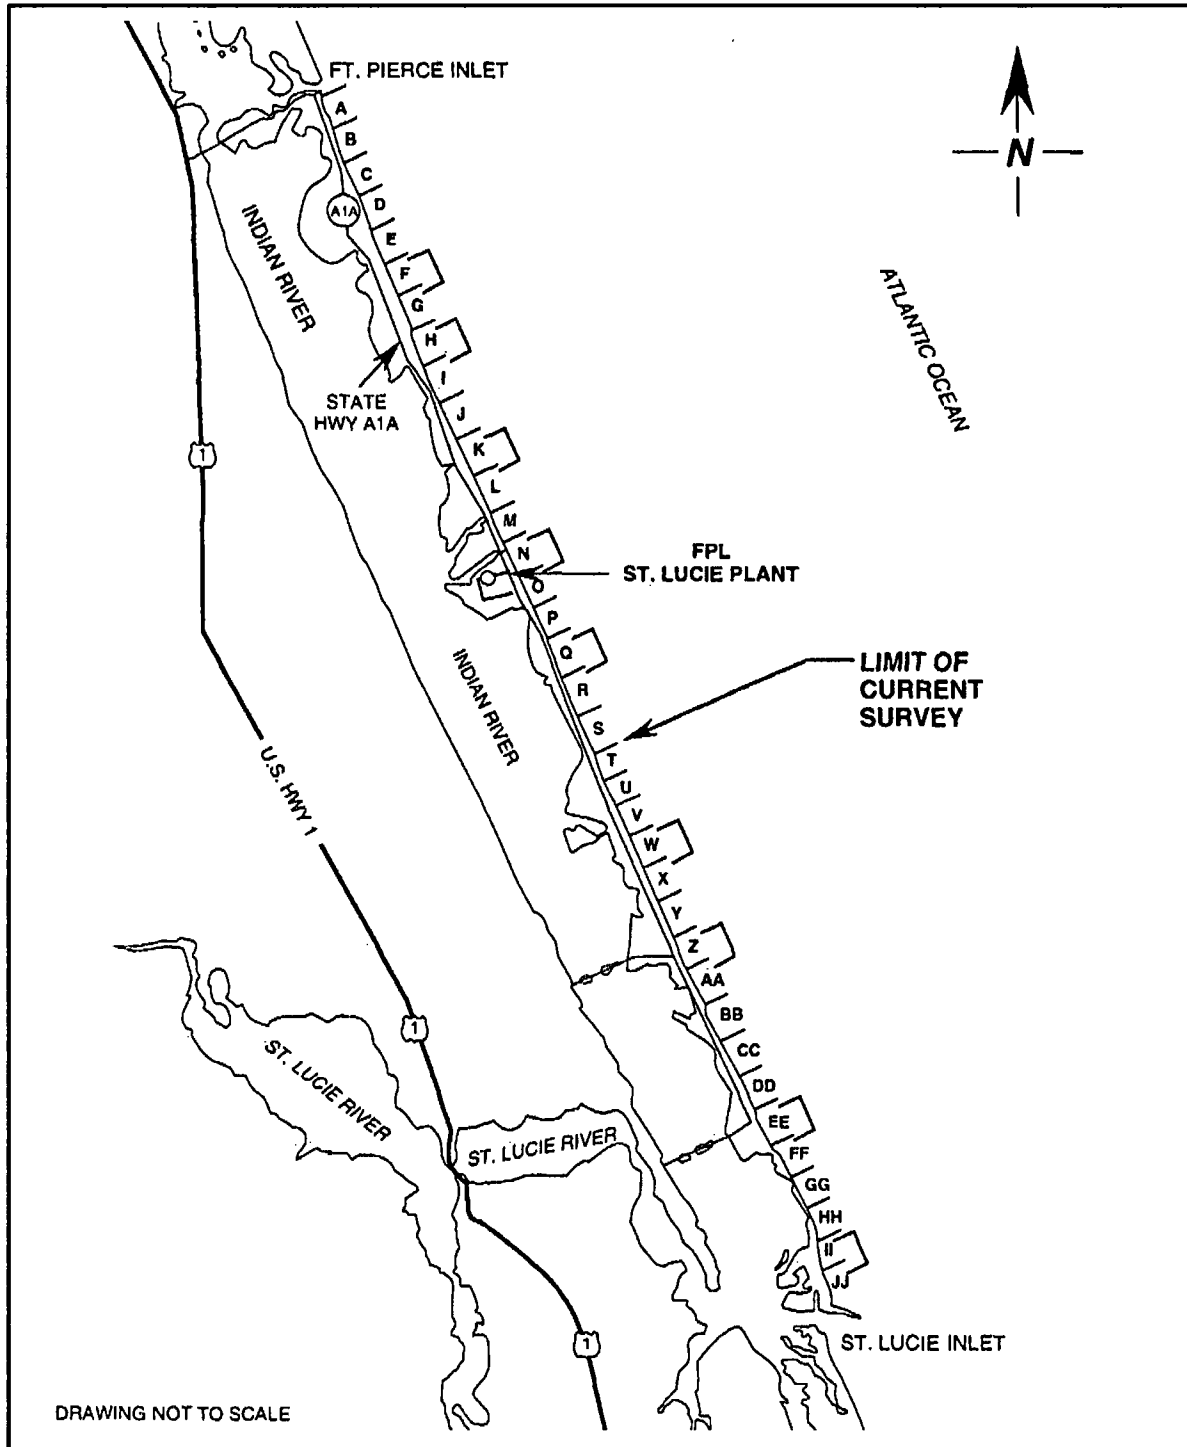
Figure 3. Designation and location of nine 1.25 km segments (in brackets) and thirty-six 1 km segments surveyed for sea turtle nesting on South Hutchinson Island (1971-2014).

From 1981 through 2014, 36 one km-long segments comprising the island's coastline have been surveyed seven days a week during the nesting season (Figure 3). These "zones" are identified starting with zone A at the northern end of the island and continue through zone JJ at the southern end. Since the 1994 nesting season, the southern half of the island (zone T to zone JJ) has been surveyed by Ecological Associates, Inc. (EAI) and their data are included in this report. Biologists used all-terrain vehicles to survey the island each morning. New nests, non-nesting emergences (false crawls), and nests affected by predators were recorded for each zone. Data collected from beach nesting surveys are reported to the Florida Fish and Wildlife Conservation Commission (FWC) as part of the Index Nesting Beach Survey and the Statewide Nesting Beach Survey.

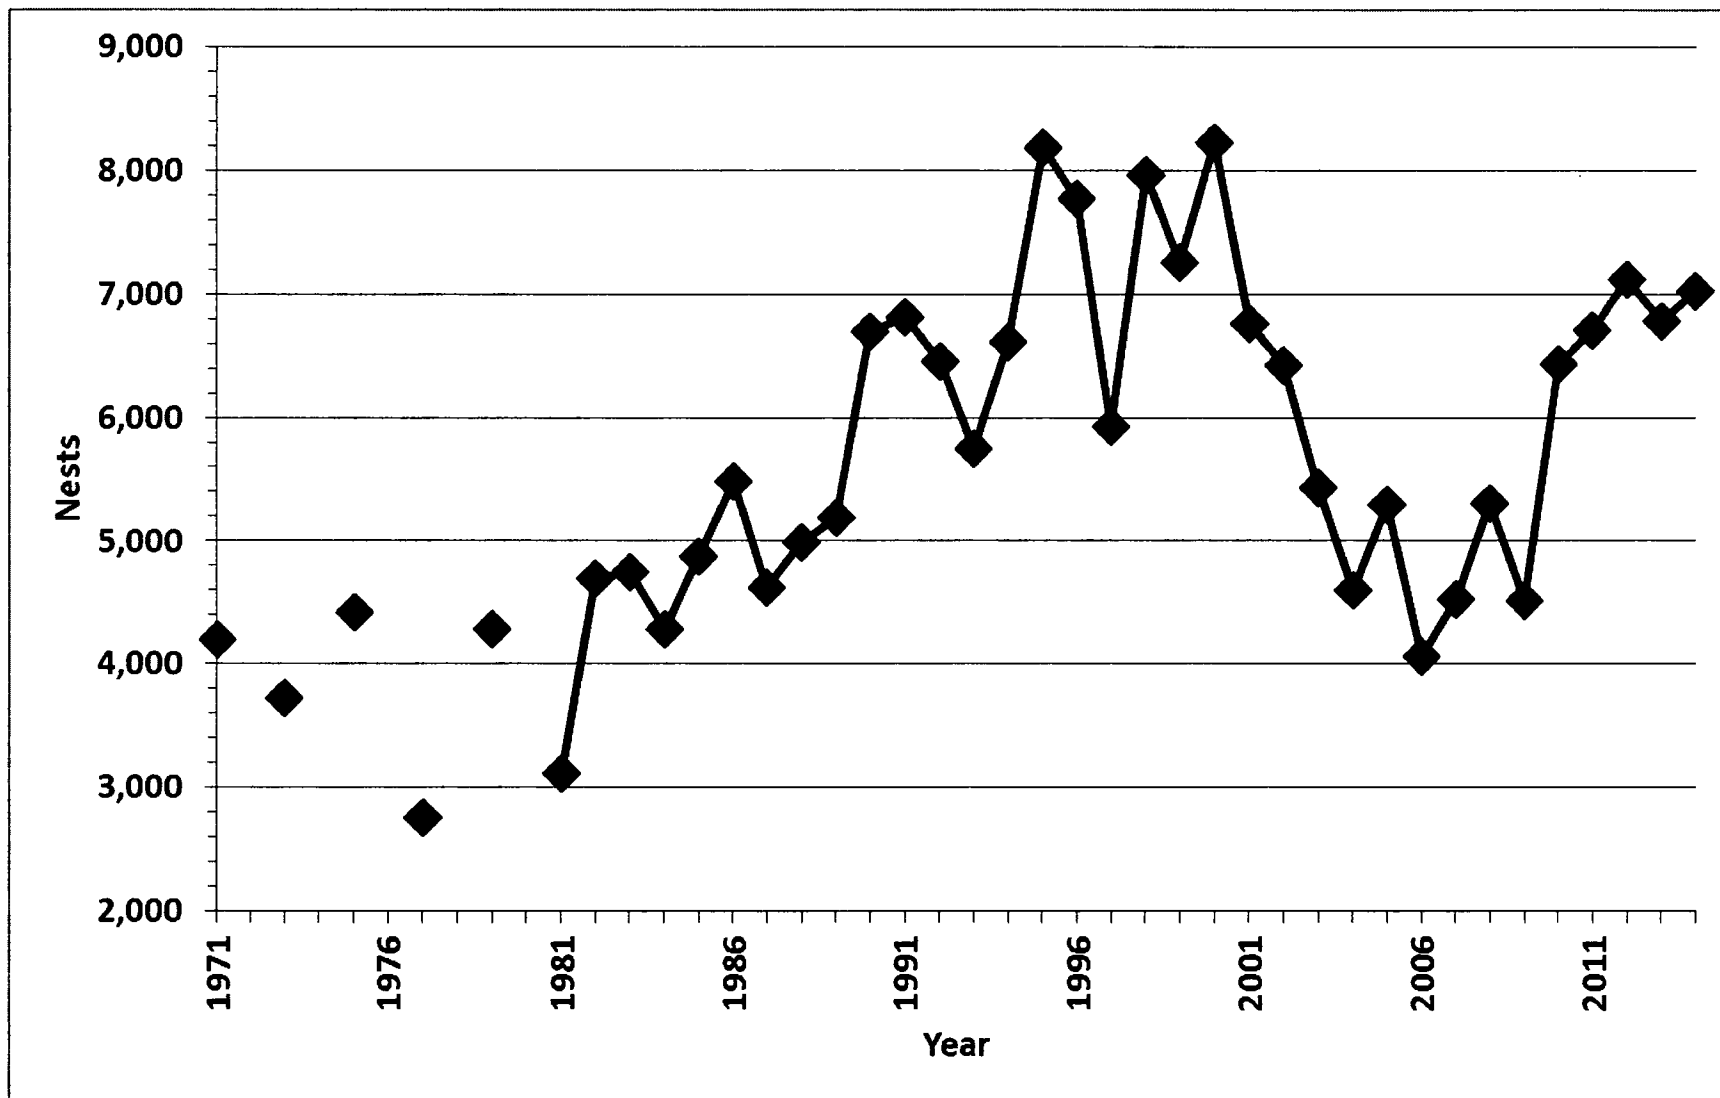
Figure 4. Number of loggerhead turtle nests on South Hutchinson Island from 1971 through 2014. Values for 1971 through 1979 are estimates (see section 2.1.1); values for 1981 through 2014 are from whole island surveys.

In 2014, 7,027 loggerhead nests were recorded on South Hutchinson Island (Figure 4). In zones A-S (the north end of the island) biologists observed 3,196 nests (Figure 8). The first recorded nest was on April 19th and the last loggerhead nest was recorded on September 8th. There were 2,795 loggerhead false crawls observed in zones A-S.

Loggerhead nesting activity on South Hutchinson Island fluctuates considerably from year to year (Figure 6). Annual variations in nest densities are also common at other rookeries, and probably result from non-annual reproductive behavior (Heppell, Snover, & Crowder, 2003). No relationships between annual fluctuations in nesting activity and power plant operation or intake/discharge construction have been found. However, loggerhead nesting on South Hutchinson Island mirrors trends in nesting statewide.

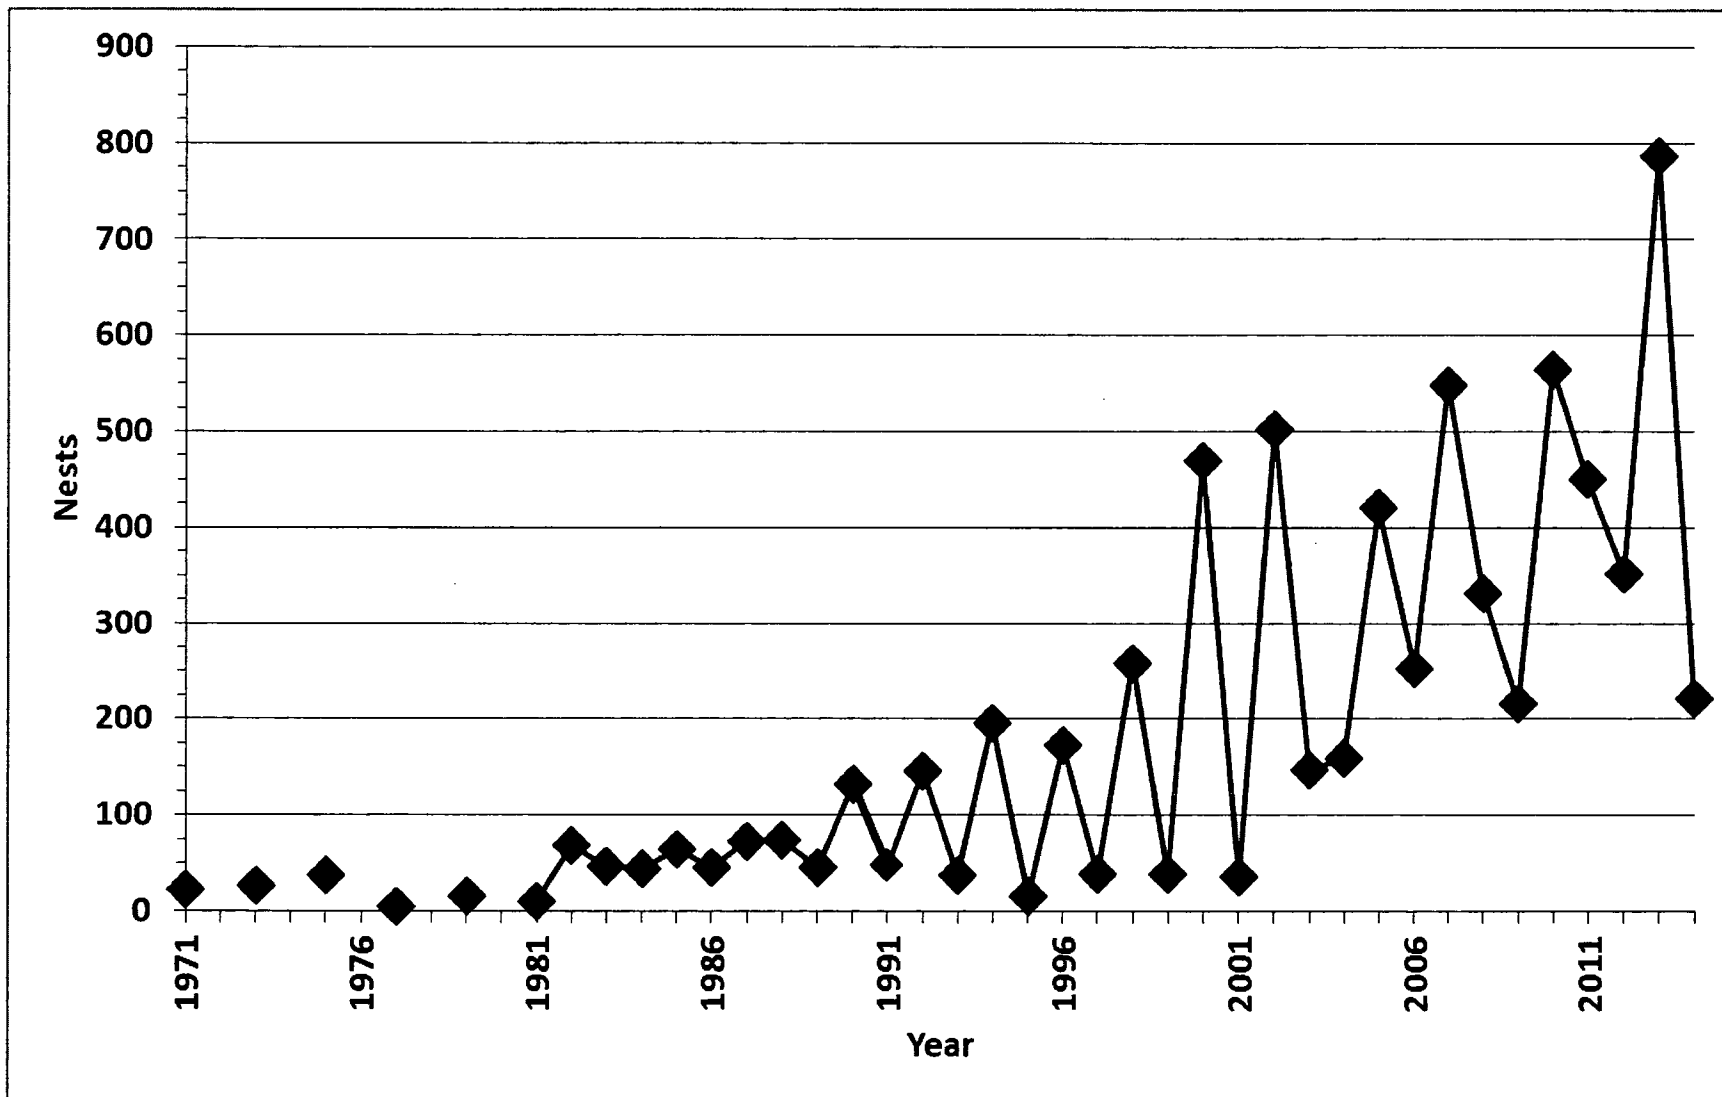
Figure 5. Number of green turtle nests on South Hutchinson Island from 1971 through 2014. Values for 1971 through 1979 are estimates (see section 2.1.1); values for 1981 through 2014 are from whole island surveys.

In 2014, 221 green turtle nests were recorded on Hutchison Island (Figure 5). Biologists observed a total of 103 green turtle nests in zones A-S (Figure 8). The first recorded nest of the season was on June 6th and the last green turtle nest was noted on September 28th. There were 105 green turtle false crawls observed in zones A-S.

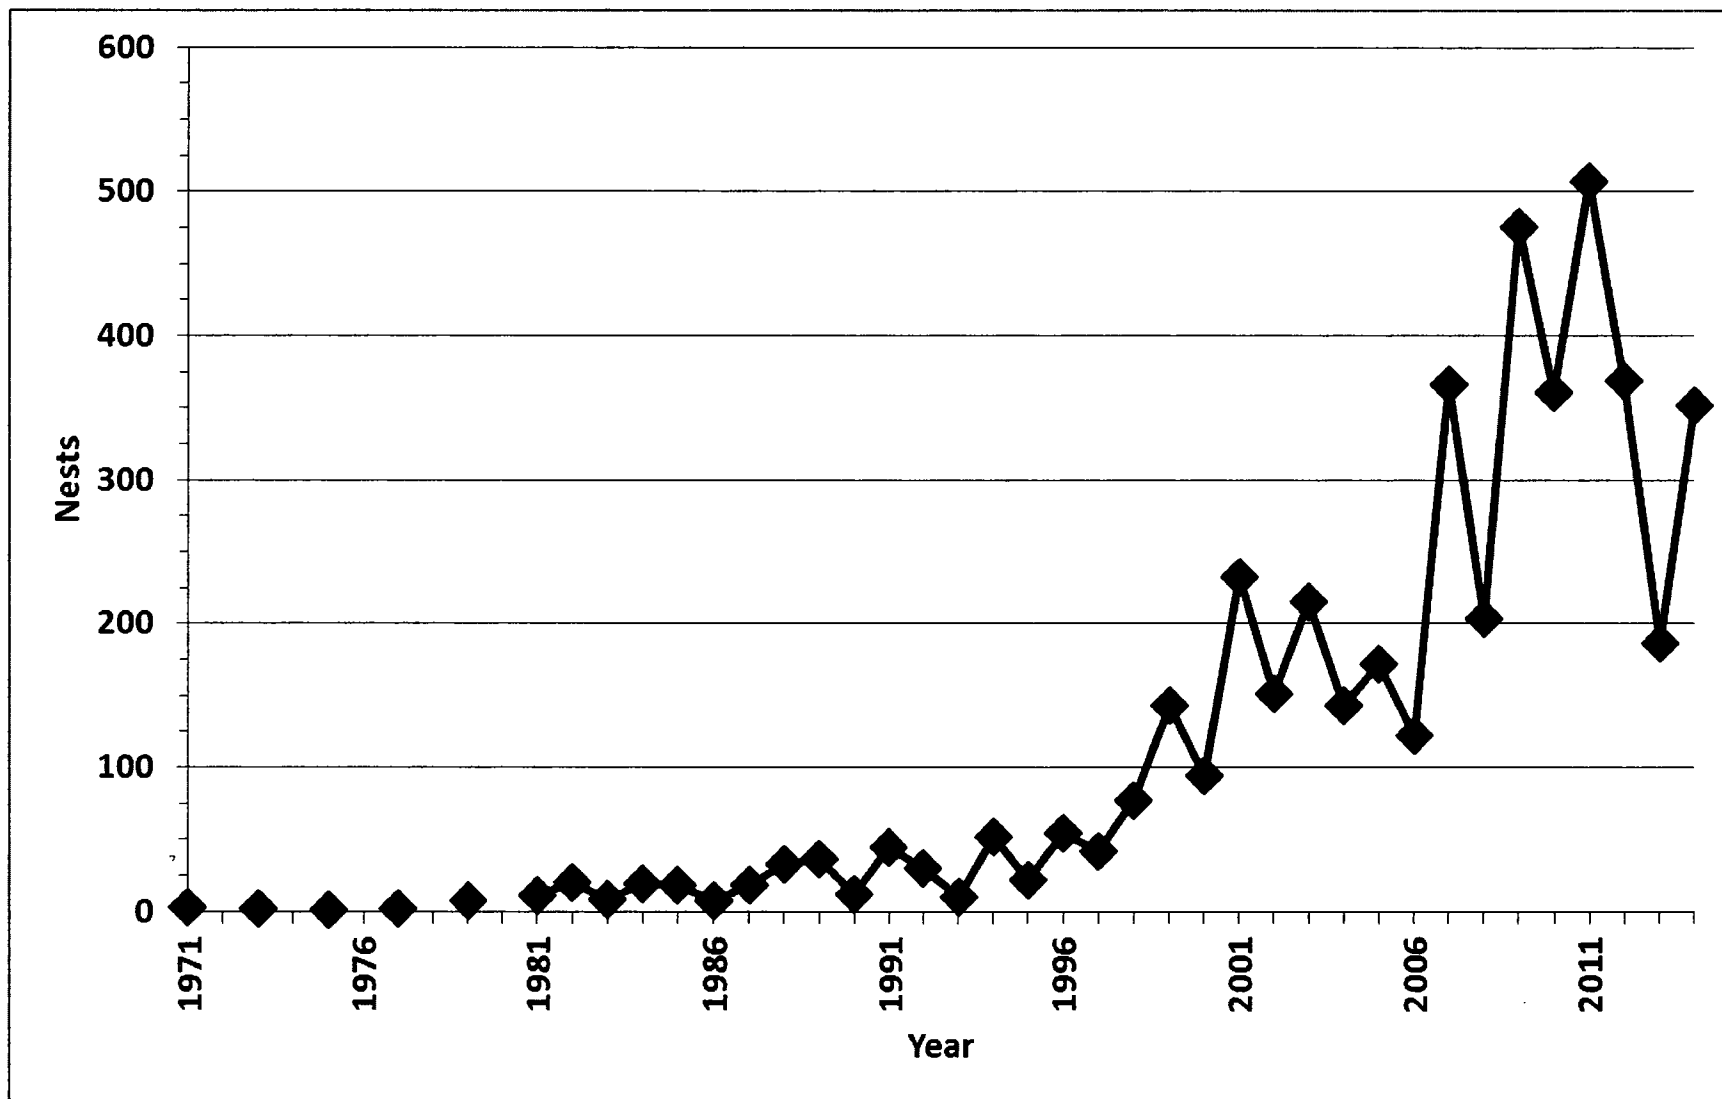
Figure 6. Number of leatherback turtle nests on South Hutchinson Island from 1971 through 2014. Values for 1971 through 1979 are estimates (see section 2.1.1); values for 1981 through 2014 are from whole island surveys.

In 2014, 352 leatherback turtle nests were recorded on Hutchison Island (Figure 6). Biologists observed a total of 106 leatherback sea turtle nests in zones A-S (Figure 8). The first recorded nest was on March 19th and the last leatherback sea turtle nest was

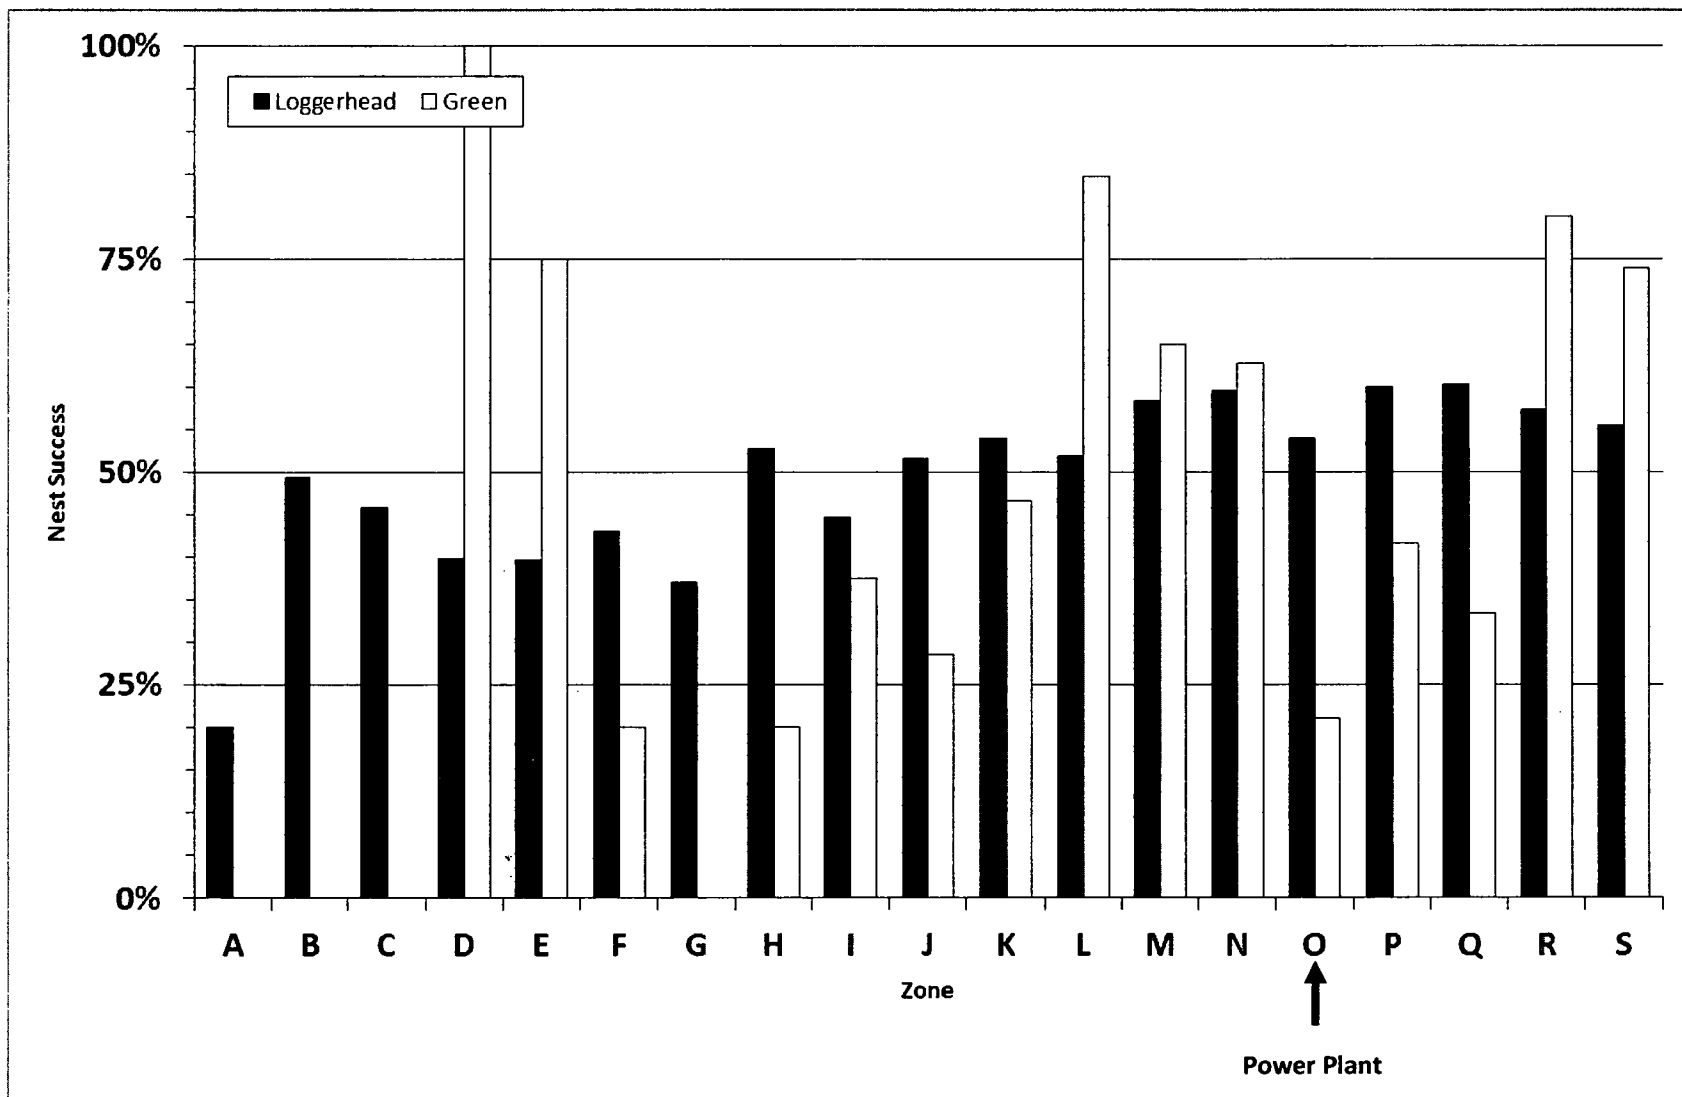
Figure 7. Loggerhead and green turtle nesting success (percentage of emergences resulting in nests) for each of the 1 km zones A through S (North to South) on South Hutchinson Island for the 2014 nesting season.

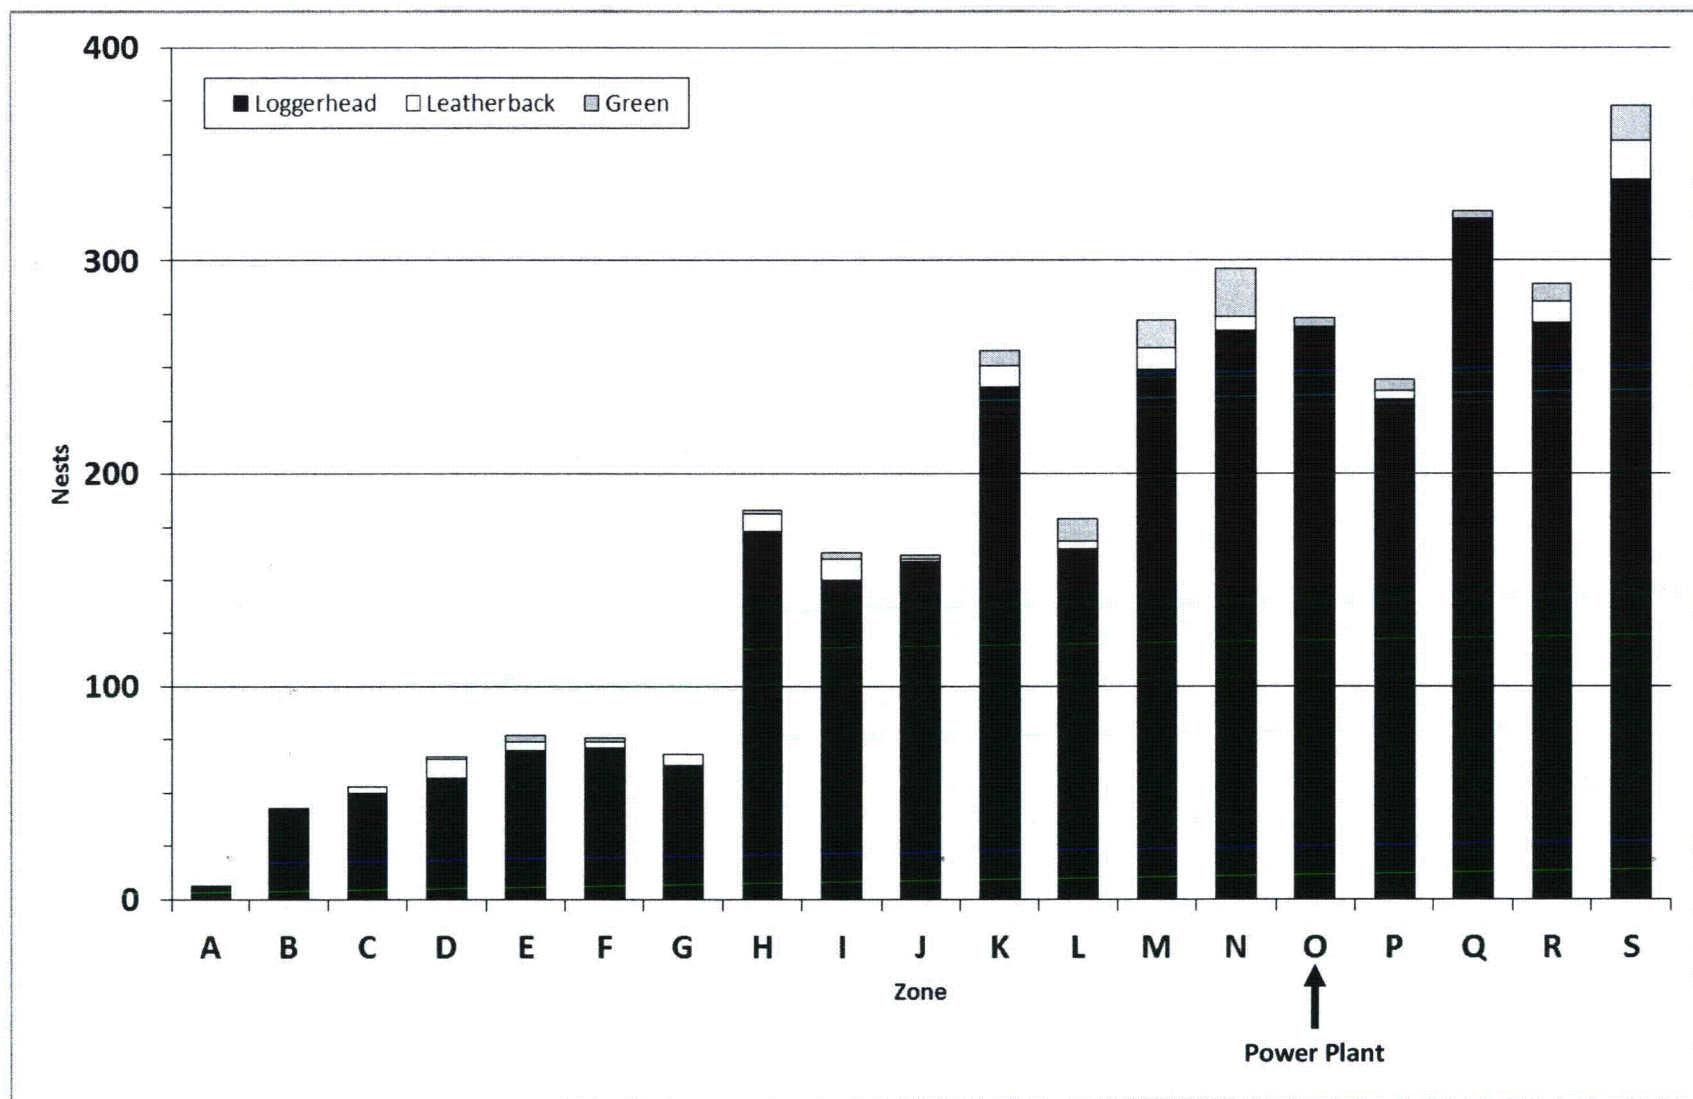
Figure 8. Number of turtle nests by species for each of the 1 km zones A through S (North to South) on South Hutchinson Island for the 2014 nesting season.

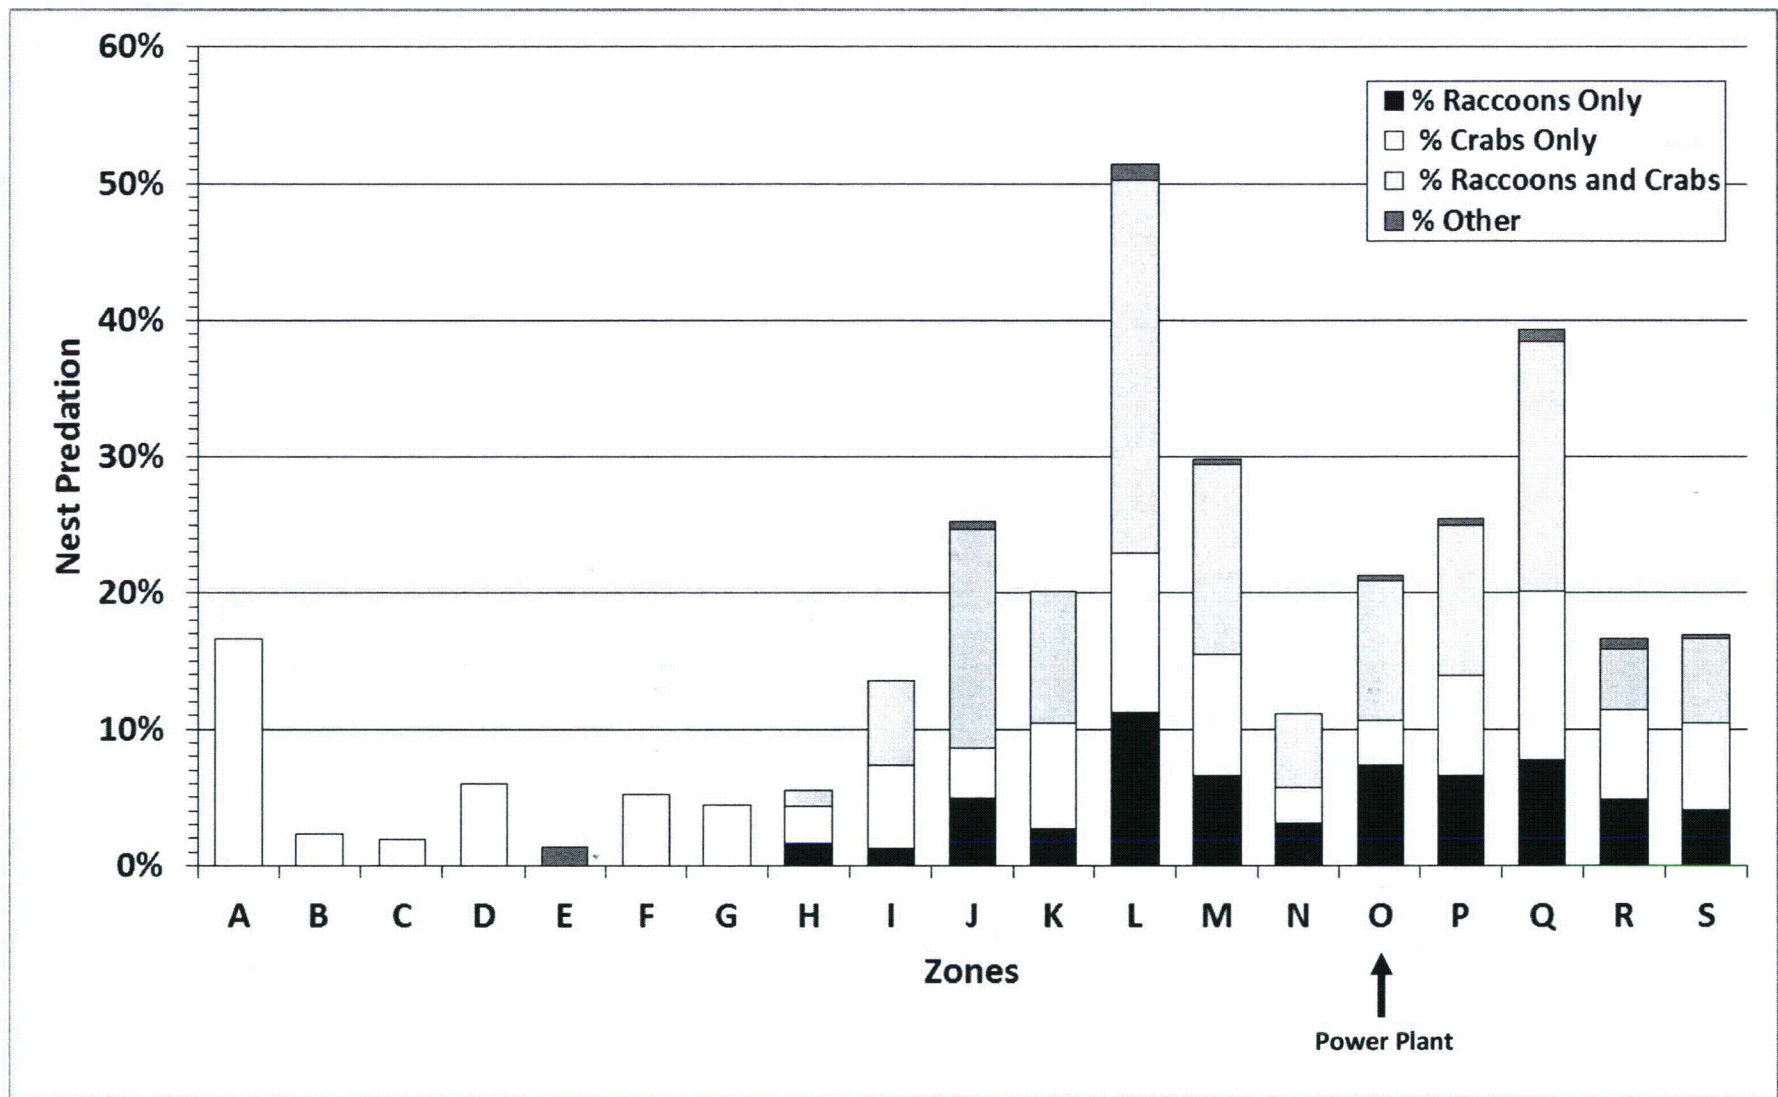
Figure 9. Percentage of sea turtle nests depredated by 1 km zones A through S (North to South) on South Hutchinson Island for the 2014 nesting season.

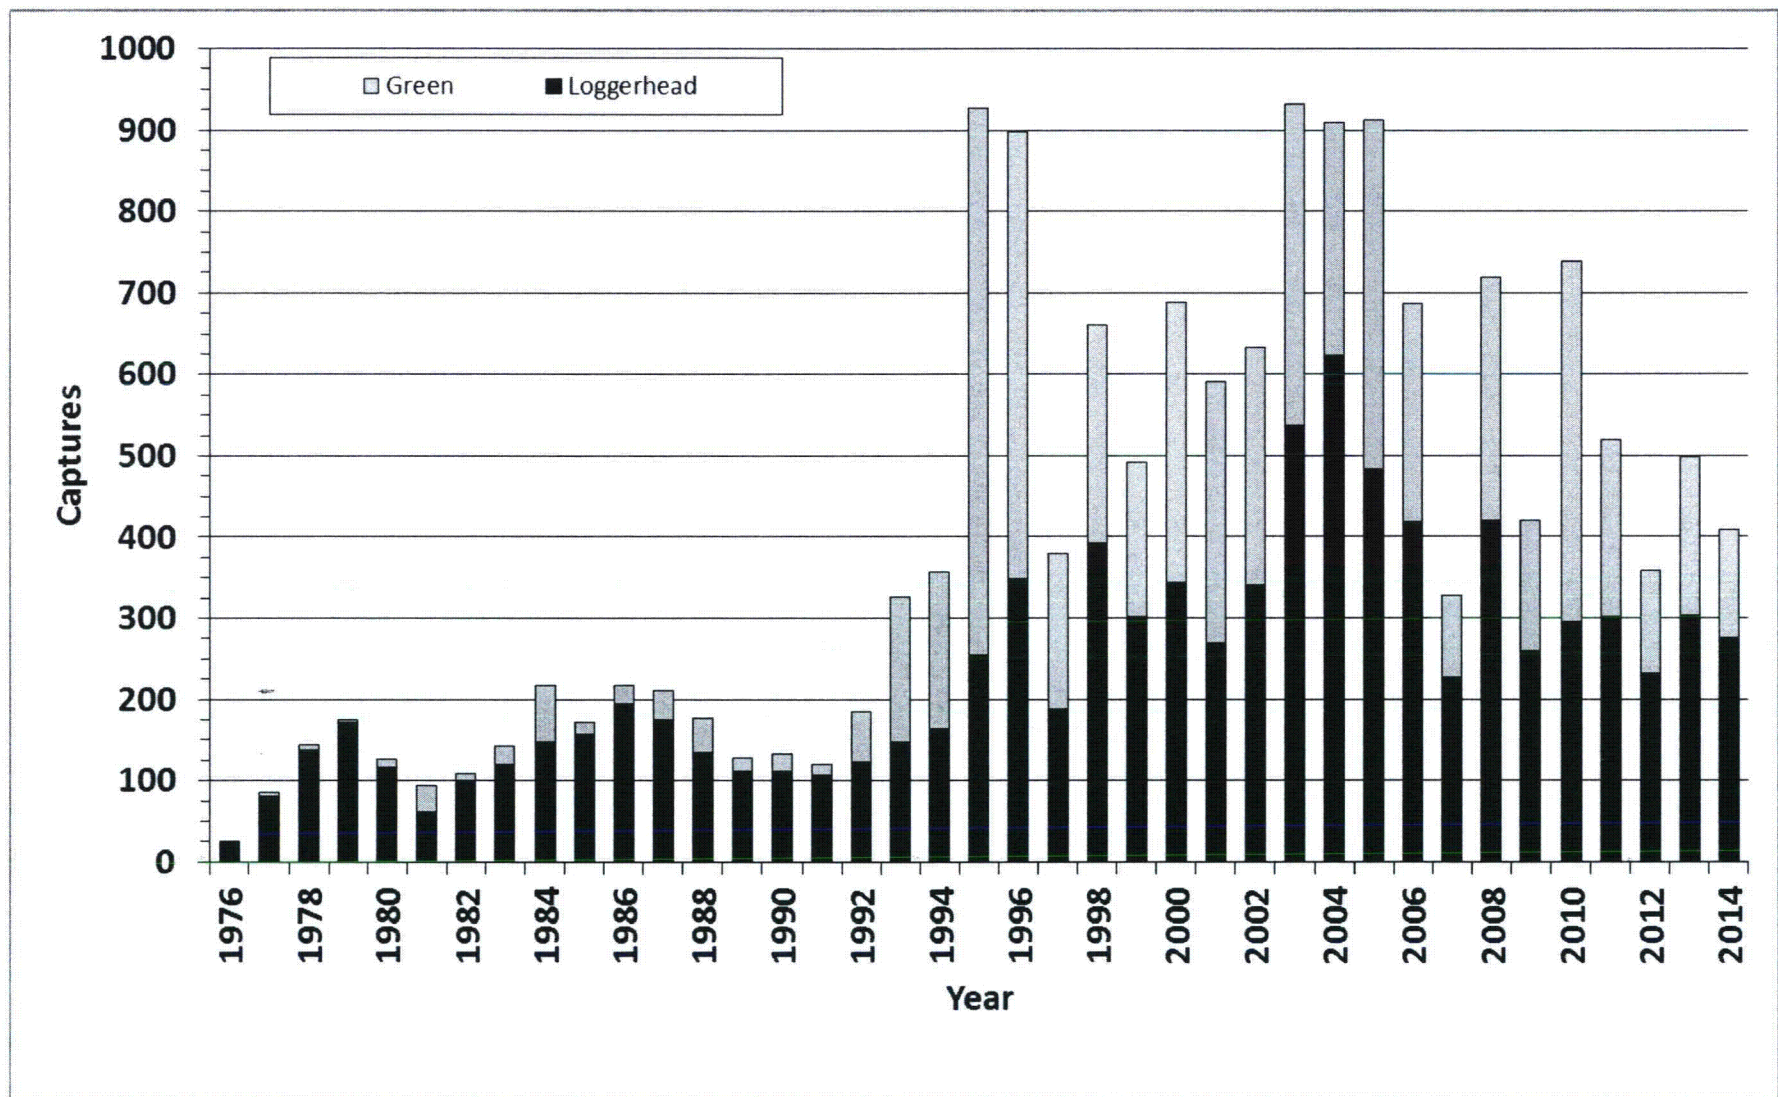
Figure 10. Number of loggerhead and green turtles captured and removed each year from the intake canal at the St. Lucie Power Plant, 1976 through 2014.

During 2014, a total of 414 sea turtles were removed from the intake canal, including 275 loggerheads, 134 green turtles, two Kemp's ridley turtles, and three hawksbills (Figures 10 and 11; Table 1). The majority of these turtles (95.4%) were captured alive and released back to the ocean. Fifteen (3.6%) were taken to rehabilitation facilities for treatment of injuries or disease and four (1.0%) turtles were found dead. None of the turtles taken to rehab facilities had injuries causal to power plant operations. None of the four turtles found dead were causal to power plant operations. Mortalities and injuries are discussed in Section 3.2.6.

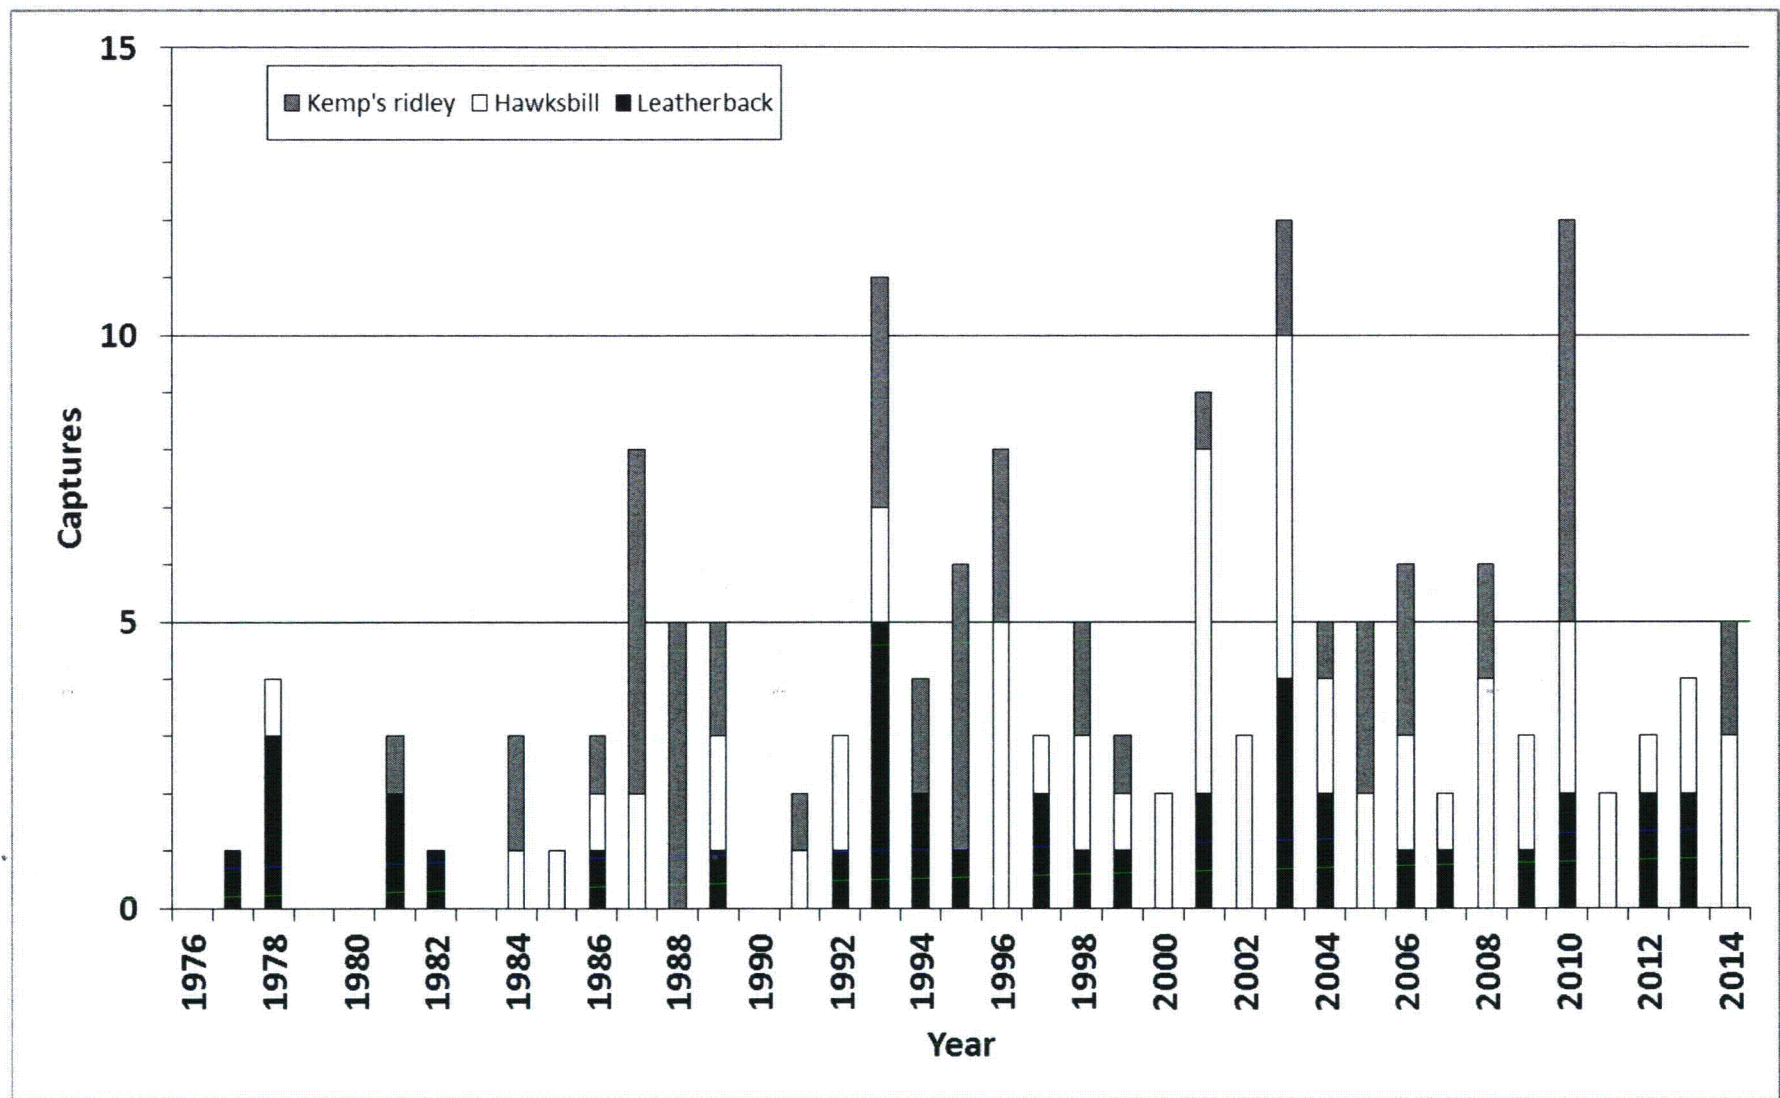
Figure 11. Number of Kemp's ridley, hawksbill, and leatherback turtles captured and removed each year from the intake canal at the St. Lucie Power Plant, 1976 through 2014.

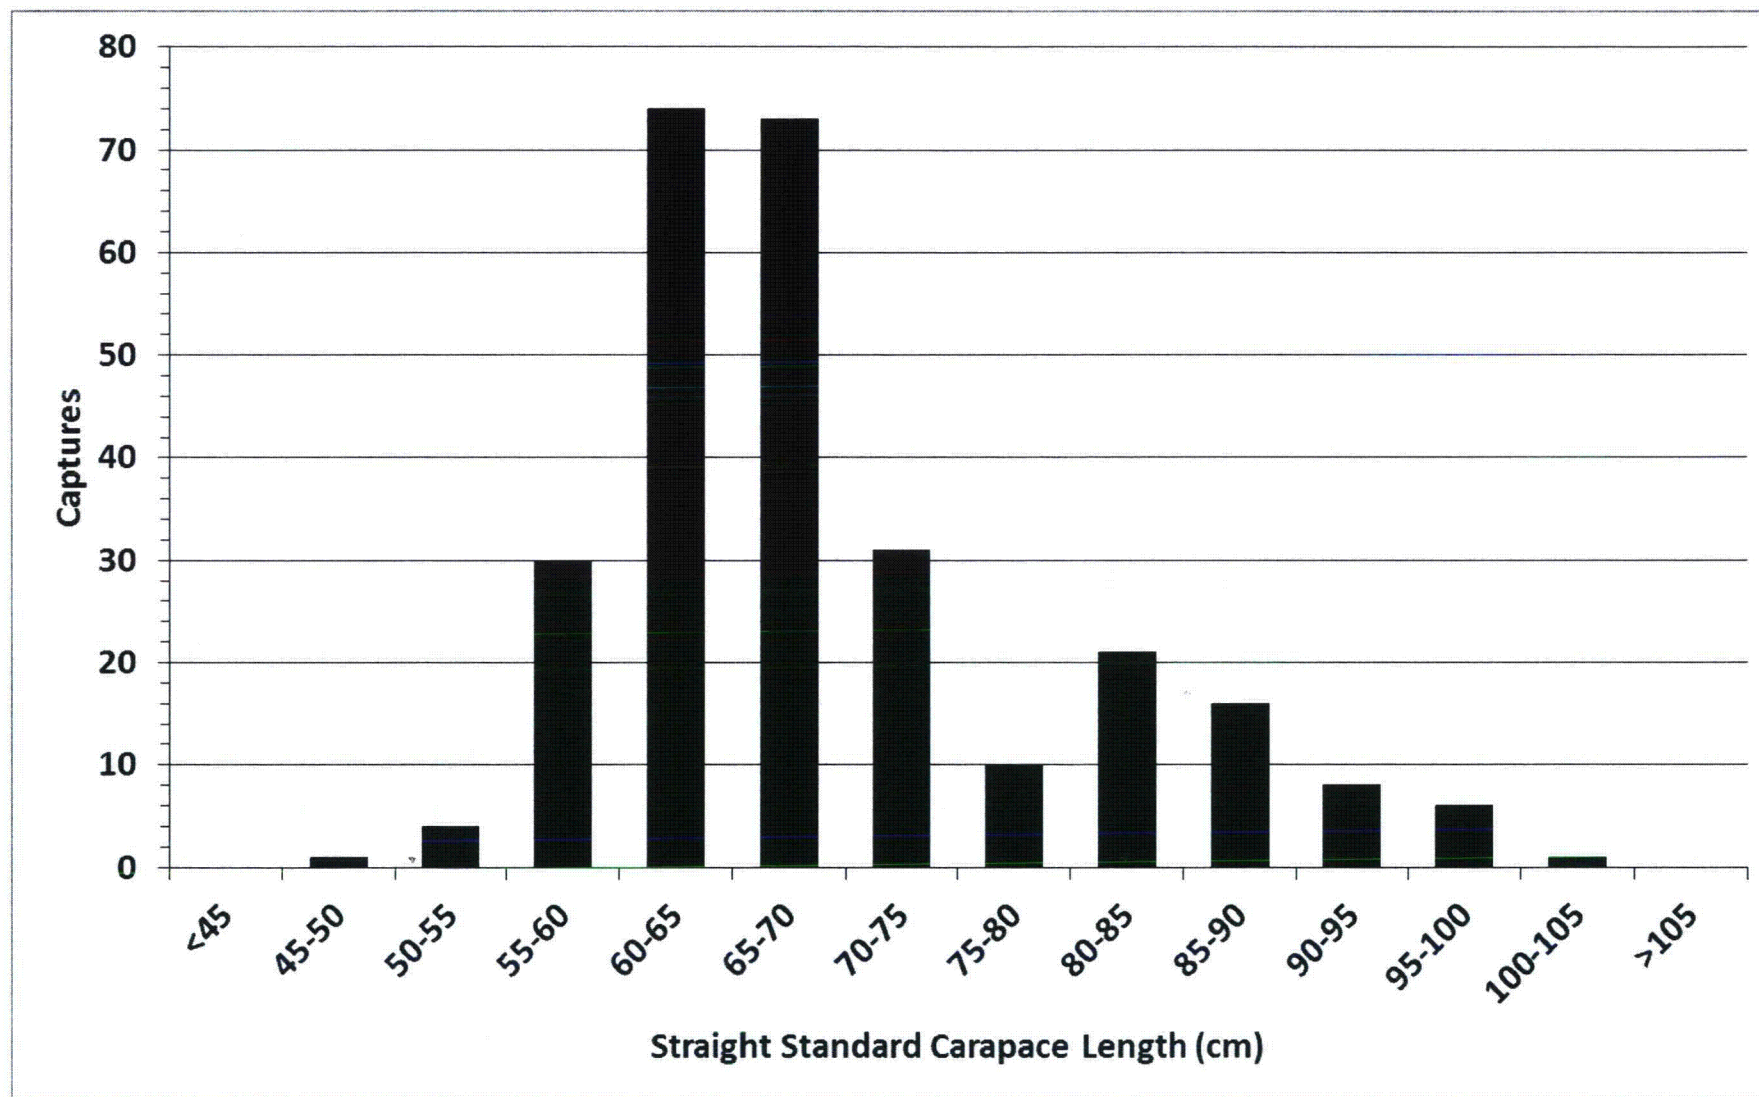
Figure 12. Size distribution (Straight Standard Carapace Length; SSCL) of loggerhead turtles (n=275) captured and removed from the intake canal at the St. Lucie Power Plant during 2014.
