Re: St. Lucie Units 1 and 2
Docket Nos. 50-335 and 50-389
2014 Annual Environmental Operating Report

FLORIDA POWER & LIGHT COMPANY

ST. LUCIE PLANT

ANNUAL ENVIRONMENTAL

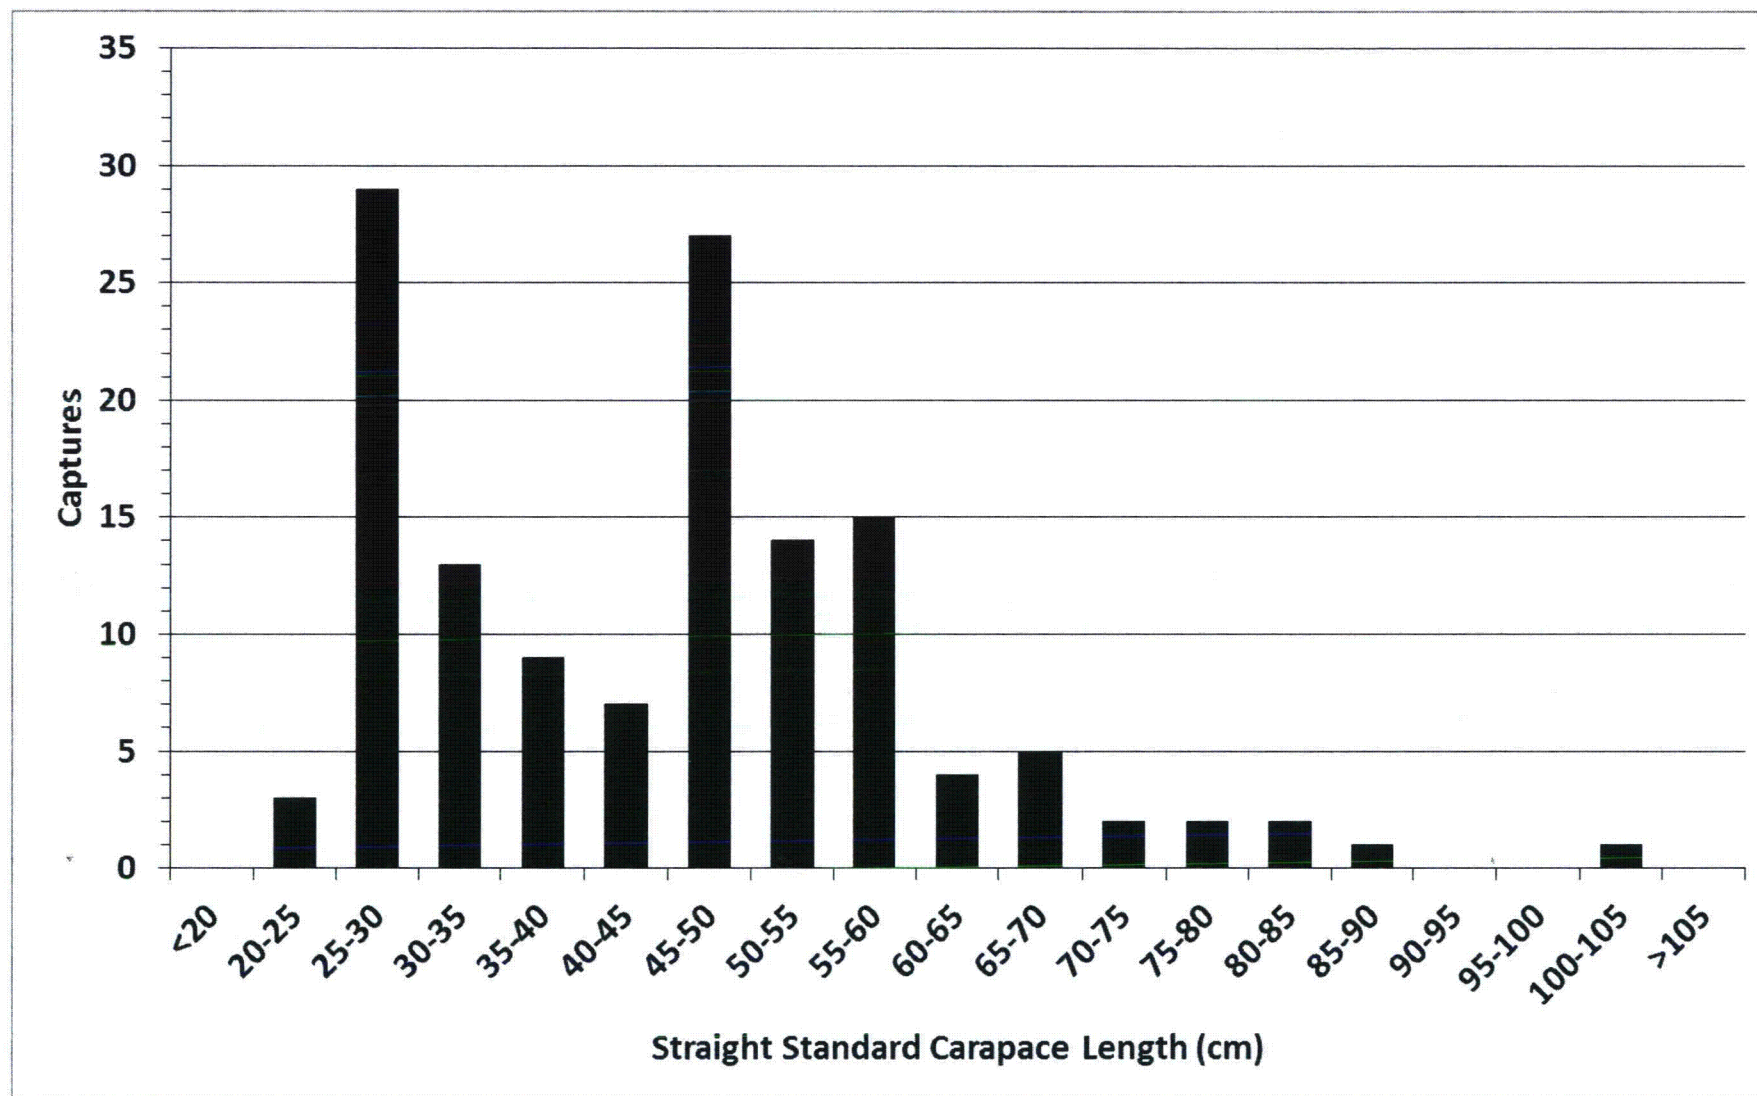
Figure 13. Size distribution (Straight Standard Carapace Length; SSCL) of green turtles (n=134) captured and removed from the intake canal at the St. Lucie Power Plant during 2014.
