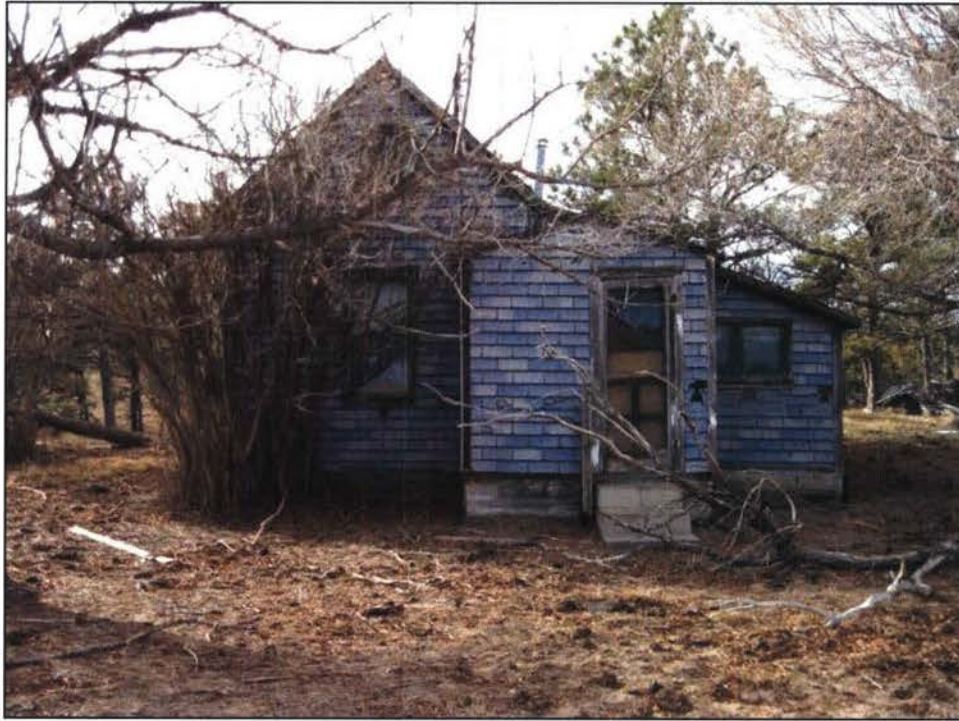
Figure 77. 25DW365, Farm House (Feature F1), facing west. Photograph taken by Ashley Howder, on 12/03/2010.

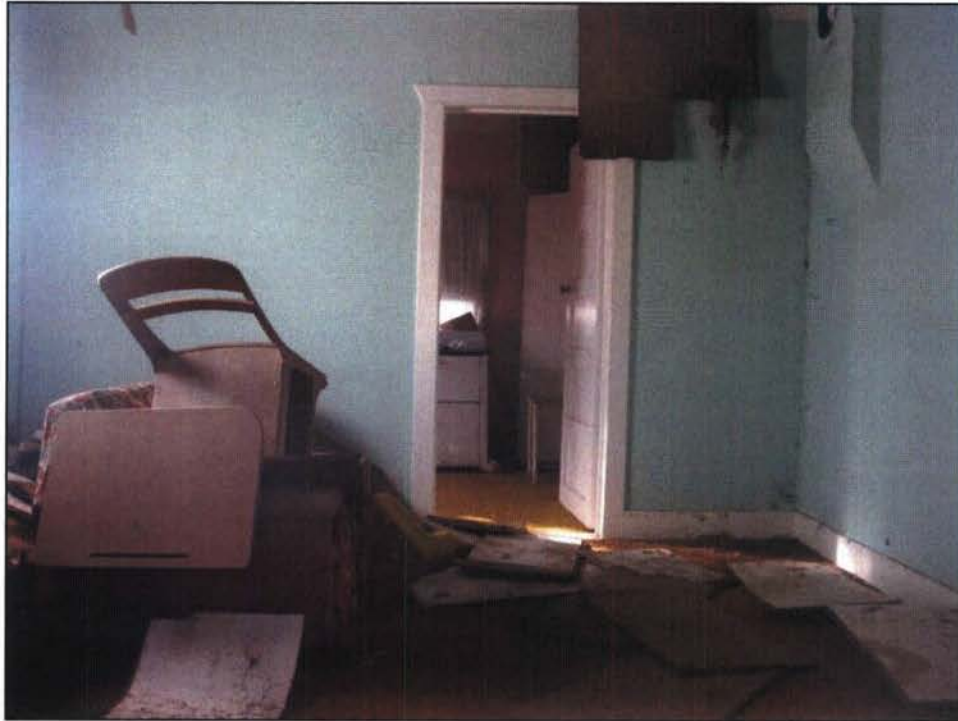
Figure 78. 25DW365, interior of Farm House (Feature F1) showing southeastern room. Photograph taken by Ashley Howder, on 12/03/2010.

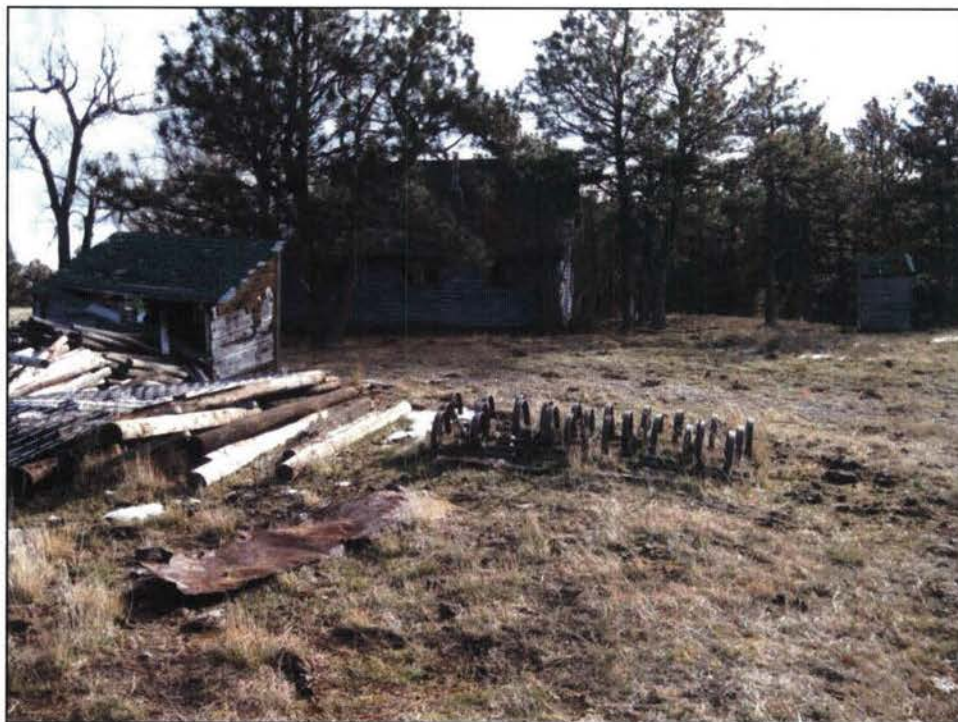
Figure 79. 25DW365, shown from left to right: oil shed (Feature F4), north face of main farm house (Feature F1), and outhouse (Feature F2), facing south. Photograph taken by Ashley Howder, on 12/03/2010.

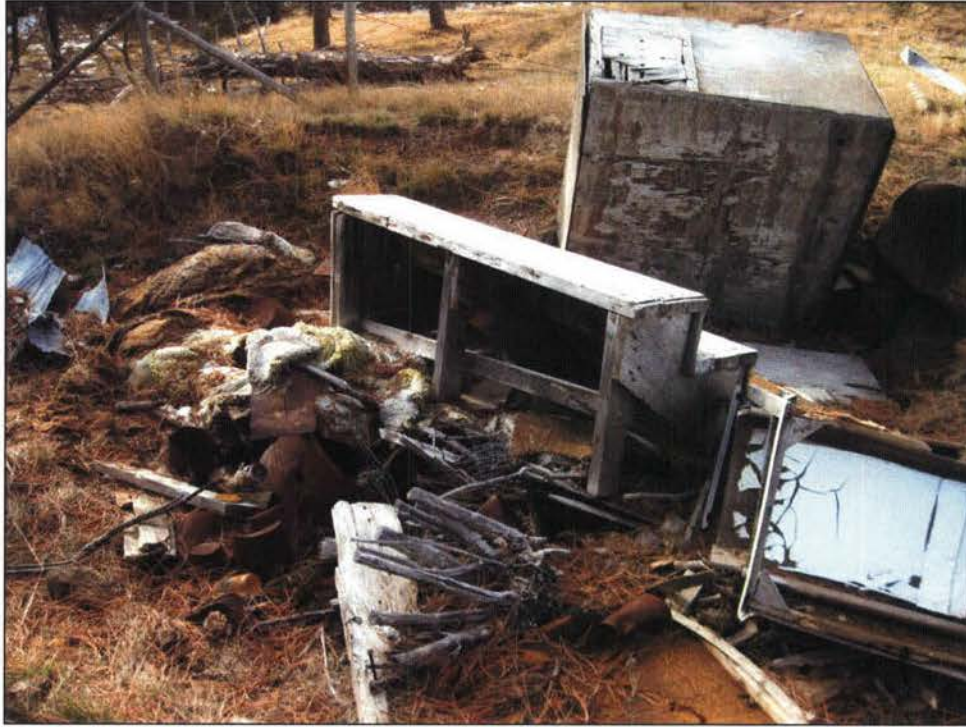
Figure 80. 25DW365, small debris pile (Feature F3) behind main house (Feature F1), facing west. Photograph taken by Ashley Howder, on 12/03/2010.

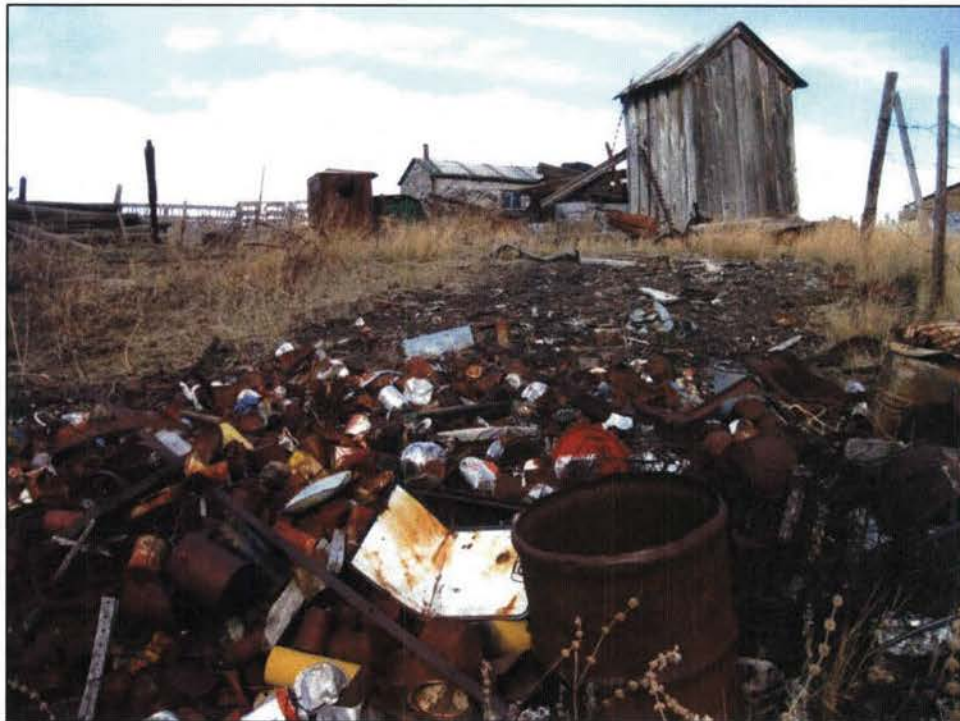
Figure 81. 25DW365, main debris dump (Feature F5) with small oil/storage shed (Feature F8) and laundry shed (Feature F7) in background, facing east. Photograph taken by Ashley Howder, on 12/03/2010.

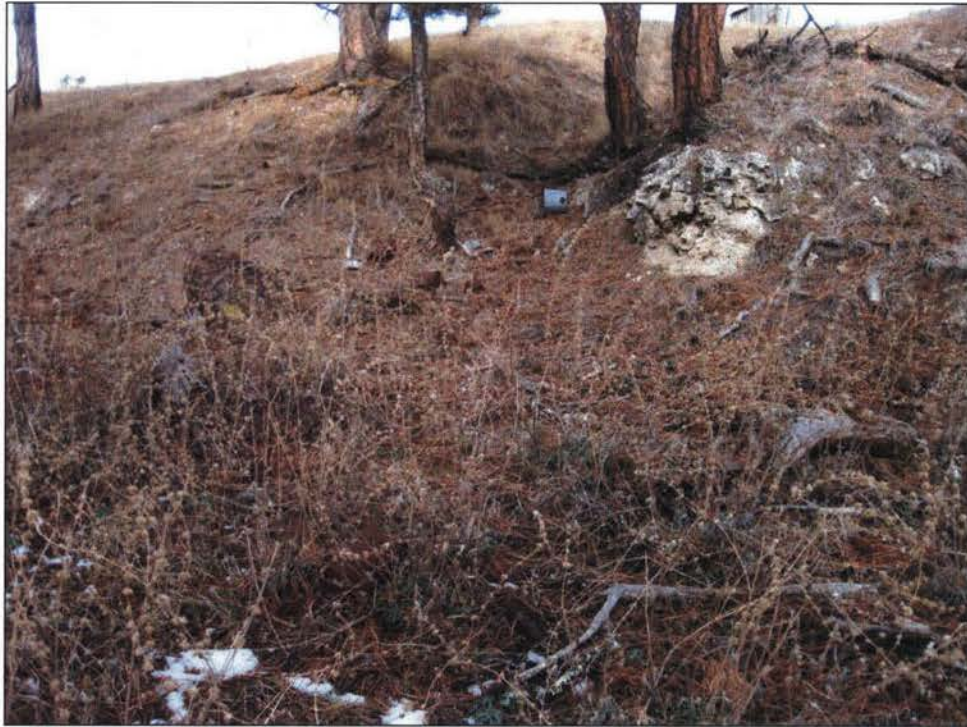
Figure 82. 25DW365, small debris dump (Feature F6), facing northeast. Photograph taken by Ashley Howder, on 12/03/2010.

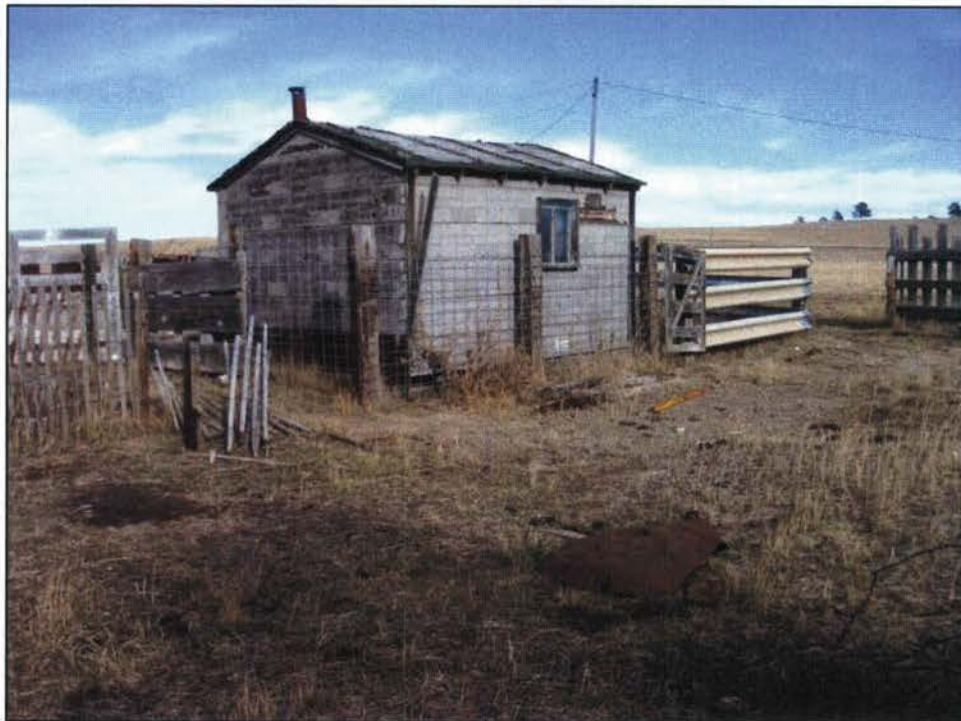
Figure 83. 25DW365, laundry shed (Feature F7) with corrals, facing northeast. Photograph taken by Ashley Howder, on 12/03/2010.

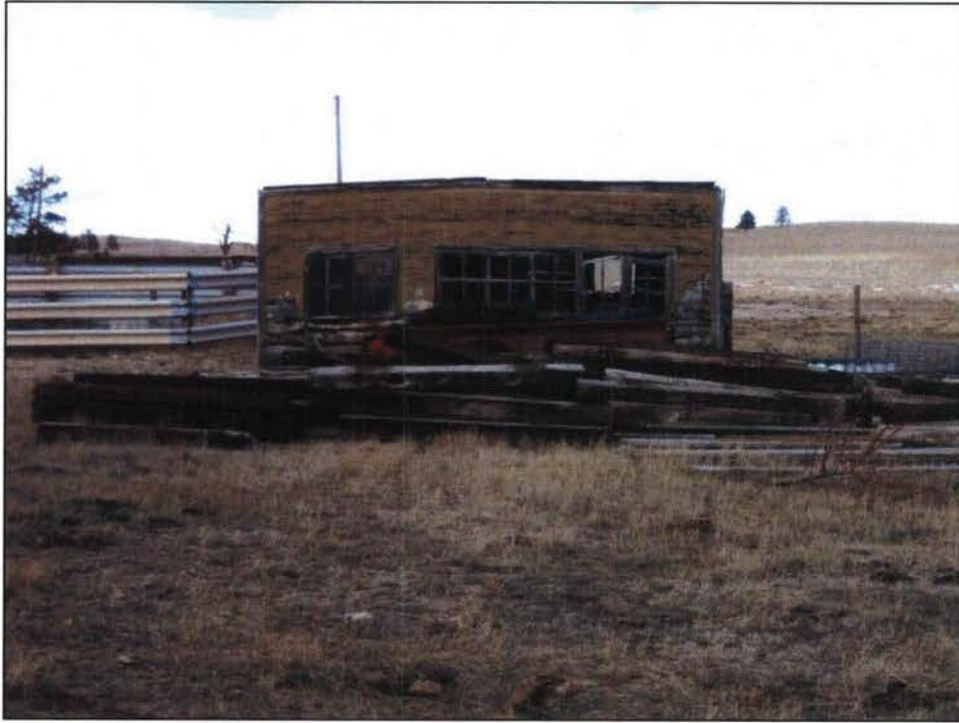
Figure 84. 25DW365, chicken coop (Feature F9), facing north. Photograph taken by Ashley Howder, on 12/03/2010.

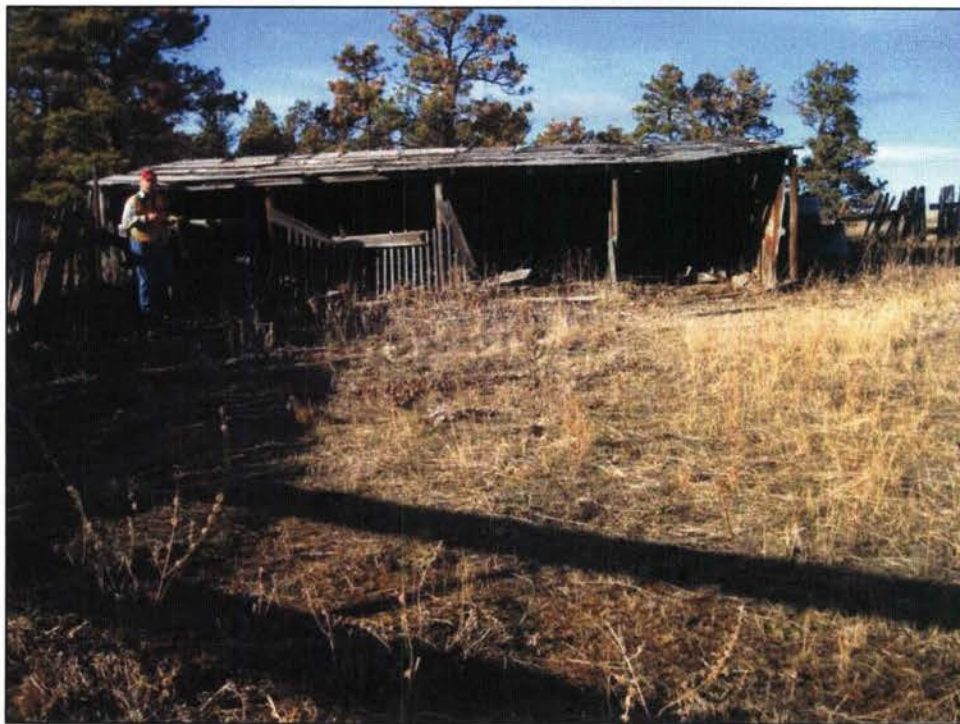
Figure 85. 25DW365, livestock shelter (Feature F10), facing north. Photograph taken by Ashley Howder, on 12/03/2010.

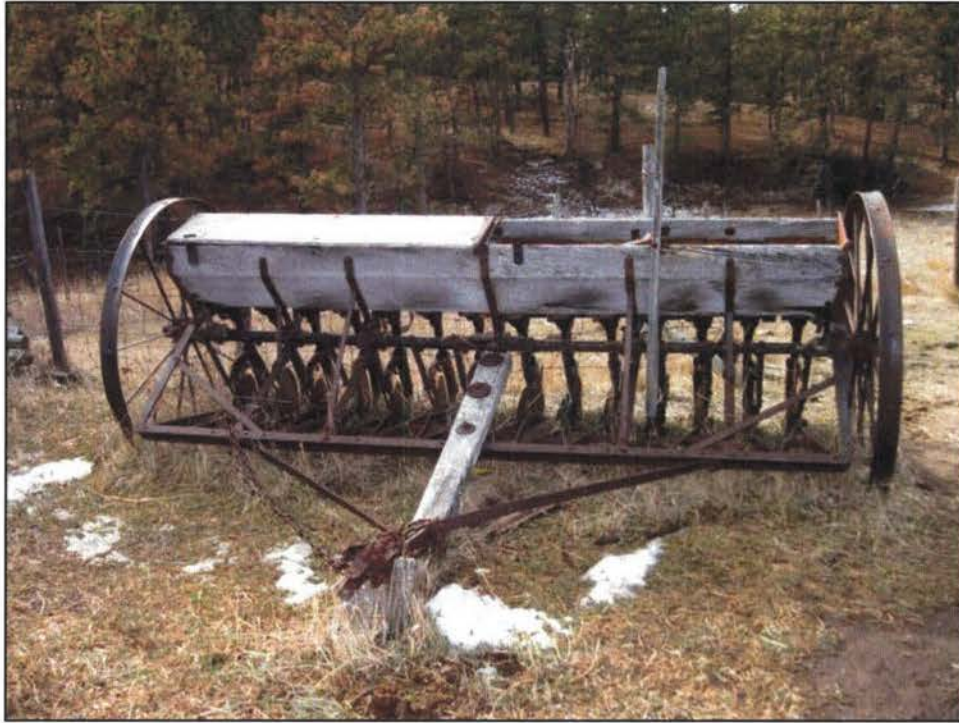
Figure 86. 25DW365, Van Brunt grain drill, facing west. Photograph taken by Ashley Howder, on 12/03/2010.

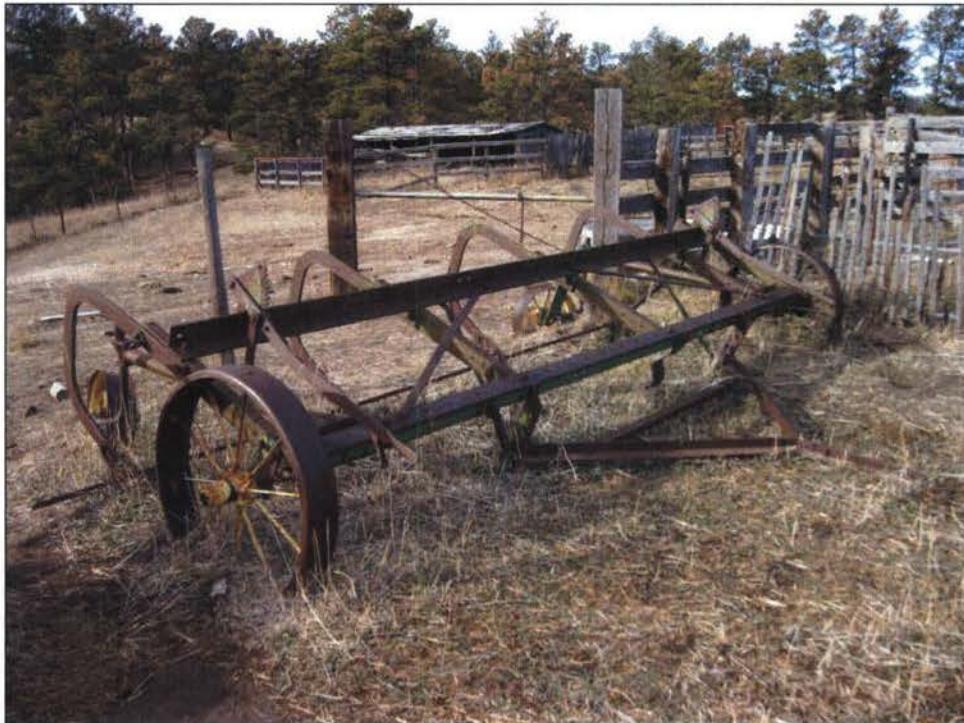
Figure 87. 25DW365, John Deere rod weeder, facing northwest. Photograph taken by Ashley Howder, on 12/03/2010.

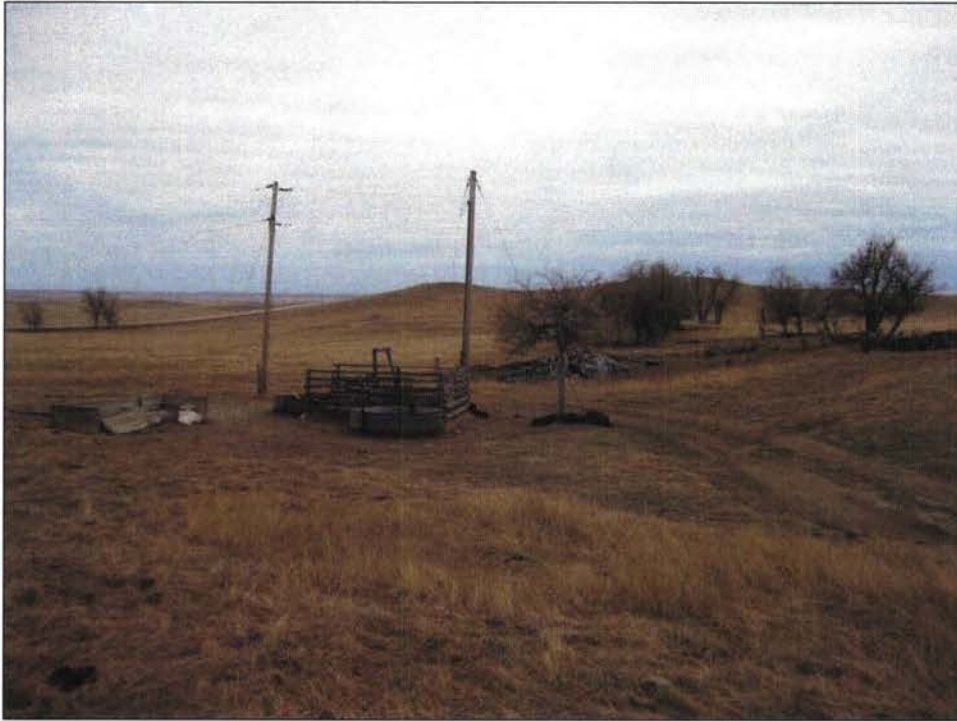
Site 25DW366 is a small historic homestead located in Section 2 T29N R51W on a rolling upland bench flanked by a large drainage to the north (**Figures 89 and 98**). The site measures 790 feet by 305 feet and covers an area of 194,780 square feet. Vegetation consists of a moderate grass cover and scattered cottonwood trees affording 75 percent bare ground visibility. Sediments consist of sandy silt loam as observed along drainage cuts and two-track roads. Impacts to the site include historic ranching and farming activities throughout the area, grazing, and wind and water erosion. The site datum is a GPS point taken from the concrete animal trough (Feature F2).

Figure 89. 25DW366, site overview, facing southeast. Photograph taken by Russ Collett 12/3/10.

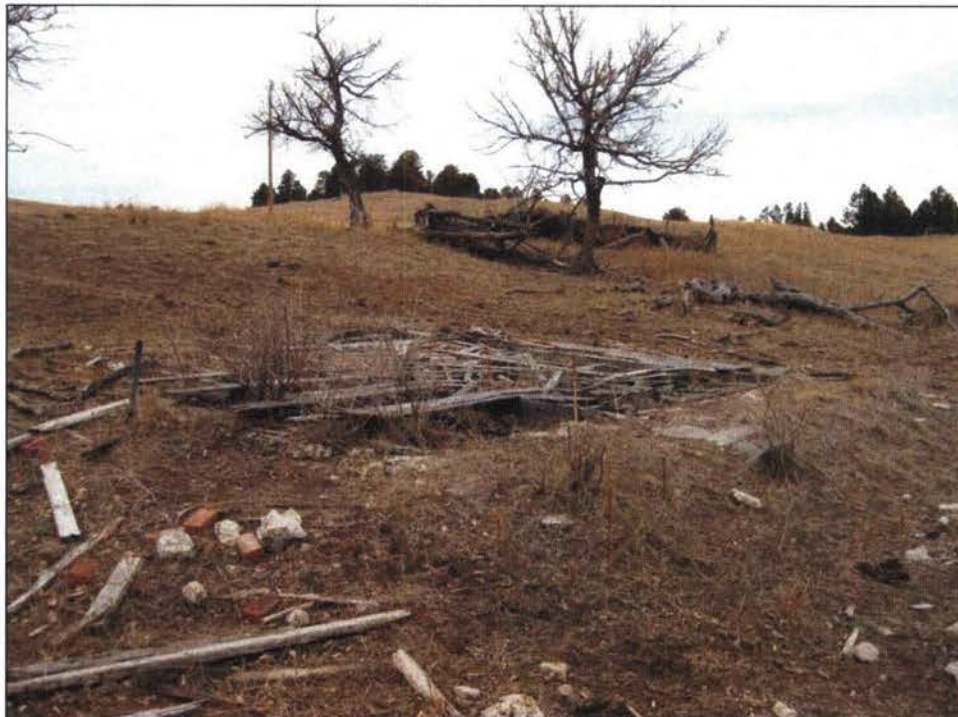
The house foundation (Feature F1) consists of locally available sandstone above which wooden remnants of a collapsed or razed frame and floorboards remain (**Figure 90**). The Feature F1 foundation has a rectangular floor plan and measures 20 feet by 25 feet. The building is presumed to have faced east as indicated by the remnants of a narrow poured concrete walkway that trend to the east. A row of trees is located east of Feature F1 and may have served as a windbreak, ornamental garden, or fruit orchard.

Figure 90. 25DW366, Feature F1 house foundation, facing northwest. Photograph taken by Russ Collett 12/3/10.
