NUREG/CR-7153, Vol. 2  
ORNL/TM-2013/532

# **Expanded Materials Degradation Assessment (EMDA)**

## **Volume 2: Aging of Core Internals and Piping Systems**

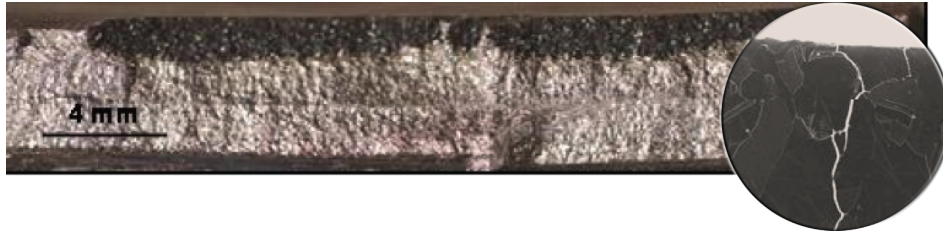
**Figure 2.1. Fracture surface and cross-sectional view of the cracking observed at the safe end in Mihama unit 2, after [10].**

Circumferential shallow intergranular cracking was identified in Mihama unit 2 in 2008 [10]. The cracks were located at the safe end made from forged 316 SS. The safe end was welded with the steam generator inlet nozzle and main coolant piping in the primary system. The temperature at the inlet nozzle is about 320 °C (608 °F) during operation. The inner surface was machined and surface-ground after welding. The surface hardness was reported to be ~400 (H<sub>v</sub> 1g load) [10]. The maximum depth of the cracking was 0.9 mm. The cracking was located about 3 to 5 mm away from the weld fusion line. An example of the fracture surface and cross-sectional view of the cracking is shown in Figure 2.1. The steam generator in Mihama unit 2 was replaced in the beginning of 1990. The replacement was outfitted with Alloy 690TT tubing. The plant resumed operation in 1994. Therefore, the cracking near the safe end weld is thought to have developed between 1994 and 2008. Significant sensitization was not observed by electrochemical potentiokinetic reactivation method (EPR) and by transmission electron microscope (TEM) observation. Since before 1994, the diaphragm of the make-up tank in Mihama unit 2 has been covered by N<sub>2</sub> gas to keep the oxygen concentration low. Consequently, the influence of oxygen ingress on the cracking of Mihama unit 2 is not postulated to be very significant.

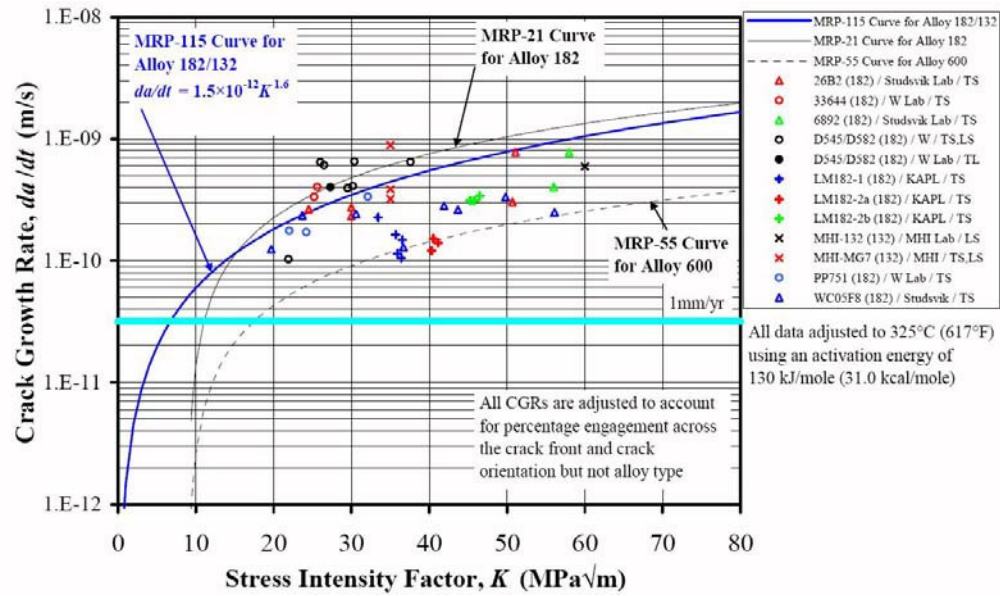
Figure 3.4. Crack growth rate of Alloy 182 and 132 weld metals in PWR primary water along with disposition curves for Alloy 182 weld metal (MRP-115 [22]) and Alloy 600 (MRP-55 [23]). Cold work and temperature cause an increase in crack growth rate.

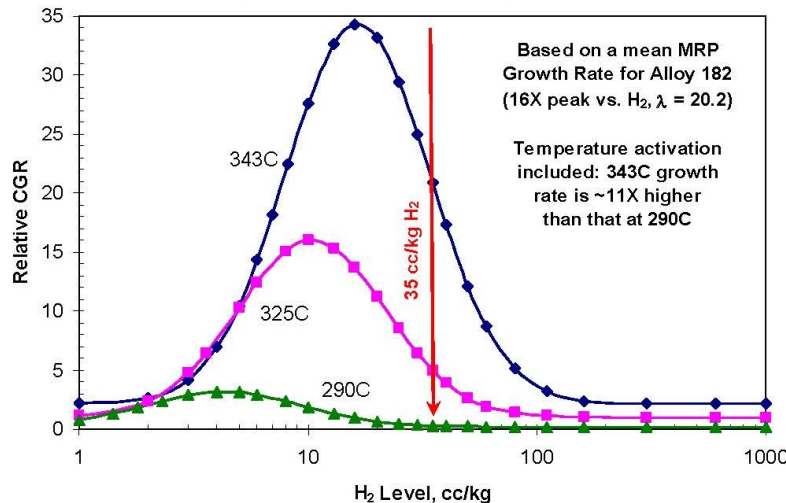
Figure 3.7. Predicted effect of H<sub>2</sub> on the relative crack growth rate of Ni alloy weld metals based on a 16× crack growth rate peak height at 290 °C, 325 °C, or 343 °C, (554 °F, 617 °F, or 650 °F) with the effect of temperature activation on crack growth rate factored in. From a H<sub>2</sub> level of 35 cc/kg, shifting to higher H<sub>2</sub> will monotonically decrease crack growth rate. For lower H<sub>2</sub>, no benefit will occur until the H<sub>2</sub> level is below about 0.52, 3.1 and 7.7 cc/kg H<sub>2</sub> for 290 °C, 325 °C, and 343 °C, respectively. While the peak height is 16× at all temperatures, the crack growth rate is much higher at 343 °C.

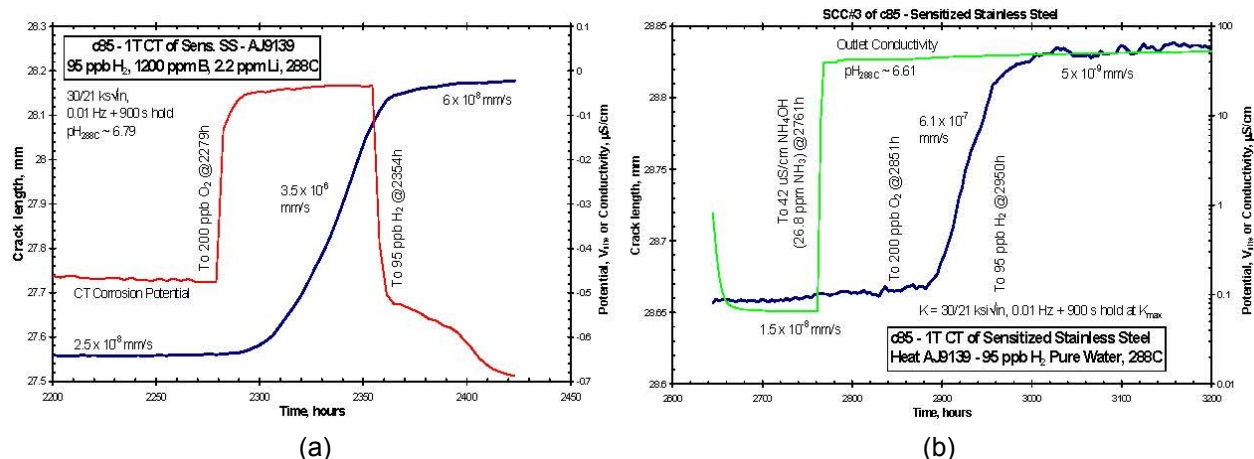
Figure 3.10. SCC crack length vs. time of sensitized stainless steel in 288 °C (550 °F) showing that the presence of (a) 1,200 ppm B as H<sub>3</sub>BO<sub>3</sub> and 2.2 ppm Li as LiOH, or (b) 26.8 ppm NH<sub>3</sub>, results in a low growth rate until the corrosion potential becomes elevated at 2,279 h by the addition of 200 ppb O<sub>2</sub> [15, 16].

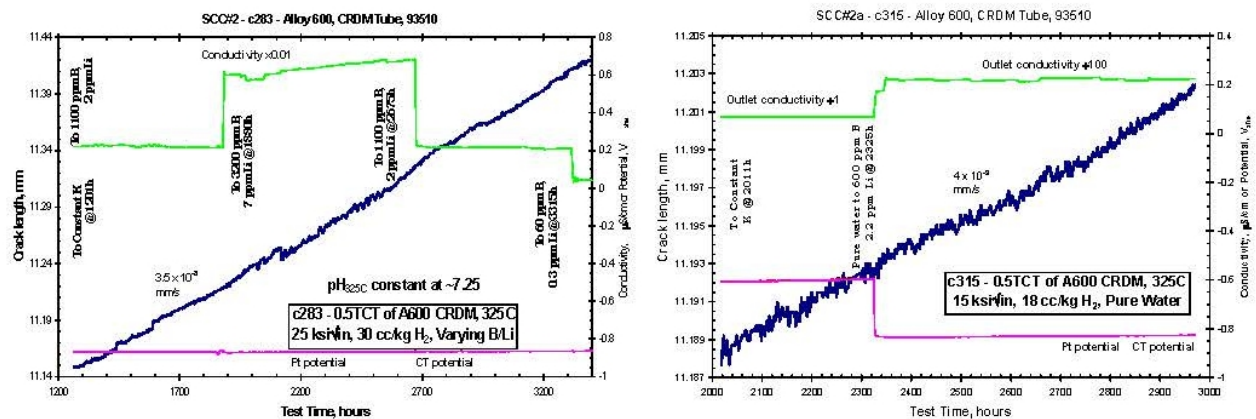
Figure 3.14. Crack length vs. time for Alloy 600 and tested in 325 °C water containing 30 cc/kg H<sub>2</sub> under constant K conditions showing that extensive variations in B and Li content in produced no change in crack growth rate [15].

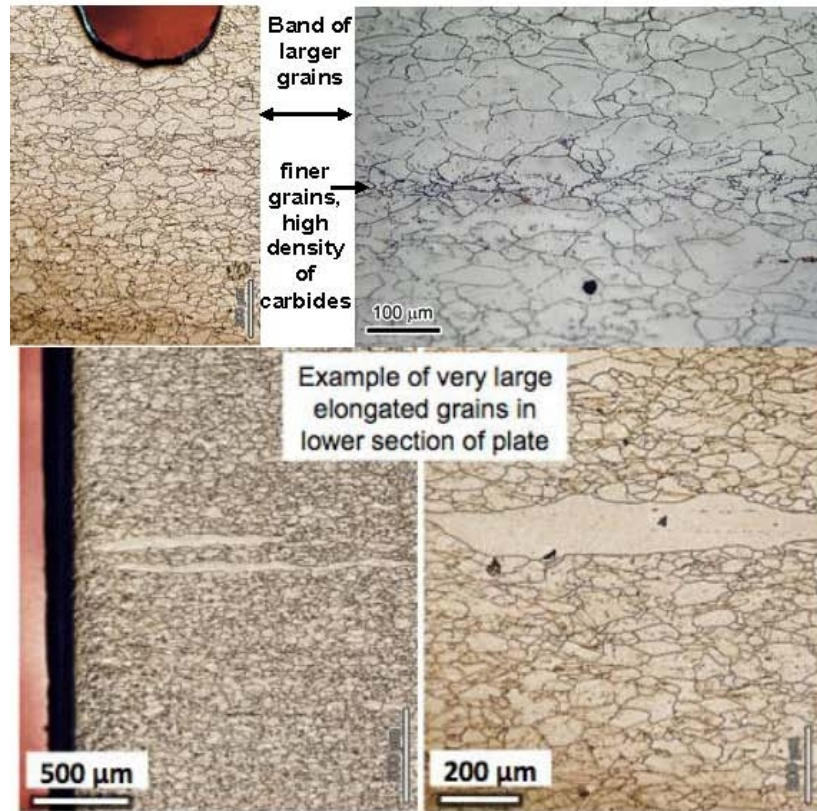
**Figure 4.2. Optical micrographs illustrating microstructural variations due to compositional banding in an Alloy 690 plate material [14].**
