Near-term Task Force Recommendation 2.1 Seismic Hazard Evaluation

Entergy

NTTF Recommendation 2.1- Summary of Preliminary Seismic Hazard Analysis: Indian Point Units 2 and 3

June 19, 2014

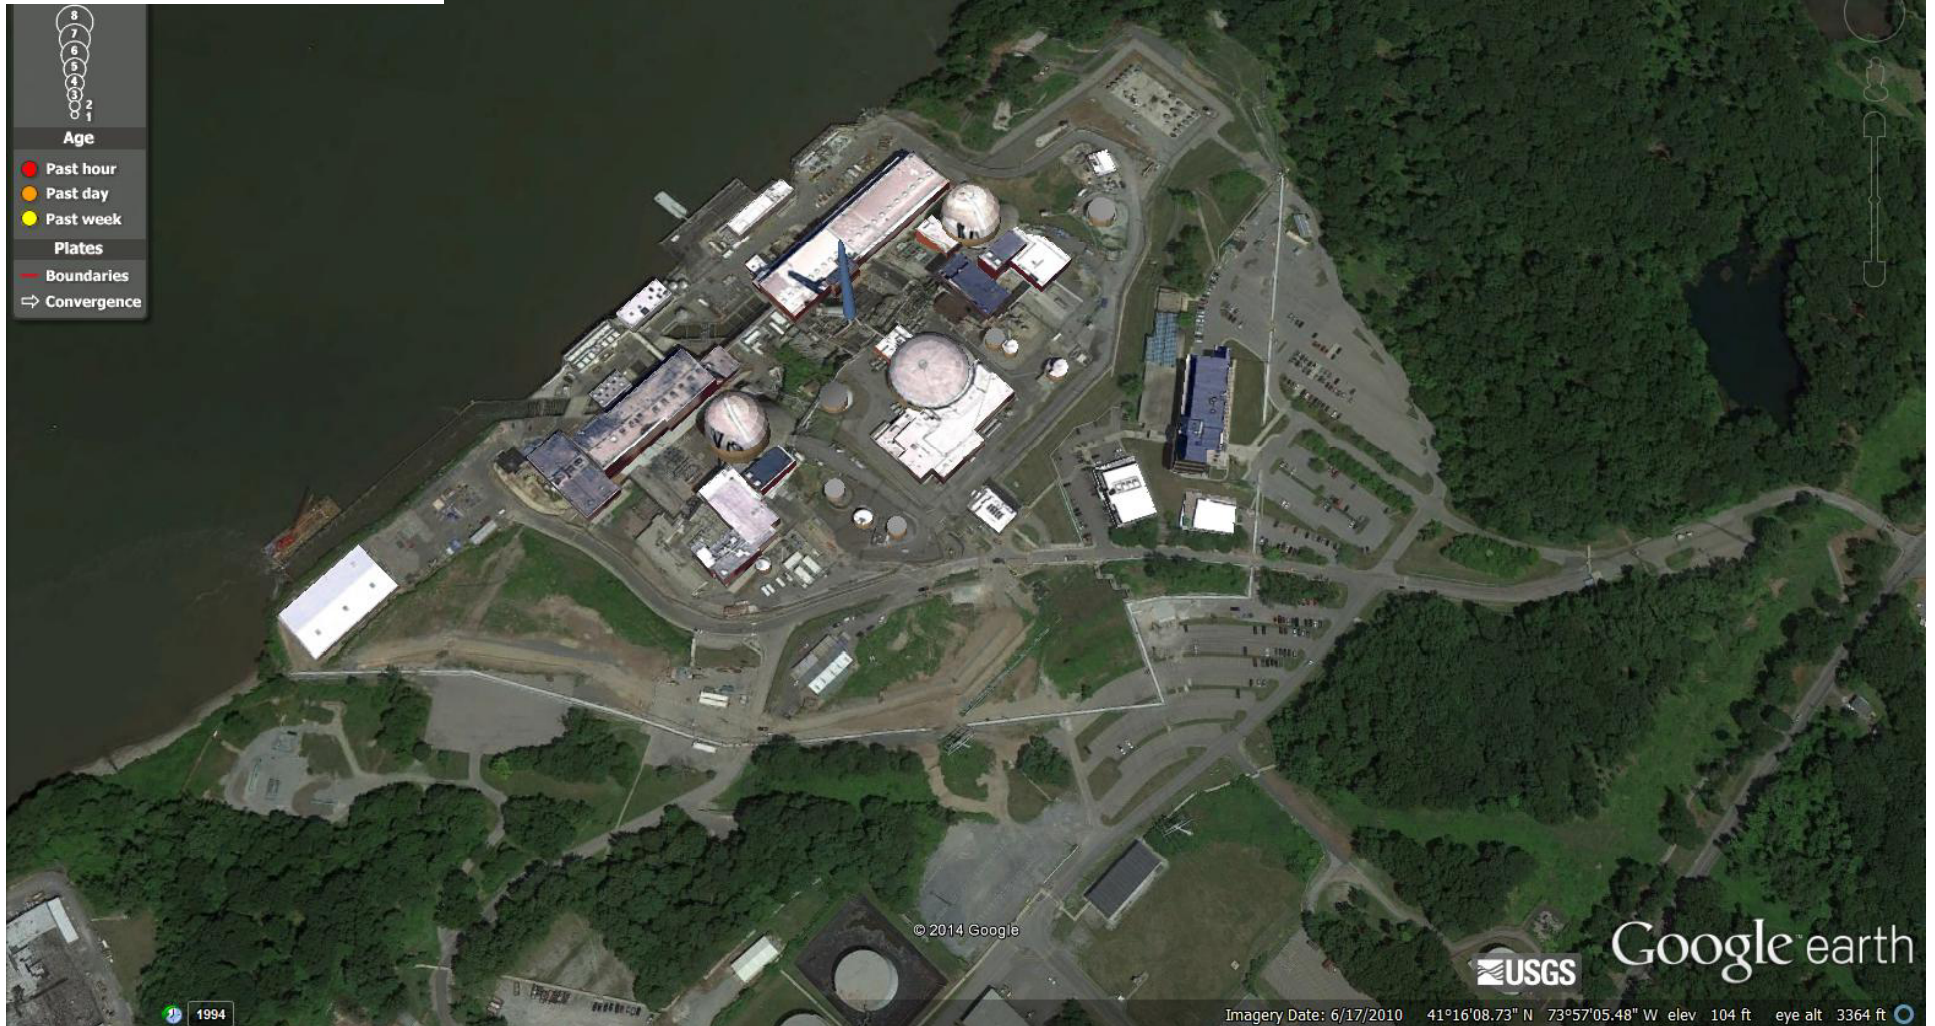
Indian Point: Local Geology

From Guide to Courtland Igneous Complex, 2008.

Bedrock: Inwood Marble w/Manhattan schist present in northeastern portion of site

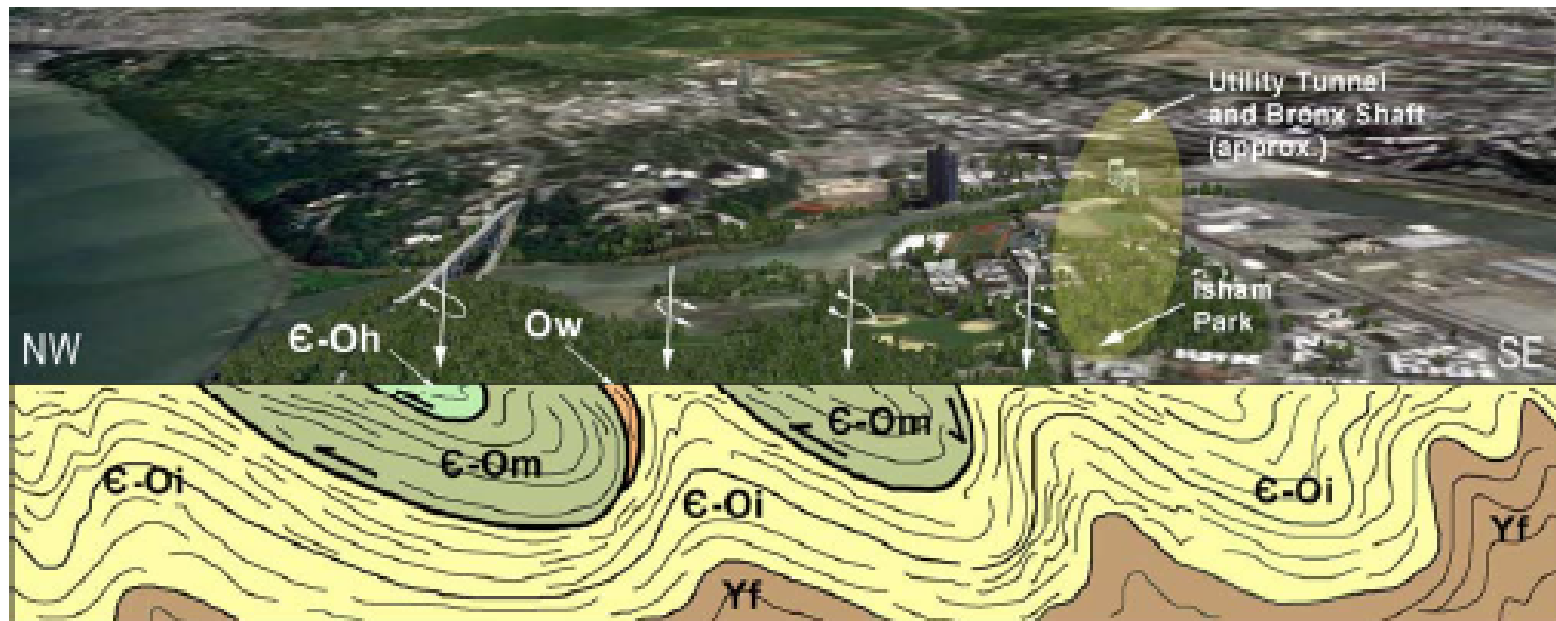
Geologic section of Inwood in Upper Manhattan (type section)

Based on regional observations: assume that the Cambrian Quartzite
And underlying units have a $V_s > V_s$ reference

- Indian Point is a firm rock site. Consistent with SPID the Control Point is defined as the top/surface of the rock unit (the Inwood Marble).
- To reiterate: it has been assumed that the underlying Ordovician Lourre Quartzite and underlying gneisses and intrusives have a velocity ≥ 9200 fps (reference rock velocity).

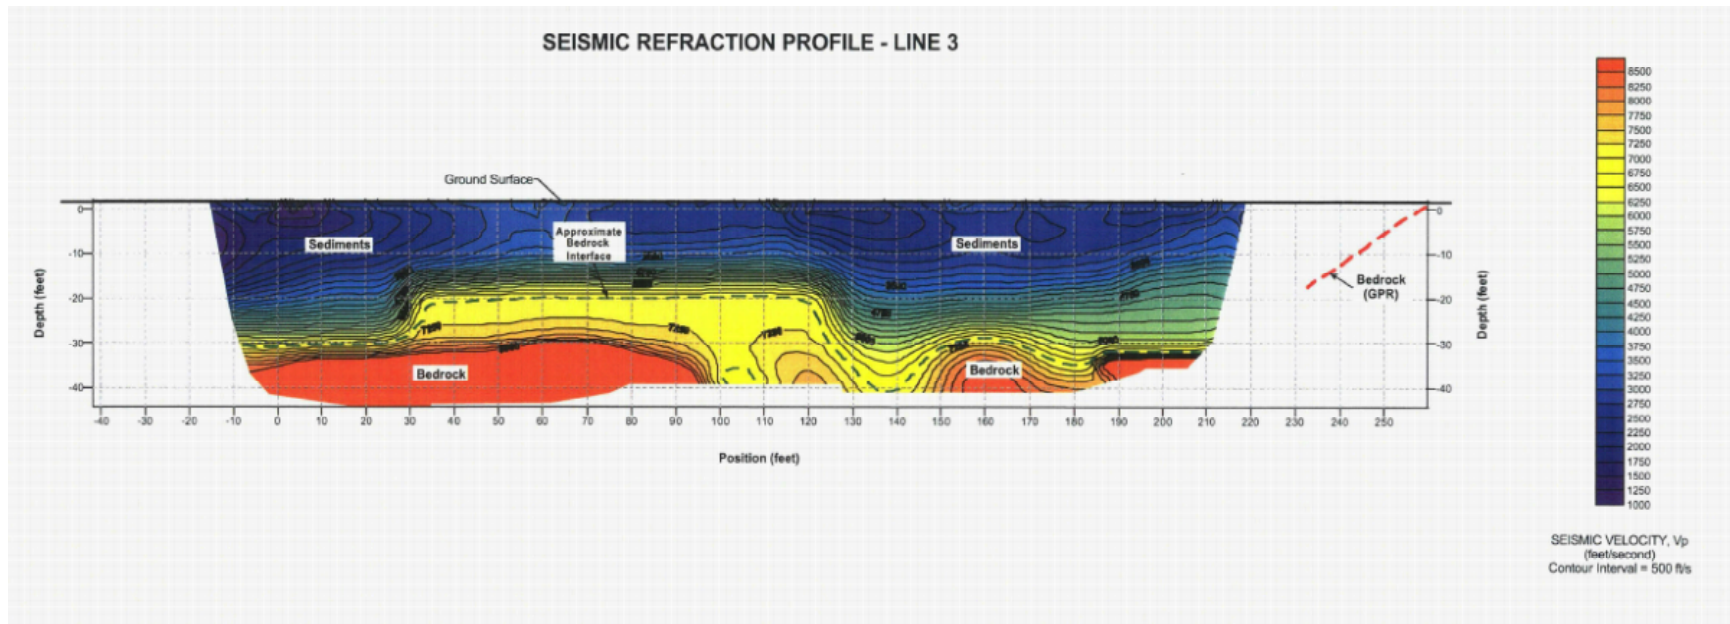
GZA Report: Seismic Profiles

Independent P-wave data indicates $V_p \sim 8-9000$ fps in near surface.

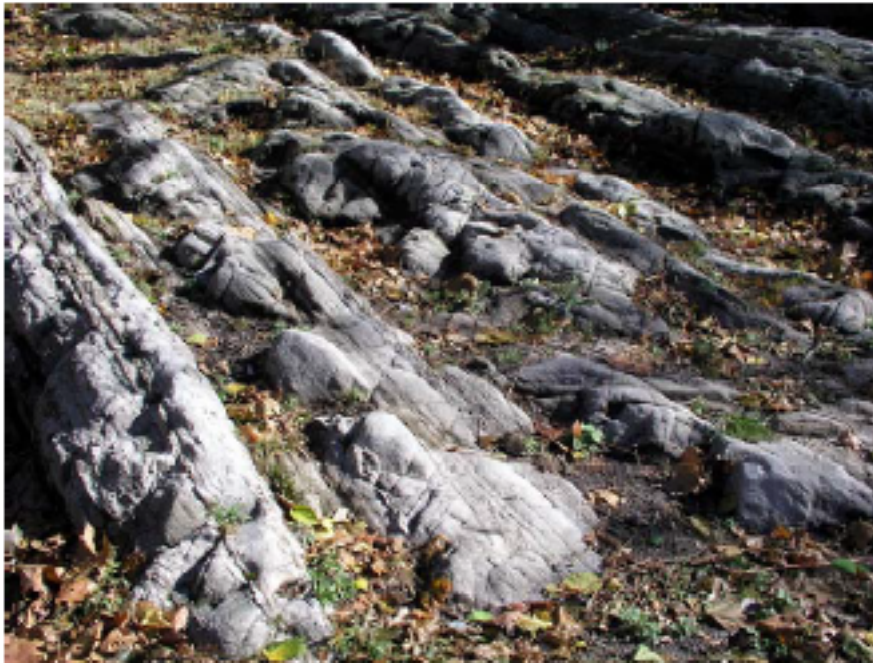
Why P-Wave Refraction Results Should be Used With Caution Here

Conclusion based on results of P-wave refraction. Velocities of 8000-16,000 fps cited.

Significant layered (bedding) in near-vertical attitude. Discontinuous "stringers" of very hard material. Very easy (maybe impossible not to) to bias refraction results to high value.

Vs for these Vp values: 4600-8550 fps (assuming $\nu = 0.3$).

From- Merguerian, C., et al., 2011
