SUBJECT: OBSERVATIONAL SITE VISIT AT LOWMAN DISPOSAL SITE

Report: WM-00043/15-001

Facility: Lowman Disposal Site

Attachment: Photographs Taken at the Lowman Disposal Site

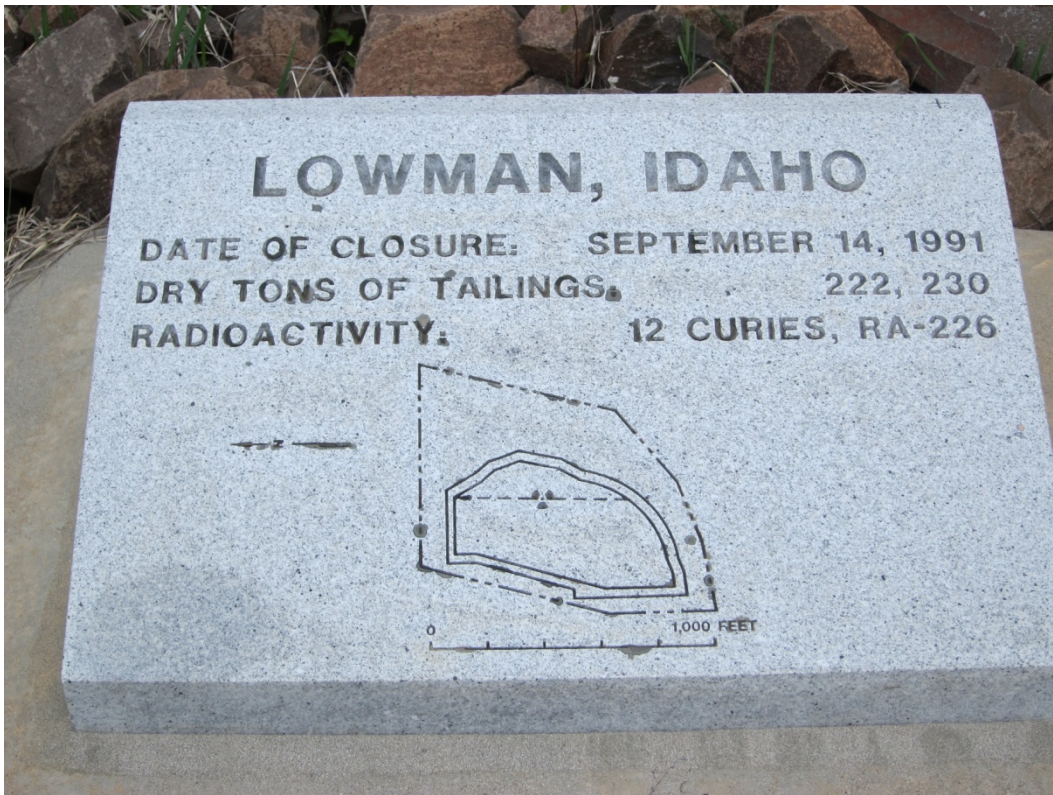
Figure 1: Lowman disposal site marker

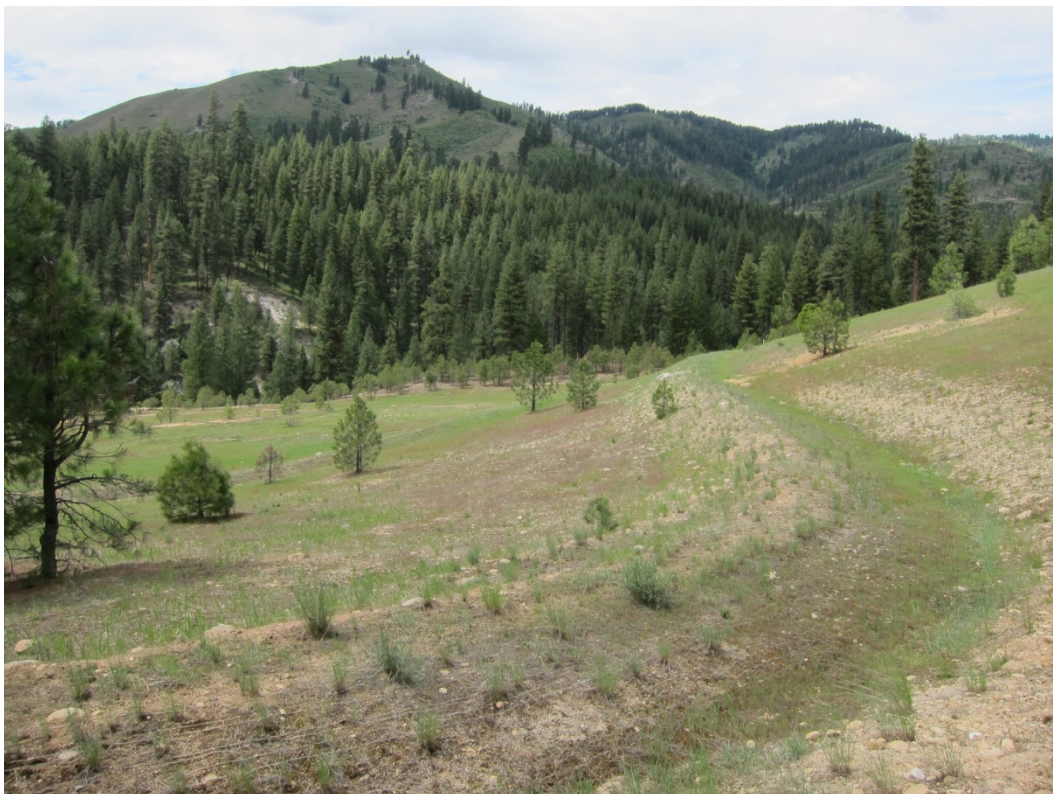
Following construction of the disposal cell, the DOE implemented a seeding and vegetation program to help control erosion in areas adjacent to the cell; however, the results were not successful. In 1997, DOE constructed a collection ditch and three drainage terraces, also called interceptor benches, to the north of the disposal cell. The collection ditch and drainage terraces were designed to intercept rainwater runoff and divert it away from the disposal site.

cell. Some minor washout/erosion was observed north of the cell, but this erosion had no impact on cell integrity.

Figure 2: Interceptor bench 2 located north of disposal cell (looking north)

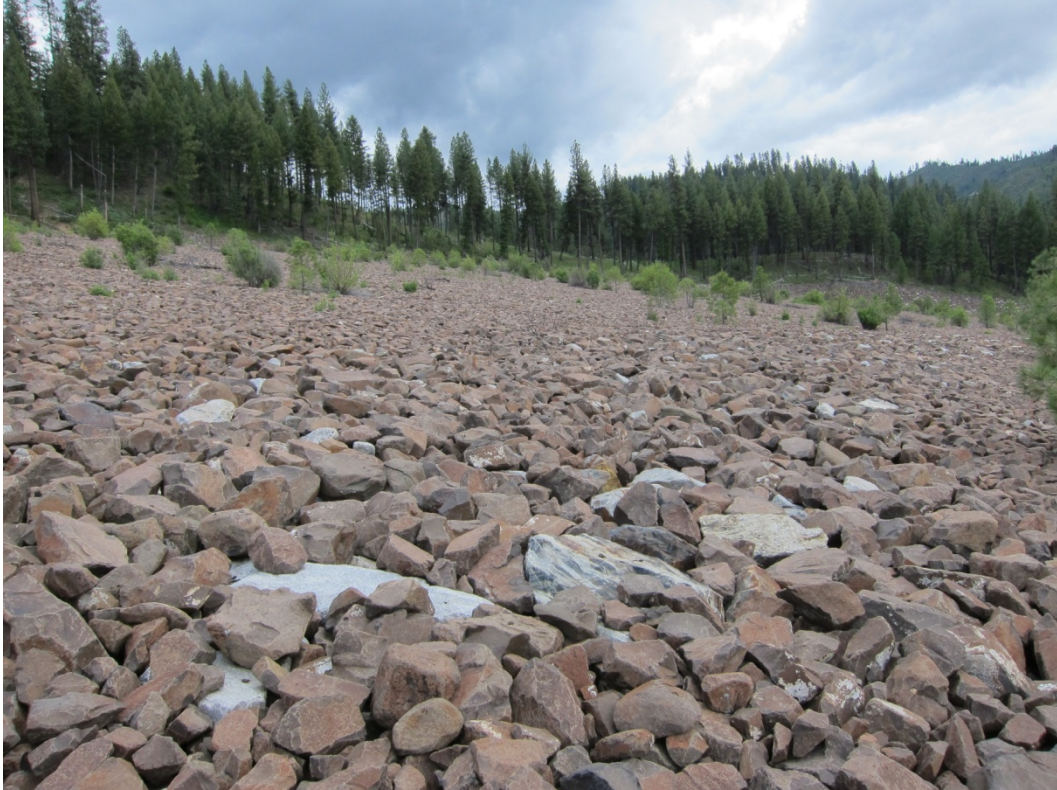
The inspector observed that the disposal cell appeared to be in excellent condition. No erosion or slumping was observed on or around the cell. Although vegetation was observed on the cell cover and apron, there were no large trees growing on top of the

Figure 3: Northwestern edge of cell looking southeast (apron in foreground)

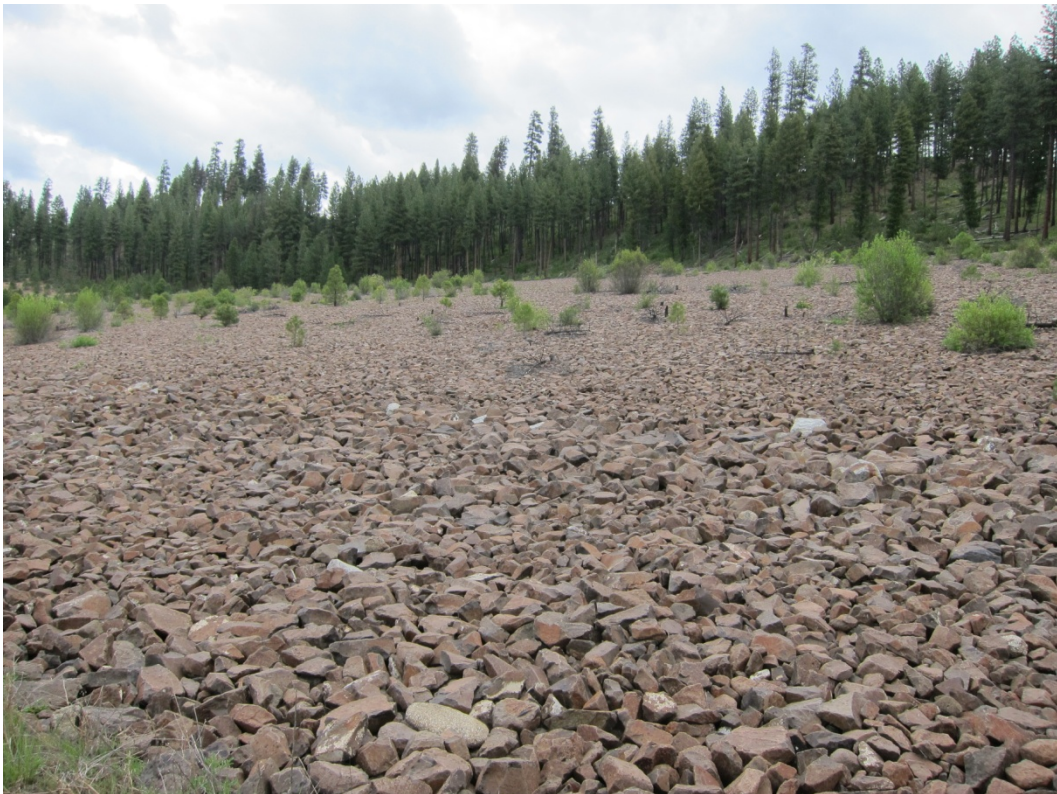
Figure 4: Southwestern edge of cell looking northeast (apron in foreground)
