Cable Insulation Resistance Measurements Made During Cable Fire Tests

Sandia National Laboratories

**U.S. Nuclear Regulatory Commission
Office of Nuclear Regulatory Research
Washington, DC 20555-0001**

Manuscript Completed: April 2002
Date Published: June 2002

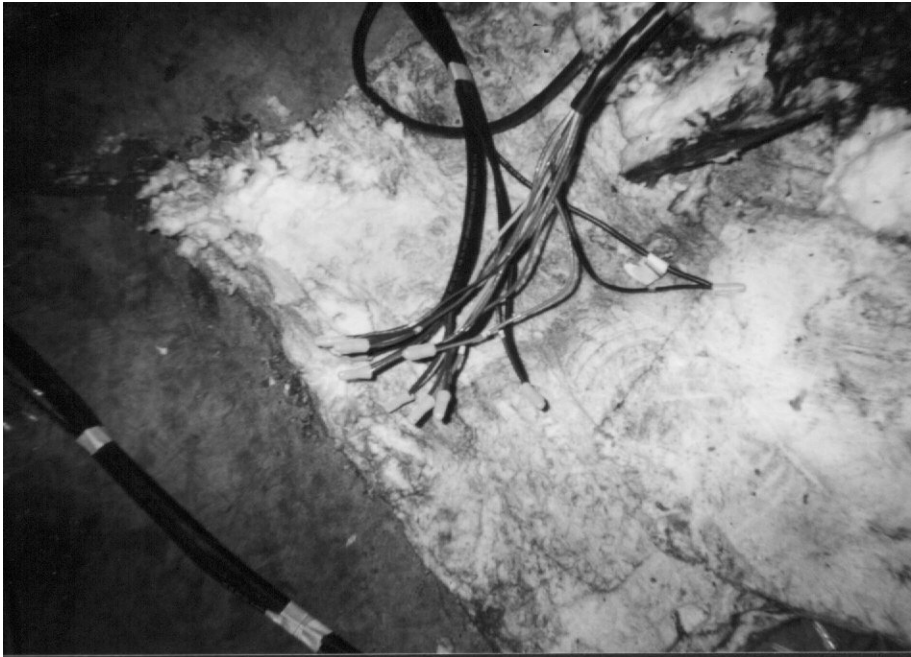
Figure 3-11. IR measurement system “in” wiring harness connection to the test cable bundle.

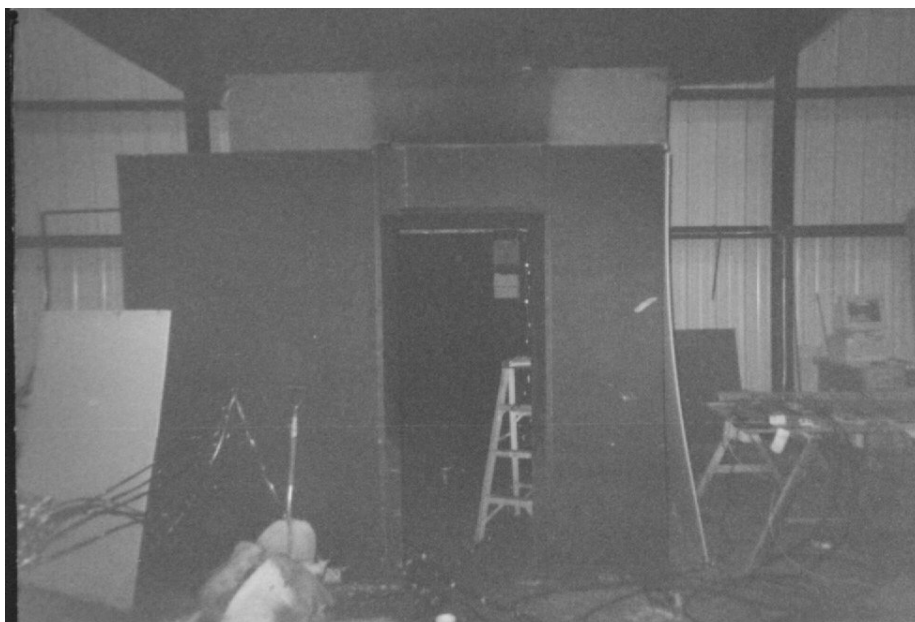
Figure 4-1. Fire test cell.

All of the 18 fire tests described here were conducted in a steel chamber measuring 3 m (10 ft) wide, 3 m (10 ft) deep, and 2.4 m (8 ft) high, shown in Figure 4-1. The chamber has an opening (door) ~76 cm (30 in.) wide by 2.1 m (7 ft) high in the center of one wall. The exposure fire was generated by flowing propane gas through a 30 cm (12 in.) \times 30 cm (12 in.) diffusion burner (a “sand burner,” see Figure 4-2). The fire intensity was controlled by the flow rate of the propane through the burner and ranged from 70 to 350 kW.

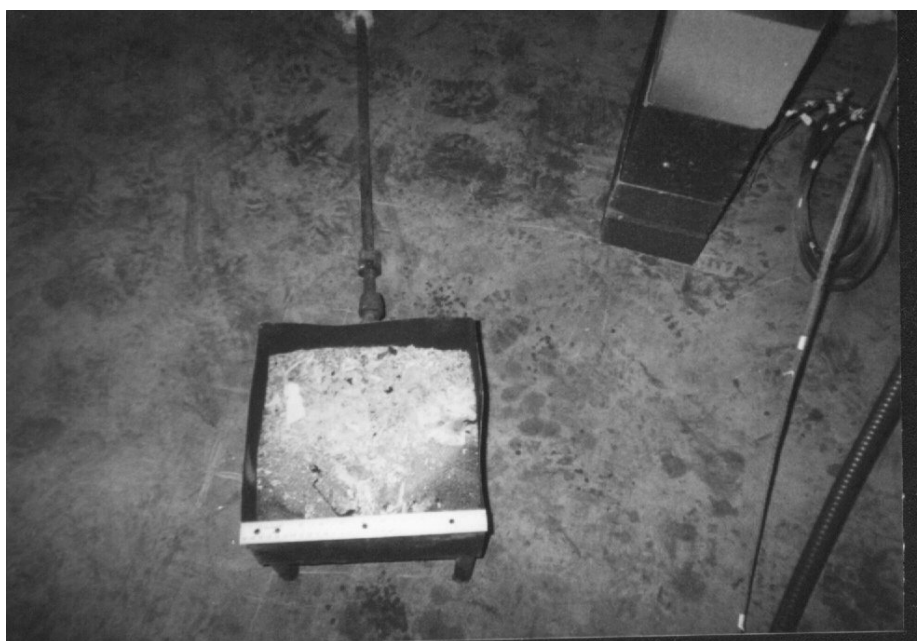
Figure 4-2. Diffusion burner—30 cm \times 30 cm (12 in. \times 12 in.).
