TEST PLAN 213 - REPORT

MODEL 867

SENTRY CHANGER

TRANSPORT PACKAGE

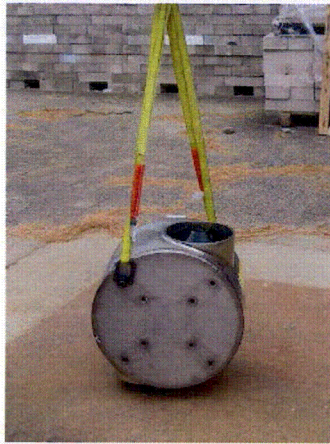
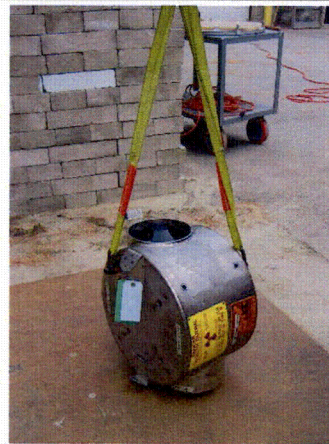
Test Specimen TP180J was dropped from 4.7 feet in the planned orientation - with port "A" facing downward towards the drop pad. See **Figures 4.1.1 & 4.1.2**.

Figure 4.1.1: Four foot drop setup – Side view

Figure 4.1.2: Four foot drop setup – End view

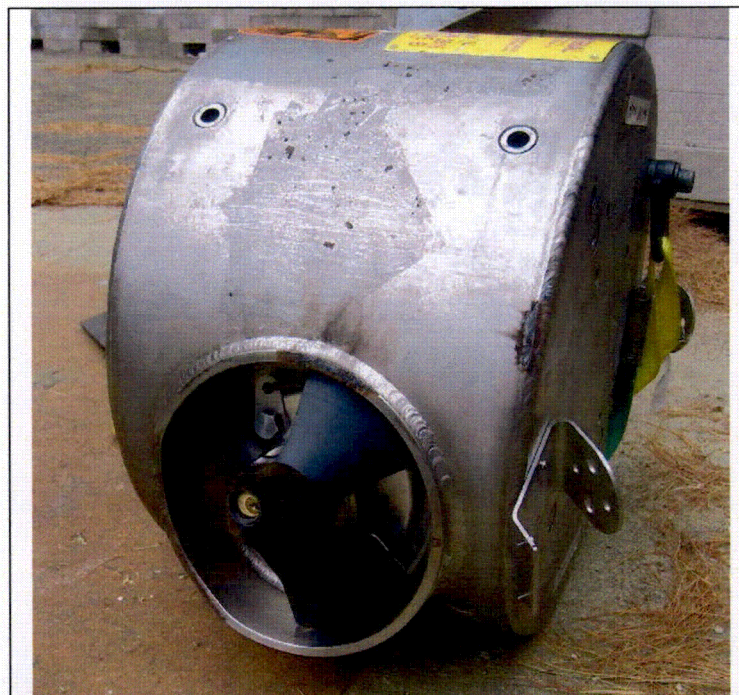
Inspection of the specimen immediately after the drop found a rusty imprint of the drop pad surface on the outward facing surfaces of the plastic dust cover and also on the rim of the welded port tube of port "A". The welded port tube of port "B" was bent slightly inward towards the center of the port by about 0.5 inches. A small screw holding the dust cover storage bracket to the top surface of the specimen had broken off leaving the bracket with one remaining screw. The dust cover storage bracket and attachment screws provide no safety function to the package and are not considered important to safety.

Figure 4.1.4: Port "A" – Immediately after drop.

- Drop pad imprinted on dust cover and port "A" rim.
- Minor dent in top edge seam near port "A" about 2 inches long.
- Minor bend in port "A" tube toward tube center about 0.12 inches
- Minor bend in port "B" tube towards tube center about 0.50 inches.
- Dust cover bracket screw broke and missing.
- No movement or damage to source assembly.
- No damage to the rear plate or the rear plate attachment bolts.

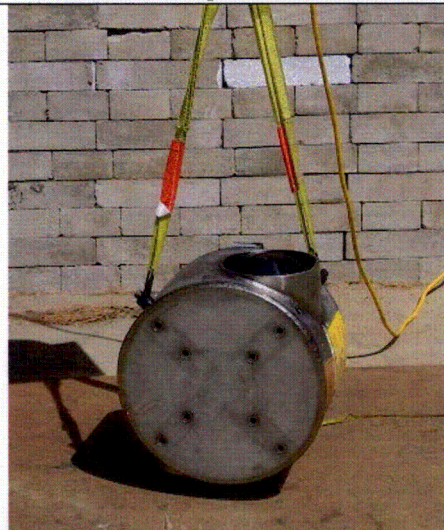
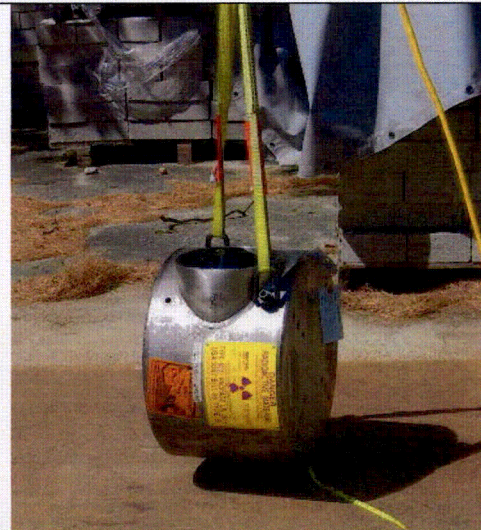
Figure 4.2.1: 1st Thirty foot drop setup – Side view

Figure 4.2.2: 1st Thirty foot drop setup – End view

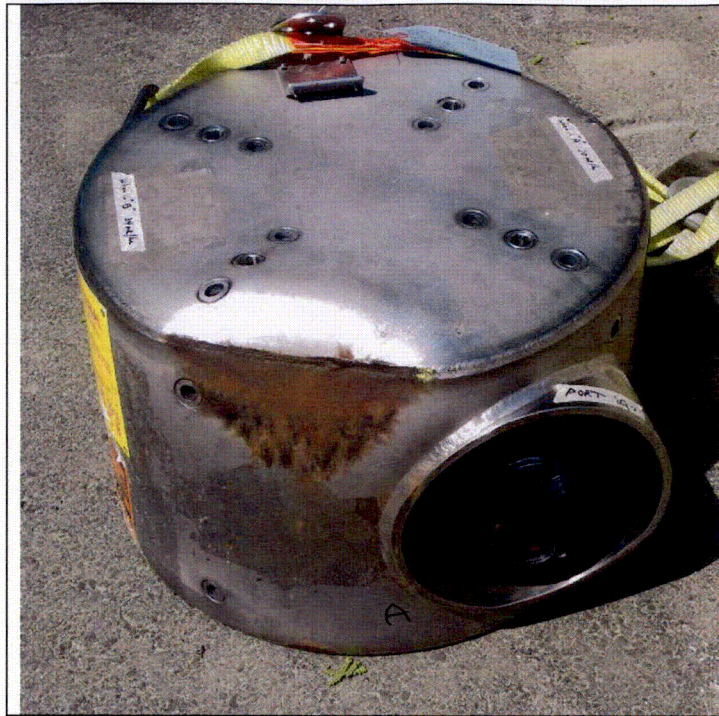
In the first 30-foot drop, the specimen rotated slightly during descent and landed near the center of the essentially unyielding drop pad hitting the top edge of the welded body near port "A". **Figure 4.2.3** shows the point of impact on the specimen. After impact, the specimen bounced about 1-foot and then flipped twice before landing on the flat bottom surface of the welded body about 4-feet from the drop pad.

Inspection of the specimen immediately after the first drop found a rusty imprint of the drop pad surface at the welded edge seam between the cylinder and top surface of the body. The impact deformed the edge seam inward about 2 inches causing an 8 inch wide flat with a 2 inch high outward bulge on the top surface of the body. The seam weld was sealed and completely intact.

Figure 4.2.3: 1st Thirty foot drop damage.

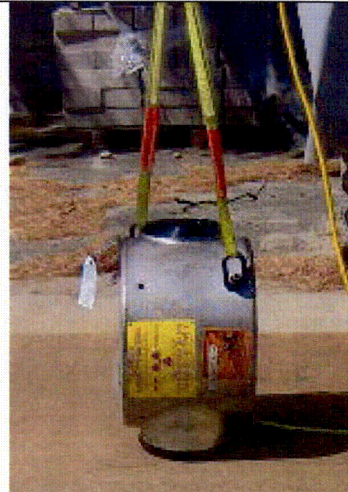
Figure 4.2.4: 2nd Thirty foot drop setup – Side view

Figure 4.2.5: 2nd Thirty foot drop setup – End view

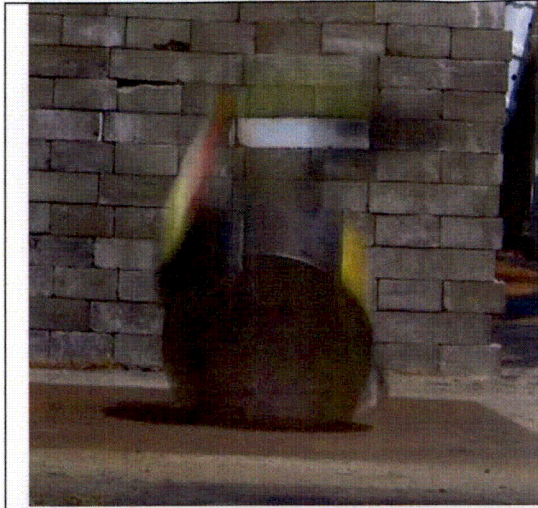
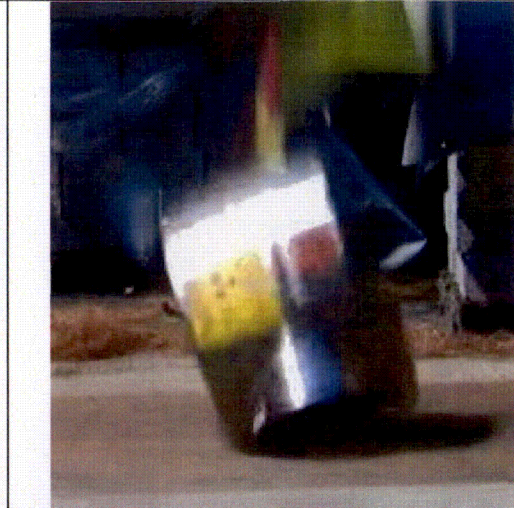
Figure 4.2.6: 2nd Thirty foot drop impact – Side view.

Figure 4.2.7: 2nd Thirty foot drop impact – End view.

Figures 4.2.6 & 4.2.7 show the approximate moment of impact for the 2nd thirty foot drop test. After impact, the specimen bounced about 2-feet and then flipped before landing again on the flat bottom surface of the welded body about 2-feet from the drop pad against the brick retaining wall.

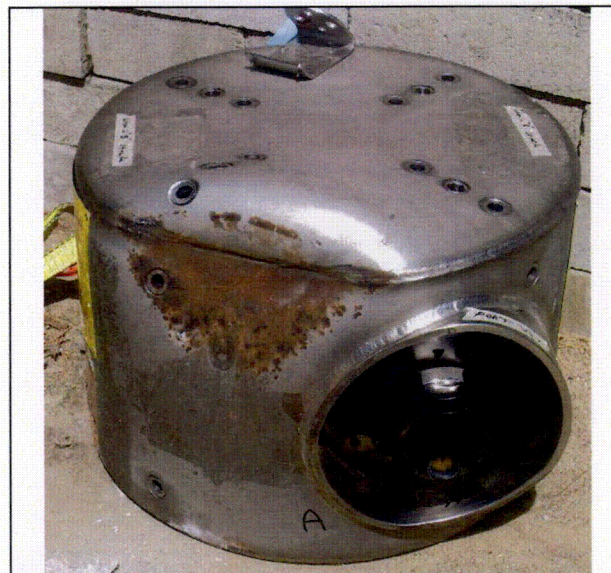
The edge seam dent from the first drop grew slightly in the second drop. The edge depression increased by about 1 inch inwards, and the top surface bulge grew about 1 inch outward. Again, the weld was sealed and completely intact.

A light rusty imprint of the drop pad surface could be seen on the outward facing surface of the port “A” dust cover. It appears the second impact was a glancing blow to the dust cover before hitting the edge seam again.

Figure 4.2.8: 2nd Thirty foot drop damage.

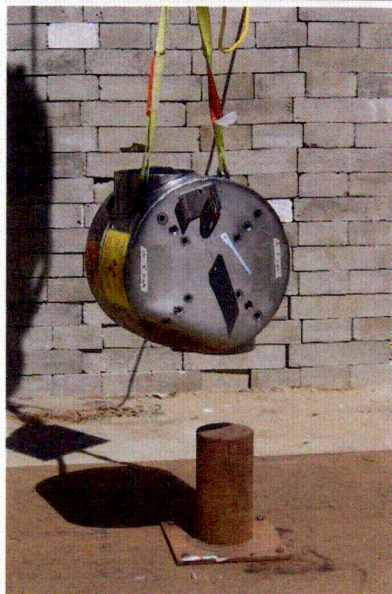
Figure 4.3.1: Puncture drop setup – Side view

Figure 4.3.2: Puncture drop setup – End view

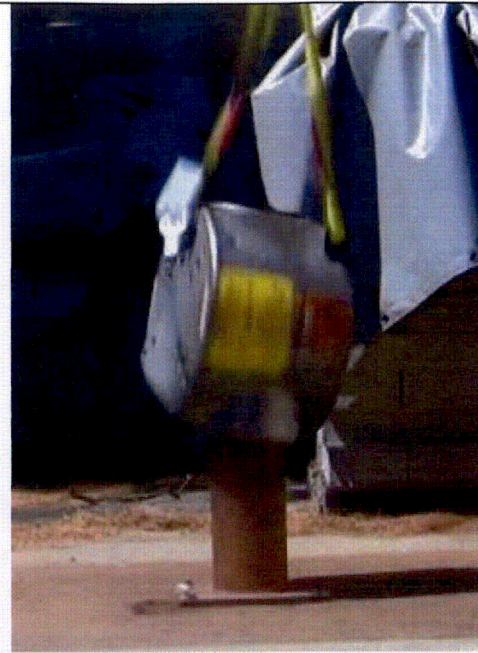
The specimen landed squarely on the top surface of the rigidly mounted puncture billet located at the center of the essentially unyielding drop pad. The plastic dust cover of the specimen hit directly onto the top of the billet. The port tube rim did not appear to contact the billet leaving the entire impact being fully applied to the plastic dust cover.

Figure 4.3.3: Puncture drop impact – Side view.

Figure 4.3.4: Puncture drop impact – End view.

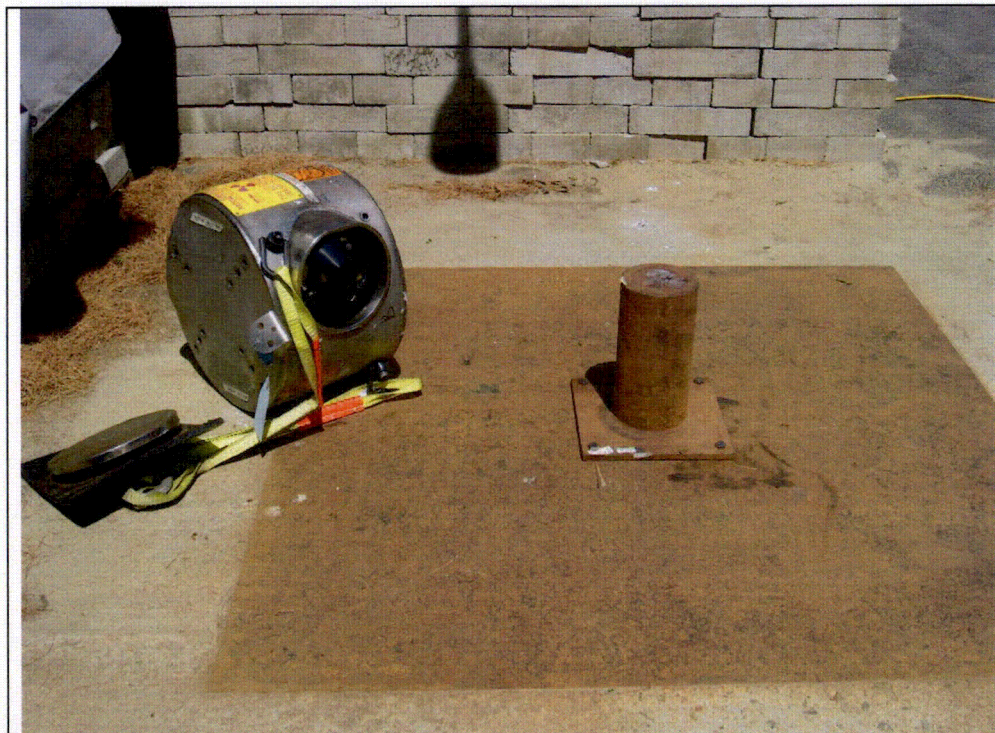
After impact, the specimen bounced up and flipped backwards hitting the side of the specimen on the billet again before landing on its side just off the drop pad. The orientation of the specimen immediately after the drop had the axis of both port tubes aligned horizontally relative to the drop pad surface with Port "A" at ground level and port "B" at the higher elevation by the parallel distance between the two ports. See **Figure 4.3.5** for the test specimen resting location and position immediately after the puncture drop.

Figure 4.3.5: Test specimen rest position after puncture drop.

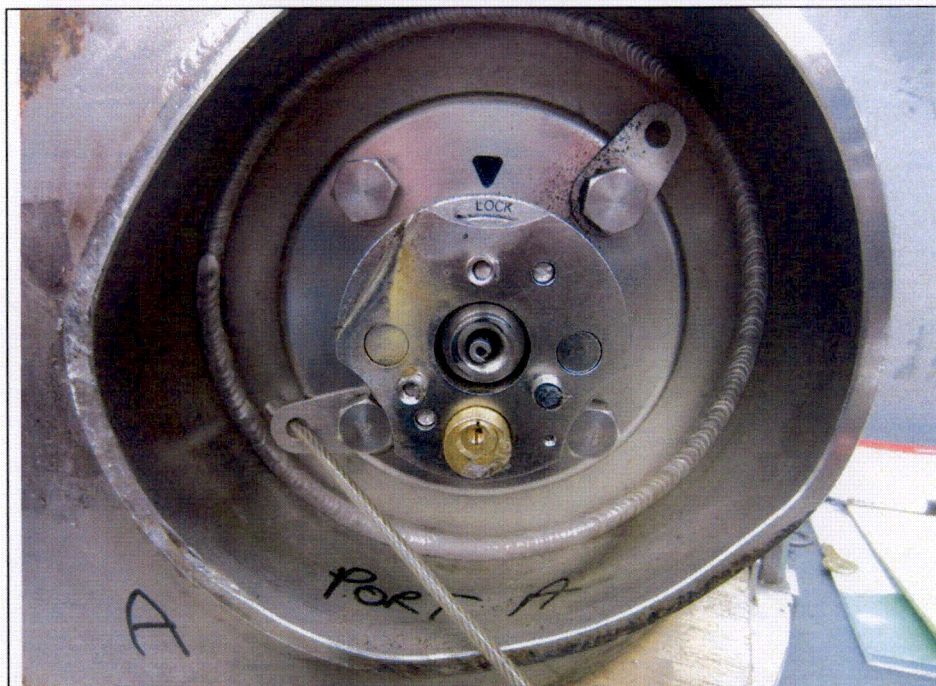
The brass lock was damaged enough to prevent key insertion. The brass lock was drilled out to remove the lock cover. The lock cover was completely intact and remained in place. The rear plate assembly continued to secure and lock the source assembly in its fully shielded position within the package.

Figure 4.4.3: Lock assembly intact and functional – except brass lock.
