# **1991 Annual Prelicensing Inspection of the Spook, Wyoming, UMTRA Project Disposal Site**

**September 1992**

**U. S. Department of Energy  
Albuquerque Field Office  
Grand Junction Projects Office  
Grand Junction, Colorado**

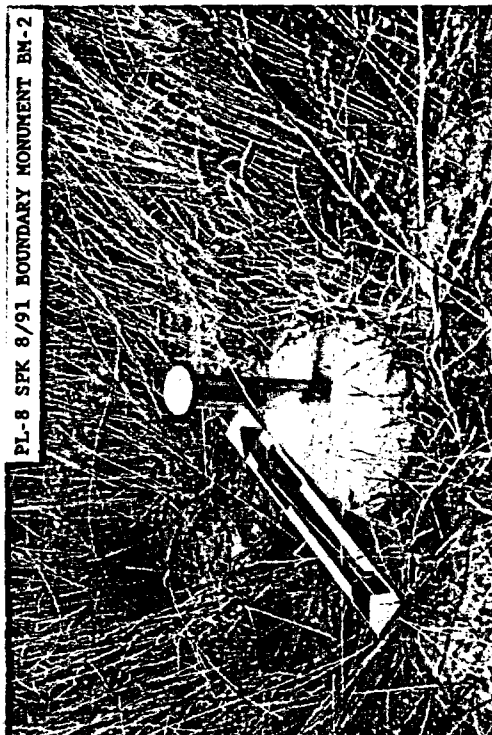
PL-8 SPK 8/91 BOUNDARY MONUMENT BM-2

Eight boundary monuments exist at the site—BM-1, BM-2, BM-3, BM-4, BM-5, BM-6, BM-7, and BM-8. The monuments delineate the approximate boundary of the 200-foot buffer zone around the perimeter of the former Spook pit highwall (PL-7 through PL-11, PL-12A, PL-13, and PL-14). All the boundary monuments are undisturbed and in good condition.

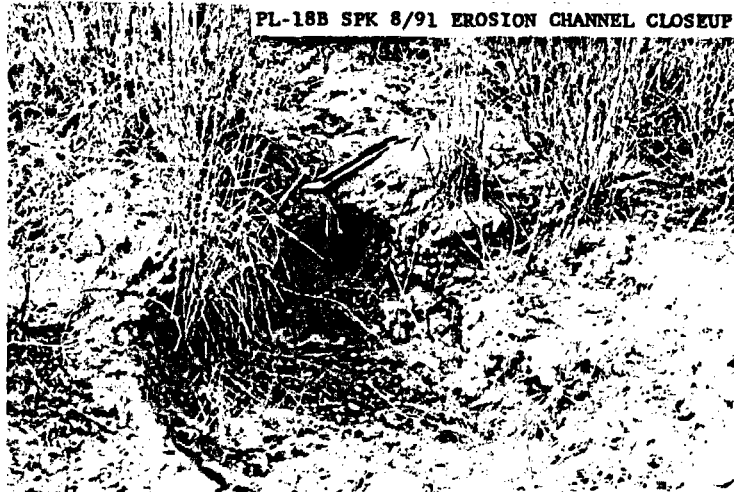
PL-18B SPK 8/91 EROSION CHANNEL CLOSEUP

The erosion observed was a channel along the northeast boundary of the site between BM-1 and BM-2 (PL-18A and PL-18B). This erosion channel trends in a southeasterly direction. This channel is not considered unusual because the contoured topography drains to the southeast in this area (Figure 2-2). Photographs PL-17 and PL-19 show the contoured topography. The erosion is not considered serious or significant because the buried embankment is approximately 500 feet away. This channeling will be monitored during future inspections.

**Recommendation:** No action is recommended at this time. The area is sufficiently removed from the buried tailings embankment. However, the erosion will be monitored during future inspections.
